**BORING MILL GEAR EXAMINED FOR METALLURGICAL DEFECTS**

**Technical Note No. WAL TN 201/1**

**E. L. Reed**

**December 1959**

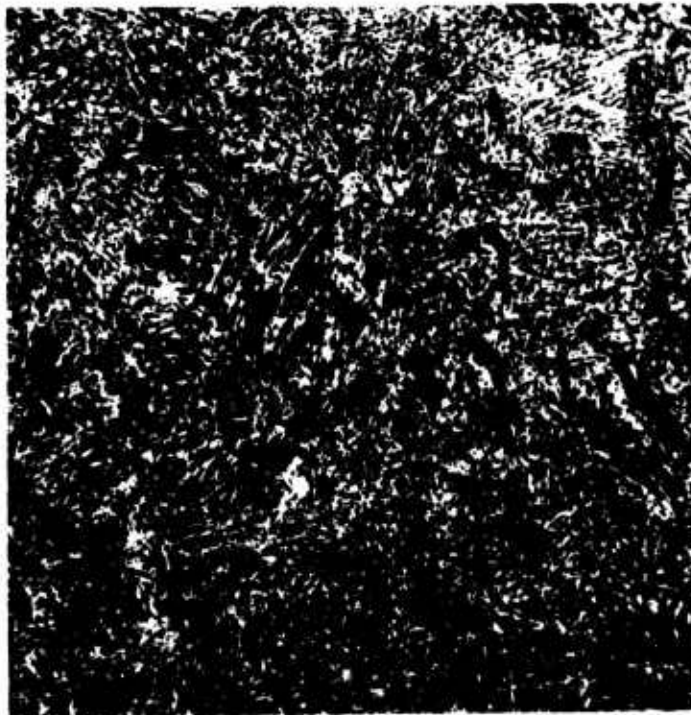
The heat treatment given the section was not adequate to obtain a desirable microstructure of tempered martensite.

PICRAL ETCH  
X1000  
TYPICAL SLACK QUENCHED STRUCTURE OF BROKEN TOOTH  
F - FERRITE,  
B - TEMPERED HIGH TEMPERATURE BAINITE,  
M - TEMPERED MARTENSITE
