Report No. 342/10  
Watertown Arsenal

December 7, 1939

BROKEN CLAMPS - HIGH FREQUENCY

5000 Lb. FURNACE - BLDG. 421

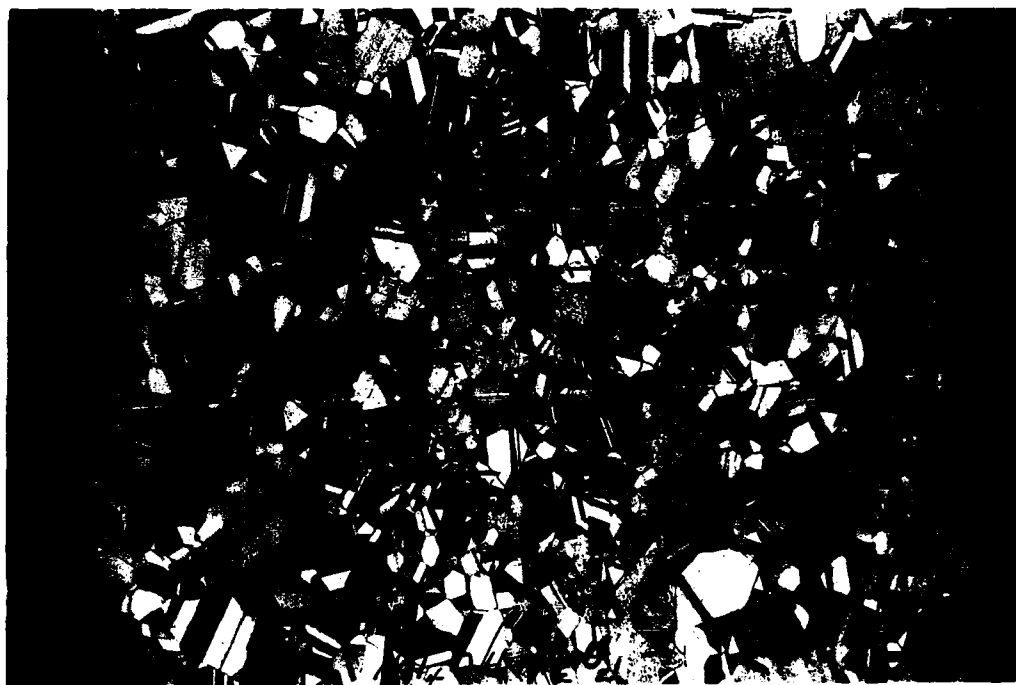
1. Embrittlement was caused by strain corrosion by some corrosive agent.
2. Intergranular cracks (many) extended nearly two-thirds through the cross section of the clamp badly covered with corrosion deposits.
3. Intergranular cracks (few in number) extended nearly two-thirds through the cross section of the clamp which was only slightly covered by the corrosion deposits.
4. The brass was apparently of satisfactory quality - fairly clean, worked and annealed, (grain size about .045-.090 mm. A.S.T.M. Standard).

5. There was considerable evidence of strain in the clamps (presence of slip lines) which might have been produced when the clamps were formed.

6. The illustration is representative of the cracks found in both clamps.

Typical Crack (Intergranular)
