REPORT NO. 310.2/12

LIGHT ARMOR PLATE

SPECIAL STUDY OF SELECTED DISSTON PLATES

October 5, 1933

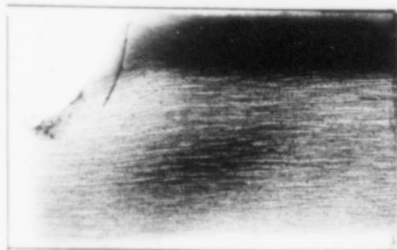
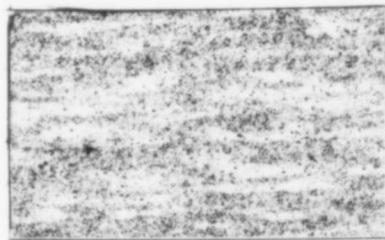
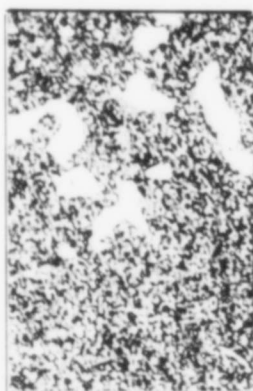
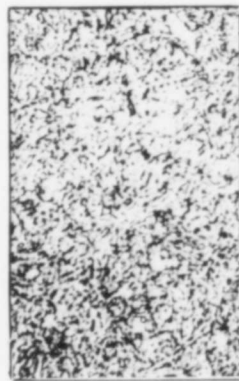
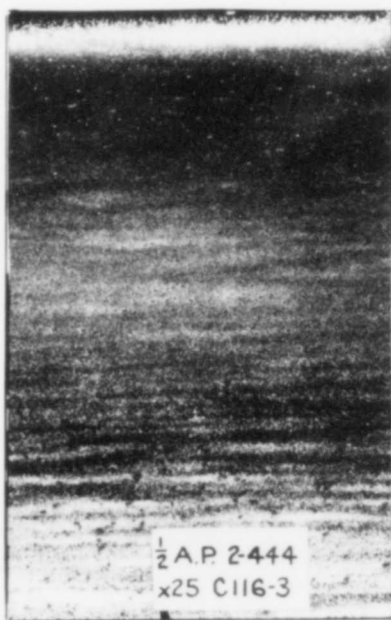
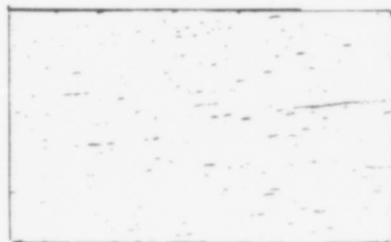
FIGURE 1.

The microstructure of all of the plates was very similar. It will be sufficient, therefore, for a general discussion, to refer to Figure No. 1. The appearance of a section of plate No. 2-4-4, 1/2", in the vicinity of a partial penetration is shown in Figure 1, A, at 3X. The depth of case, and the marked banding of the core are readily apparent. This banding as it appears in a transverse section, (i.e. at right angles to that shown in A) is pictured at 25X in Figure 1, B. The steel contained an objectionable amount of dirt, as shown in longitudinal and transverse sections at 25X in Figures 1, G, and H, respectively. The appearance of the case and core is shown at 25X in Figure 1, F. The light band at the top of the case is caused by an agglomeration of large carbide particles. It extends into the case for a distance of about 0.2 m.m.

This unusual condition might be attributed to "abnormality". It is felt, however, that what is commonly termed an "abnormal" steel would show signs of agglomeration for a greater depth into the case. A possible

reason for the condition noted may be that the steel was exposed to the atmosphere at a rolling heat in the rolling which took place after carburization. Absorption of oxygen from the atmosphere might cause agglomeration in the surface zones thus involved. It should, however, also leave evidence of surface decarburization which was not apparent. Figure 1,C, shows the nature of these carbide particles as seen at 1000X, and the abrupt change from the surface zone to rest of the case is evident. The structure of the rest of the case is shown in Figure 1,D, at 1000X, and that of the core at the same magnification is shown in Figure 1,E.

<u>Section</u>	<u>U.S.A. Negative No.</u>	<u>Etchant</u>	<u>Magnifi- cation</u>	<u>Remarks</u>
A	C116-2	Nital-1%	3X	Longitudinal section near indent left by partial penetration.
B	C116-8	" "	25X	Transverse section of core.
C	C116-4	" "	1000X	Hyper-eutectoid zone in case.
D	C116-5	" "	1000X	Eutectoid zone in case.
E	C116-6	" "	1000X	Core - very little free ferrite.
F	C116-3	" "	25X	Case and core.
G	C116-1	None	25X	Non-metallic content - longitudinal.
H	C116-7	"	25X	Non-metallic content - transverse section.

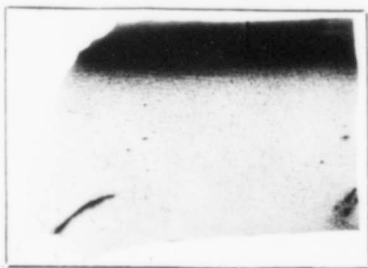
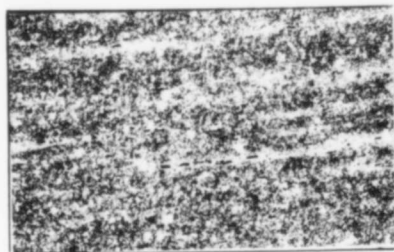
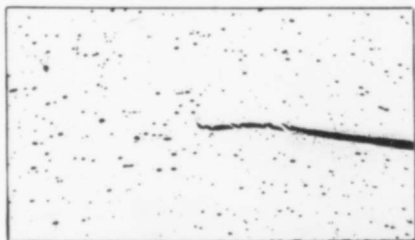
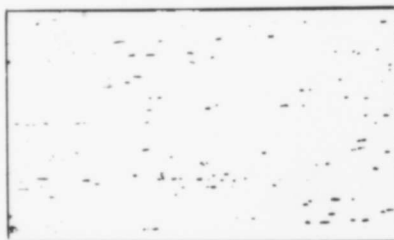
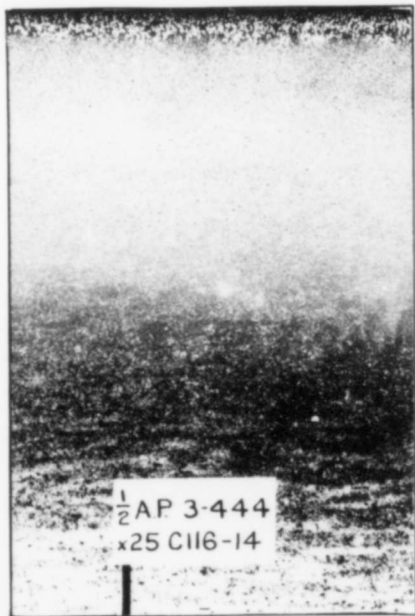
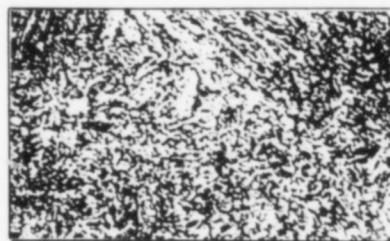
FIGURE 2

Figure 2,C, and Figure 5,A and C, present striking evidence that cracks in the plate that finally develop into button or petal spalls have their origin in chains of inclusions or "dirt" particles in the steel. A cleaner steel should result in material increase in resistance to spalling, even with lower draw temperature.

Section	V.A. Negative No.	Etchant	Magnifi- cation	Remarks
A	C116-10	Nital-1%	3X	Longitudinal section near bullet hole. Note cracks.
B	C116-11	" "	25X	Transverse section of core.
C	C116-13	None	25X	Non-metallics were cause of crack. Transverse section.
D	C116-9	"	25X	Non-metallic content - longitudinal section.
E	C116-14	Nital-1%	25X	Case and core.
F	C116-12	" "	1000X	Core - a small amount of free ferrite in segregated areas.

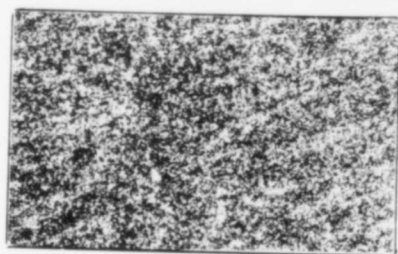
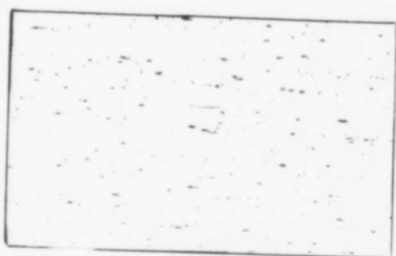
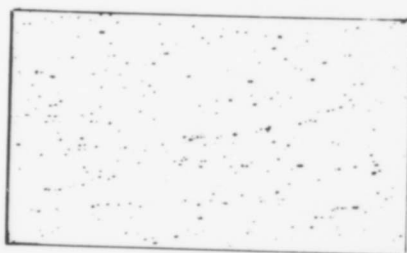
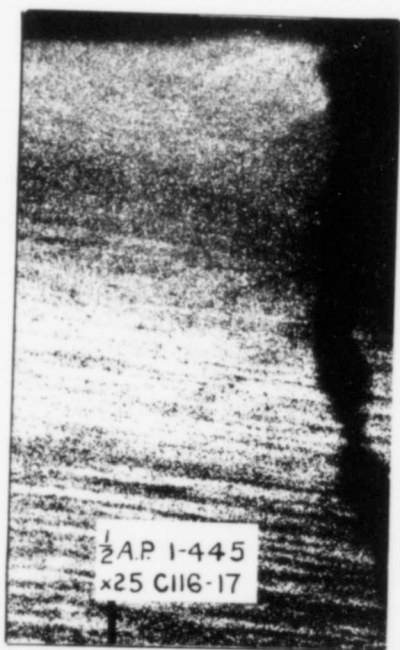
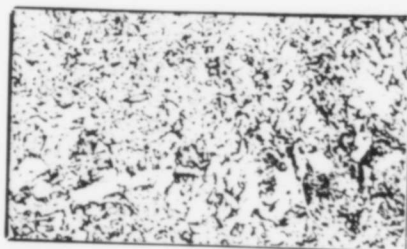
FIGURE 3.

Section	W. A. Negative No.	Etchant	Magnifica- tion	Remarks
A	C116-10	Nital-1%	3X	Note the thin case on this plate.
B	C116-20	" "	25X	Transverse section of core.
C	C116-15	None	25X	Non-metallic content long.
D	C116-19	"	25X	Non-metallic content transverse.
E	C116-17	Nital-1%	25X	Case and core. Note pronounced banding in core.
F	C116-18	" "	1000X	Core showing considerable free ferrite in segregated areas.

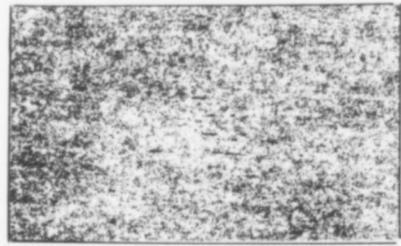
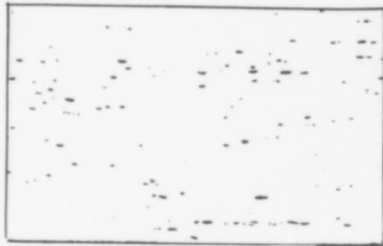
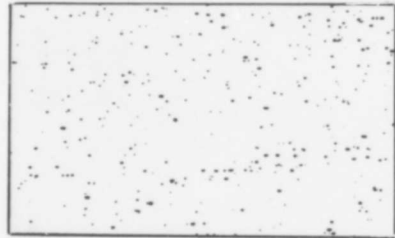
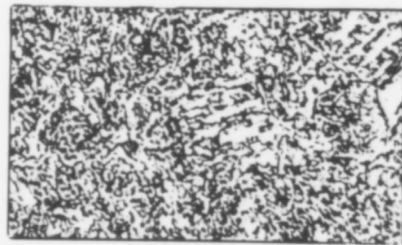
FIGURE 4.

The depth of case was not particularly uniform, as can be seen from Table II, or from an examination of figure 4, A. Plate No. 3-445 was accidentally carburized on both sides. Apparently the depth of case was but a small factor in determining the quality of the 1/2" plates. 2-444 had a case 3.2 m.m. deep and gave a ballistic limit of 3076 f.s., while plate 1-445, which had a case only 1.8 m.m. deep gave a ballistic limit of 3009 f.s., and plate 3-444, with a 3.0 m.m. case had a ballistic limit of 2948 f.s.. The fourth plate of the group, 3-445, was cased on both sides and cannot be considered. It would seem that plate 1-445 showed high resistance in spite of its thin case chiefly because of its hardness. Although plate 1-445 showed a high ballistic resistance it did spall considerably. It was drawn at 600°F. Plate 2-444, with a 3.2 m.m. case, shown at 900°F, was undoubtedly-

<u>Section</u>	<u>Fig. No.</u> <u>Negative No.</u>	<u>Etchant</u>	<u>Magnifi-</u> <u>cation</u>	<u>Remarks</u>
A	C116-22	Nital-1%	3X	Note that this plate was cased on both sides. The curvature at the edge was caused by a bullet which penetrated from the rear surface of the plate.
B	C116-23	" "	25X	Transverse section of core.
C	C116-21	None	25X	Non-metallic content - longitudinal
D	C116-25	"	25X	Non-metallic content - transverse
E	C116-27	Nital-1%	25X	Case and core.
F	C116-24	" "	1000X	Core - Some free ferrite in segregated areas.

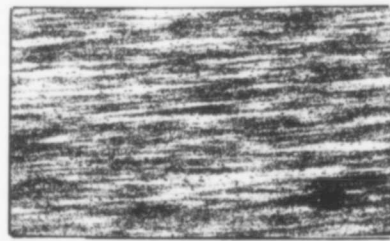
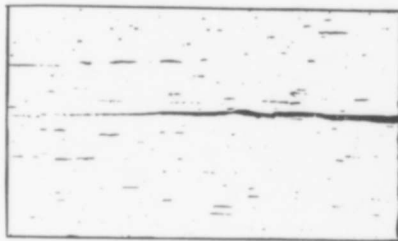
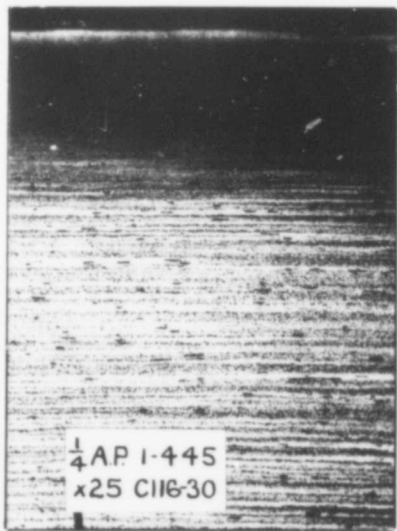
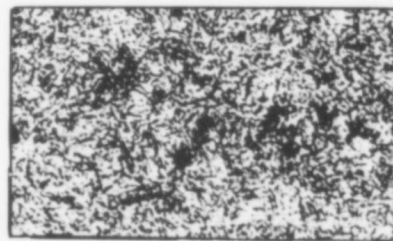
FIGURE 5.

Section	" A. Negative No.	Etchant	Magnification	Remarks
A	C116-10	Nital-1%	3X	Note crack which leads to spalling.
B	C116-37	" "	25X	Transverse section of core.
C	C116-28	None	25X	Non-metallic content. Typical cause of cracks shown in A.
D	C116-32	"	25X	Non-metallic content - transverse.
E	C116-30	Nital-1%	25X	Case and core. Note pronounced banding and presence of non-metallics in ferrite bands.
F	C116-31	" "	1000X	Core - Very little free ferrite.

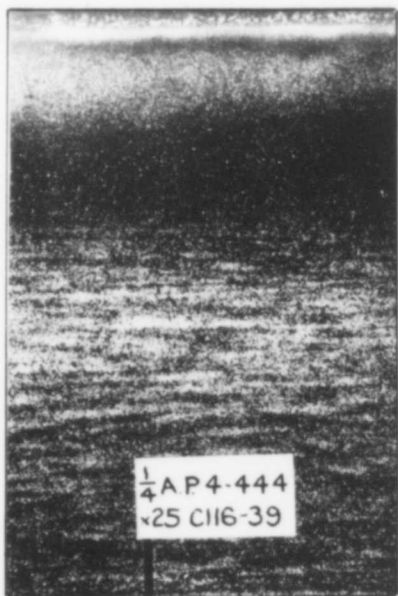
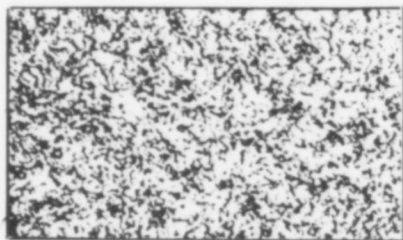
FIGURE 6.

Section	Negative No.	Etchant	Magnification	Remarks
A	C116-22	Nital-1%	3X	Good ductility indicated by freedom from cracks after penetration.
B	C116-36	" "	25X	Longitudinal section of core.
C	C116-34	None	25X	Non-metallic content -
D	C116-38	"	25X	longitudinal Non-metallic content -
E	C116-39	Nital-1%	25X	transverse. Case and core
F	C116-37	" "	1000X	Relative freedom from banding. Core - small amount of free ferrite in scattered areas.

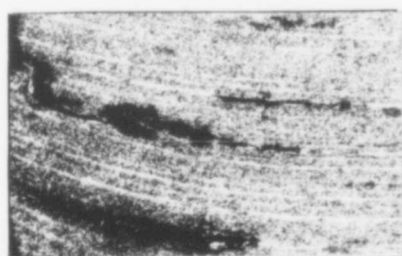
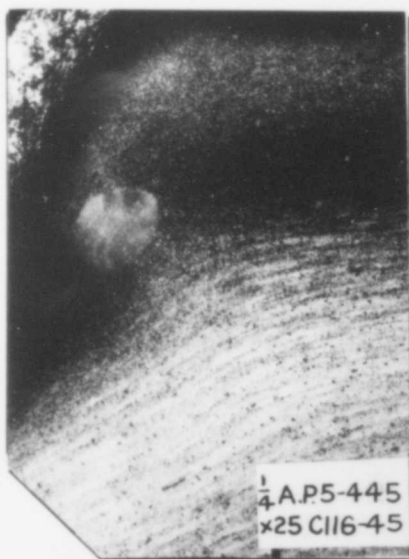
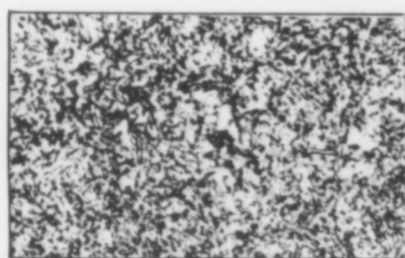
FIGURE 7.

Section	W.A. Negative No.	Etchant	Magnifi- cation	Remarks
A	C116-16	Nital-1%	3X	Case and core.
B	C116-42	" "	25X	Longitudinal section of core. Cracks follow bands.
C	C116-40	None	25X	Cracks follow non-metallic long. Section.
D	C116-44	"	25X	Non-metallic content - transverse.
E	C116-45	Nital-1%	25X	Case and core.
F	C116-43	" "	1000X	Core. Some free ferrite in segregat- ed areas.

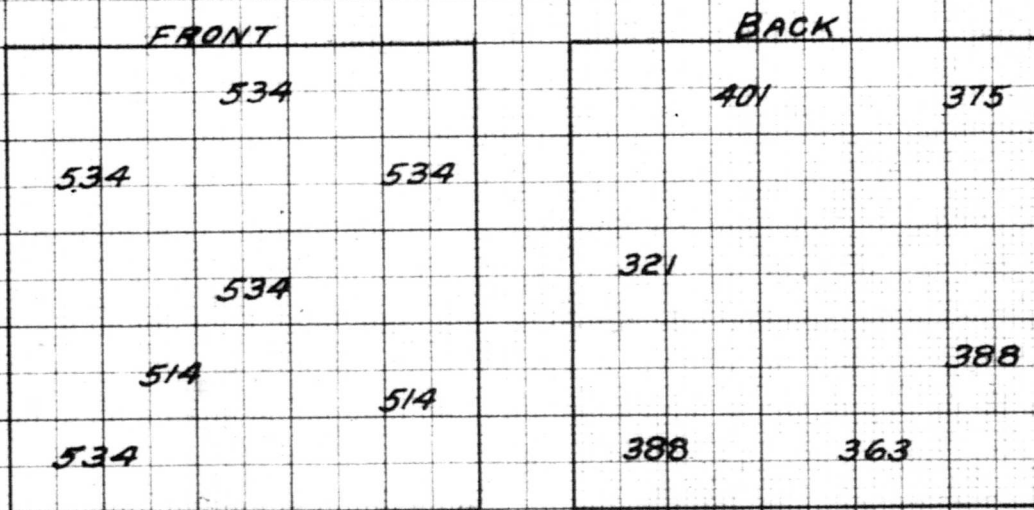
PLATE NO. 3-444

FRONT-	493	503
	493	483
	493	483
	493	483
	493	464
	473	421
	446	383
	390	376
BACK-	369

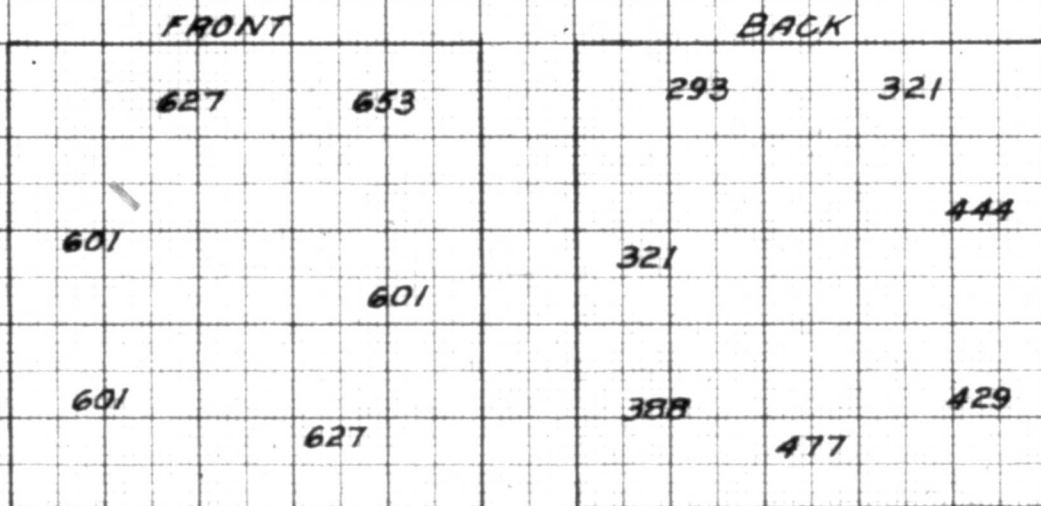
PLATE NO. 1-445

fully to determine the uniformity of hardness in any given plate. The results obtained are set forth in Figures No. 8 to No. 14, inclusive. The lack of uniformity is at once apparent, especially on the back surfaces of plates 1-445, and 3-445. Such variations in hardness were not apparent under the standard method of taking hardness readings, as can be seen from a glance at Table IV. The question may well be raised as to whether tentative Specification AXS-54, Rev. 1, May 1, 1933 should be revised to cover the conditions encountered. Granting that this lot of plate was purely experimental in nature, nevertheless, five plates that passed satisfactory ballistic tests might have been rejected without ever coming to test under the present hardness specification. The other two plates examined, neither of which met ballistic requirements, were satisfactory from the point of view of uniformity of hardness.

FRONT-	493	464
	493	421
	455	390
	405	376
	369	351
	357	351
BACK-	357	351

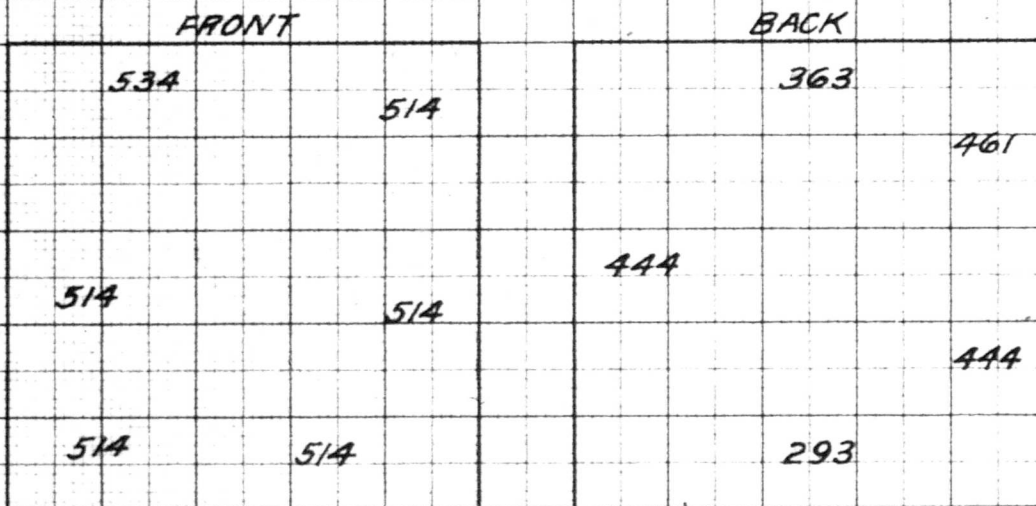
PLATE NO. 3-445

FRONT		
464		464
464		464
464		464
464		464
437		446
405		390
363		339
333		322
345		317
333		322
333		327
333		345
343		339
369		357
397		390
413		413
455		437
BACK	473	455

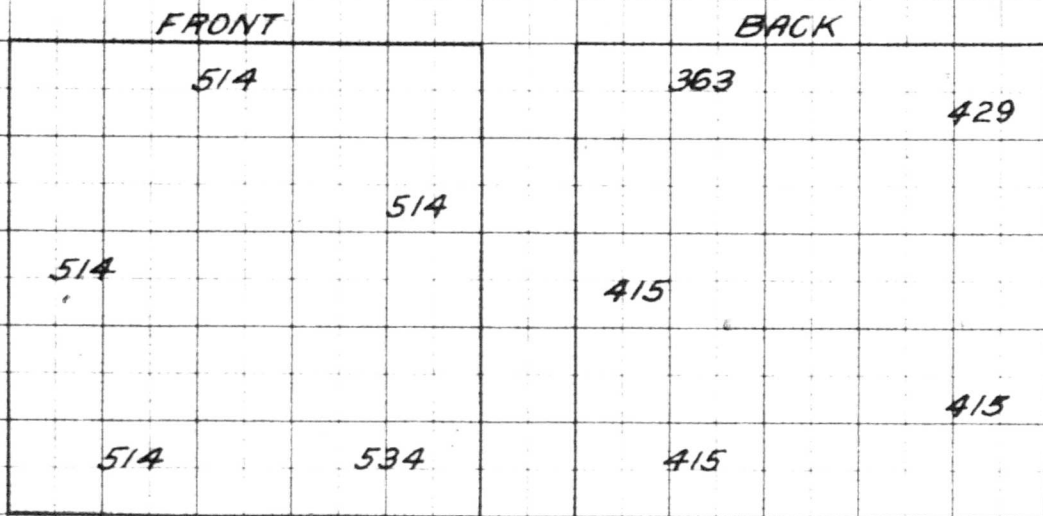
PLATE NO. 4-444

FRONT -	464	464
	464	464
	464	464
	437	446
	421	429
	405	421
	405	421
BACK -	405

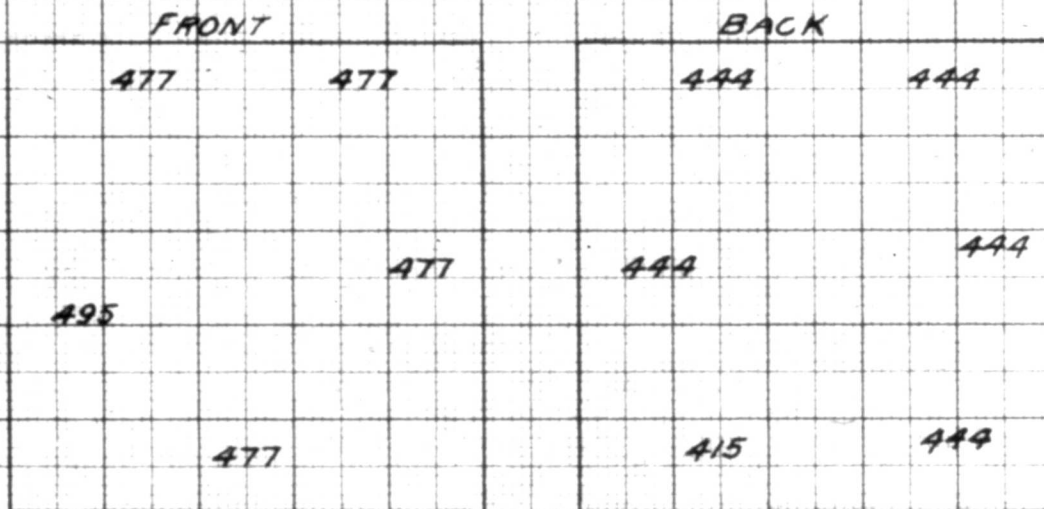
PLATE NO. 5-445

FRONT -		
473	493	
483	493	
468	493	
437	464	
405	429	
376	397	
397	397	
397	397
