CRACKS IN MONEL METAL

Report No. 344/46
Watertown Arsenal

December 9, 1936

To determine cause of cracks in piece 175814, clamp screw - Ex. Order 509-156.

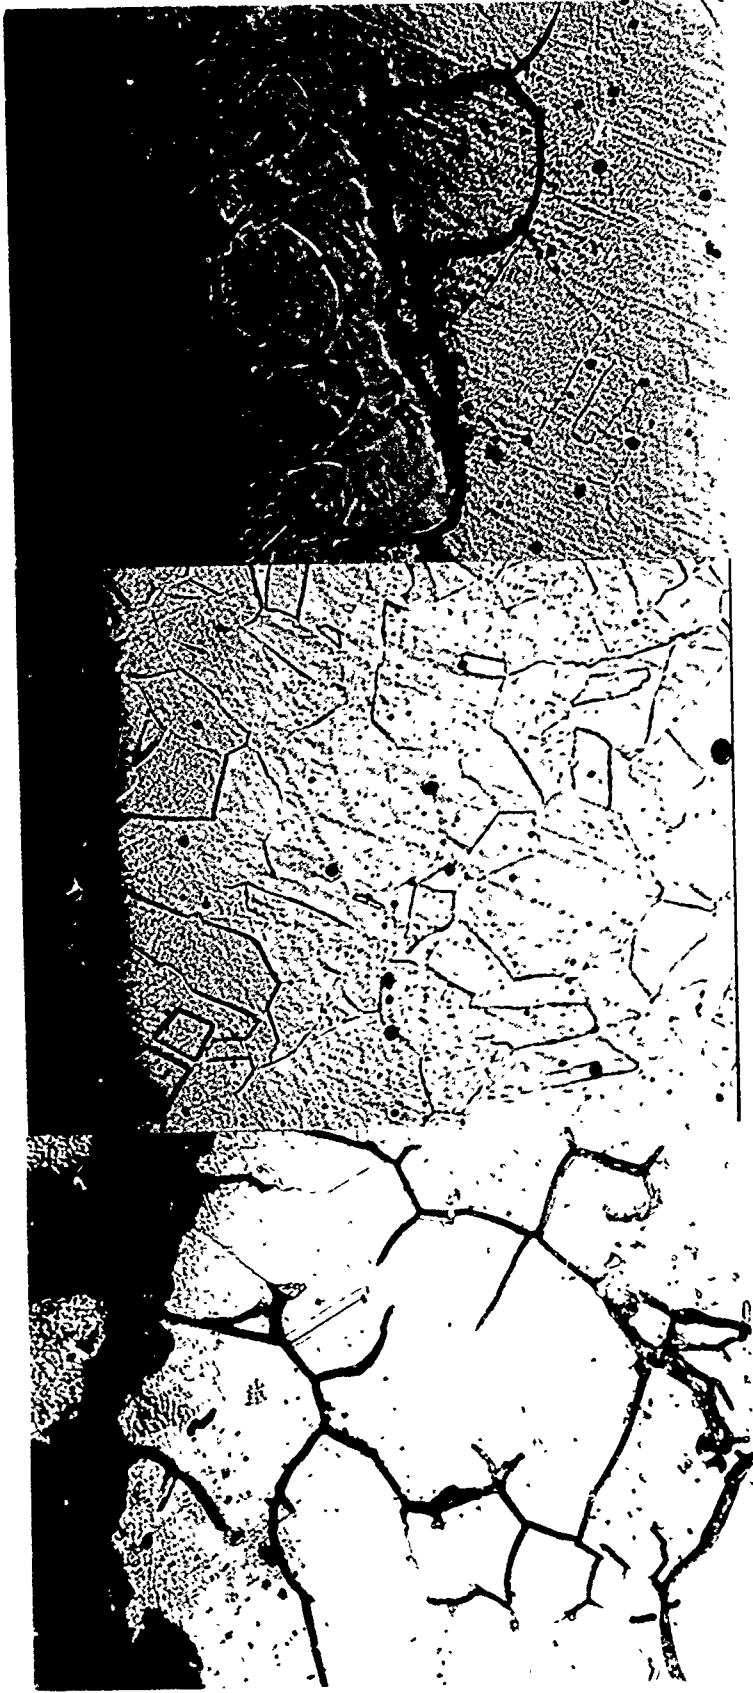
Cracks were due to intergranular embrittlement by sulfur picked up when monel metal rod was heated for bending, in forge fire. Coal or coke fires must not be used for heating monel metal.

The microstructures are shown on Figs. 1, 2, and 3, these being taken by Mr. Carter. Fig. 1 shows the ruined grain boundary due to S contamination of the clamp screw; Fig. 2 shows the clean grain boundary of the original metal; and Fig. 3 shows the grain boundary contamination due to S pick up of the experimental piece placed in forge fire.

The pick up of sulfur was not uniform throughout the periphery of the metal subjected to heating in coal or coke fire. Where sulfur had been picked up the penetration was quite deep and by way of the grain boundary. Any bending, hot or cold, would cause cracking. Metal contaminated with S cannot be reclaimed except by machining off the contaminated layer.

- Fig. 1 Ruined Grain Boundaries of monel metal clamp screw 175814 due to S contamination (Long)
Fig. 2 Clear Grain Boundaries of original monel metal (Trans)
Fig. 3 Grain Boundaries contamination due to S pick up when monel metal was placed in forge fire (Trans)

Monel metal is very susceptible to sulfur and must not be heated in coke or coal fires, or in oil fires, from fuel running over 1/2% S.
