# WATERTOWN ARSENAL LABORATORY

NO. WAL 710/586

Metallurgical Examination of 20 M1 Helmets, Made by the  
Schlueter Manufacturing Company, Which Cracked after Aging

DATE 29 January 1944

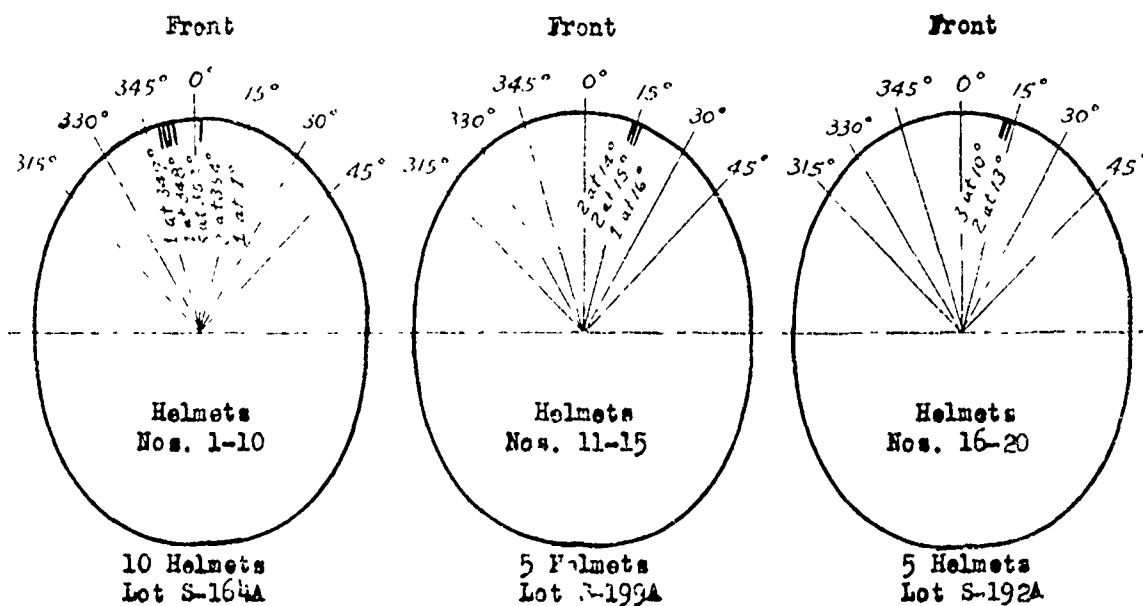
FIGURE 1

Except for one crack, located at 1°, all the cracks from the 10 helmets of Lot S-164A are located in a relatively constant position on each helmet, from 347° to 354°. The cracks on the 5 helmets from Lot S-199A are located from 14° to 16°, and those on the 5 helmets from Lot S-192A are located from 10° to 13°. The constancy of the locations of the cracks on helmets from one lot suggests a trimming die defect producing a notch or edge irregularity in a constant position on a series of helmets from one lot. The trimming dies apparently become quickly chipped, particularly in the region of the visor. This is indicated by the large number of notches and irregularities observed on hundreds of helmets.

Locations of Cracks on 20 Helmets Manufactured by the  
 Schluster Manufacturing Company
