Rolled Armor Report No. 44 Regraded *Declassified* by Auth
of C. O. Watertown Arsenal
in compliance w/Par 25, AR
390-5, dtd 6 June 1952

May 6, 1942

Types of Failure Occurring in the Shock Test of

1/2" Homogeneous Armor with Caliber .50 A.P. Projectiles

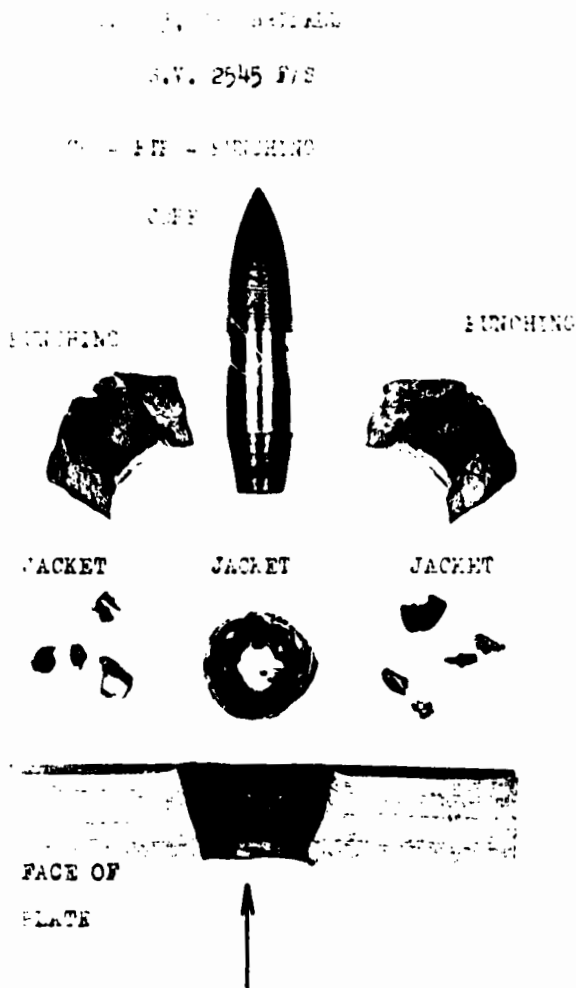
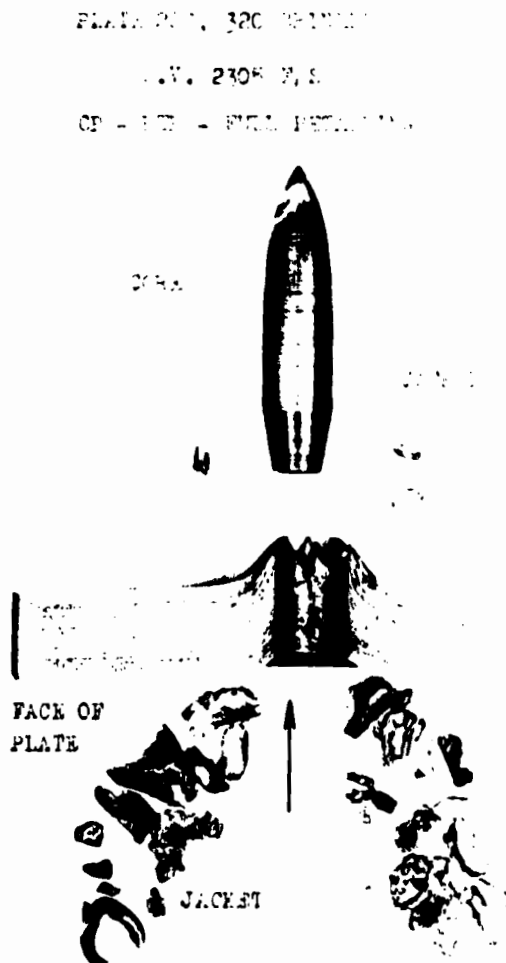
FIGURE 1

Consideration of Figures 1 and 6 indicates that the two types of failure (punching shown in Figure 1 and back spalls illustrated in Figure 6) are associated with the high impact velocity and the resulting jacket effect. In both cases with a lowering of striking velocity to 2300 f/s, the jacket, in its entirety essentially, is rejected from the face of the plate and a small exit hole results. With the soft plate, there is a tendency for the jacket to "ball up" on its way through the plate and influence the formation of the punching. This condition is apparently a manifestation of the lower shear strength of the softer material.

COMMERCIAL STEEL QUALITY
LOW ABILITY HOMOGENEOUS (1) APMS

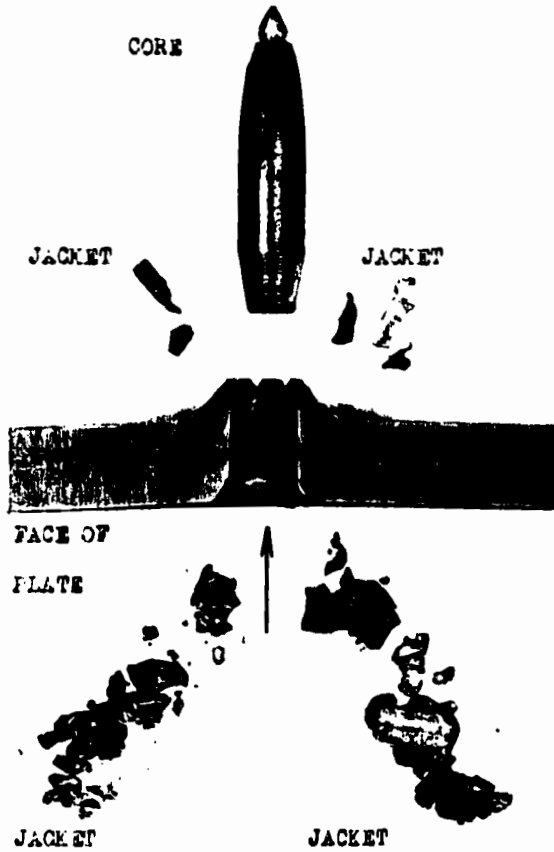
PLATE 657-2, 320 BRINELL

S.V. 2535 F/S

CP - PTP - FULL PETALLING

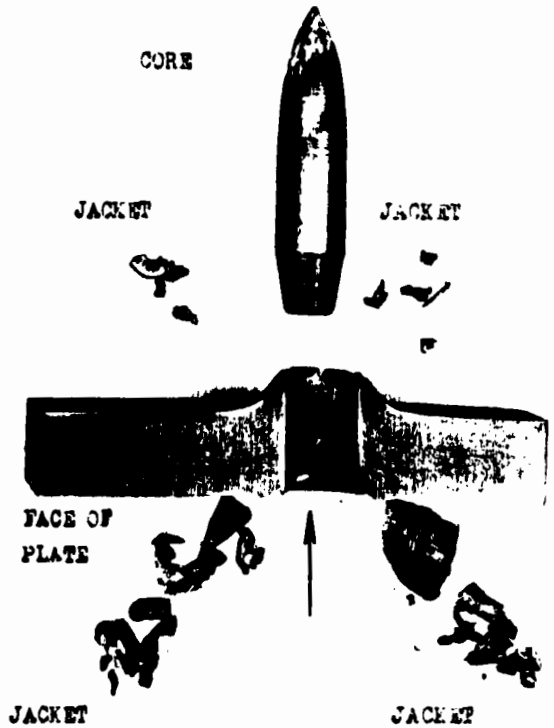
PLATE 657-2, 320 BRINELL

S.V. 2323 F/S

CP - PTP - FULL PETALLING

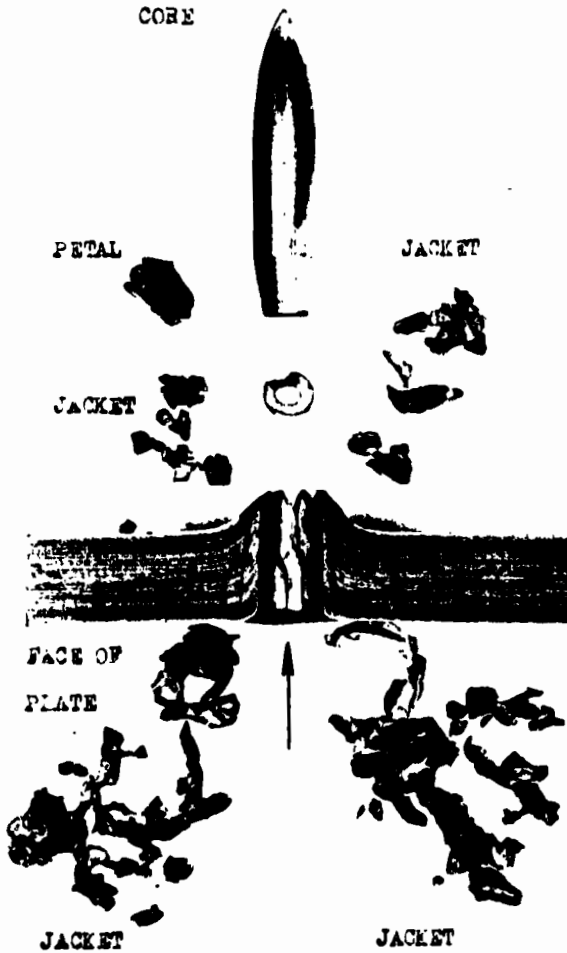
PLATE 1000, 360 BRINELL

Reference to Figures 3 and 4 shows the satisfactory results obtained on both the induction furnace steel and the commercial quality steel at the hardness level of approximately 360 Brinell.

S.V. 2535 F/S

CP - PTP - FULL PETALLING

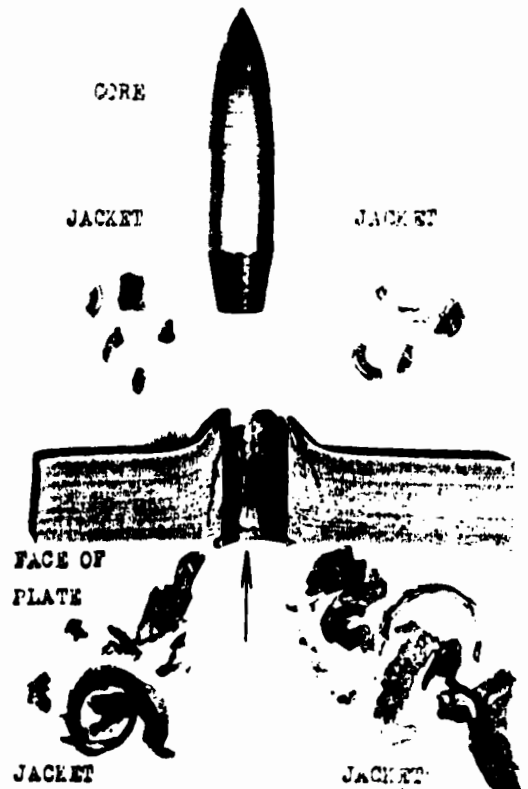
PLATE 1000, 360 BRINELL

S.V. 2320 F/S

CP - PTP - FULL PETALLING

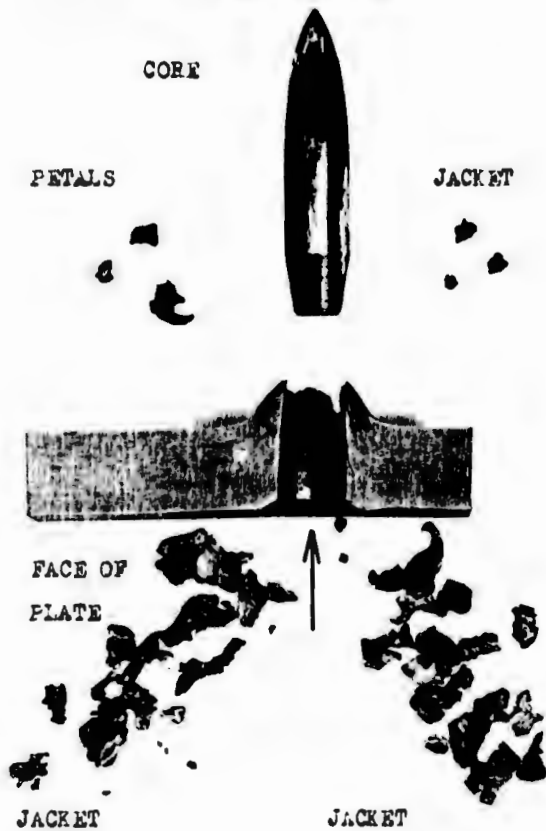
PLATE 656-2, 352 BRINELL

S.V. 2535 F/S

CP - PTP - FULL PETALLING

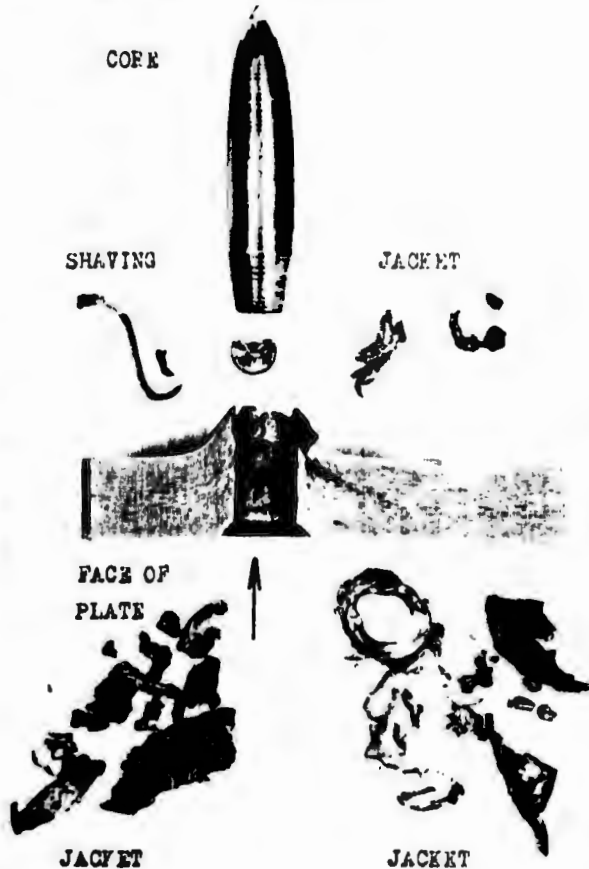
PLATE 656-2, 352 BRINELL

S.V. 2298 F/S

CP - PTP - FULL PETALLING

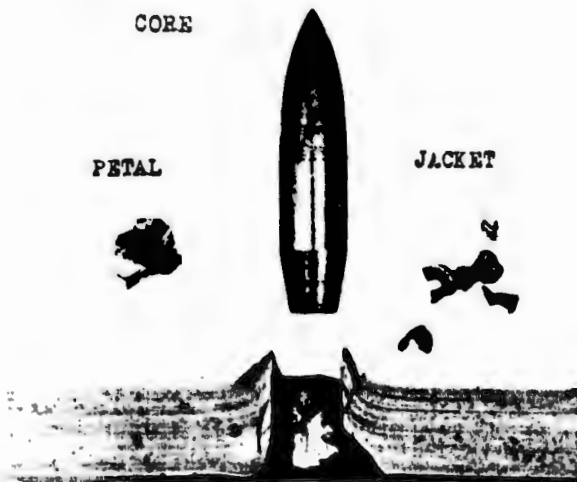
PLATE 900, 388 BRINELL

With respect to steel cleanliness, it will be noted that throughout the hardness series the comparatively clean and less segregated induction furnace steel gives satisfactory results when the commercial steel fails except at the 360 Brinell hardness level. A comparison of Figures 5 and 6, which illustrate the effect upon two pieces of commercial quality steel at the same hardness level, demonstrates that whether or not back spalling will result is dependent upon the degree of uncleanliness in the steel. Study of the macroetched sections reveals that Plate 900 is somewhat cleaner than Plate 200.

S.V. 2535 F/S

CP - PTP - PETALLING

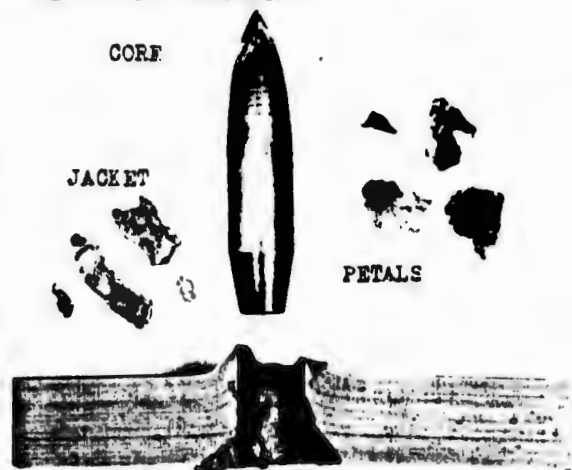
PLATE 900, 388 BRINELL

S.V. 2285 F/S

CP - PTP - PETALLING

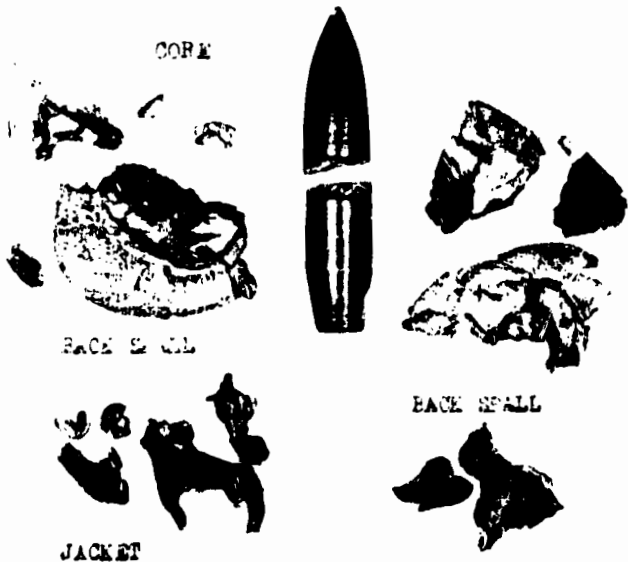
PLATE 200, 388 BRINELL

Examination of Figure 6 shows that shear failure produced by the jacket effect is also a factor in the failure of the high hardness plate by back spalling. Apparently the tip of the core starts a back spall which decreases the effective plate thickness. Then the jacket proceeds to initiate shear failure in the remaining thickness and in doing so greatly enlarges the size of the back spall.

S.V. 2550 F/S

CF - PTP - BACK SPALL 1 1/2" x 1-1/4"

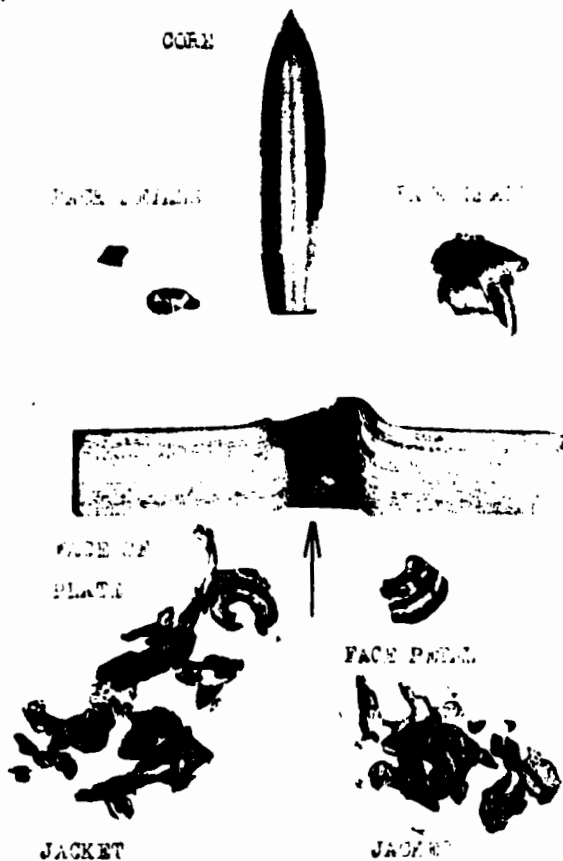
PLATE 200, 388 BRINELL

S.V. 2700 F/S

CF - PTP - BACK SPALL 1 1/2" x 1-1/4"

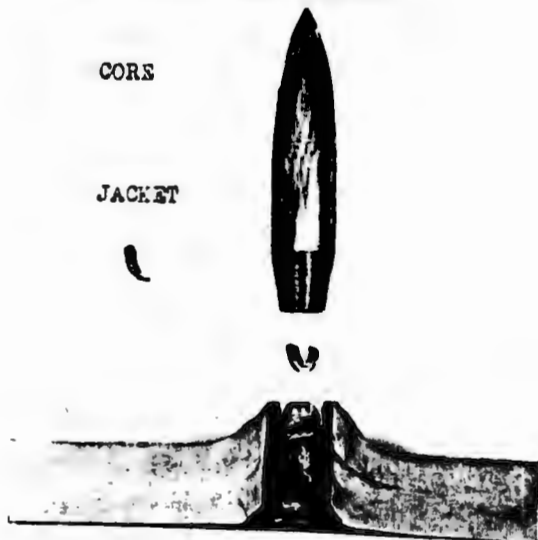
PLATE 656-1, 388 BRINELL

S.V. 2545 F/S

CP - PTP - FULL PETALLING

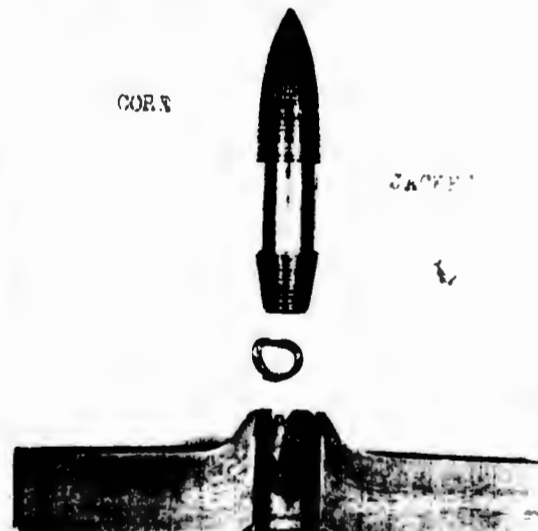
PLATE 656-2, 387 BRINELL

S.V. 2238 F/S

CP - PTP - FULL PETALLING
