REPORT NO. 710/201

EXAMINATION OF SLUGS FROM ARMOR PLATE  
SUBJECTED TO HIGH VELOCITY BULLET IMPACT  
INDEXED

June 30, 1937

WATERTOWN ARSENAL  
WATERTOWN, MASS.

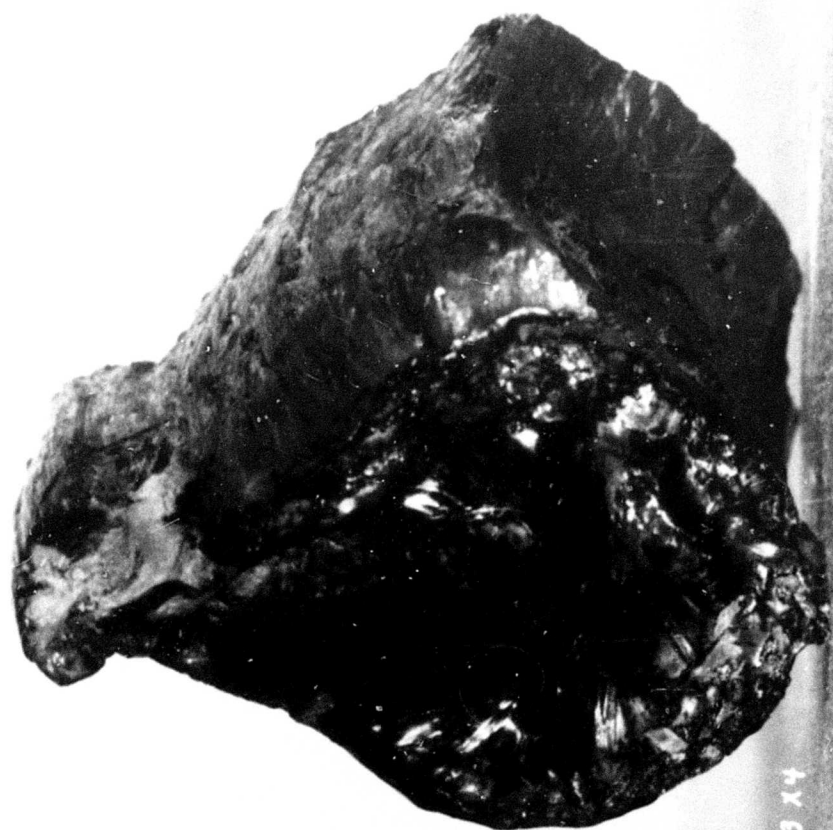
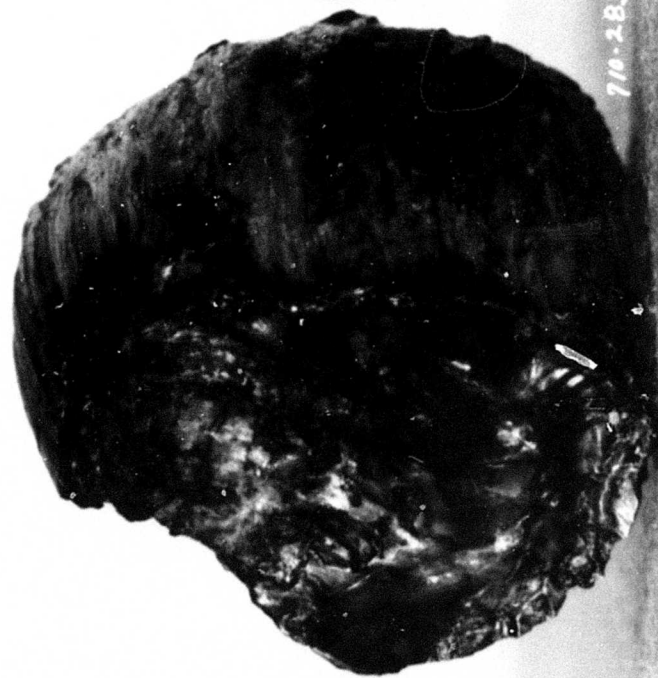
Fig. 1

The appearance of the slugs as received is shown in Figure 1.

Photographs of Slugs

Showing battered surface of slugs  
attacked by bullet.

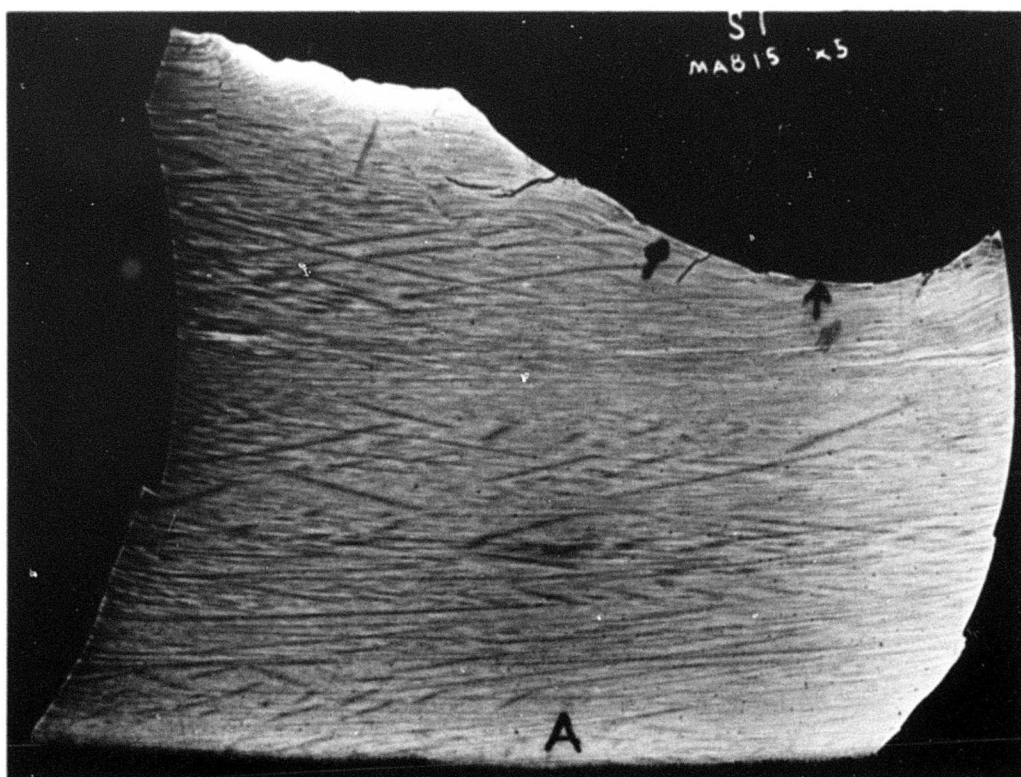
(a) X5 Punching #S1. Etched Oberhoffer's  
Reagent.

A macroscopic study of sections cut through the slugs shows the presence of dendritic segregation elongated in the direction of rolling, Figure 2. Also, faulting of the metal and white layer is evident near the face of impact and areas adjacent.

An examination of the macrostructures in Figure 2 shows failure occurring along some of the white layers which are oriented in many directions with respect to the direction of impact. In a few cases, however, the white layers associated with crack systems partially follow the contour of the sheared surfaces of the slugs. This indicates that the shearing out of the slugs may have occurred along the white layers.

In both samples, deformed dendritic segregation is evident in the direction of rolling. Also faulting of the metal and white layer is evident at area of impact. See arrows.

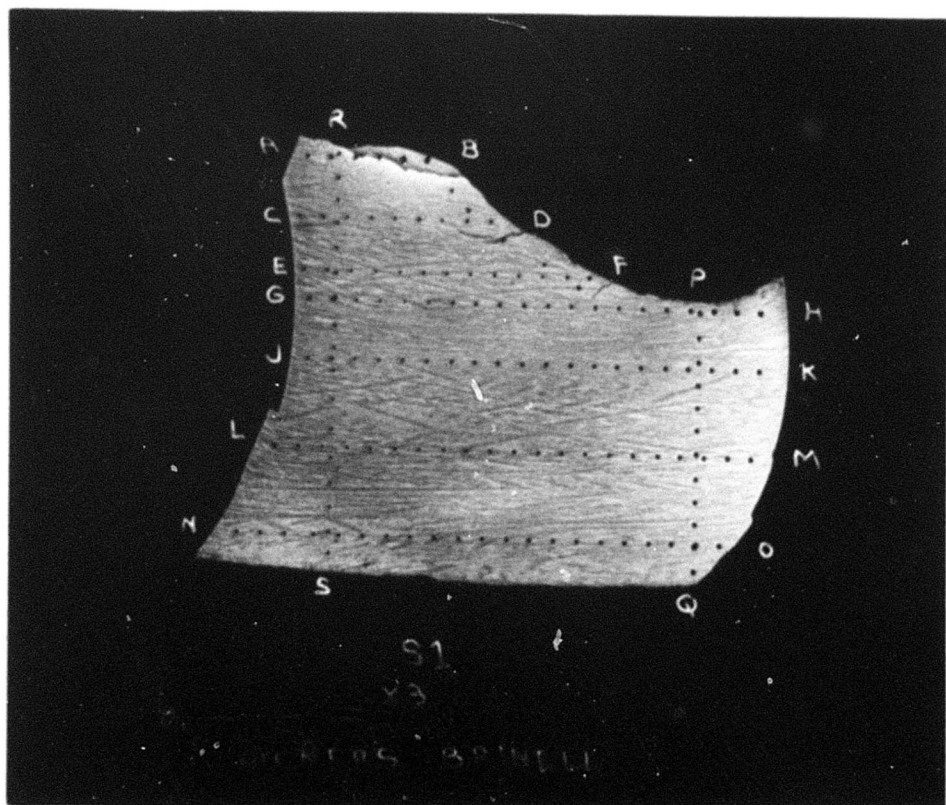
Small fragments of bullet core were attached to the slugs near the surface hit by the bullets, see Figures 2a-1, 2a-2. The structure of the fragments is typical of cold-worked medium high carbon steel, see Figures 3a, b, and d. The microstructure of the slugs in each case is typical of acicular troostite (see Figure 3c). The grain size is relatively coarse.

- (1) X3 #S1. Showing hardness surveys, results of which are given in Figures 6 and 7. Also remnant of bullet core shown at R-B.

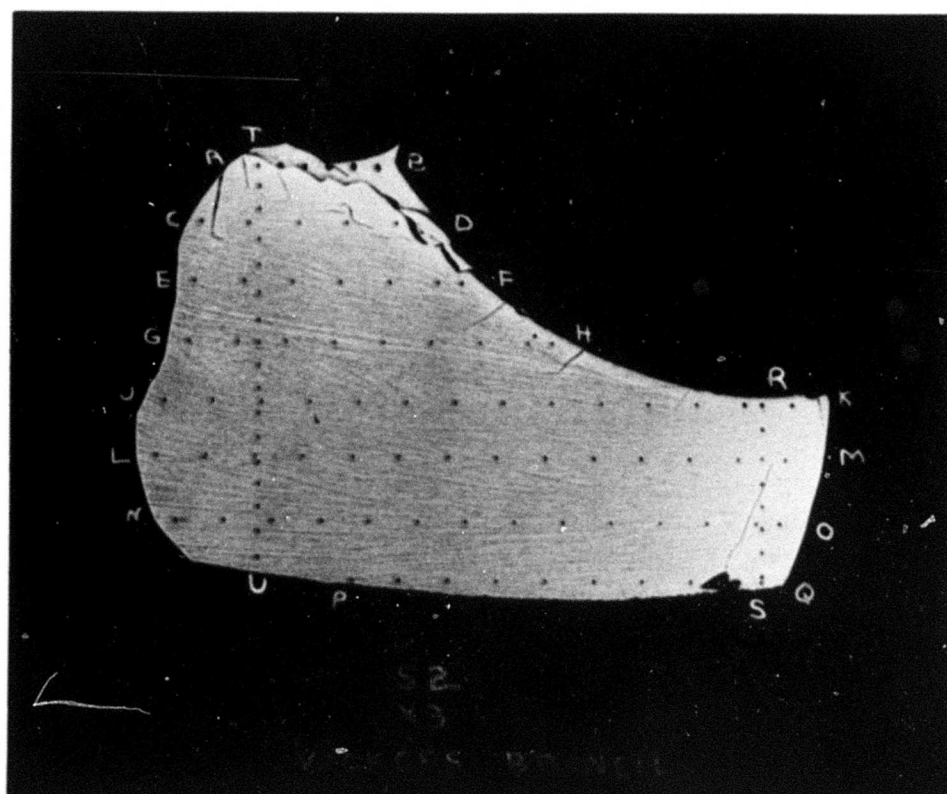
- (2) X3 #S2. Showing hardness surveys, results of which are given in Figures 7 and 8. Also remnant of bullet core shown at T-B.

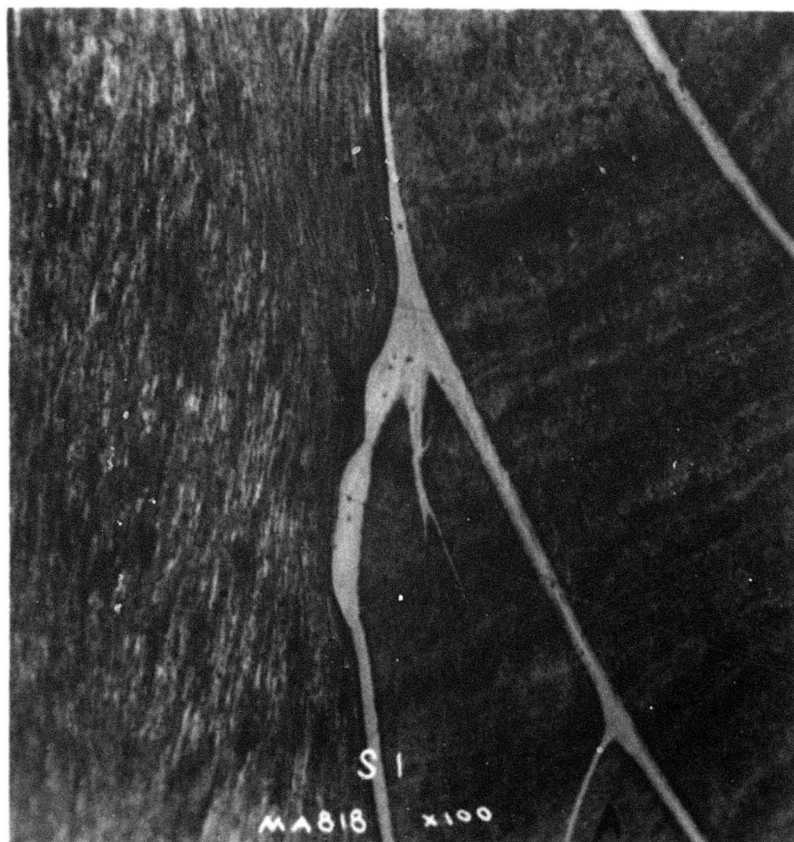
- (a) X100 #S1. Base metal of slug to right of white layer, with layer branching into it. At the left, a foreign matter coating parts of the penetration, and not shown in Figures 1a and b, because of etching difficulties. We assume this material to be part of the bullet core which adhered to the plate.

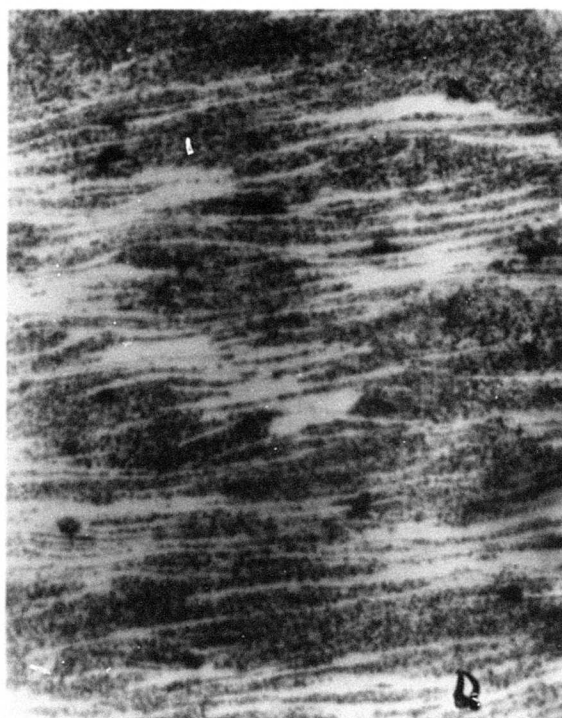
- (d) X1000 #S1. Bullet core, badly distorted by cold work. Lower carbon, possibly poorly heat treated because of the considerable ferrite areas present in the sorbite. Scattered nonmetallic inclusions. This is typical of both specimens.

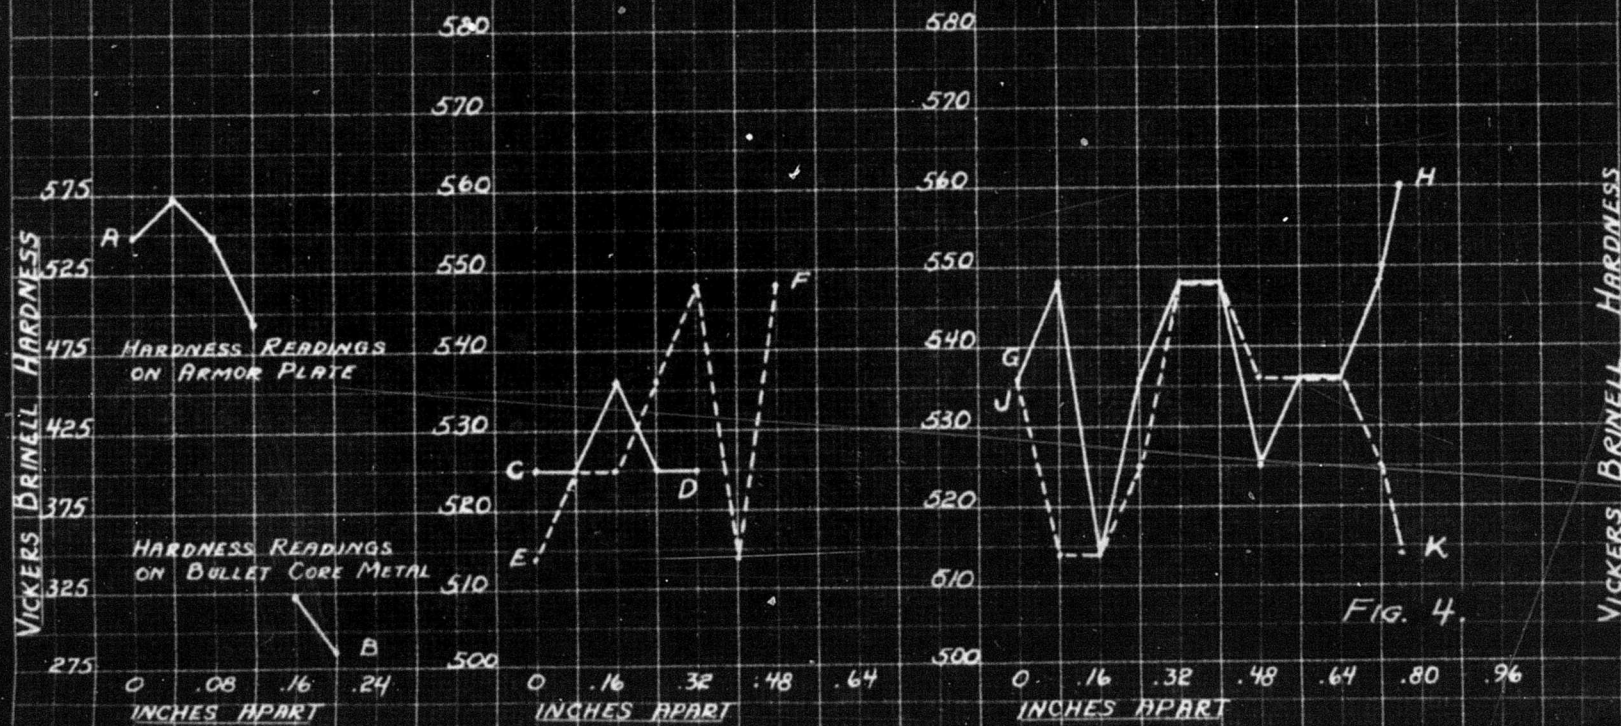
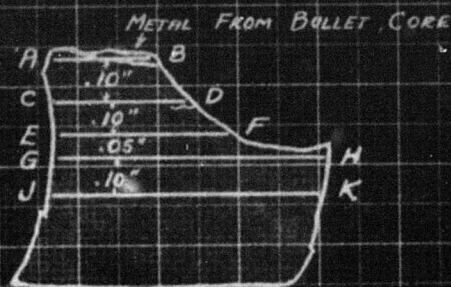
FIG. 4.

The hardness surveys of slugs S-1 and S-2 are given in Figures 4, 5, 6 and 7. It is evident that the metal was severely work hardened at the area of impact. Hardness surveys reveal the presence of the remnant of the medium high carbon bullet core stock at the surface of impact.
