REPORT NO. 710/78

PHOTOGRAPHIC STUDY OF IMPACT  
OF BALL AND ARMOR PIERCING AMMUNITION  
ON ARMOR PLATE

E. L. Reed  
Research Metallurgist

December 21, 1936  
WATERTOWN ARSENAL  
WATERTOWN, MASS.

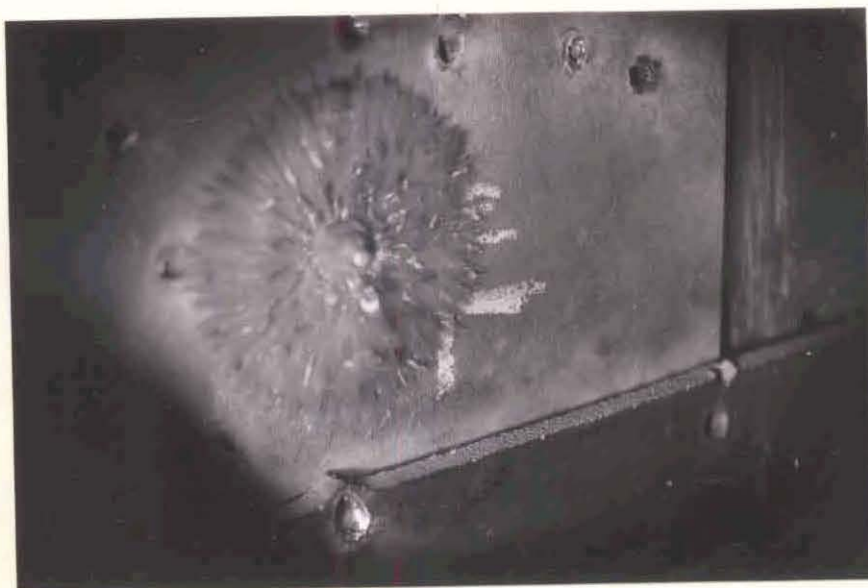
Figure 10 - Photograph by reflected light of Cal..30 Armor Piercing service velocity bullet in progress of penetrating Armor Plate. Note lead splash and particles of jacket metal being blown from impact. (striking distance 100 yards).

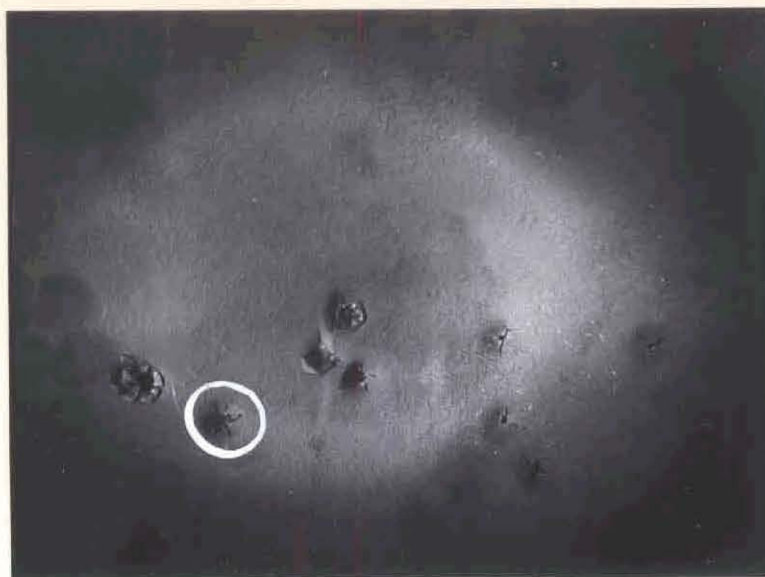
plate in Figure 14. Progress of bullet penetration of the rear face of the plate are illustrated in Figures 17 and 18.

Figure 17 - Back face during impact.  
Nose of bullet core appearing through  
back of plate.

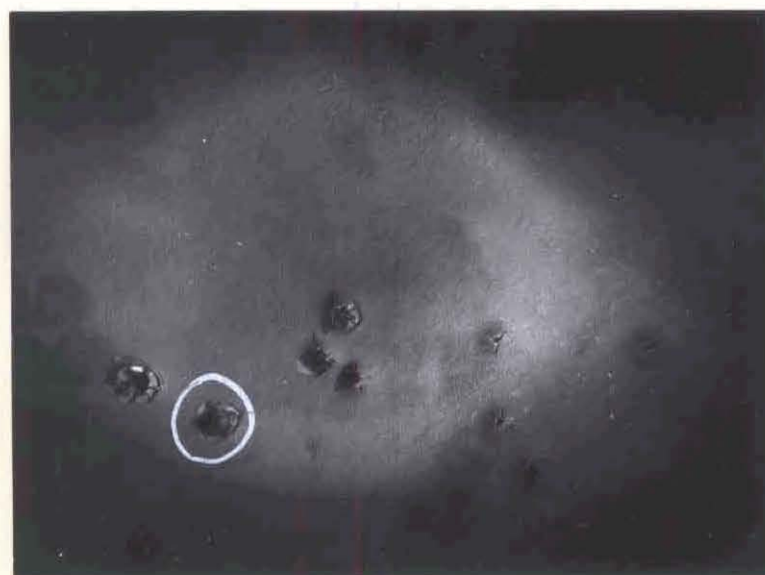
Figure 18 - Back face of plate. Fragments  
blown off. Photographs taken by reflected light.  
Ammunition Caliber .30 Armor Piercing service  
velocity at a distance of 100 yards.
