AD-A953 799

WIAL-710/662

15 Jun '44

It is intended in this report to evaluate the metallurgical properties of the armor samples received by means of the two fracture and other tests, to determine the causes of failure in every case if possible, and by comparison of the ballistic results with the metallurgical data of the passing and failing plates to establish the characteristics which must be possessed by rolled armor, 1" to 2" in thickness, for successful ballistic performance at subnormal temperatures.

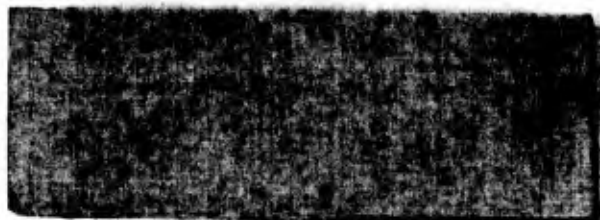
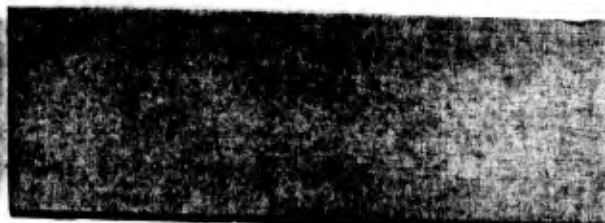
DISSTON - HEAT 3339 - PLATE 1 - FAILED SHOCK - NO PTP TEST

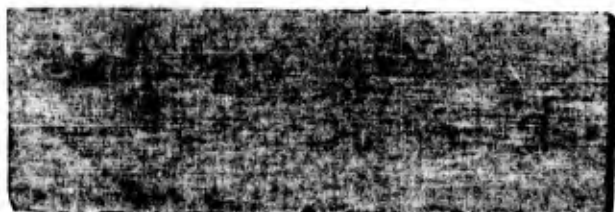
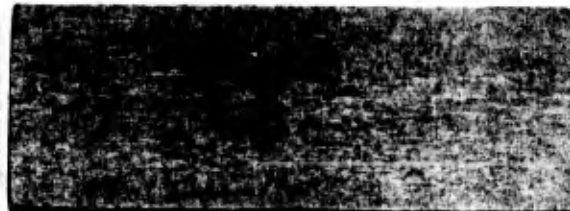
CARNEGIE - HEAT B-52607 - PLATE 4-2-T-4 - PASSED SHOCK - FAILED PTP

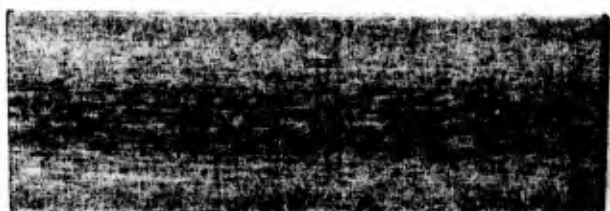
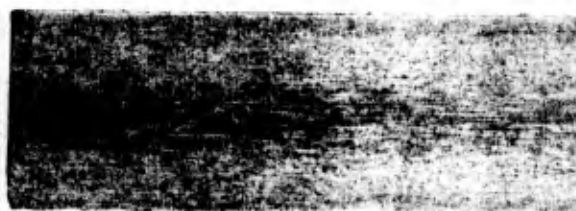
VAN DORN - HEAT H-40297 - PLATE 1 - PASSED SHOCK - FAILED PTP

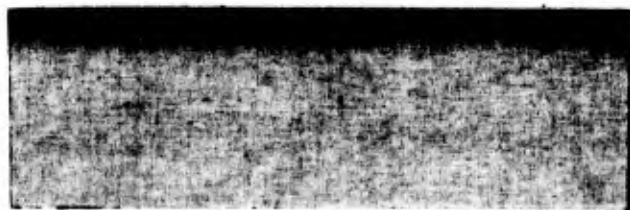
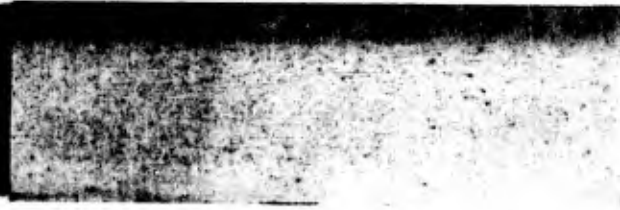
AMERICAN CAR - HEAT H-50196 - PLATE 1702-7 - NO SHOCK TEST - FAILED PTP

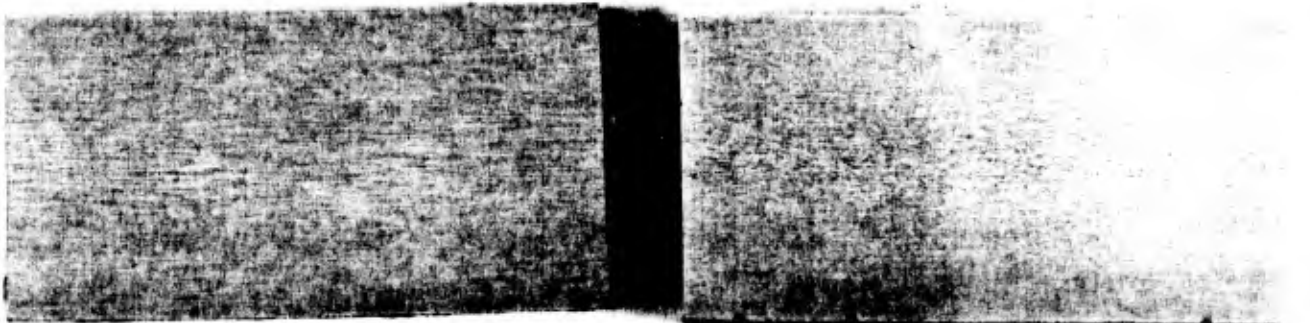
" B + " DISSTON - HEAT 22851 - PLATE 2 - FAILED SHOCK - NO PTP TEST " B "

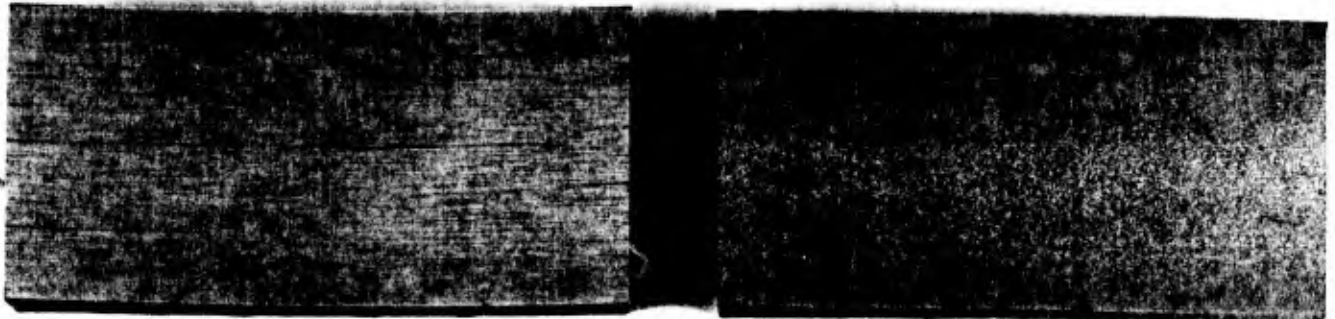
" E " STANDARD (GREAT LAKES) - HEAT GSG-724 - PLATE IX5 - FAILED SHOCK - NO PTP TEST " E "

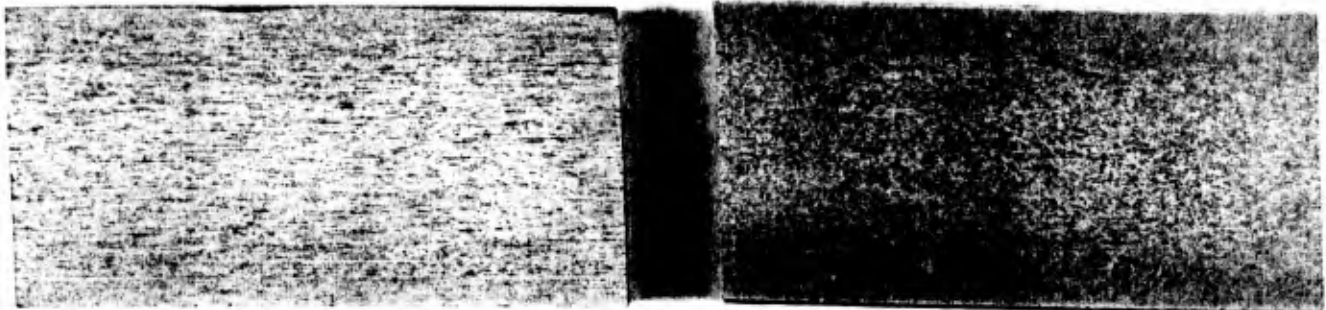
" C - " REPUBLIC - HEAT RH-50307G - PASSED SHOCK - FAILED PTP " D "

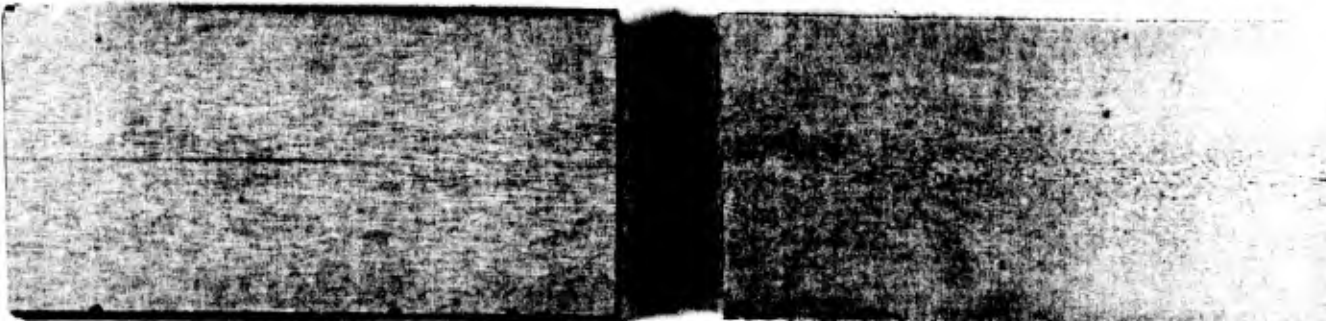
" B - " DISSTON - HEAT 22851 - PLATE 5 - PASSED SHOCK - PASSED PTP " B "

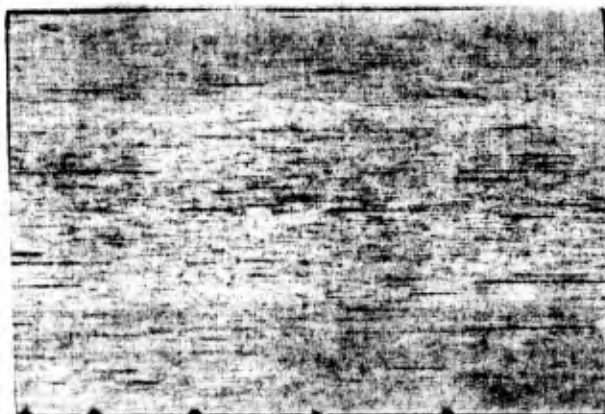
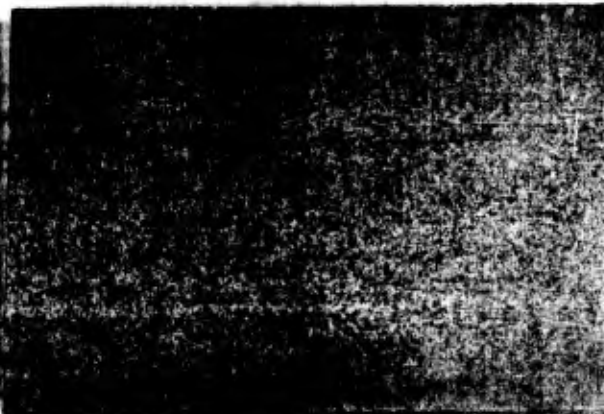
" E " STANDARD (GREAT LAKES) - HEAT G80-635 - PLATE IXI - FAILED SHOCK - FAILED PTP " E "

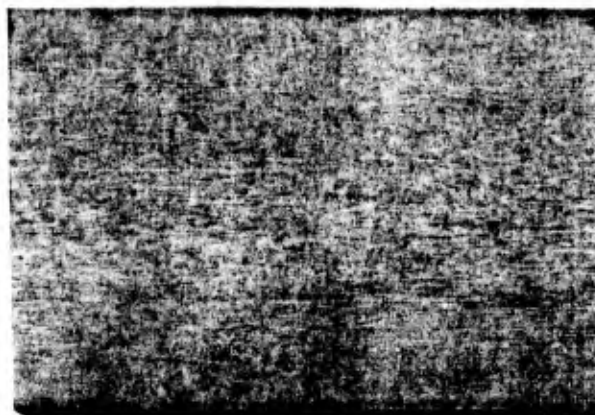
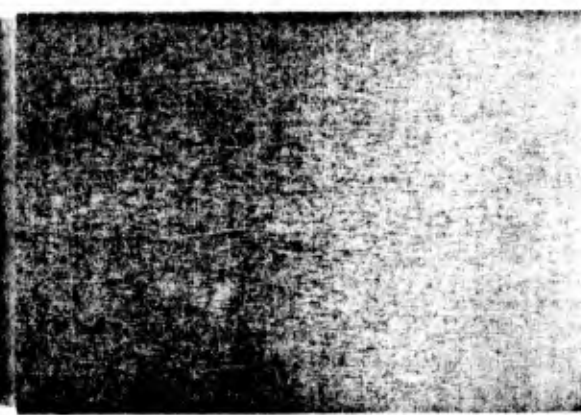
" B " CARNEGIE - HEAT 15378 - PLATE TB-143317 - PASSED SHOCK - FAILED PTP " B "

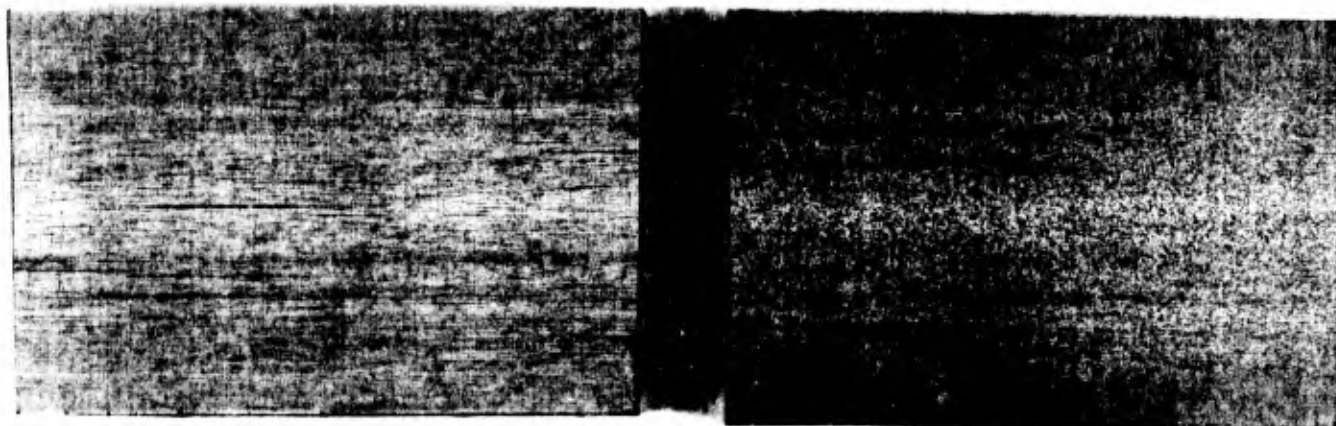
" E " STANDARD (GREAT LAKES) - HEAT G8G-635 - PLATE 1X4 - PASSED SHOCK - FAILED PTP " E "

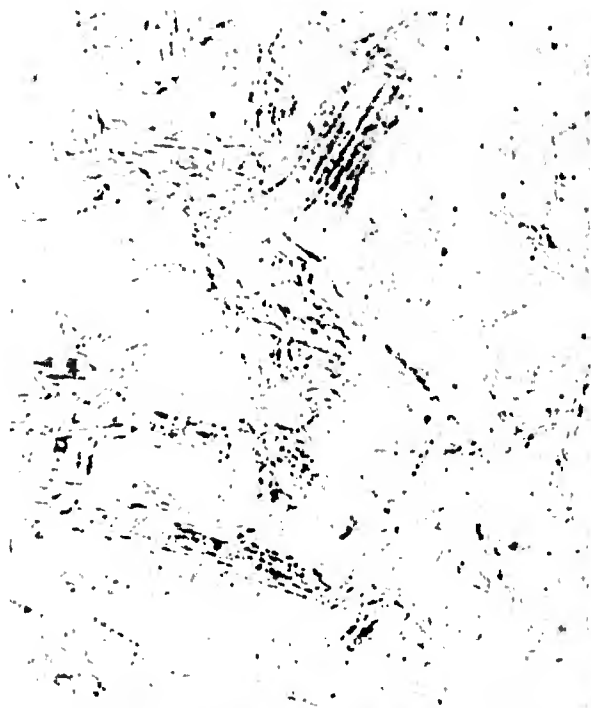
Great Lakes 2# Plate No. 1X1
Microstructure at 7/16" from the
quenched end. Amount of non-mar-
tensitic products is 15%.

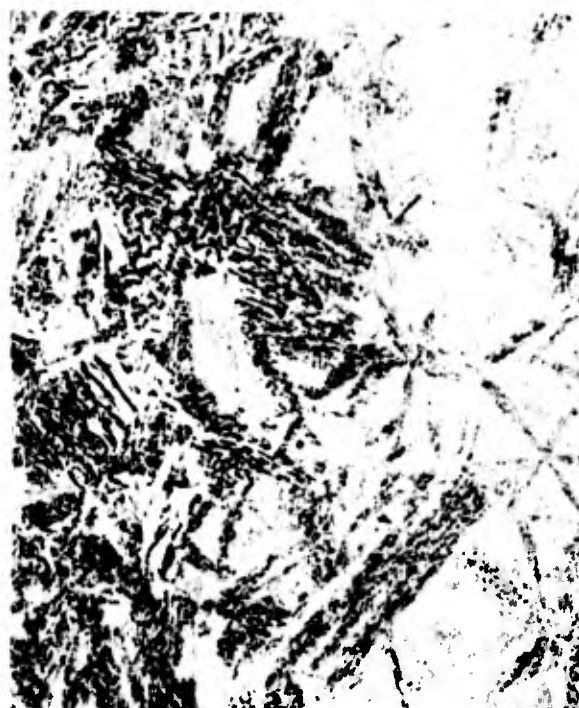
Van Dorn 1# Plate No. 1
Microstructure at 16/16" from the
quenched end. Amount of non-mar-
tensitic products is 30-40%.

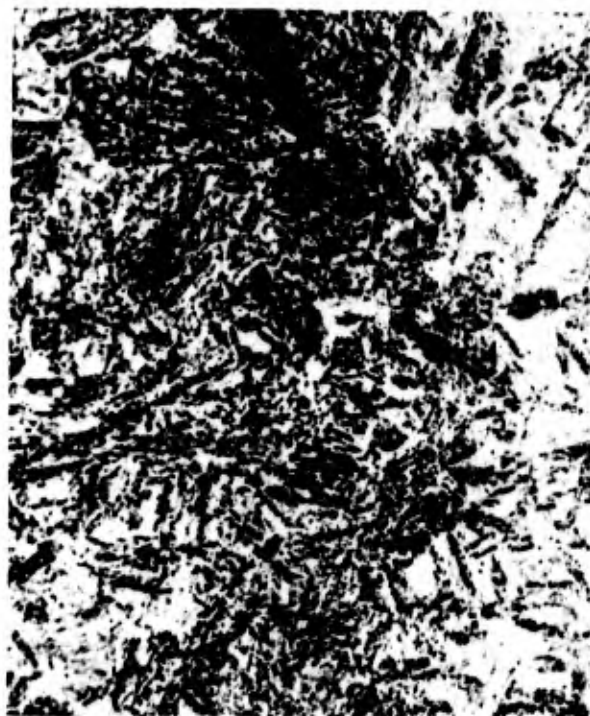
Jones and Laughlin 1# Plate No. MLX3
Microstructure at 40/16" from the
quenched end. Amount of non-marten-
sitic products is 75%. (Note: In this
case hardness is Rc 44.5.)

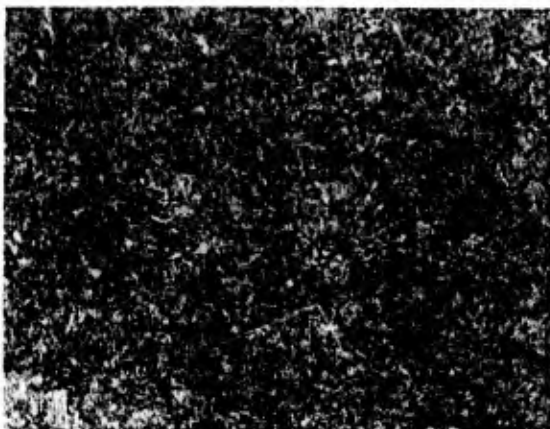
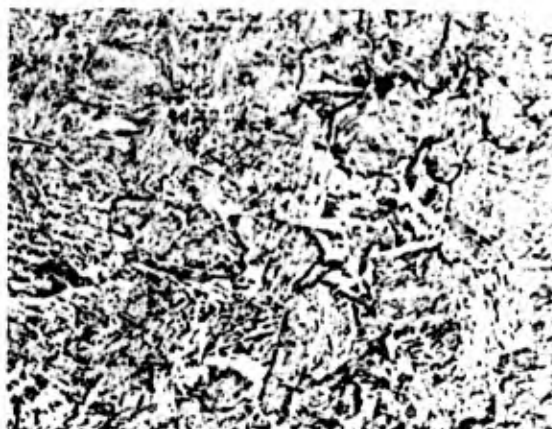
Carnegie-Illinois 1[#] Plate No. 4-2-T-4
 (Microspecimen etched with 4% Picral)

X200 Midway Between Center and 321 Brinell Face X1000
 No banding - Microstructure consists of tempered martensite and some tempered non-martensitic austenite decomposition products.

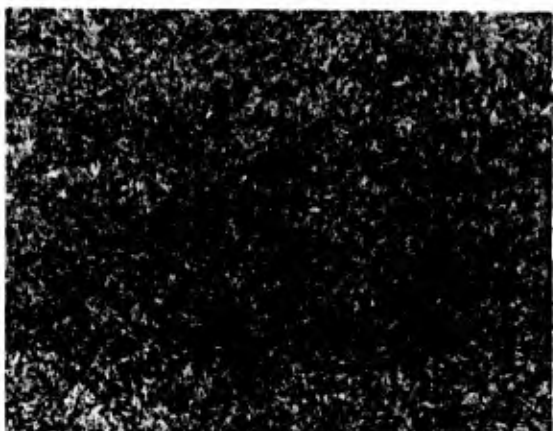
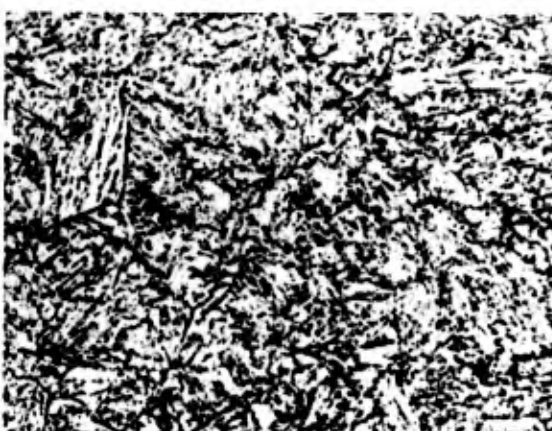
X200 Midway Between Center and 352 Brinell Face X1000
 No banding - Microstructure is tempered martensite with only traces of non-martensitic austenite decomposition products.

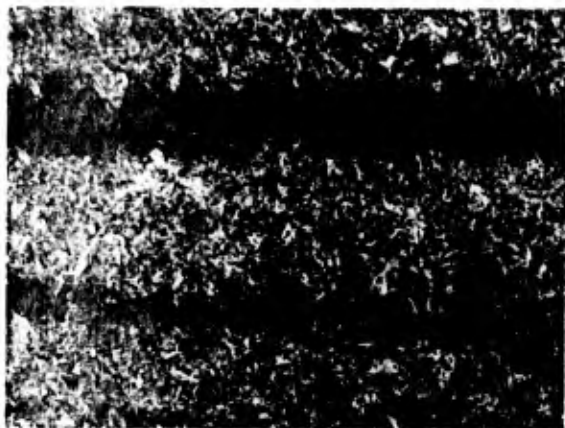
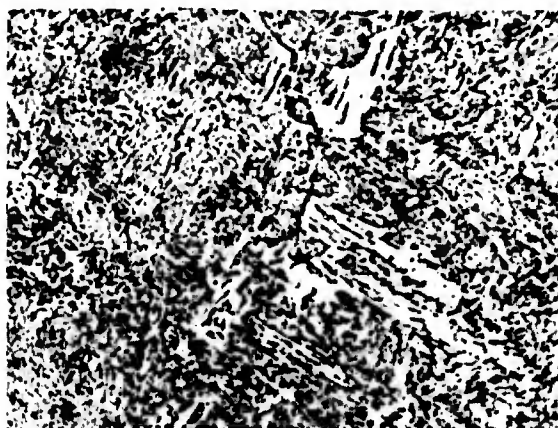
Van Dorn Iron Works 1" Plate No. 1
 (Microspecimen etched with 4% Picral)

Prominent banding - The light etching matrix consists of tempered martensite and some tempered non-martensitic austenite decomposition products (X1000 photo.).

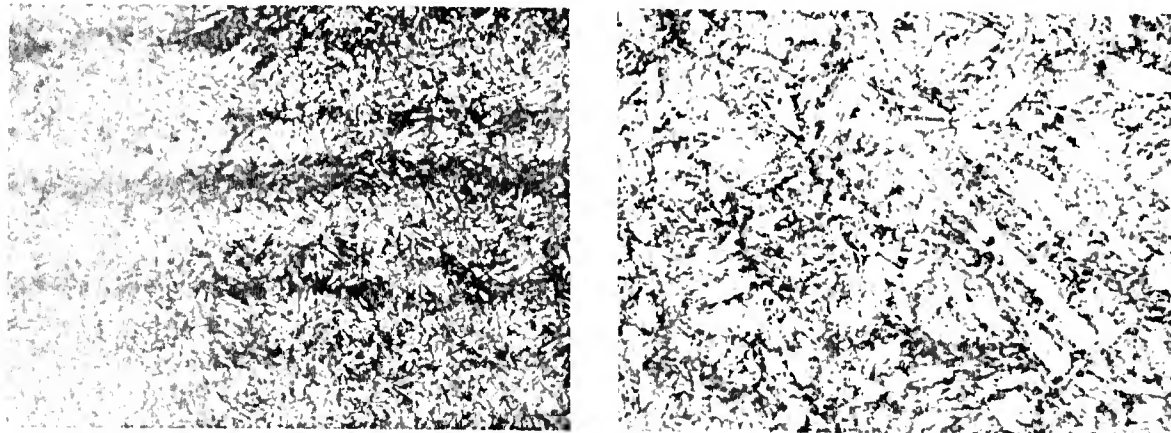
Standard (Jones and Laughlin) 1 $\frac{1}{2}$ " Plate No. M1X3
 (Microspecimen etched with 4% Picral)

Moderate banding - The structure throughout the section consists of acicular tempered martensite.

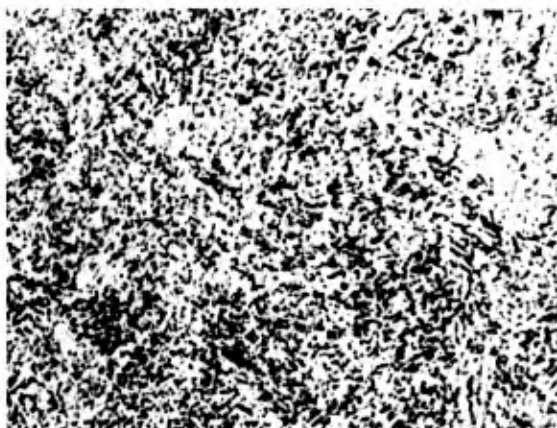
Van Dorn Iron Works 1 $\frac{1}{2}$ " Plate No. 4
 (Microspecimen etched with 4% Picral)

The fiber fracture is wholly fibrous, but a deep lamination is present which may have influenced the attainment of complete fibre. Resistance of the entire series to ballistic shock was excellent, as would be expected, because impact properties although not optimum are nevertheless good. No spalling occurred even at the lowest PTP testing temperature of the series although steel quality, judged by the plate examined, was somewhat poor.

Prominent banding - The matrix structure consists of tempered martensite plus a very small amount of tempered non-martensitic austenite decomposition products.

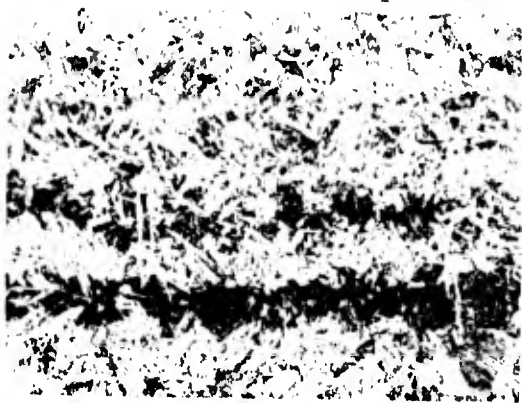
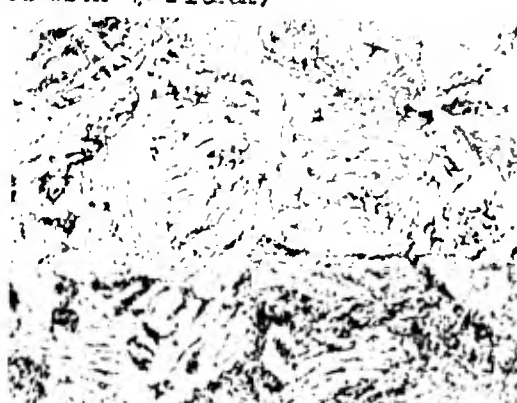
Standard (Great Lakes) 2nd Plate No. LXI
 (Microspecimen etched with 4% Picral)

X200 Center of Section X1000
 Moderate banding - Typical microstructure is largely tempered non-martensitic austenite decomposition products.

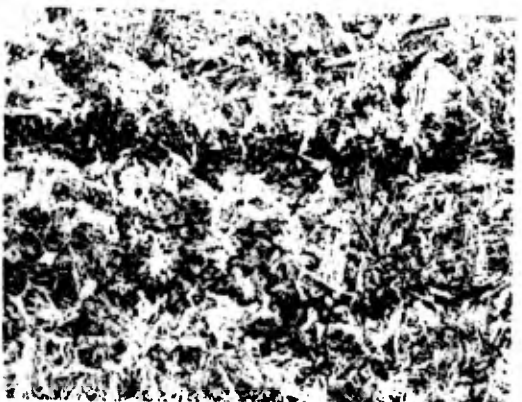
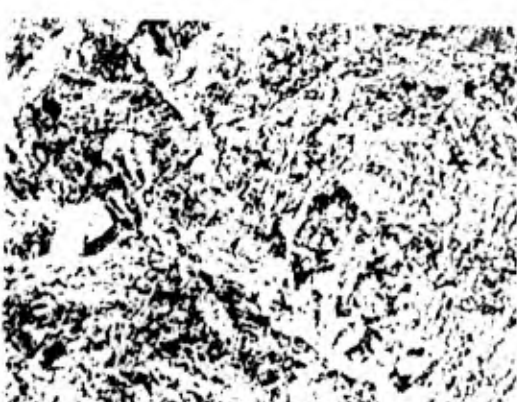
X200 Midway Between Surface and Center X1000
 Some banding - Typical microstructure is tempered martensite and a large amount of tempered non-martensitic products.

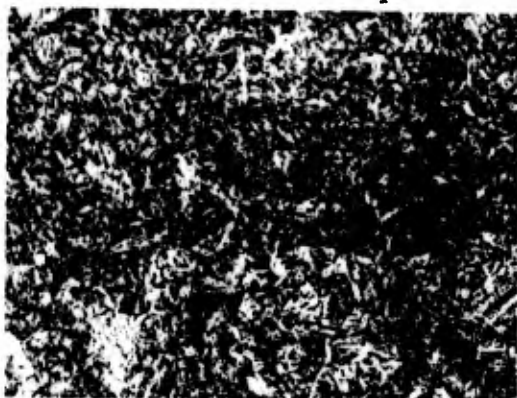
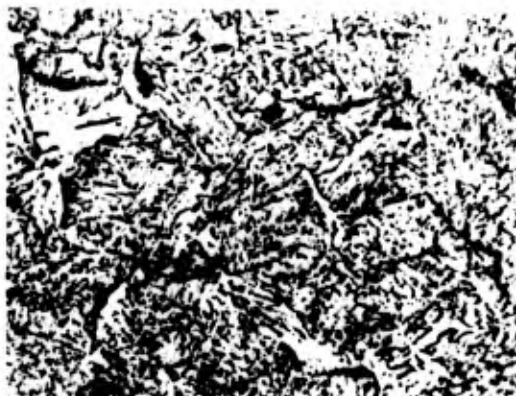
Carnegie-Illinois 2nd Plate No. TB-143317
 (Microspecimen etched with 4% Picral)

The plate was so badly laminated throughout the section that the impact properties of the material cannot be determined from the V-notch Charpy tests or the fibre fracture test. This extreme unsoundness was reflected in the PTP test by the failure of all the plates of the series at -12°F and -15°F even though the projectile was only undermatching.

X200 Center of Section **X1000**
 Moderate banding - A fairly large amount of tempered non-martensitic products is present in the light-etching bands (X1000 photo.).

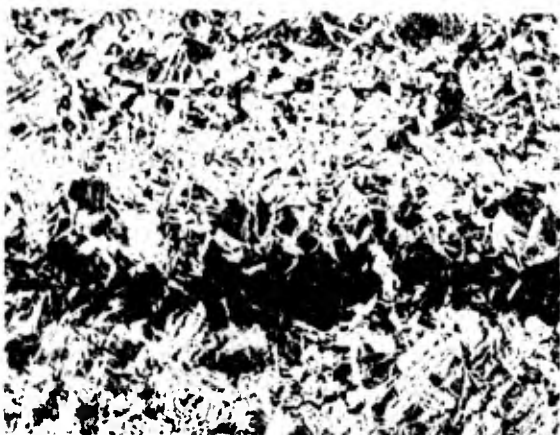
Standard (Great Lakes) 2nd Plate No. LX4
 (Microspecimen etched with 4% Picral)

The behavior of the series when PTP tested illustrates again the effect of decrease in temperature upon spalling occurrence. Since no long stringers were detected in the sample examined, the cause of the spalling is apparently the 300 Brinell hardness.

Moderate banding - Typical microstructure is largely tempered non-martensitic austenite decomposition products.

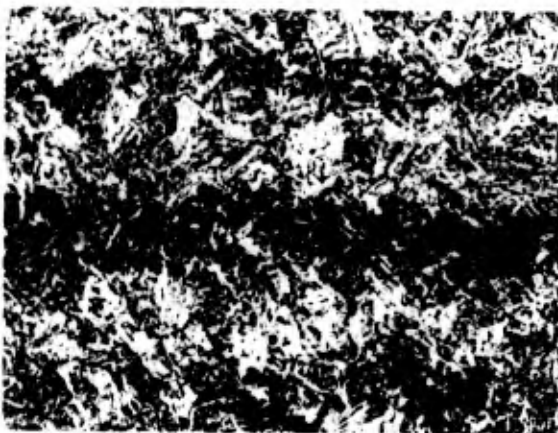
Some banding - Typical microstructure is tempered martensite and a large amount of tempered non-martensitic products.

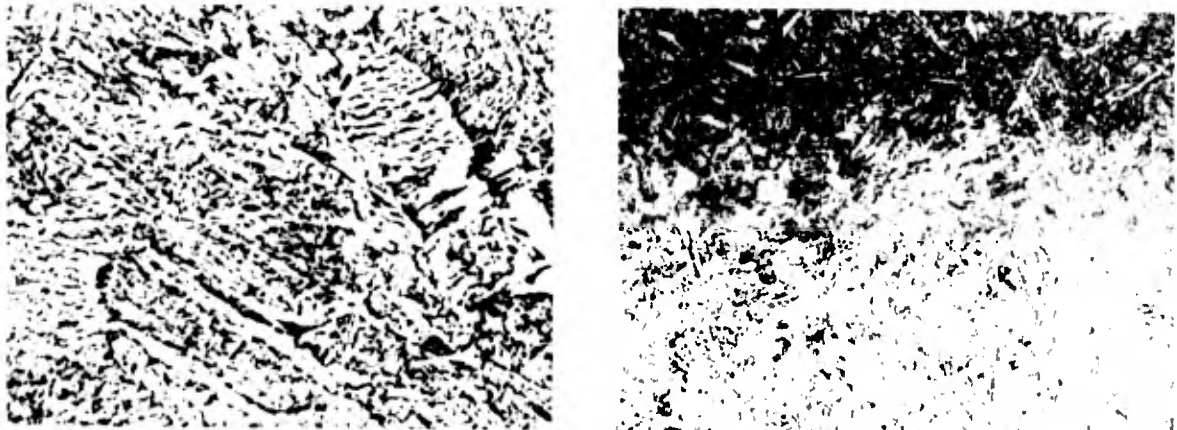
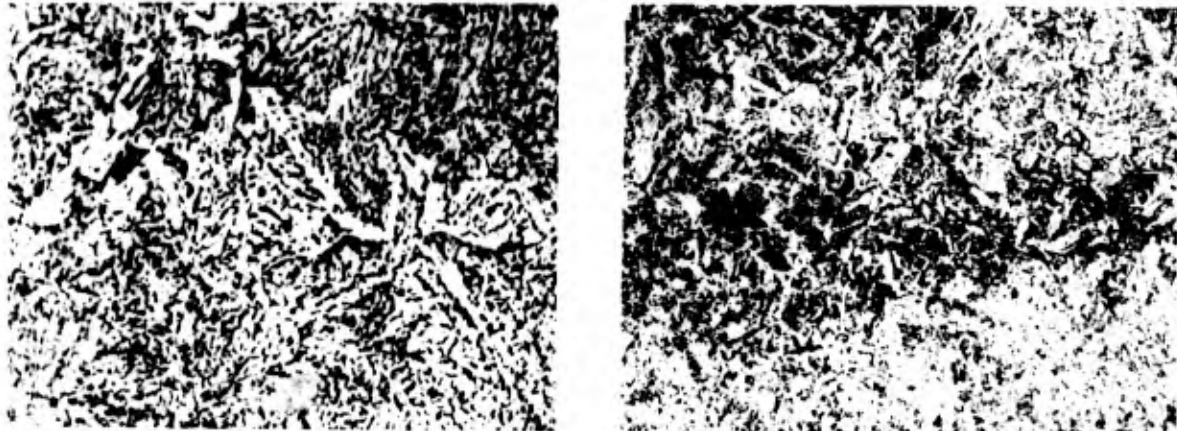
Ford 2nd Plate No. 2040-R
(Macro specimen etched with 4% Picral)

Moderate bending - The light-etching matrix is tempered martensite plus a large amount of tempered non-martensitic products (X1000 photo).
