WATERTOWN ARSENAL LABORATORY

MEMORANDUM REPORT

NO. WAL 710/664

Study of "Woody" Fractures in Rolled Armor Plate

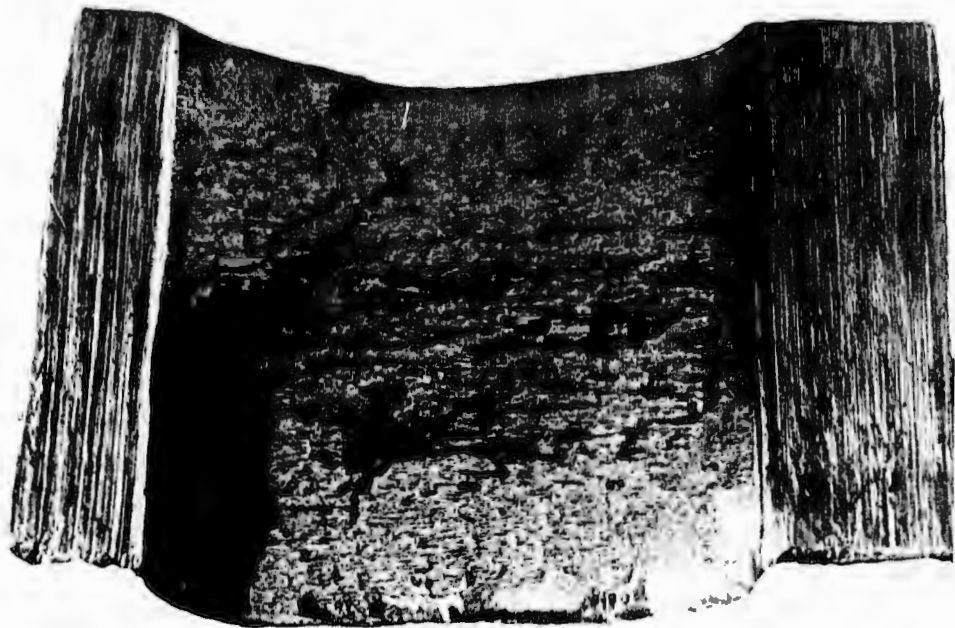
FIGURE 1

The results of the microscopic examination indicate that fine nonmetallic inclusions in the plane of rupture result in the "woody" type of fracture. Figure 1, illustrates a "woody" fracture, broken in the longitudinal direction of the $1\frac{1}{2}$ " thick plate No. RH 11761. This fracture was nickel plated in order to preserve the contour of the fracture during the metallographic polishing operation and subsequently cut transversely and examined for the presence of nonmetallic inclusions in planes of rupture. As noted in Figure 8, the cross section of a "woody" fracture has a "stepped" appearance. Microscopic examination revealed the presence of fine nonmetallic inclusions on the "shelves" of the stepped fracture, indicating that rupture has occurred along these planes. These nonmetallic inclusions were identified as silicates, complex oxide-sulphide-silicates and in one case zirconium nitride was present on a plane of rupture, see Figure 8. The distribution of nonmetallic inclusions in the cross section of these materials is also shown in Figure 8.

1 1/2" THICK ROLLED ARMOR EXHIBITING WOODY FRACTURE
17 MAY 1944 MAG. X 2 WTN.710-2307

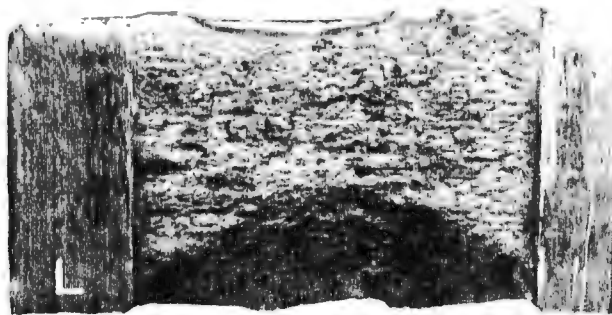
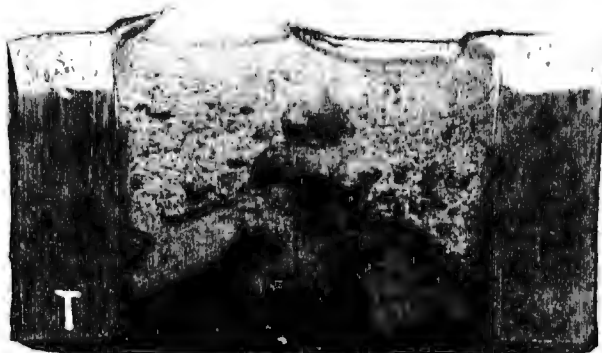
1 1/2" PLATE RH 11792
PTP TEST 2 3/8" X 2 3/8" EXIT DIA.

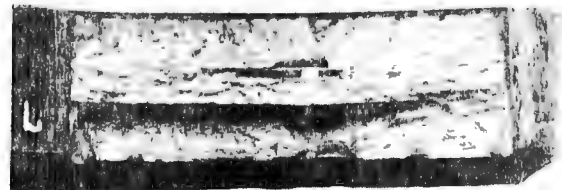
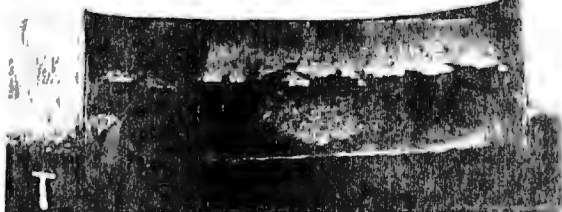
3/4" PLATE RH 53715
PTP TEST 2 1/4" X 3" EXIT DIA.

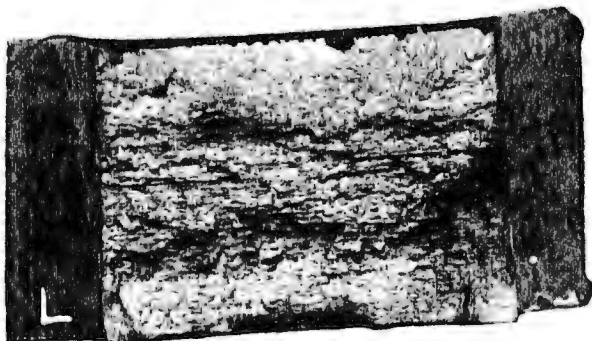
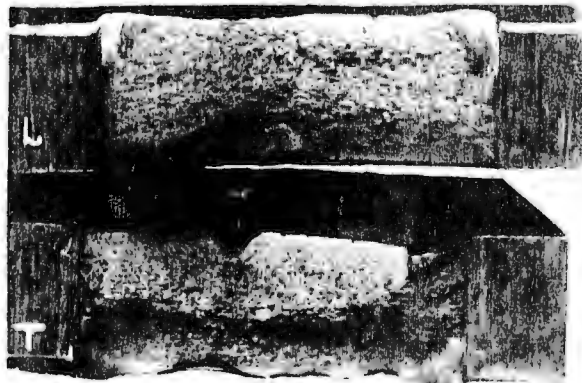
3/4" PLATE RH 11761
PTP TEST 2 3/4" X 3" EXIT DIA.

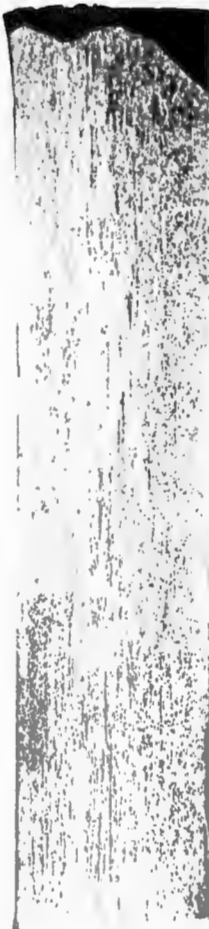
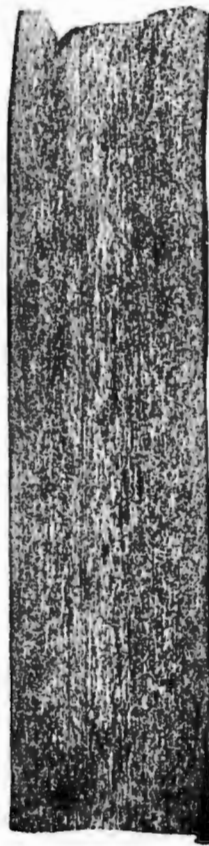
FIGURE 4

In the case of sample No. 10, which showed no evidence of a "woody" fracture, see Figure 4, no elongated nonmetallic inclusions were evident. A uniform distribution of small nonmetallic inclusions was scattered throughout the matrix, see Figure 10.

FRACTURES FOR STEEL SOUNDNESS AND MACROSTRUCTURE OF 3/4" THICK ARMOR PLATE NO. 10 CONTAINING:

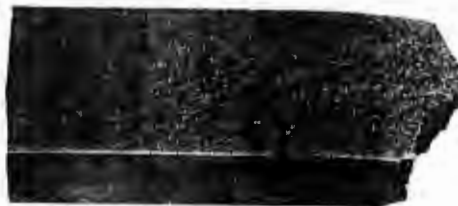
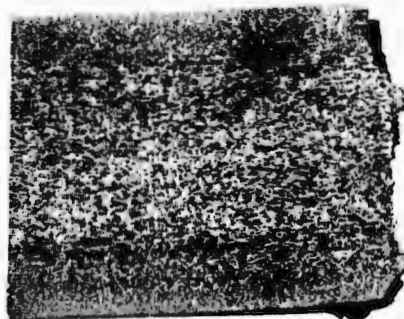
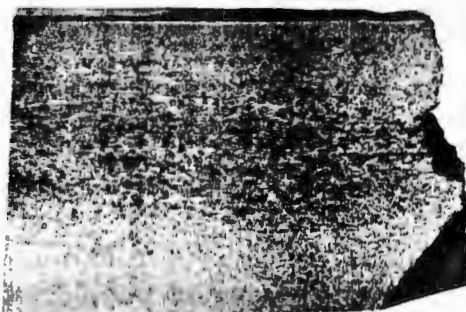
FIGURE 5

SAMPLES NOS 1 AND 5 - POOR BALLISTIC PROPERTIES
SAMPLES NOS 6 AND 9 - SATISFACTORY BALLISTIC PROPERTIES

MACROSTRUCTURE OF ROLLED PLATE SUBMITTED BY REPUBLIC STEEL CORP
31 JANUARY 1944 WTN.710-2269

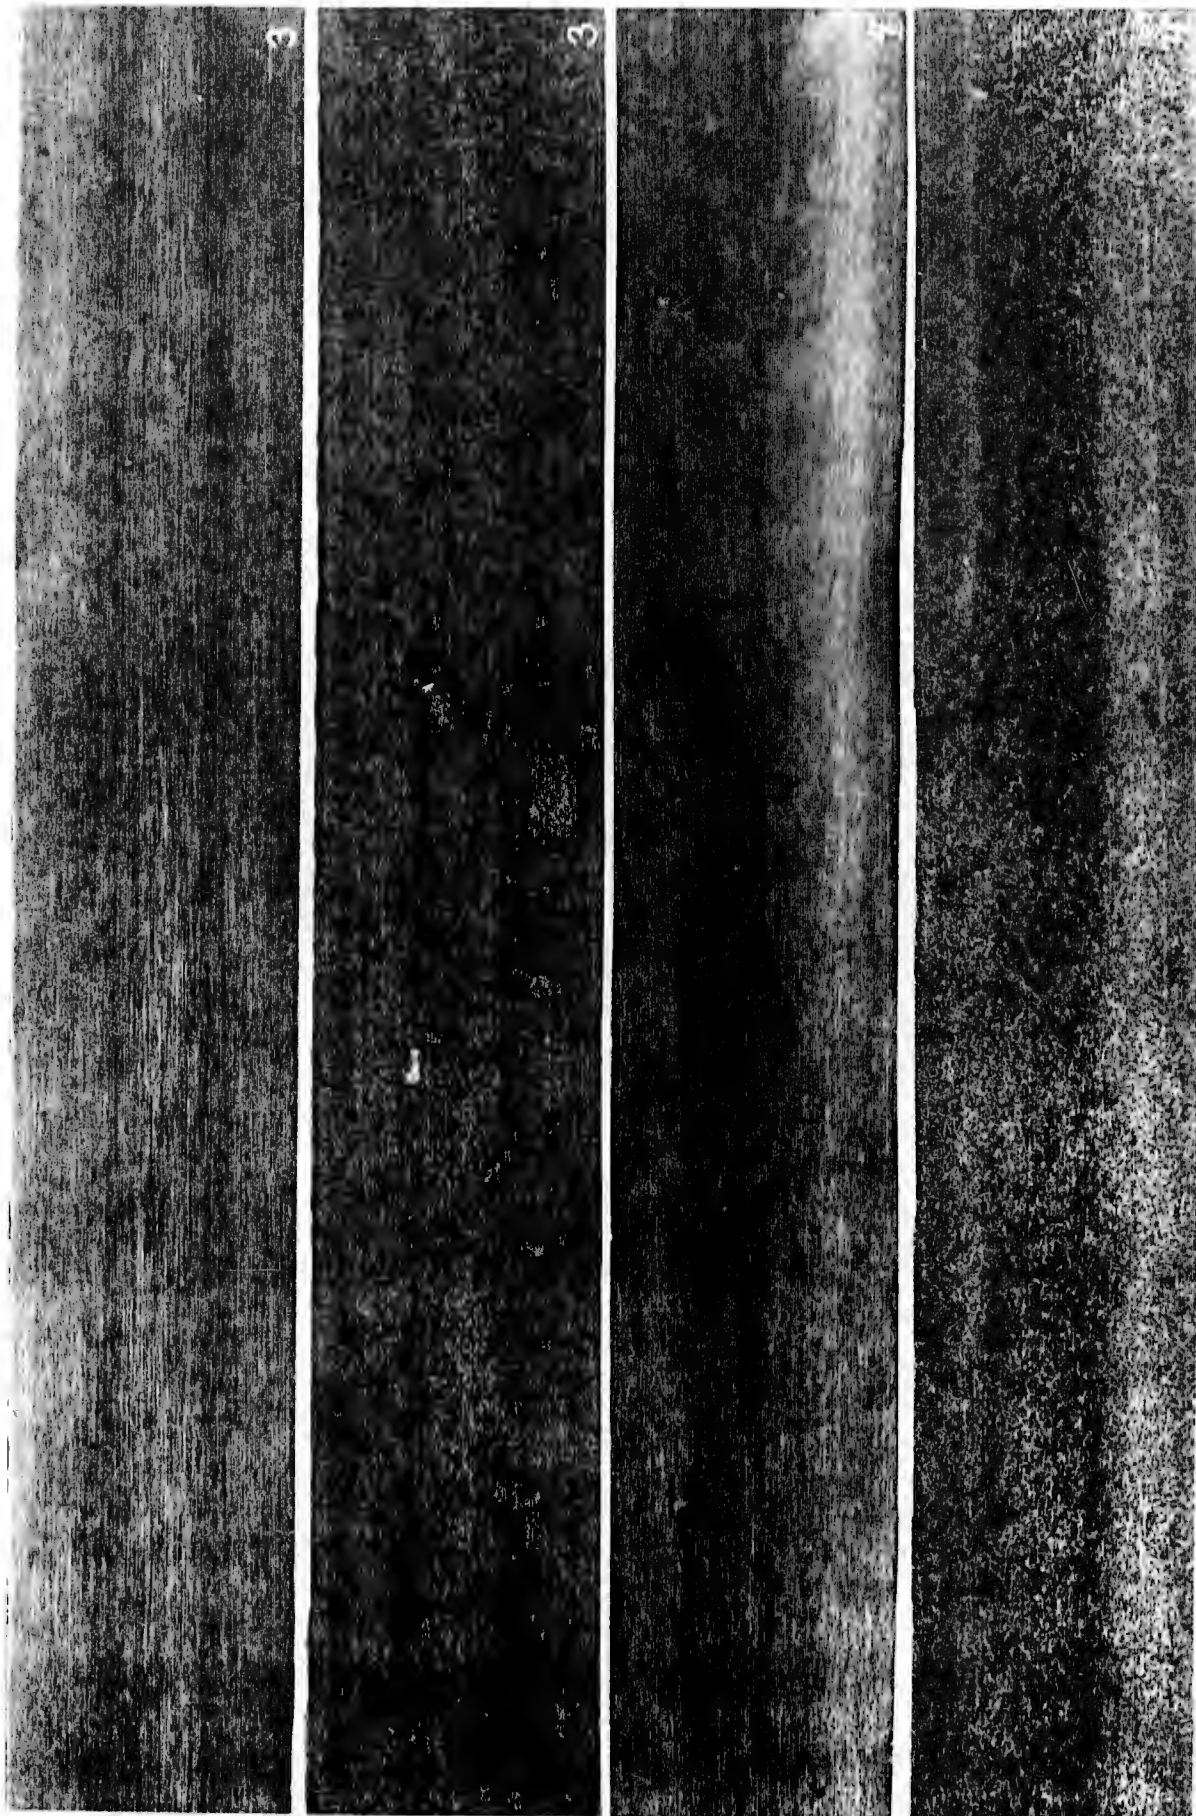
WATERTOWN ARSENAL
 (3) 1 1/2" PLATE RH 11792 - LONGITUDINAL (3) 1 1/2" PLATE RH 11792 - TRANSVERSE (4) 1 1/2" PLATE RH 11761 - LONGITUDINAL
 (4) 1 1/2" PLATE RH 11761 - TRANSVERSE MAG. XI 10 MARCH 1944
 WTN.71C-2288

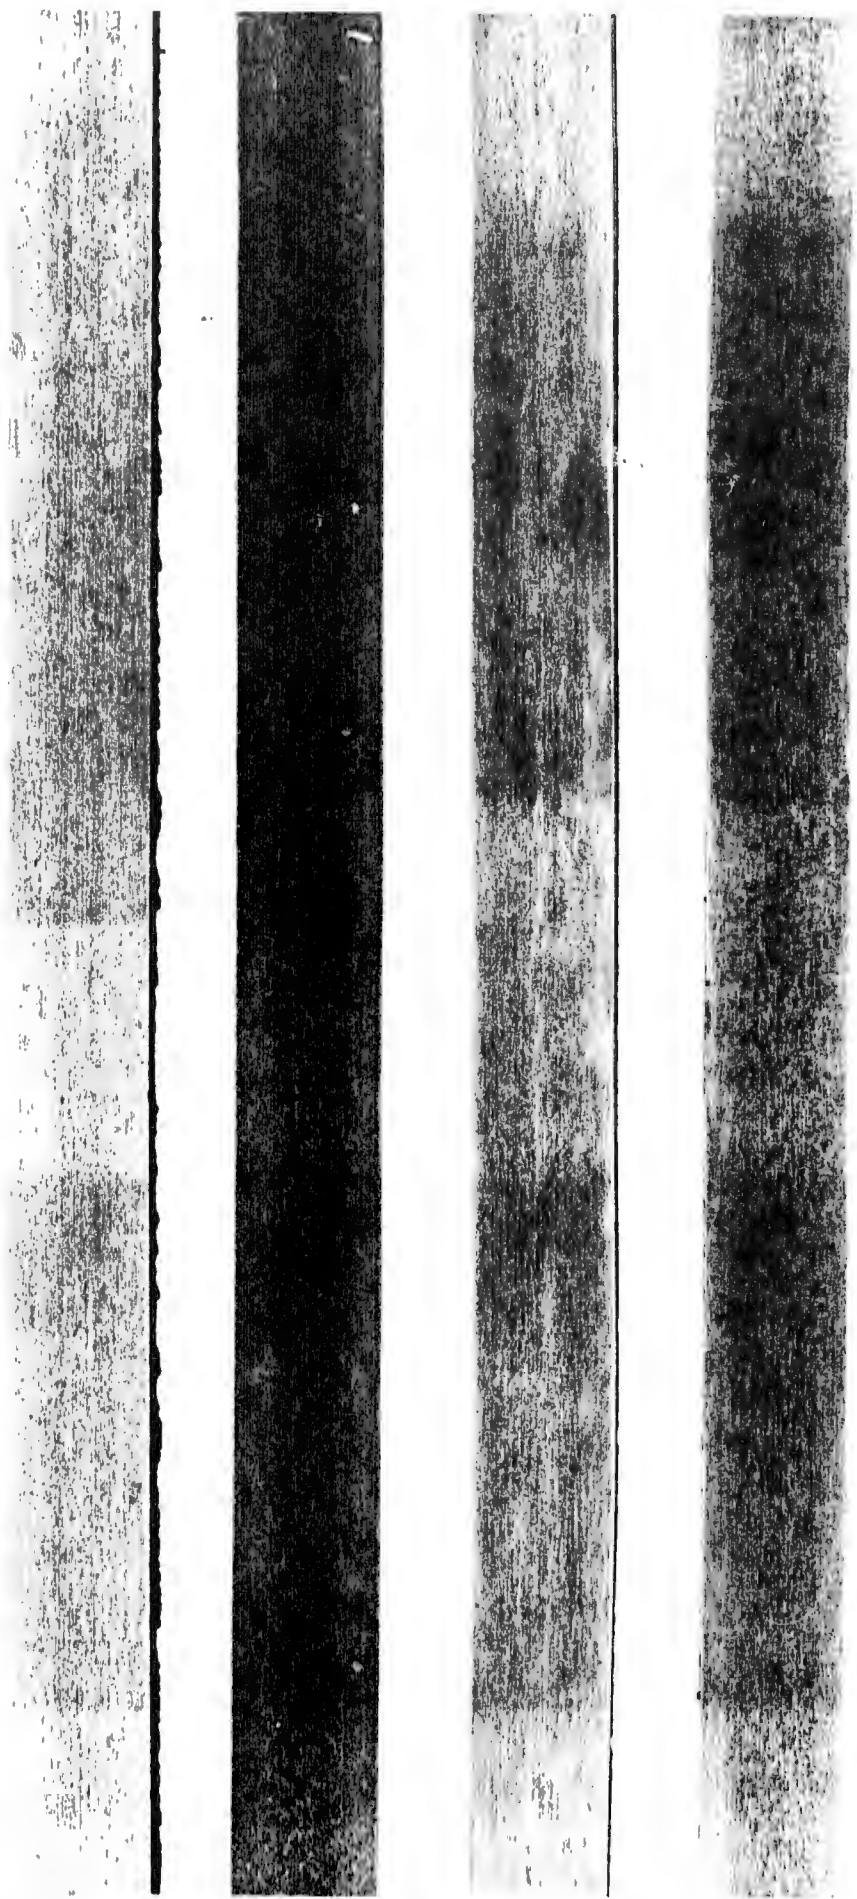
{ 1 } 3/4" PLATE RH 53715 - LONGITUDINAL (1) 3/4" PLATE RH 11761 - TRANSVERSE (2) 3/4" PLATE RH 11761 - LONGITUDINAL
{ 2 } 3/4" PLATE RH 11761 - TRANSVERSE MAG XI 10 MARCH 1944 WTN.710-2287
MACROSTRUCTURE OF ARMOR PLATE SUBMITTED BY REPUBLIC STEEL CORP.

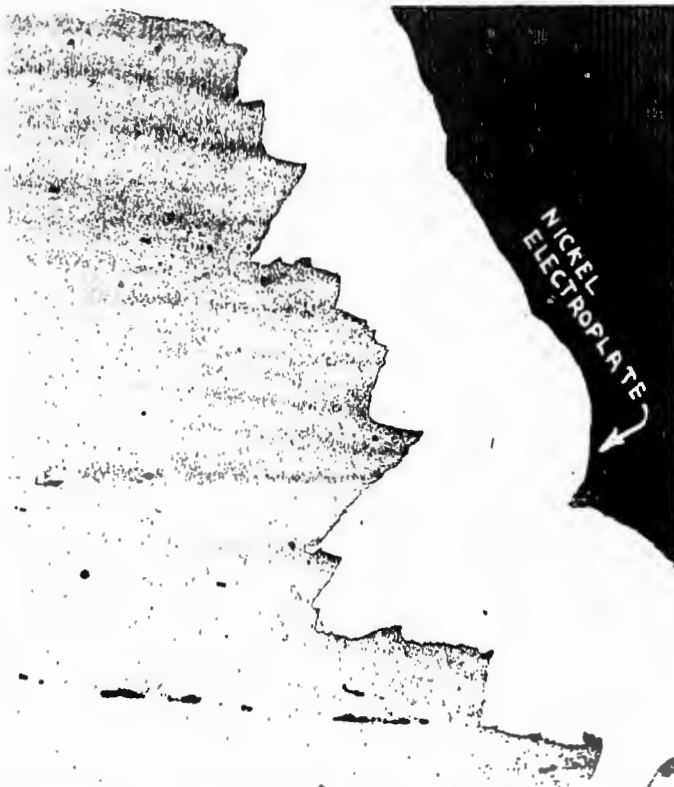
Sample No. RH 11761 - $1\frac{1}{8}$ " thick. Typical contour of "woody" fracture. Stepped appearance. Sulphide-silicate inclusions in steel base. Failed PTP test. Macy. X100

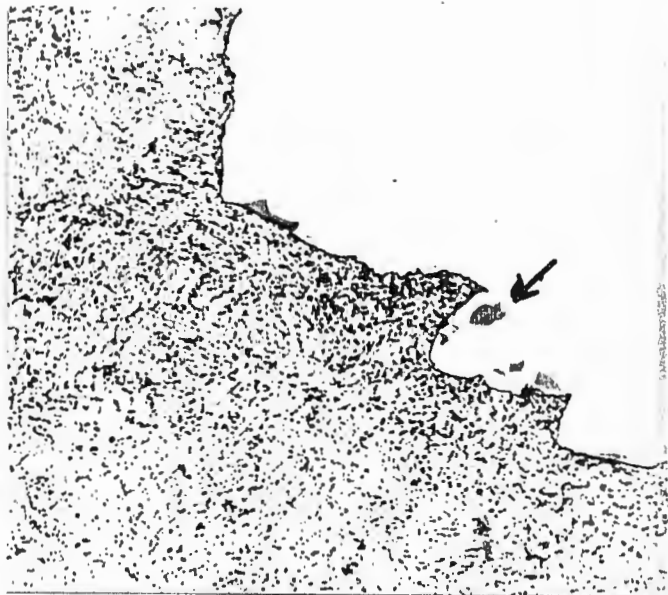
Sample No. RH 11761 - $1\frac{1}{8}$ " thick. Series of fine nonmetallic inclusions on stepped rupture. Fragment of zirconium nitride (yellow under white light) at tip of middle step, see arrow. Gray inclusions are oxide-silicate inclusions.

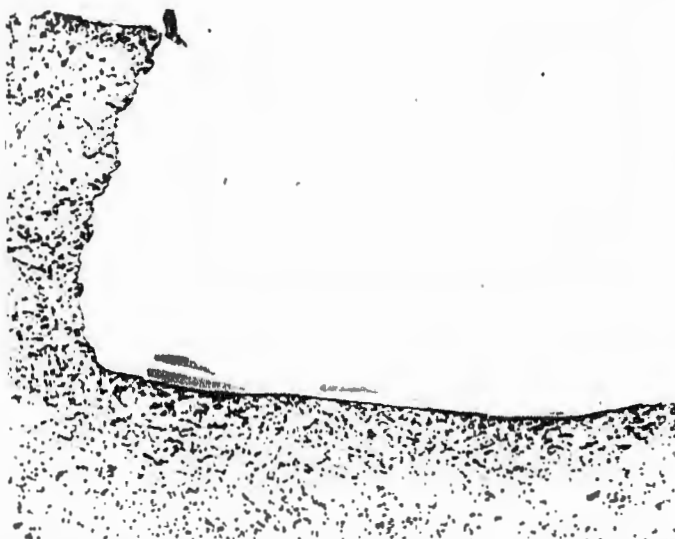
Sample No. RH 11761 - $1\frac{1}{8}$ " thick. Sulphide-silicate inclusion on stepped plane of rupture of "woody" fracture.

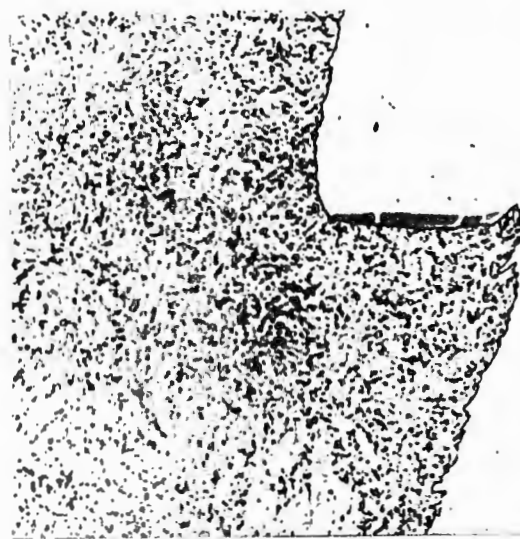
Sample No. H 11761 - $1\frac{1}{8}$ " thick. Broken silicate inclusion on stepped plane of rupture of "woody" fracture.

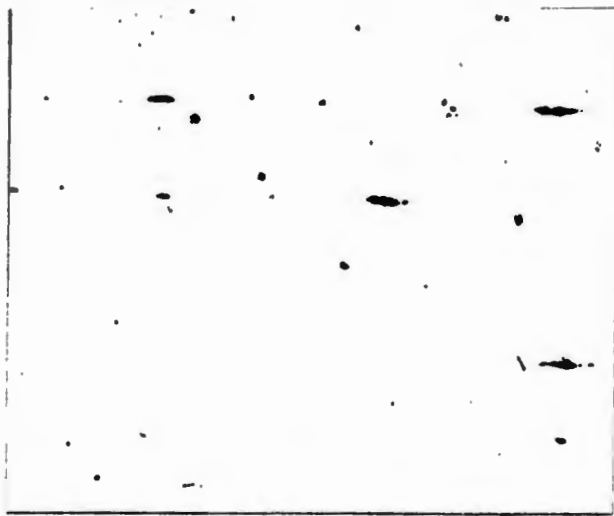
Sample No. 1 - 3/4" thick. Fine oxide-sulphide-silicate inclusions well distributed. "Woody" fracture - Failed PTP test.

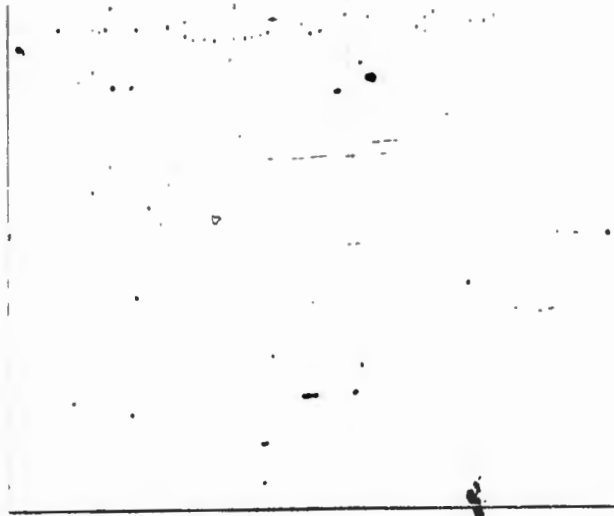
Sample No. 6 - 3/4" thick. Scattered fine oxide-sulphide-silicate inclusions. Traces of "woodiness" in fracture - Passed PTP test.

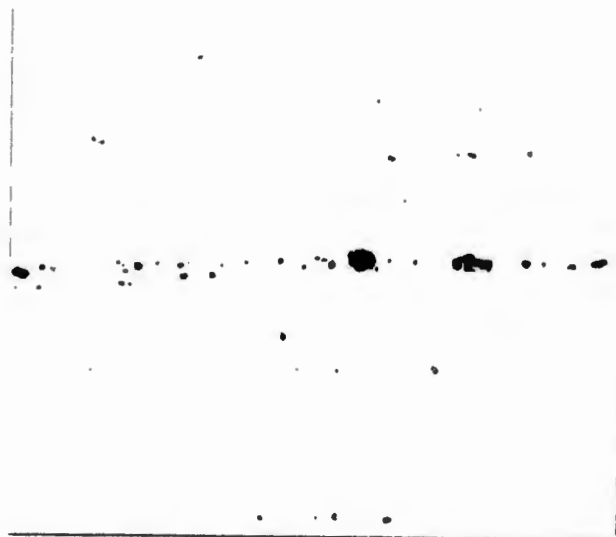
Sample No. 5 - 1 1/2" thick. Typical alumina inclusion streak in center of plate. Silicates were also present. "Woody" fracture - Failed PTP test.

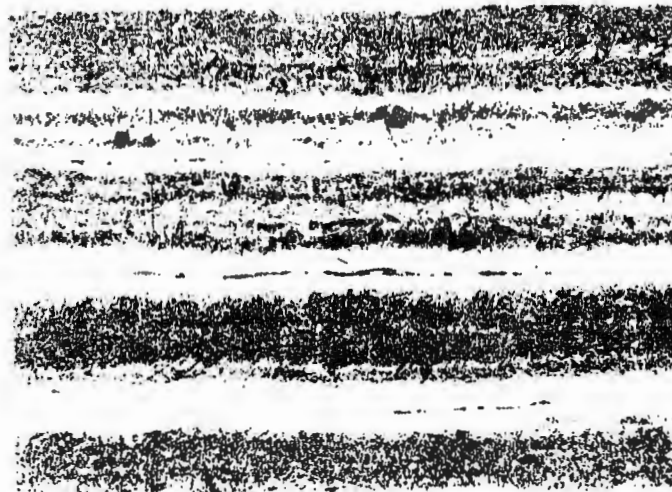
Sample No. 5 - 1 1/2" thick. Pronounced banding associated with fine oxide-sulphide-silicate inclusions. "Woody" fracture. Failed PTP test.

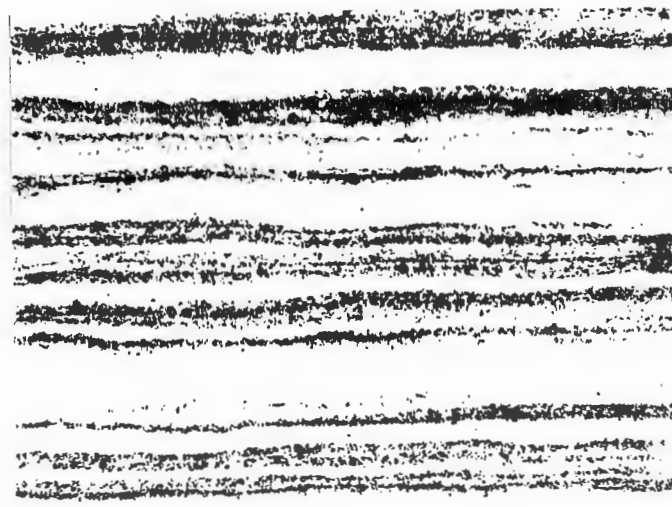
Sample No. RH 11761 - 3/4" thick.
Pronounced banding associated with a few small inclusions. No evidence of "woody" fracture. Failed PTP test.

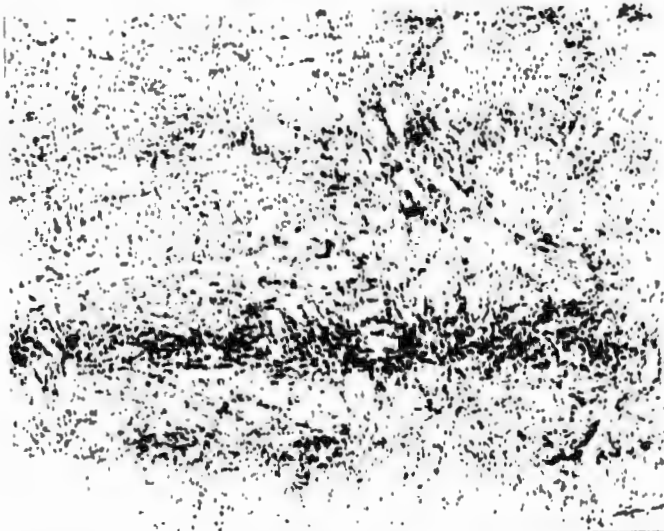
Sample No. 1 - 3/4" thick. Ferrite, tempered martensite, banded structure. "Woody" fracture - Failed PTP test.

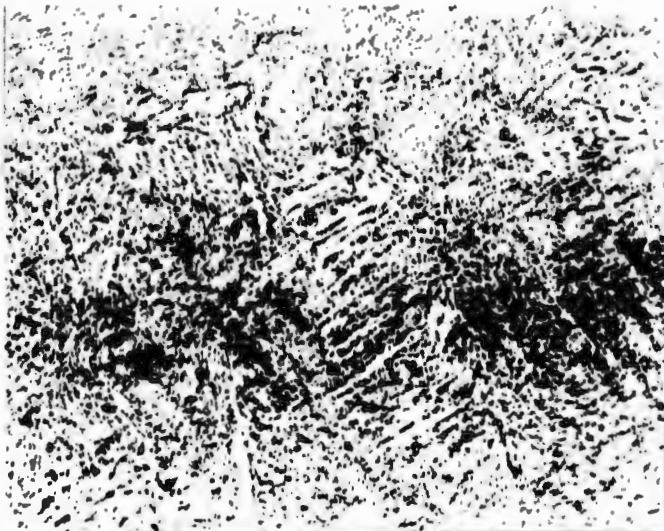
Sample No. RH 11792 - 1 1/2" thick. Ferrite, upper temperature transformation products and tempered martensite. "Woody" fracture. Passed PTP test.

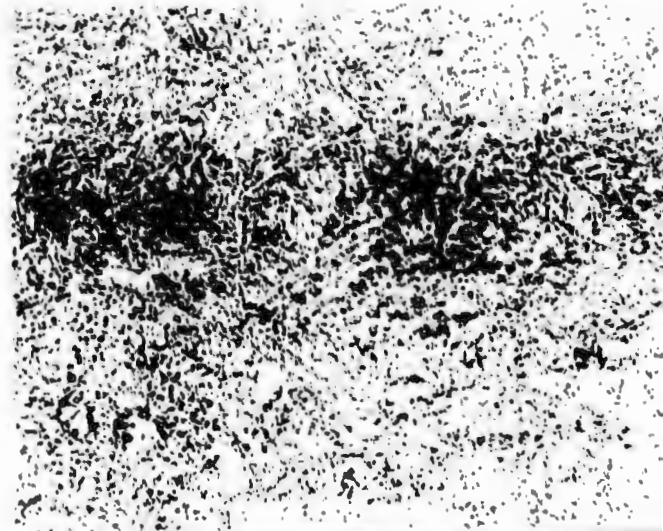
Sample No. 9 - 1" thick. Tempered martensite, banded structure. Traces of "woody" fracture - Passed PTP test.

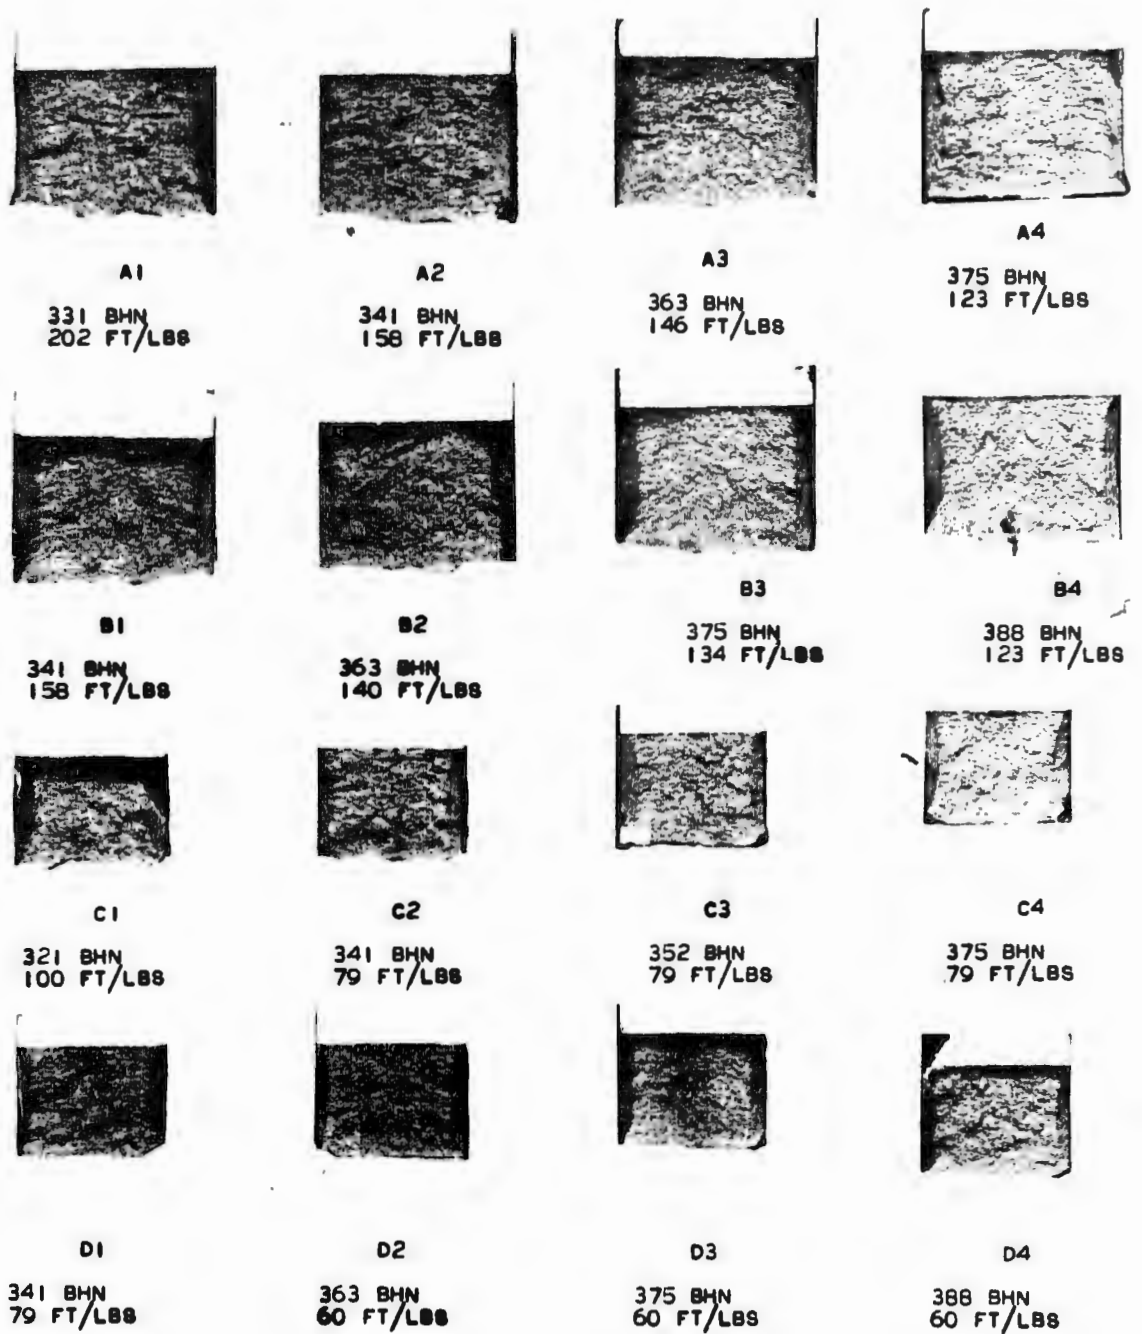
This particular material which showed only traces of woodiness as fractured, see Figure 13 was heat treated to several hardness levels, namely from about 320 to 388 Brinell and had impact values not too inferior to cross rolled material heat treated to the same hardness levels. These steels all exhibited fibrous fractures at the several hardness levels.

FRACTURES OF 1" AND 3/4" SQUARE V-NOTCH CHARPY BARS MACHINED FROM
 REPUBLIC STEEL CORP. ARMOR HEAT TREATED TO SEVERAL HARDNESS LEVELS
 24 MARCH 1944 MAG. XI WTN.710-2292
