WATERTOWN ARSENAL
LABORATORY

MEMORANDUM REPORT

NO. WAL 710/571

DEFECTIVE HELMET STEEL

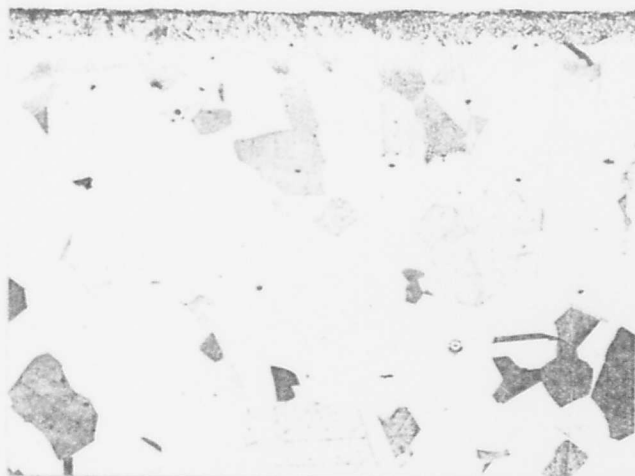
Steel A, which in the basic correspondence was declared defective due to improper annealing, was found to be decarburized on both surfaces to the extent that 0.0025" thick layers of martensite exist at both surfaces, see Figure 1A. In a previous investigation¹ of helmet stock, cracking during the deep drawing of helmets was attributed to undissolved carbides resulting either from incomplete solution of the carbides during heating of the steel, or from improper quenching practice. No undissolved carbides were found in any of the steels studied in this investigation.

Nital Etch -A- X100
Steel A. Surface decarburization.
0.0025" thick layer of martensite.

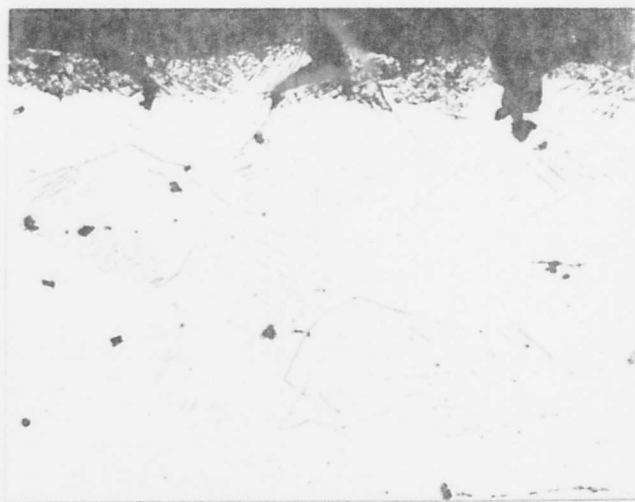
Specimens from item B, which consists of helmets broken in the drawing operation, show surface decarburization similar to that found in item A. Cold working decarburized helmet stock causes cracking of the brittle martensite surface layers, Figure 1B, and this cracking, once initiated, evidently propagates readily through the otherwise ductile austenitic body of the sheet. Deep drawing of the helmet stock induces high stresses in the material, and small cracks, by their notch effect, are very dangerous stress raisers.

Microscopic examination of discs #1-5 and helmets #1-5 revealed greater or lesser amounts of surface decarburization on all sheets. Specimens from the helmets show precisely the same condition that was observed in item B, see Figure 1B, and it was concluded that the helmets failed the ballistic acceptance test because of the deleterious effect of the brittle martensitic skin which causes early failure by crack formation.

Nital Etch -B- X250
Steel B. Cracking of brittle martensite
layer resulting from cold forming of
helmets. 0.001" decarburized layer of
martensite.

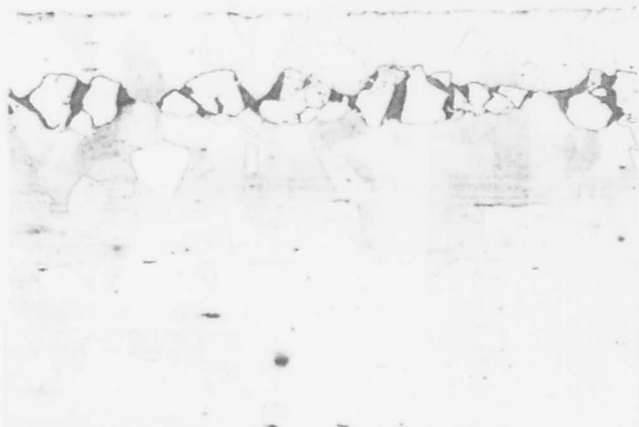
Steel C, which was described as defective due to laminations, contains a streak of fragmented grains of coarse martensite below and parallel to the surfaces of the sheet, see Figures 1C and D. This defect is probably the result of the rolling out of residual ingot piping that escaped being cropped. The surfaces of ingot pipes may be decarburized either by entrapped gases or by exposure to the air. A decrease in the normal carbon content of Hadfield manganese steel makes the austenite unstable and leads to the formation of martensite.

Nital Etch -C- X100
Steel C. Streak of fragmented grains of
martensite, probably residual ingot piping
rolled out in sheet.

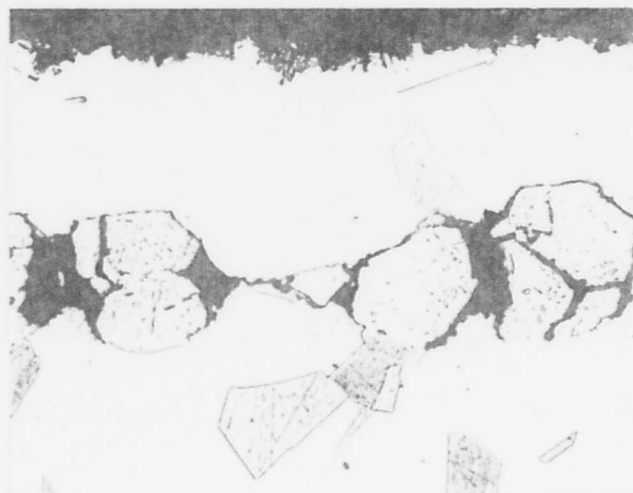
Nital Etch -D- X250
Steel C. Same as -C-. Hard brittle grains
of martensite. No decarburization at
surface of sheet.

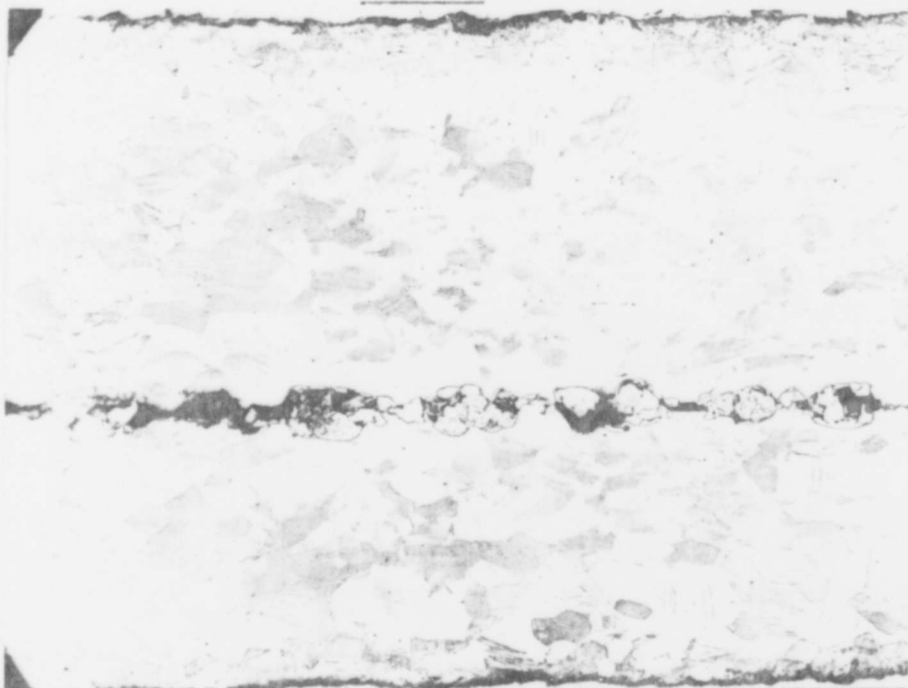
Specimens for microscopic examination cut from helmets from item D, which broke in the draw because of laminations, exhibit the same type of martensite streak that was observed in item C, see Figures 2A and B. In this heat of steel, the streak occurs approximately in the middle of the cross-section. The grains of martensite are fragmented

Nital Etch -A- X100
Steel D. Streak of martensite into which crack resulting from deep drawing extends.

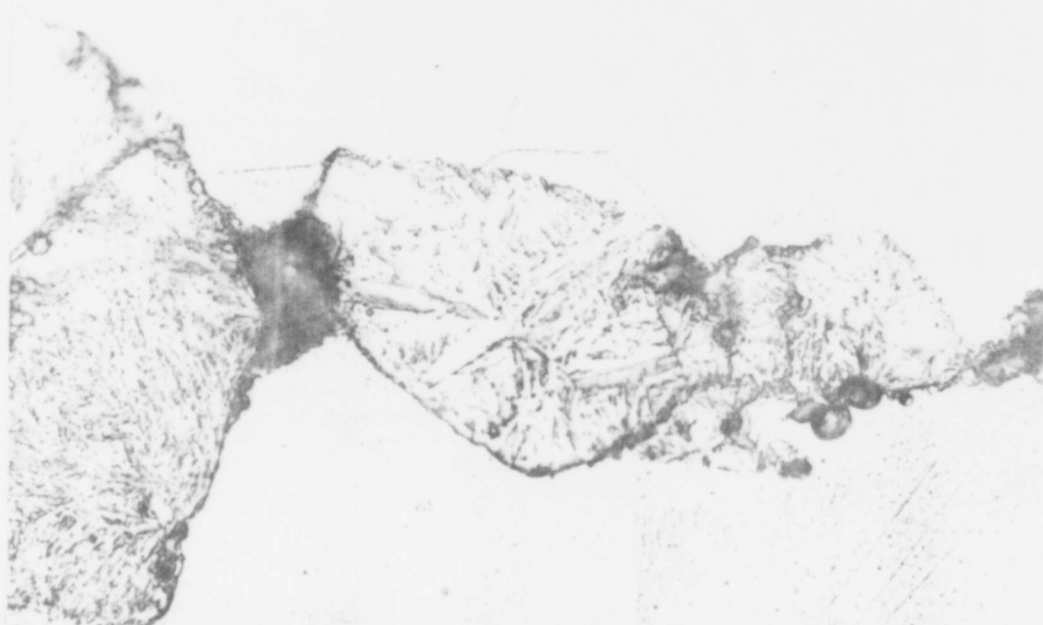
because it is the practice of the Sharon Steel Corporation to finish the sheet by cold rolling prior to the final anneal; and the martensite, being hard and brittle, cracks during the rolling.

Nital Etch -B- X750
Steel D. Same as above. Fragmented grains of martensite probably resulting from residual ingot piping rolled out into streak.

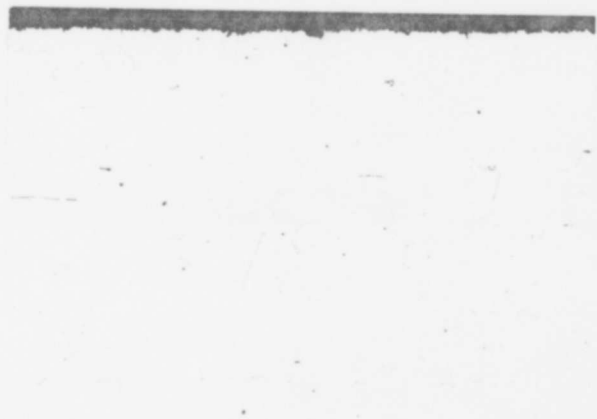
Steel E is completely free from martensite resulting from surface decarburization and contains no martensite streaks, see Figures 3A and B. This steel was found to be satisfactory for the helmet application. In an attempt to reproduce the surface decarburization noted in other steels, a sample of steel E was reheat treated for 1 hour at 1850°F, followed by water quenching. The furnace atmosphere was not controlled; and some surface decarburization consequently occurred; compare Figures 3C and D with Figures 1A and B.

Steel E. -A- X100
Satisfactory for helmet application.
No decarburization.

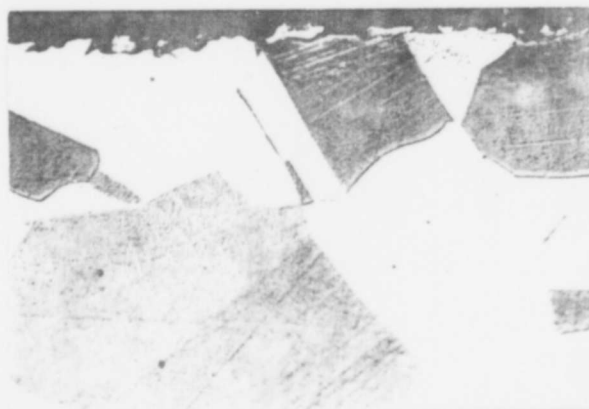
Steel E. -B- X750
Same as -A-. No decarburization to
martensite.

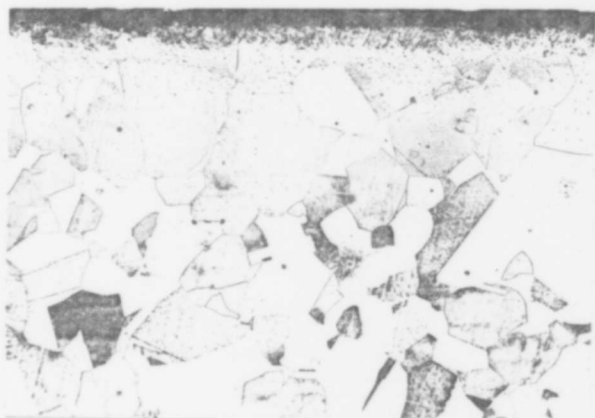
Steel E. -C- X100
Reheat-treated at Watertown Arsenal.
1800°F. - 1 hour - water. No atmosphere
control. Surface decarburized to
martensite.

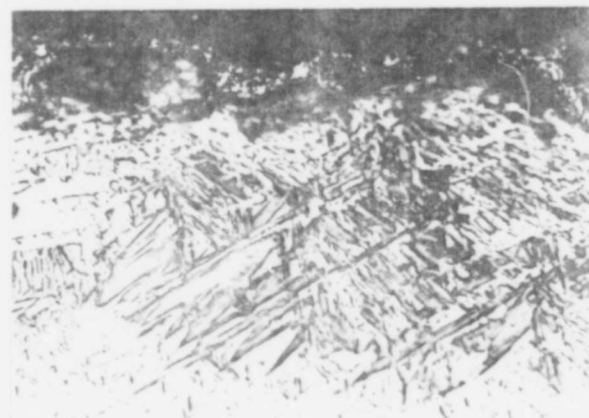
Steel E. -D- X1000
Same as -C-. Martensite needles at
surface. 0.002" layer decarburized to
martensite.

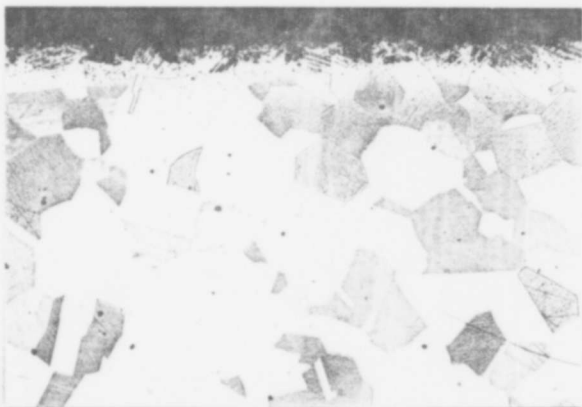
Microscopic examination of several of the above mentioned discs reveals that those having smooth surfaces are free from surface decarburization to martensite, while those having rough surfaces are decarburized to some extent. Martensite layers as much as 0.002" thick resulting from surface decarburization were found on both Sharon and Carnegie-Illinois steels, see Figures 3E and F. The Sharon steels are decarburized on both surfaces, while the Carnegie-Illinois steels are decarburized on only one surface. This is traceable to the fact that the Carnegie-Illinois steel is pack-rolled while hot, with one surface protected by contact with another sheet, while the Sharon steels are individually heated and rolled.

-E- X100
Sharon "Rough Surface". Decarburized
surface typical of Sharon and Carnegie
STEEL PRODUCED AT GOVERNMENT EXPENSE

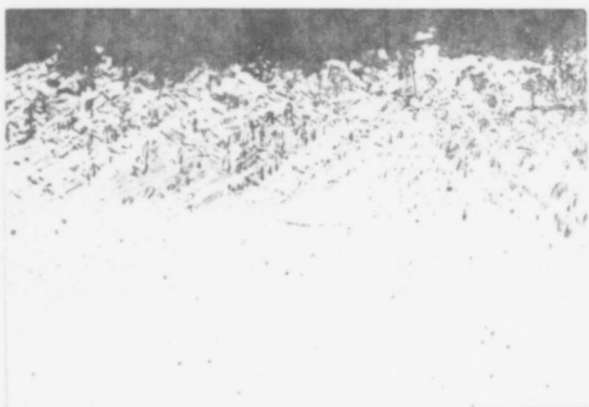
-F- X750
Sharon "Rough Surface". Martensite
level surface. 0.0017" layer de-
carburized to martensite. 12
