Metallurgical Examination of 2 1/2" Rolled Homogeneous Armor Plate

Manufactured by H. Disston and Sons, Inc.

Which Backspalled under the PTP Test

Memorandum Report No. WAL 710/583

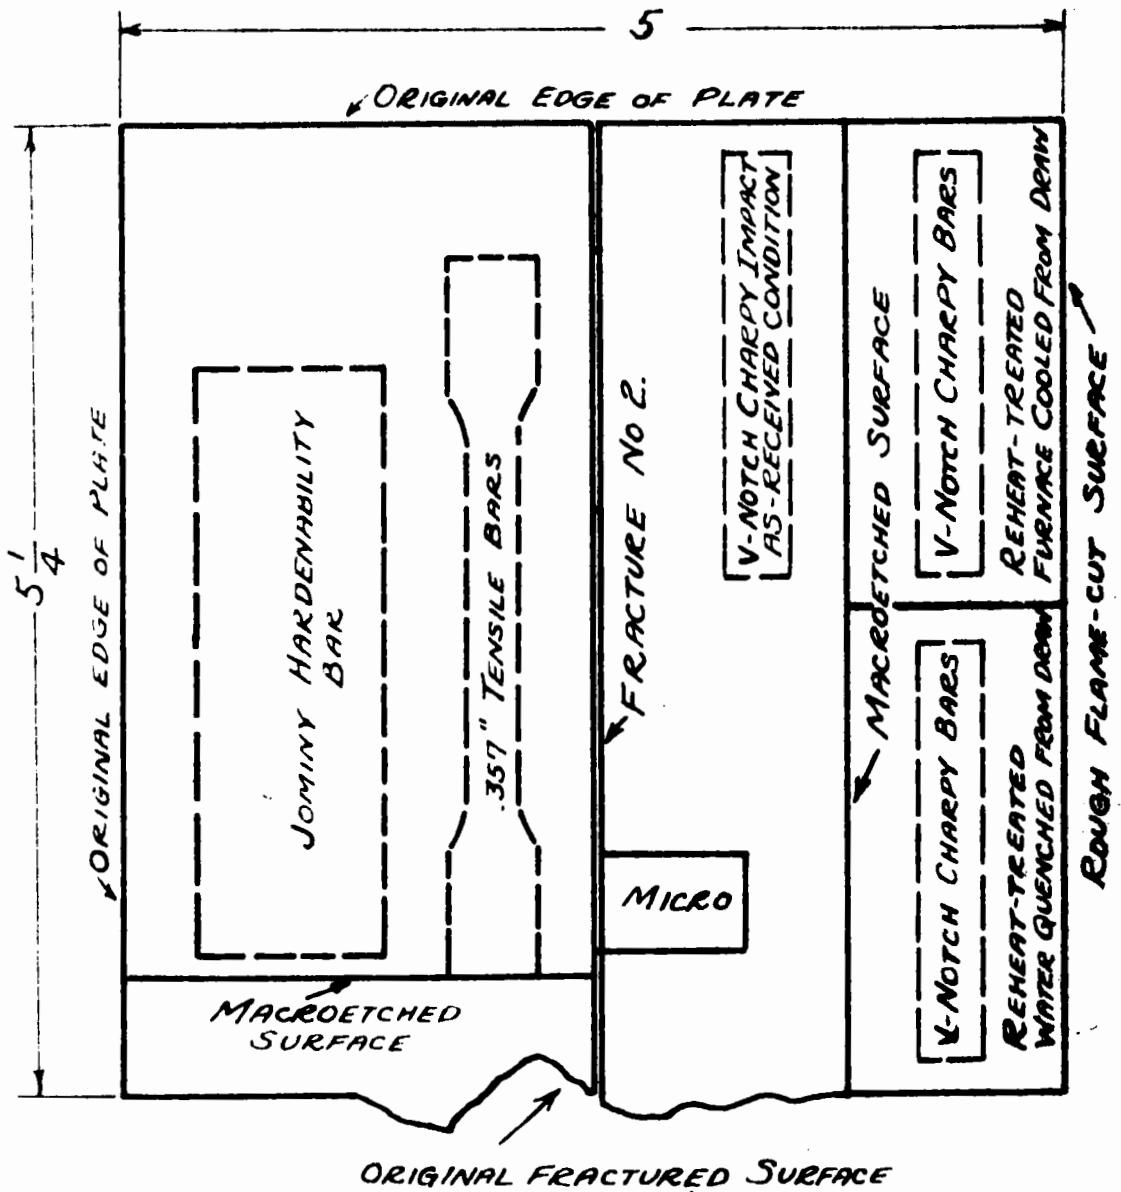
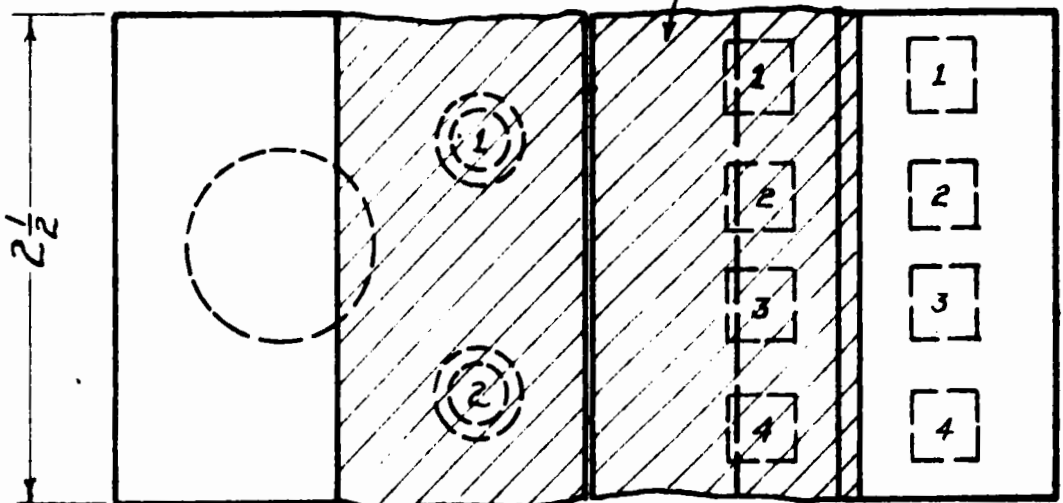
LAYOUT OF SPECIMENS CUT FROM SAMPLE OF DISSTON PLATE NO. 4529-1.

The locations of the various test specimens are indicated in Figure 2.

Cracks occur at the edge of the specimen taken parallel to the original fracture. This position corresponds to the left edge of the sketch shown in Figure 2, which is one of the plate edges which had been flame cut prior to the final heat treatment. It is believed that these cracks resulted from thermal stresses engendered by flame cutting. These cracks are confined to the plate edges and are not related to the ballistic failures.

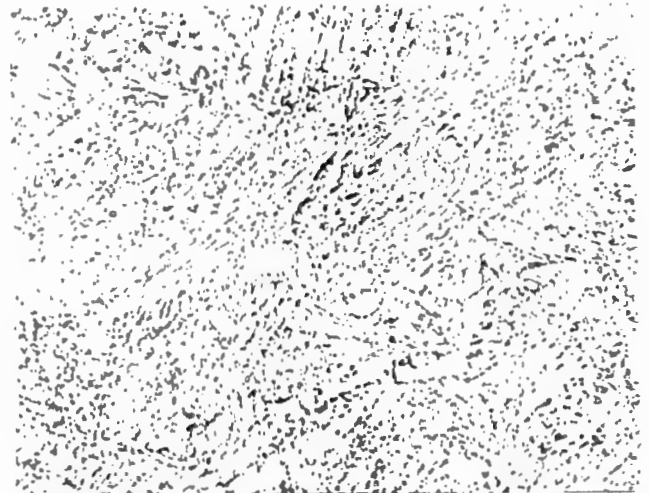
4. Microscopic Examination. Microscopic examination of the cross section of the plate in the unetched condition reveals only small scattered nonmetallic inclusions and no laminations, Figure 3C. The microstructure consists of tempered martensite with some ferrite and pearlite which had formed at high temperature due to the hardenability being insufficient to quench out a 2½" thick section, Figure 3D.

Unetched
Clean steel. Small nonmetallic in-
clusions. No lamination.

Pical steel
Incompletely quenched structure.
Martensite tempered pearlite and

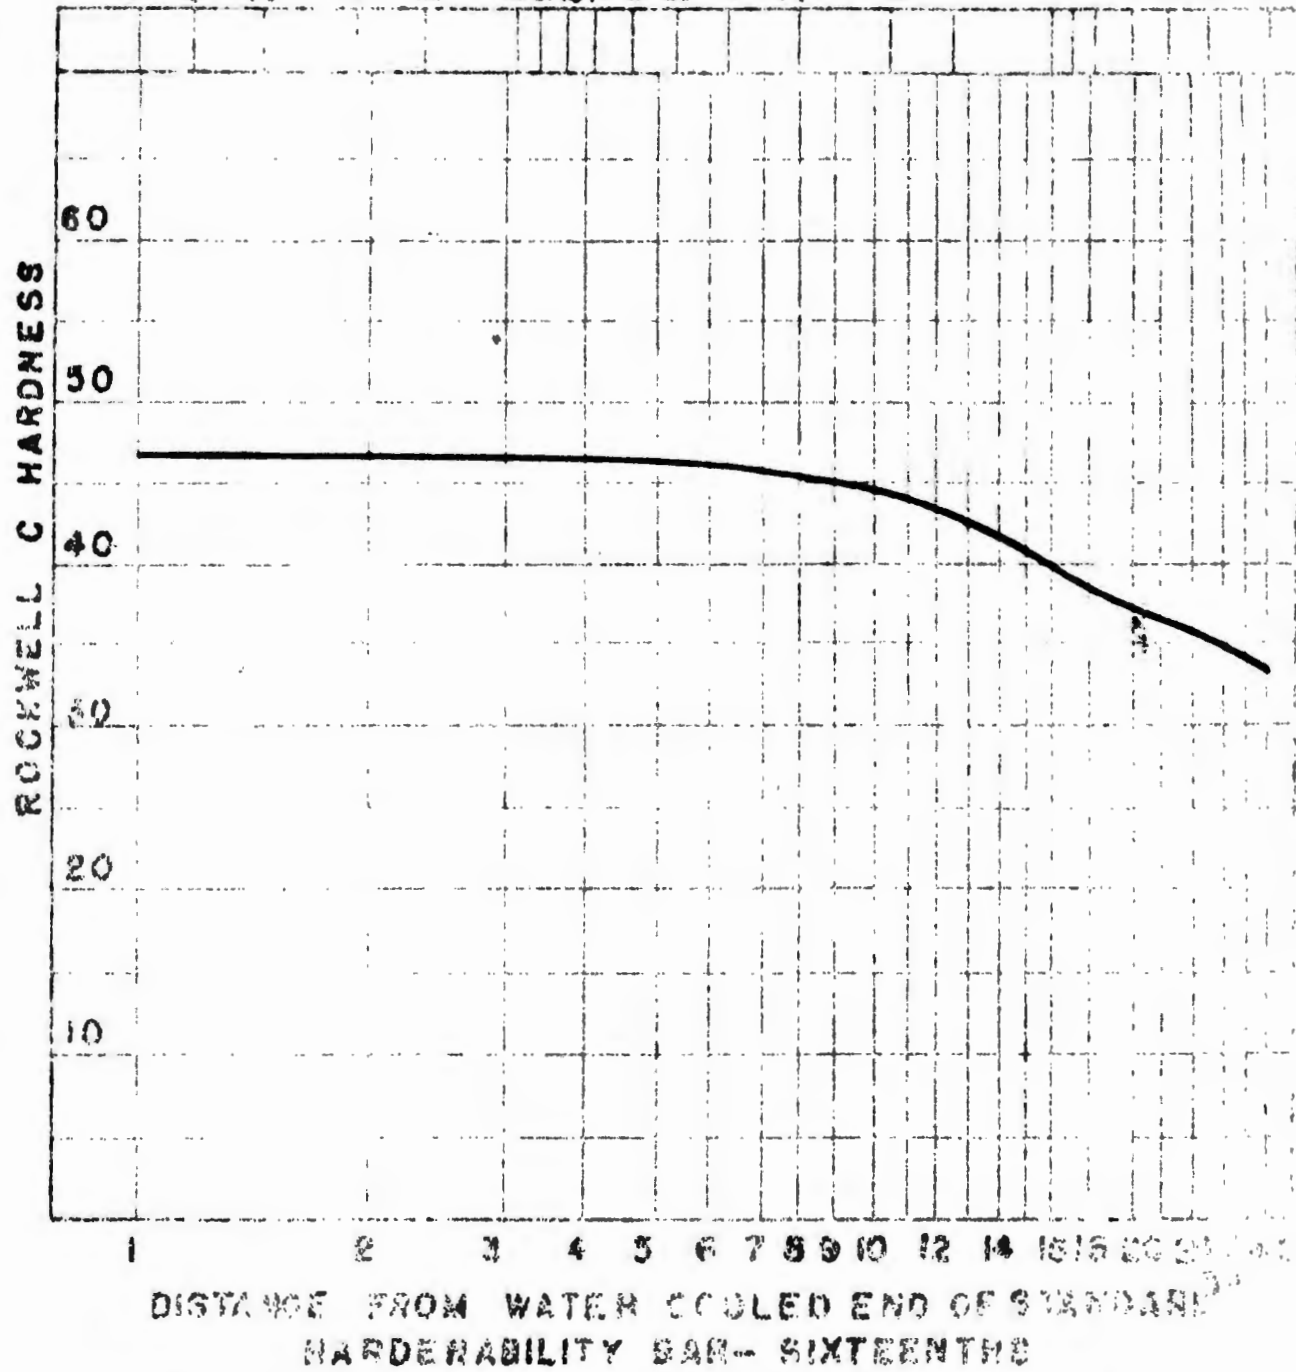
d. The Jominy hardenability determination showed the steel to possess somewhat insufficient hardenability for the section thickness.

c. Jominy Hardenability. The hardenability test specimen was end-quenched after heating for 1 1/2 hours at 1500°F, the same temperature used by the manufacturer in heat treating the subject armor plate. The Jominy bar retained a hardness in excess of Rc 43 up to 12/16ths of an inch from the water quenched end, see Figure 4, indicating sufficient hardenability to harden plate to 400 BHN in the center up to a thickness of 1.9" in still water and to 2.3" in thickness upon spray quenching. Since the thickness of the subject plate is 2.5", the steel has insufficient hardenability to completely quench harden to martensite using the most drastic quench available. A slight increase in the carbon content would undoubtedly raise the hardenability to a satisfactory level.

PLATE HEAT NO.	HEAT NO.	C	MN	SI	S	P	NI	CR	NO	B	CU	AL	QUENCH TEMPERATURE
1	4529	.21	.48	.23	.021	.015	4.53	.12	.26	.0009	.17	.01	1500° 1 1/2 HRS.
