Watertown Arsenal Laboratory  
Report Number WAL 710/539  
Problem Number B-4.12

25 October 1943

Metallurgical Examination of Eleven Sections of Enemy Armor  
Including Homogeneous, Flame-Hardened,  
Carburized, and Welded Components

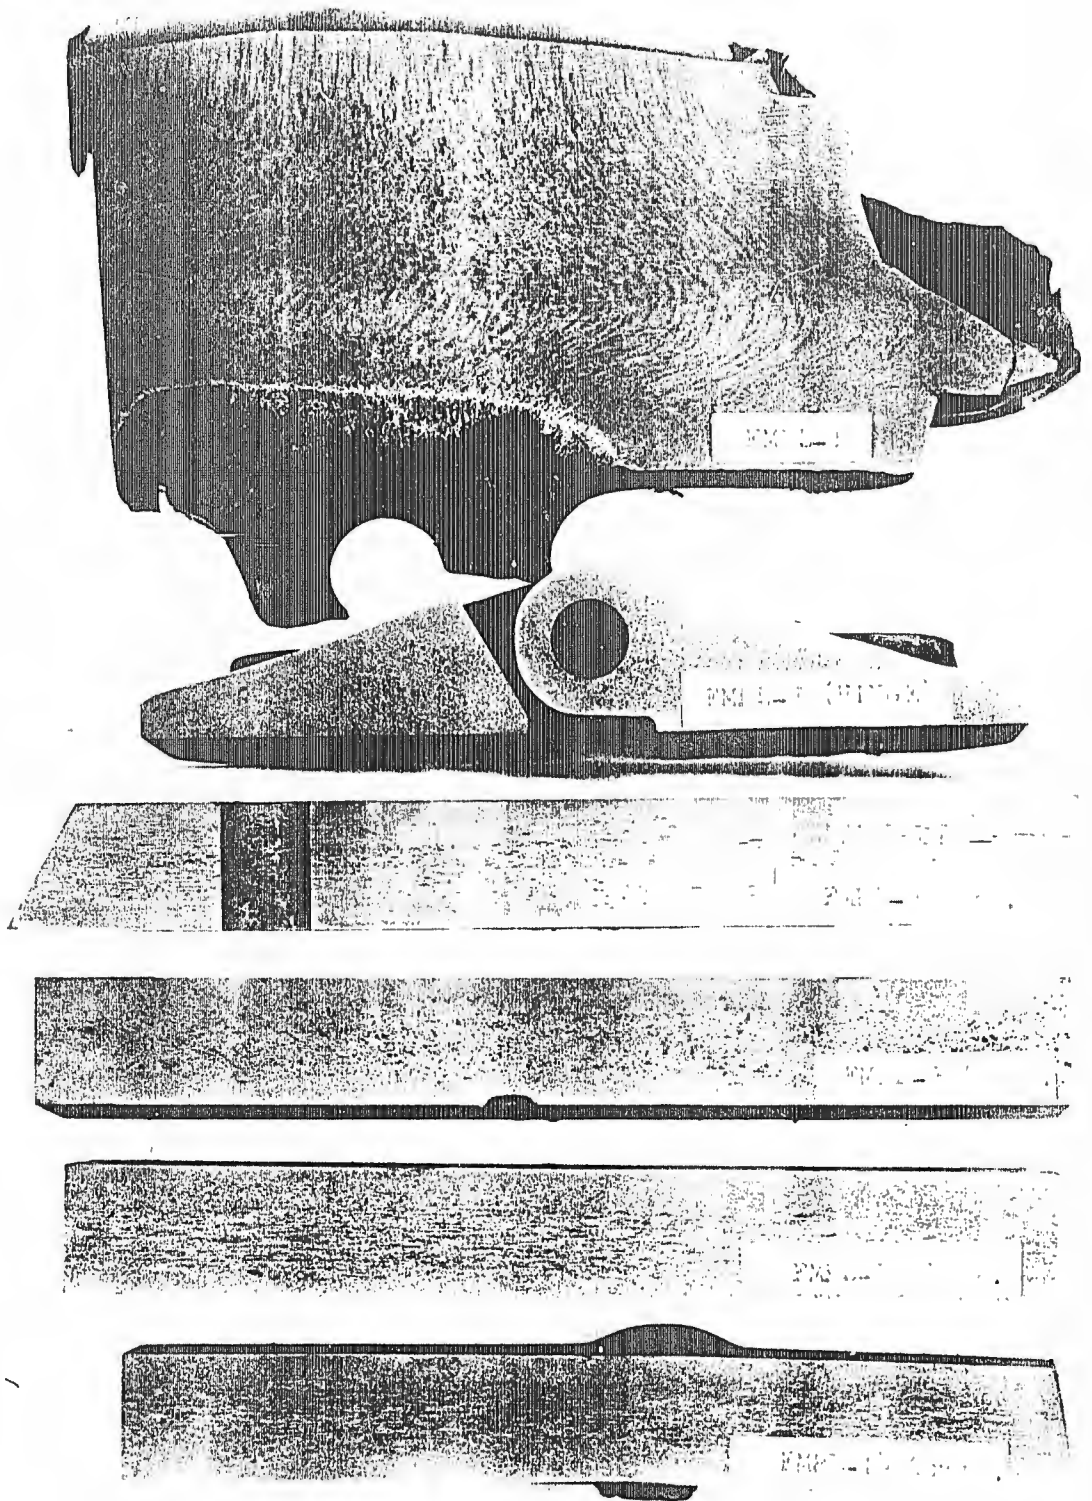
MACROETCHED SECTIONS OF GERMAN ARMOR  
WTN.710-2134

Macrophotographs of the hot acid etched sections of plate FMPL-25 are shown in Figure 10. The steel is dense, well-worked and free of segregations. The cracks are believed caused by ballistic impacts in adjacent areas of the plate.

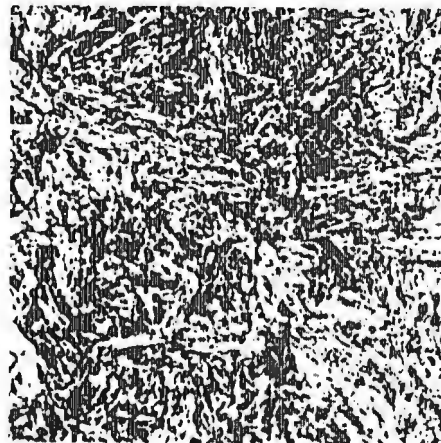
FMPL-1 -a- X1000  
Flame-hardened armor.  
Microstructure of core.  
Tempered martensite.

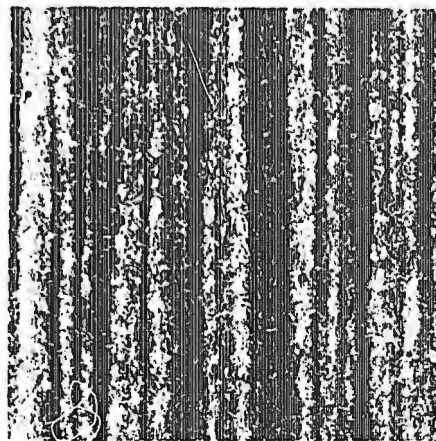
The steel is relatively dirty, containing many slightly elongated inclusions, Figure 11b. The microstructure consists of tempered martensite with relatively severe banding, Figures 11c and d. The microstructure of the hinge consists of tempered martensite similar to that of the plate. The threaded bolt has a microstructure of tempered martensite, Figure 11f, and is very similar in all respects to the bolt studied and reported in WAL Report No. 710/4723. The plate, hinge, and bolts were probably oil quenched and tempered back to their respective hardnesses.

FMPL-3 -c- X100  
Severe banding.

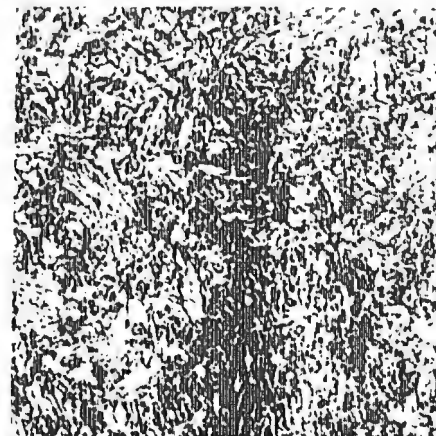
FMPL-3 -d- X1000  
Homogeneous armor.  
Tempered martensite.

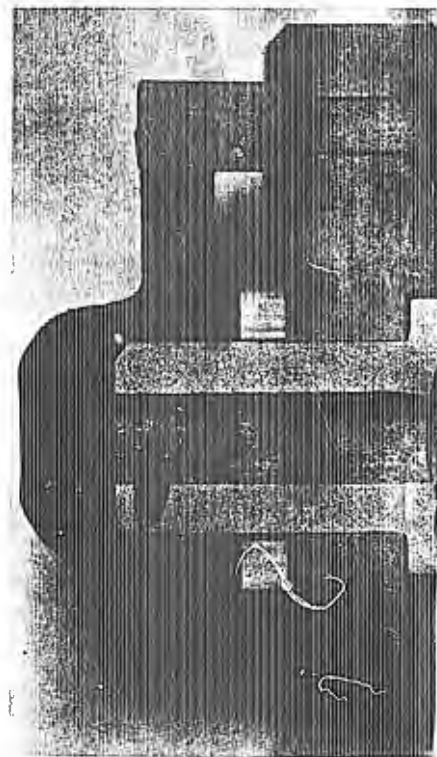
FMPL-3 -e- X1  
Cross-section of locking device in Top Engine  
Plate FMPL-3. Hot acid macroetch.

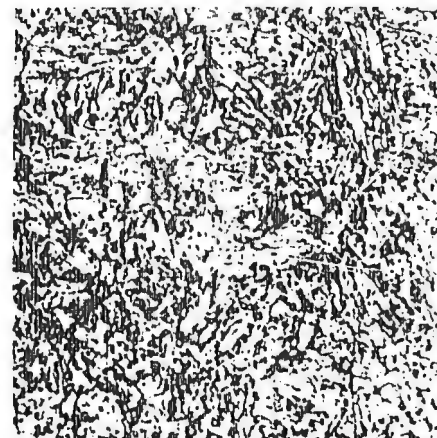
FMPL-3 -f- X1000  
Microstructure of threaded  
bolts attaching hinges to  
Top Engine Plate FMPL-3.  
Tempered martensite.

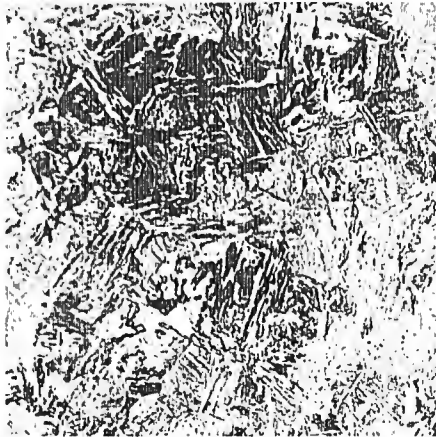
FMP-11 -b- X100  
Widmanstätten pattern of ferrite.

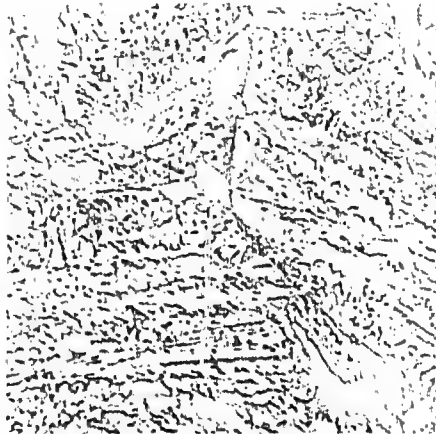
FMP-11 -c- X1000  
Ferrite and high temperature transformation products.

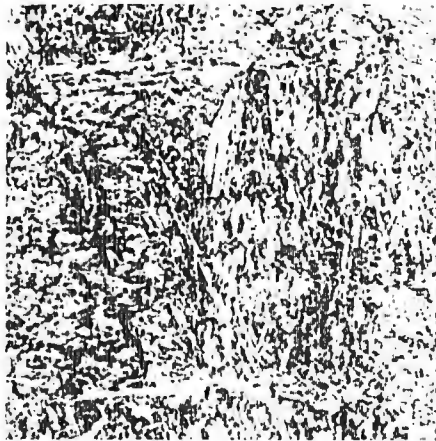
The steel is relatively dirty, with many short stringers distributed throughout the cross-section, Figure 12d. The microstructure consists of acicular tempered martensite, Figure 12e, probably resulting from oil quenching and tempering.

FMP-14 -d- X100  
Dirty steel. Many short inclusions. Unetched.

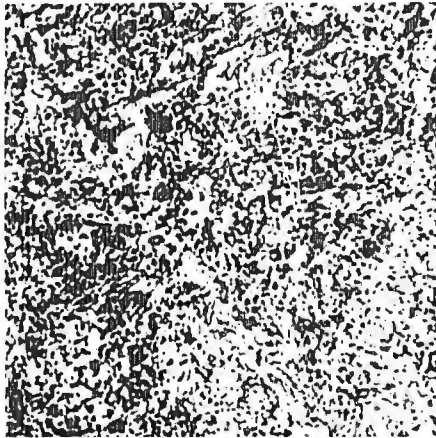
FMP-14 -e- X1000  
Homogeneous armor. Tempered martensite.

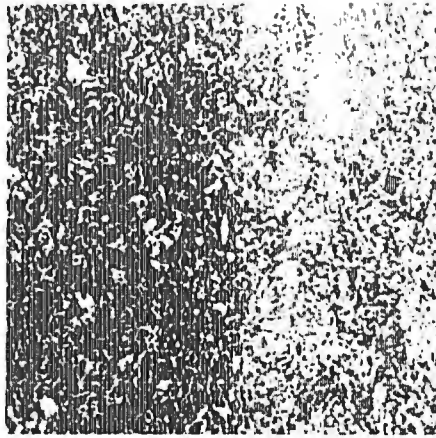
FMP-20 -f- X1000  
Flame-hardened armor. Core structure. Carbides and tempered martensite.

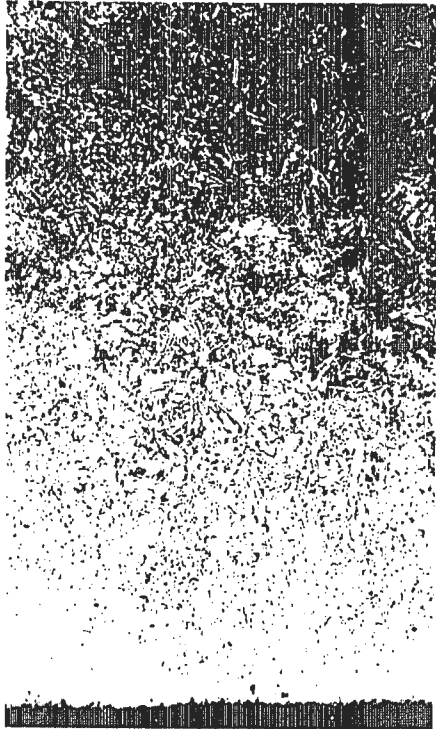
The plate surfaces are decarburized to an unusually severe extent for homogeneous armor, having decarburized layers averaging 0.025" deep, Figure 13a. The microstructure consists of a mixture of tempered martensite, ferrite, and pearlite, Figure 13b, resulting from incomplete quench hardening. This plate represents one of the very few cases of poor heat treatment observed in German armor. Almost all the samples of German armor which have been examined at this Arsenal have indicated excellent heat treatments and satisfactory tempered martensitic microstructures.

FML-23 -a- X100  
Homogeneous armor. Decarburized surface of plate. Total decarburization - 0.025".

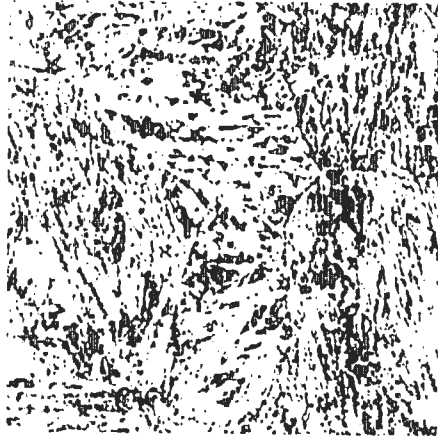
FML-23 -b- X1000  
Tempered martensite and high temperature transformation products.

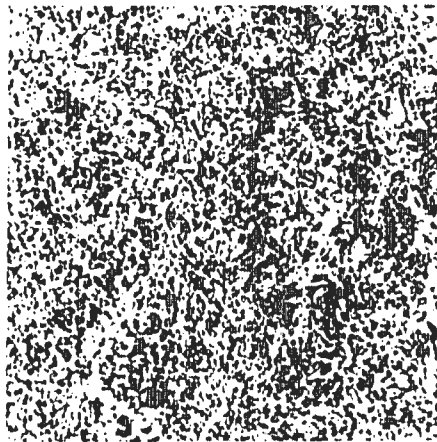
The microstructure of the case of carburized plate FMPL-25 consists of hypereutectoid carbide particles in a matrix of fine martensite, see Figure 13c. The microstructure of the core consists of grains of tempered martensite with clusters of acicular ferrite segregated in larger ferrite grains, see Figure 13d. This microstructure is believed to result from incomplete quenching from below the upper critical range, so that ferrite is formed in two manners; some because the steel had not been completely austenitized so that some ferrite remained out of solution upon heating, and some resulting from high temperature transformation during cooling. The back surface of the plate has a layer 0.15" thick that is severely decarburized, Figure 13e.

FML-25 -c- X1000  
Carburized armor. 0.010" below surface. Carbides and tempered martensite.

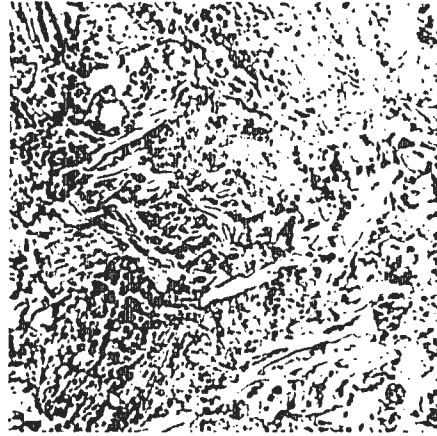
FML-25 -d- X1000  
Core structure of carburized armor. Tempered martensite, carbides, and ferrite.

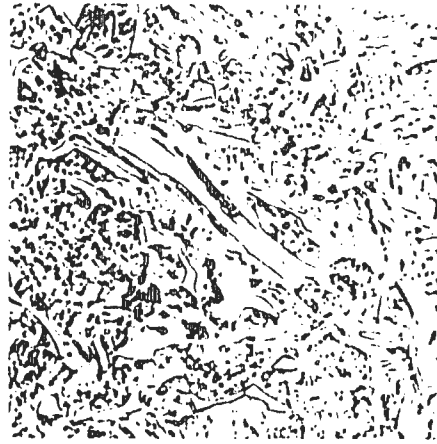
FML-25 -e- X1000  
0.05" above back surface of plate. Decarburized region. Ferrite and carbides.

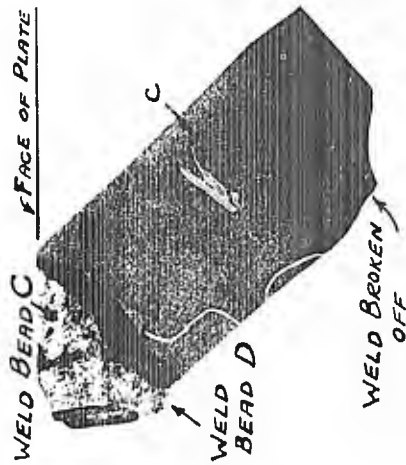
The microstructure of weld bead C, the outer weld, consists of martensite with small amounts of austenite; and that of weld bead D, the inner weld, consists of austenite with small amounts of martensite. The hard weld is severely cracked, with the crack extending into the heat affected zone of the base armor, Figures 15a and b.

FMPL-28 -a- X2  
 Macrostructure of duplex weld  
 Weld bead C is martensitic  
 and is cracked, with crack  
 extending into heat-affected  
 zone of base metal. Weld  
 bead D is largely austenitic  
 and considerably softer than  
 weld bead C.

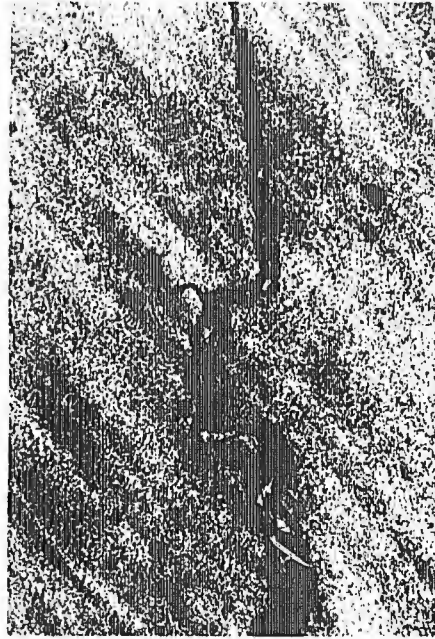
-b- X100  
 Crack in heat affected zone of base  
 armor.

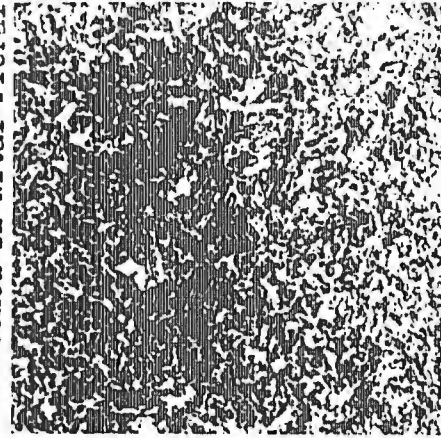
-c- X1000  
 Homogeneous armor. Tem-  
 pered martensite.

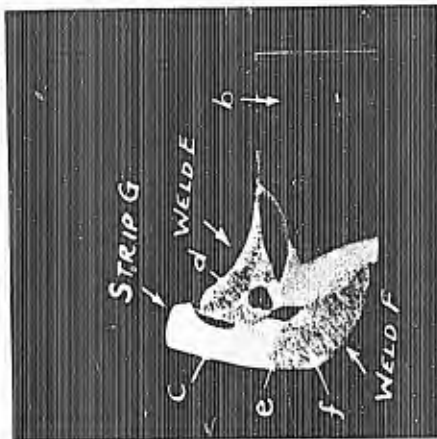
**F MPL-29 -a-**  
 X2  
 Macrostructure of welded section of armor.

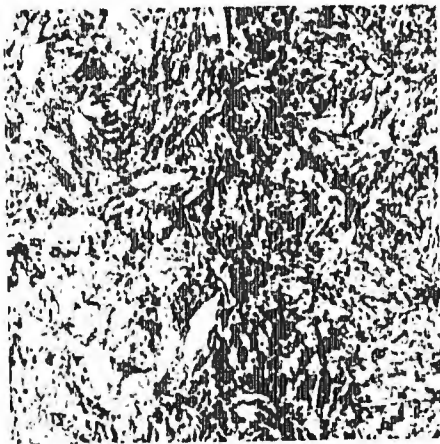
**-b-**  
 X1000  
 Microstructure of base armor. Tempered martensite. Hardness - 450 VPN.

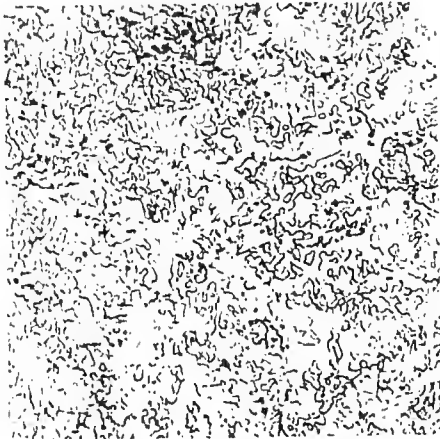
**-c-**  
 X1000  
 Microstructure of strip G. Martensite and ferrite. Hardness - 375 VPN.

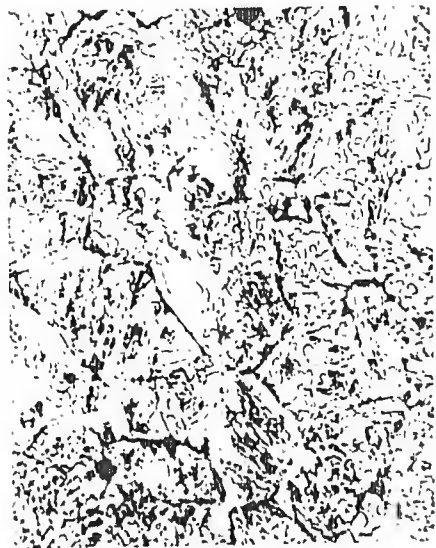
**-e-**  
 X1000  
 Junction of weld F and strip G. Martensite, ferrite, and grain boundary segregate. Hardness - 450 VPN.

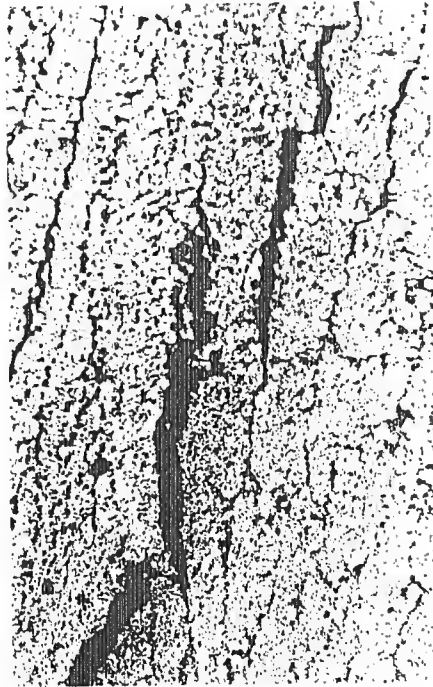
The microstructure of the armor steel composition strip welded to the base armor consists of martensite and ferrite resulting from quenching from an intercritical temperature, Figure 16c. The microstructure of the two weld deposits is identical, consisting of ferrite, carbides, and some martensite, Figure 15d. The weld metal contains a large degree of dendritic segregation; with many cracks associated with the segregation, Figure 15f.

**-f-**  
 X100  
 Interdentritic cracks found in weld F. Cracks associated with intergranular segregate. Hardness - 250-300 VPN.
