Watertown Arsenal Laboratory
 Report No. WAL 710/608
 Problem No. D-2.3

4 April 1944

ARMOR AND WELDING

Metallurgical Examination of Armor and Welded Joints
 from German PzKw IV Tank, Model GF-2

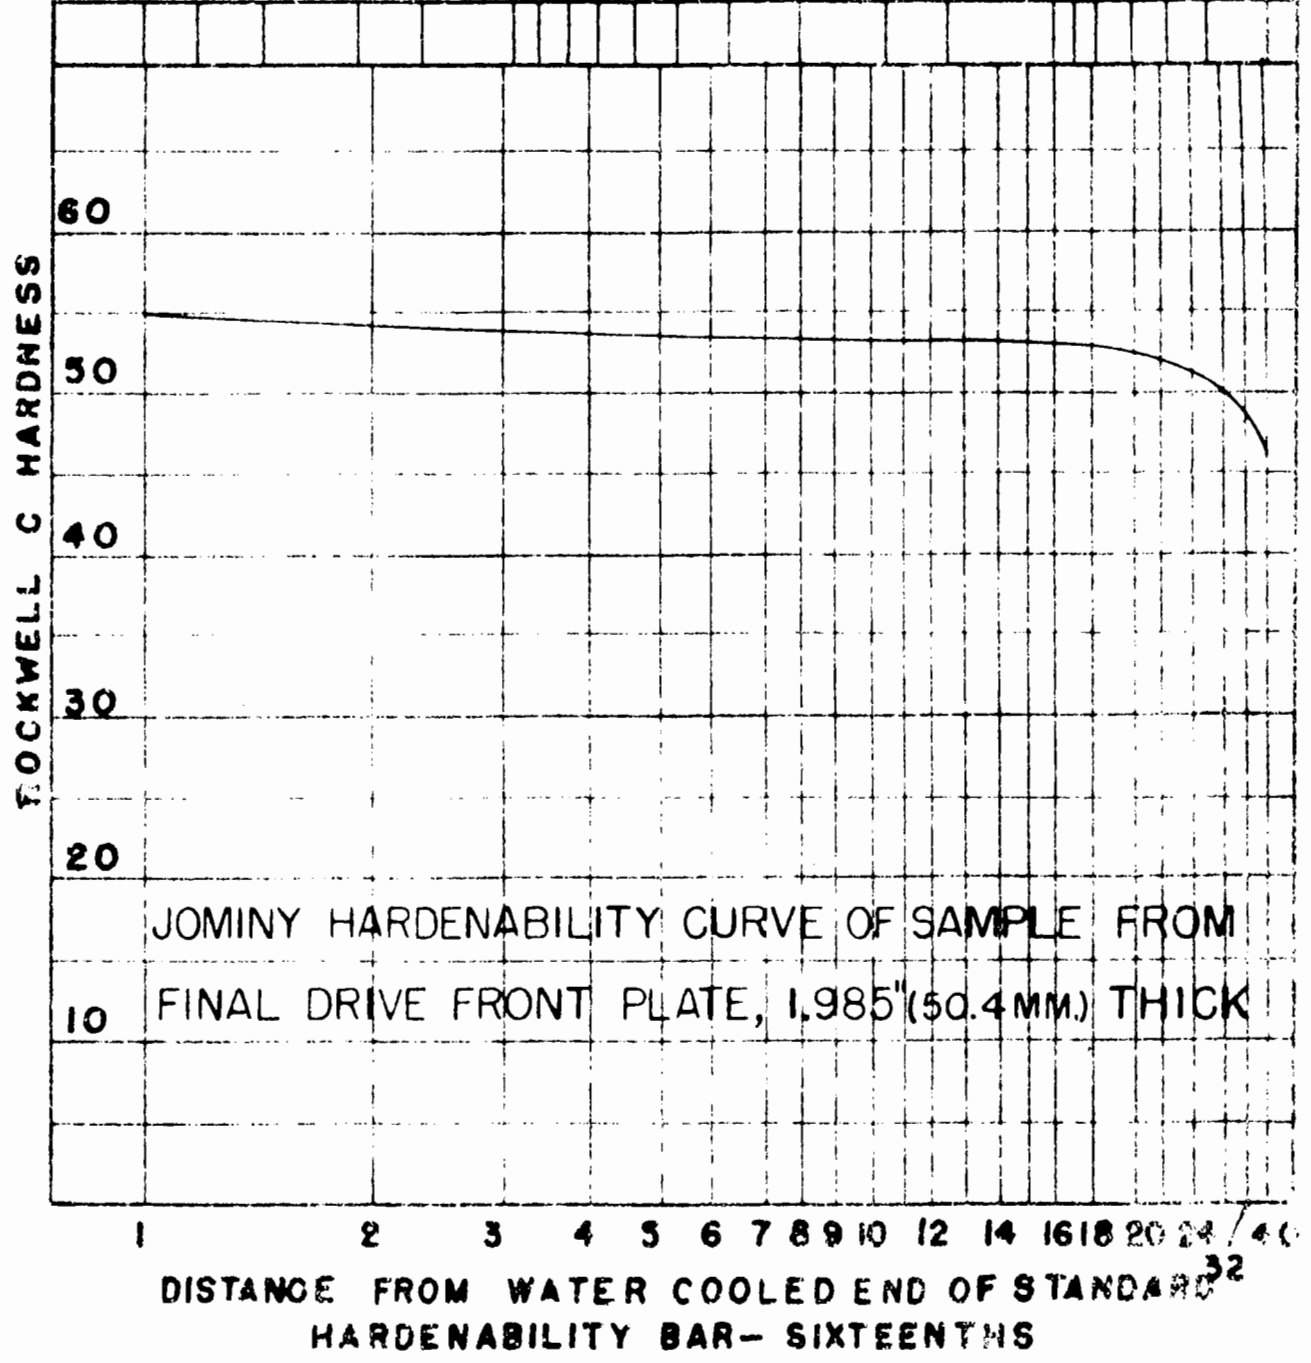
FIGURE 1

A Jominy bar machined from the 2-inch thick Final Drive Front Plate was austenitized for 3 hours at 1675° F. and end-quenched by the standard practice. The hardenability curve (see Figure 1) shows adequate hardenability for this 2-inch thick section when properly quenched, and more than adequate hardenability for the lighter gauge sections which were of the same type alloy composition.

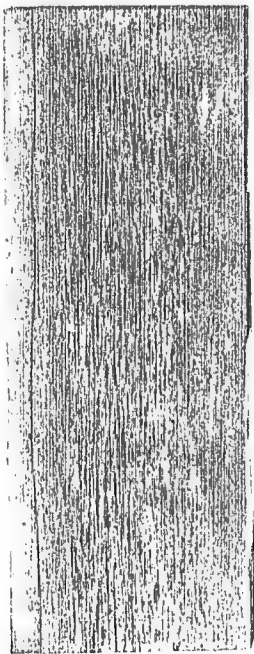
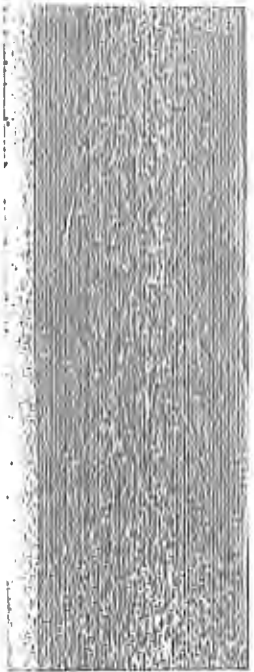
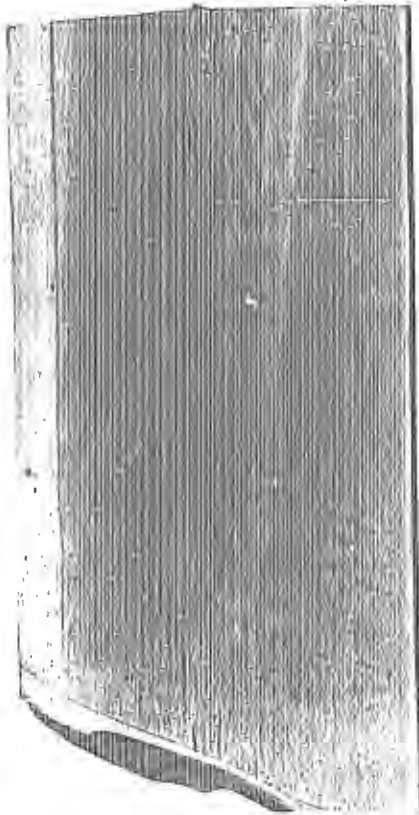
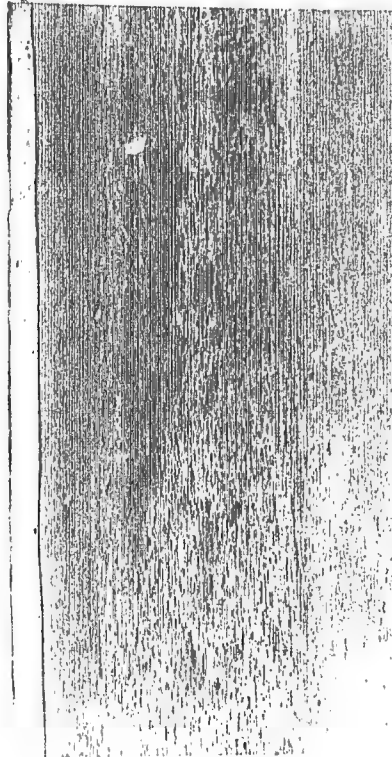
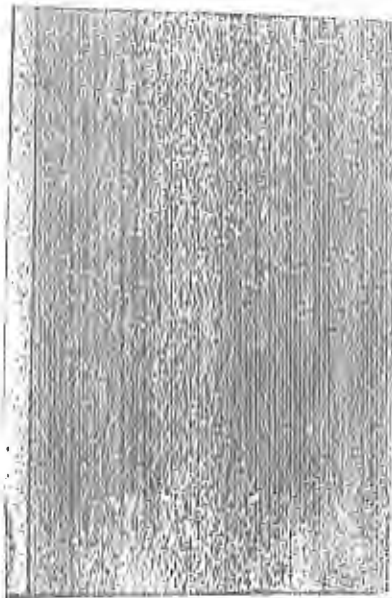
MACROSTRUCTURE OF SAMPLES FROM PZKW IV MODEL GF-2 GERMAN TANK
12 FEB 1944
MAG. X 1 WTN.710-2277

Macroetched cross sections from each armor sample are shown in Figures 3 and 4. Macrostructure reveals presence of finely divided nonmetallic inclusions throughout all plates except for Hull Roof Plate (see discussion of microstructure). Excessive centerline segregation is shown in Driver's Front Plate and Final Drive Front Plate.

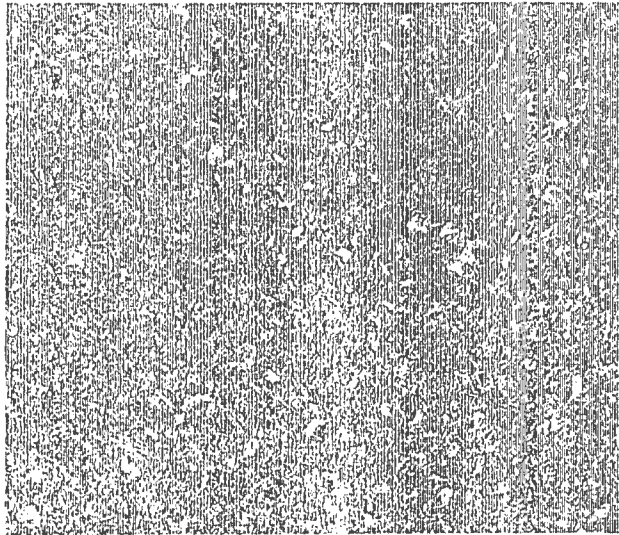
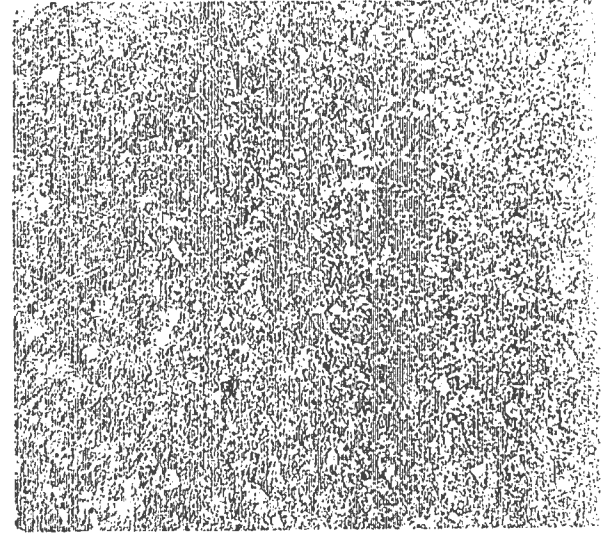
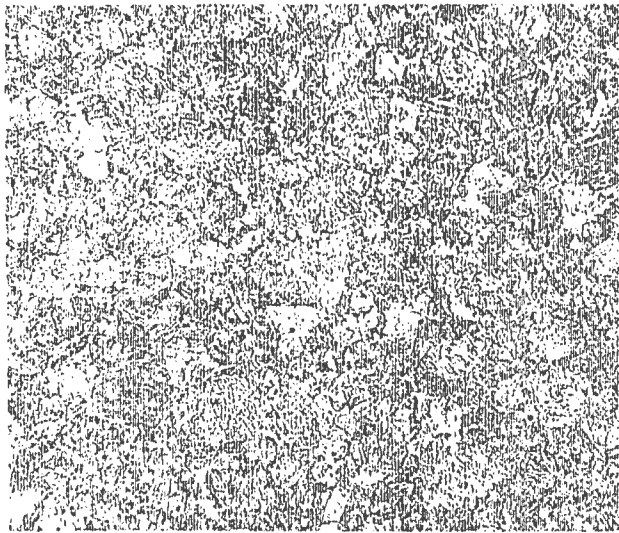
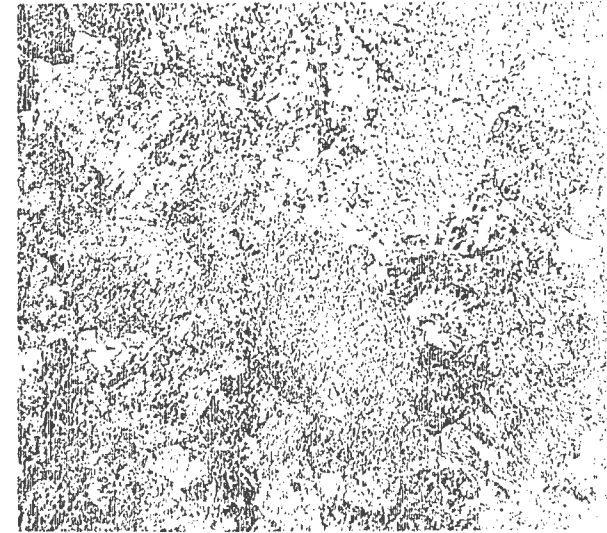
Typical Grain Size Observed in Samples
From PzKw IV Model G F-2 German Tank

No. 2A - Core
ASTM grain size No. 8

No. 2A - Case
ASTM grain size No. 7-8.

No. 1A
ASTM grain size No. 4-6.

No. 6A.
ASTM grain size No. 1-5.

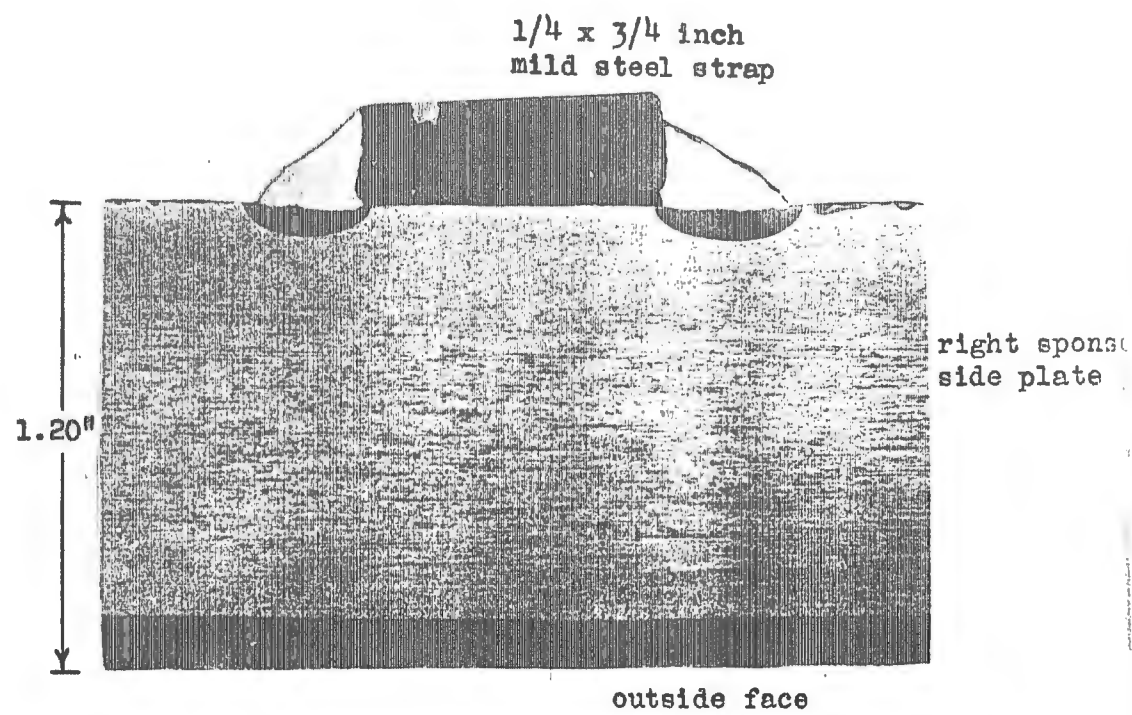
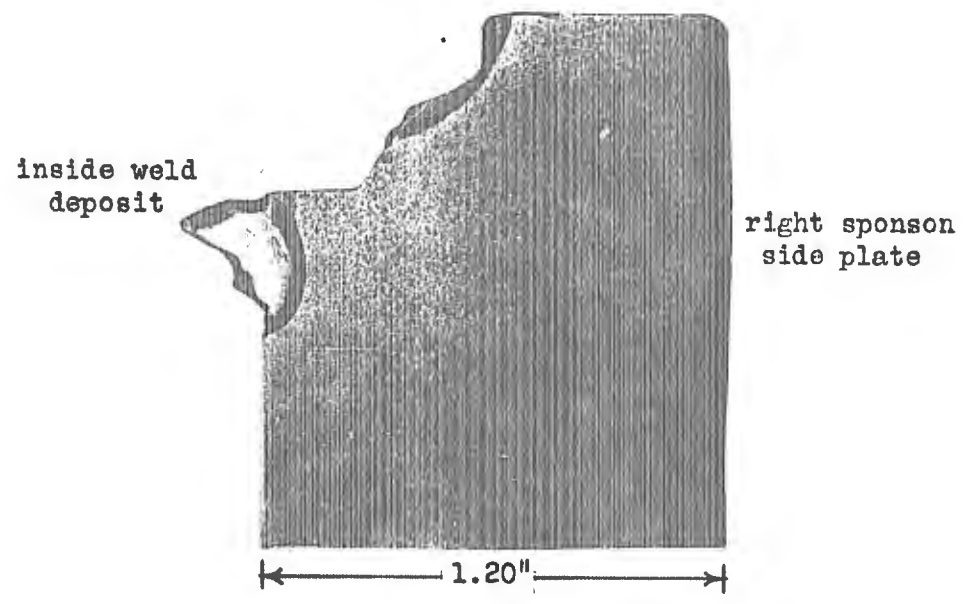
Figure 10. Macroetched Transverse Sections Through Attachment Weld and Broken Weld Joint of Sample No. 1.

Complete weld joints of samples Nos. 4 and 7 and broken weld joints of samples Nos. 1, 3, and 6, were each prepared by machining a groove in the heavy armor section to give a fitted or mortised joint which is in compression on impact from the direction of principal ballistic attack.

Photomicrographs of samples Nos. 4 and 7 show base metal cracks in heavy base metal sections. The severity of these cracks is strikingly illustrated by the fact that failure of broken weld joints, samples Nos. 1, 3, and 6, was almost entirely along these crack systems.

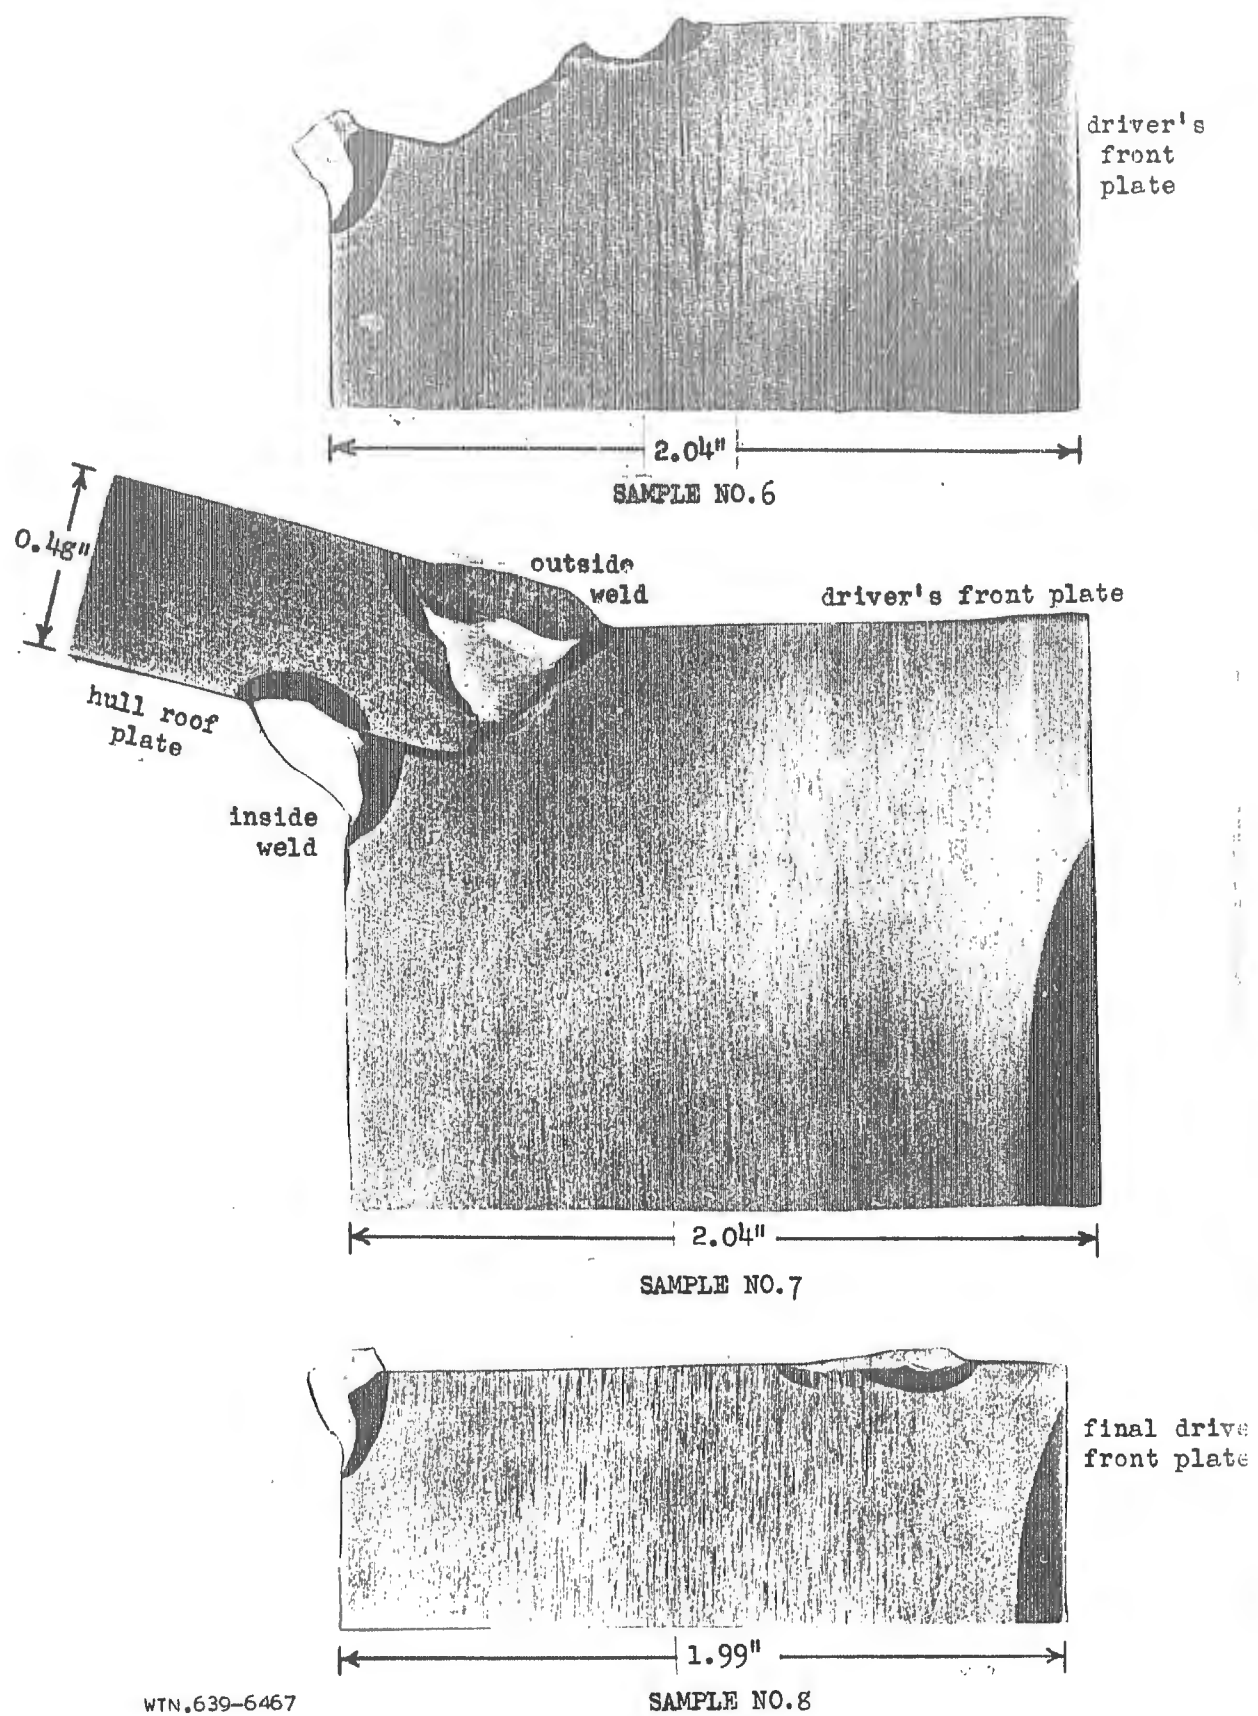
Figure 13. Macroetched Transverse Sections Through Weld Joints in German PzKw IV Tank

A crack was visible at surface of heavy base metal section parallel and immediately adjacent to the outer weld deposit of Sample No. 7.

The broken weld of sample No. 8 apparently represents a joint made by grinding edge of plate flat and butting another plate against it at an angle to be held by the two shallow penetration weld deposits. This weld joint has failed by shearing through weld metal. The trace of heat-affected zone along top edge of photomicrograph indicates flame cutting prior to heat treatment and grinding.

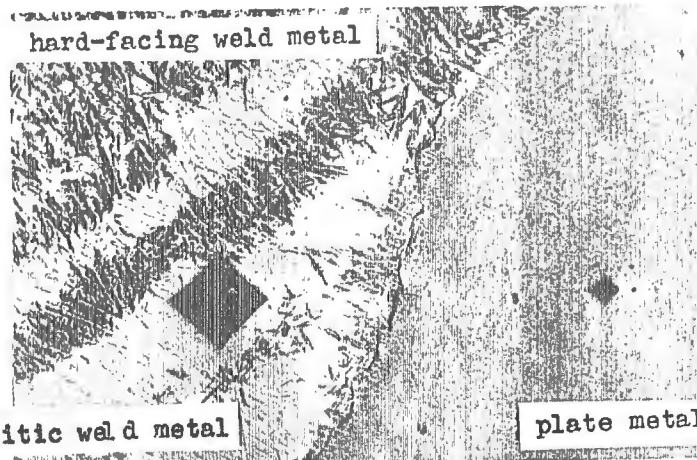
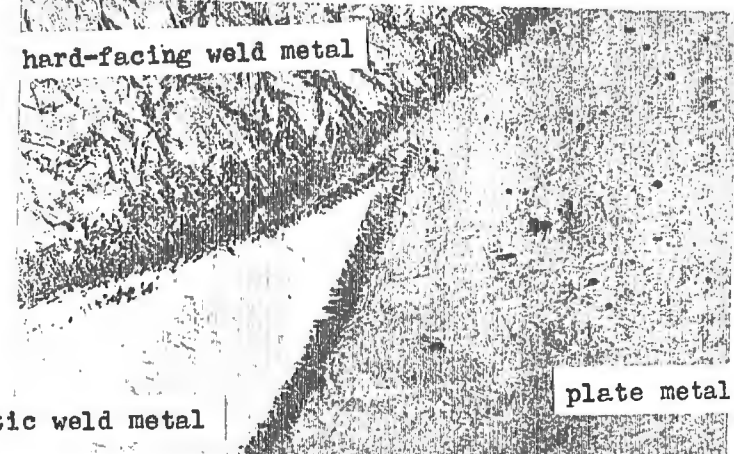
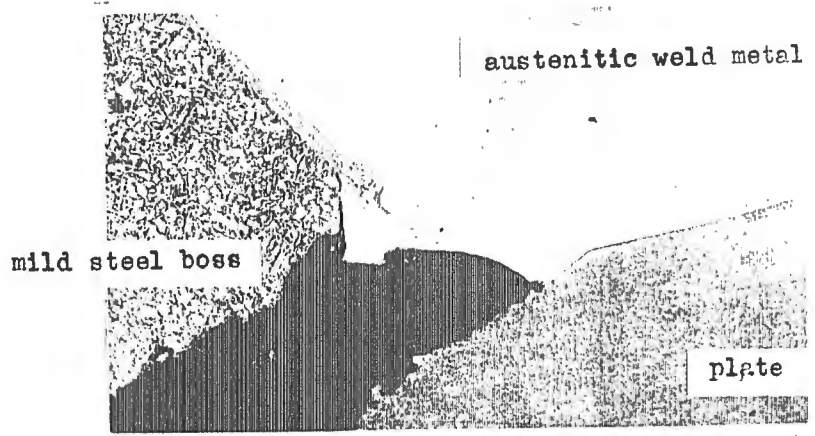
Figure 14. Photomicrographs of Fusion Zone of Welds
 in German PzKw IV Tank

Figure 14 shows microstructures at junction of hard-facing crown, austenitic body weld deposit and base metal of joint samples Nos. 4 and 7, and junction of base metal, austenitic deposit and mild steel attachment (1-1/4 dia. boss, Sample No. 2). Upper picture shows a small fusion zone crack. Diamond shaped marks are Vickers-Brinell impressions and afford comparison of heat-affected zone and austenitic weld metal hardnesses.

Most of the heat-affected zone cracking observed in these specimens is of the type illustrated in a previous report on German armor and welding¹. The cracks are believed to have occurred while the metal was at a relatively high temperature and under stresses due to thermal expansion resulting in plastic deformation or "upsetting" and followed by thermal contraction against the restraint of adjacent unheated metal sections.

Heat-affected zone microstructures vary from a coarse-grained martensite near the fusion line to a fine-grained martensite at greater distances from the fusion zone and finally there is a tempered zone where carbides of original plate structure have been coarsened. Usual recrystallizing and retempering effects of multiple pass welding are seen.

The relatively high carbon armor plate heat treated to hardnesses of 331 to 415 Brinell is very susceptible to base metal cracking. Re-welding experiments on armor from a previously examined German PzKw VI tank indicated that a preheat of 300° F. was required to prevent base metal cracking when welding with commercial American austenitic electrodes.
