NO. WAL. 710/346

Metallurgical Examination of German Aircraft Armor  
from Heinkel III and Junkers 87 Planes

BY  
P. V. Riffin  
Pvt., Ordn. Dept.

DATE 22 November 1944

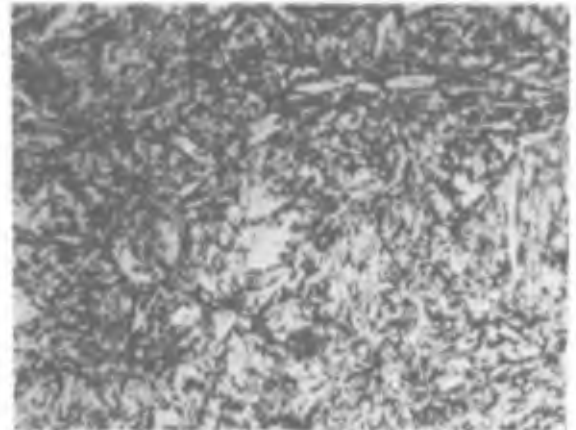
X1000            B            Picral  
Plate 1B - Tempered martensite.

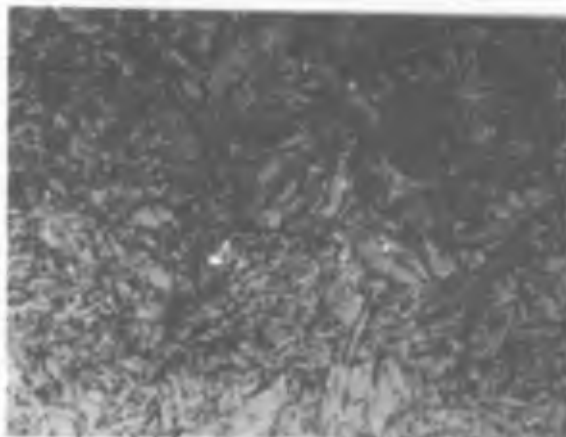
Item 2 possessed a tempered martensitic structure which should exhibit satisfactory properties. It is possible that the poor fracture of this steel was associated with temper brittleness which would be manifested in the plate when tempered at about 1000°F. in obtaining a hardness of 400 Brinell.

X1000            E            Picral  
Plate 2 - Tempered martensite.

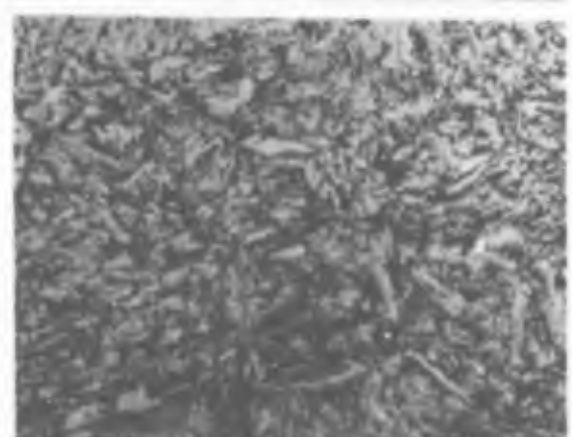
Item 4 possessed a tempered martensitic structure quite like that of item 2. The analysis differed from the previous item in that high manganese was used instead of the 1.34% chromium.

X1000            F            Picral  
Plate 4 - Tempered martensite.

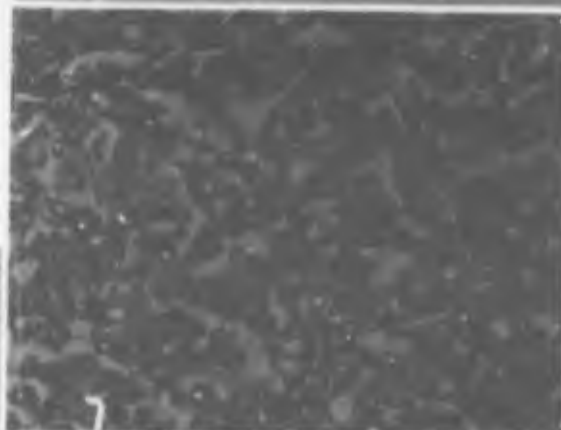
11000 D Pictorial  
Same area as B - containing  
ferrite and undissolved carbides.
