WATERTOWN ARSENAL  
LABORATORY

NO. WAL 710/575

Metallurgical Examination of Defective and Satisfactory

Helmets and Helmet Steel Stock Furnished by the

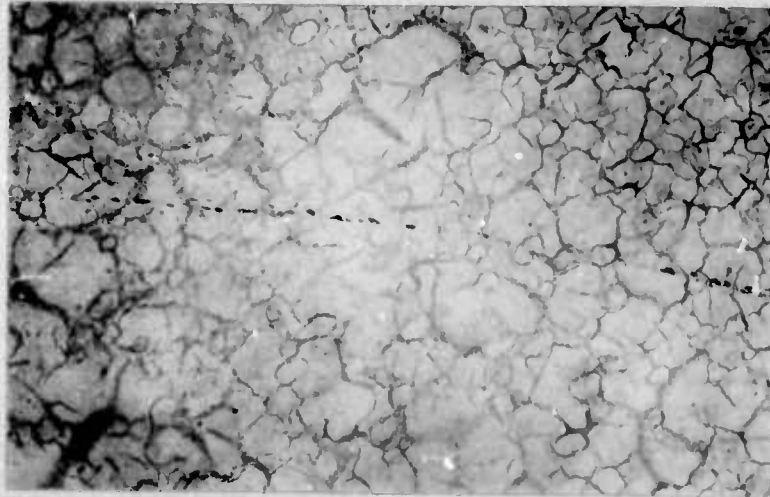
Disc A3. McCord Lot 596-0. Carnegie Heat 255799.  
"Onion-skin" surface. Magnetic traverse - 4.5".  
No decarburization. Surface condition probably  
caused by etching during pickling.

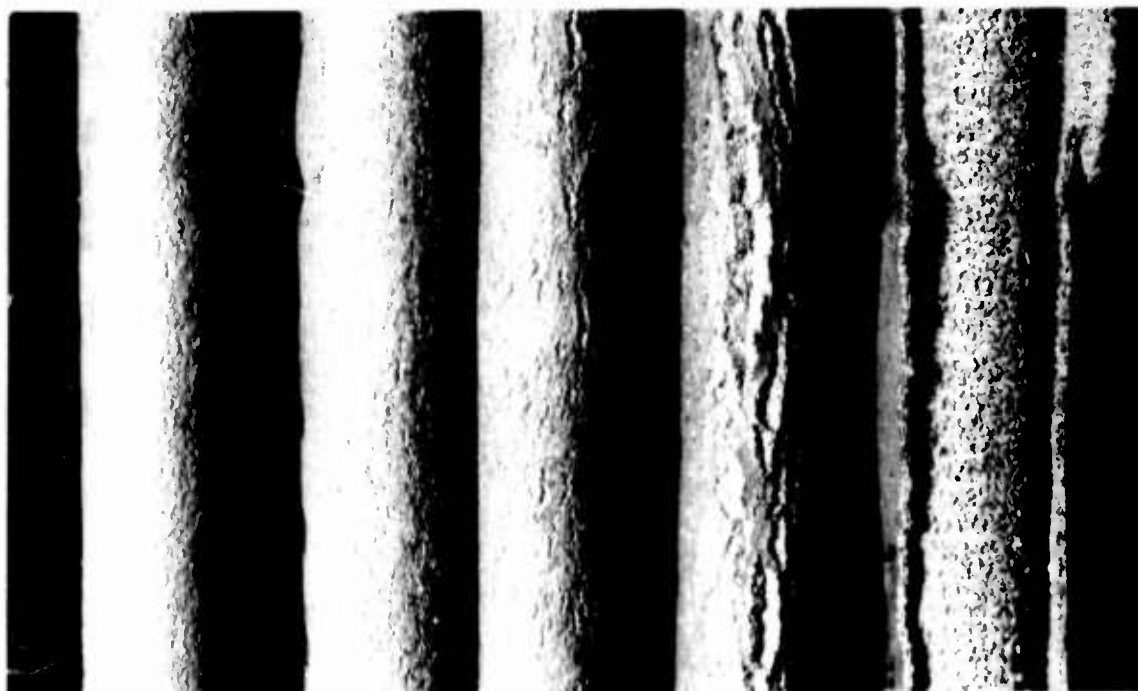
Photographs of the bend test samples of the five steels at magnifications of X2 and X5 are shown in Figure 2.

Steel K1 produced no cracks whatsoever on the outside of the bends of both specimens. This steel had been found to have satisfactory deep drawing characteristics, a low magnetic traverse, and complete freedom from decarburization.

Steel 4 showed only tiny cracks on the surfaces of both bends, and according to a strict interpretation of the wording of the specification probably represents a borderline rejectable condition. A magnetic traverse of 10 inches also represents a borderline rejectable condition. A close correlation is indicated between the bend and the magnetic tests. Steel from this lot (Sharon heat no. 72202) had produced helmets which failed the ballistic acceptance test because of the presence of martensitic surface layers resulting from decarburization.

Steel CB is of considerable interest. Metallographic examination had revealed the presence of decarburization on only one surface. The bend with the decarburized surface on the outside produced the cracks shown in Figure 2. The bend with the undecarburized surface on the outside produced an uncracked appearance similar to that obtained with steel K1. This experience emphasizes the necessity for conducting the bend test in both directions so that both surfaces of the steel will be equally subjected to the tensile stresses occasioned by the bending.

Steel SB cracked severely in both directions upon being bent. This steel showed a magnetic traverse of 19" and was decarburized on both surfaces, with 0.0017" thick layers of martensite being developed on the surfaces.

Steel C1 split open upon being bent. Metallographic examination revealed the presence of a lamination of martensite below the surface of the steel. This lamination probably originated in an ingot defect that was rolled out in the sheets.\* This steel had a magnetic traverse of 37".

| | E1 | 4 | CB | SB | C1 |
|---|---|---|---|---|---|
| Defect: | None | Decarburized | Decarburized | Decarburized | Lamination of<br>martensite |

The results of the bend test indicate that strict application of this test is capable of rejecting steel which is decarburized or laminated to an extent having a deleterious effect upon the deep drawing and ballistic properties of Hadfield manganese steel sheet.

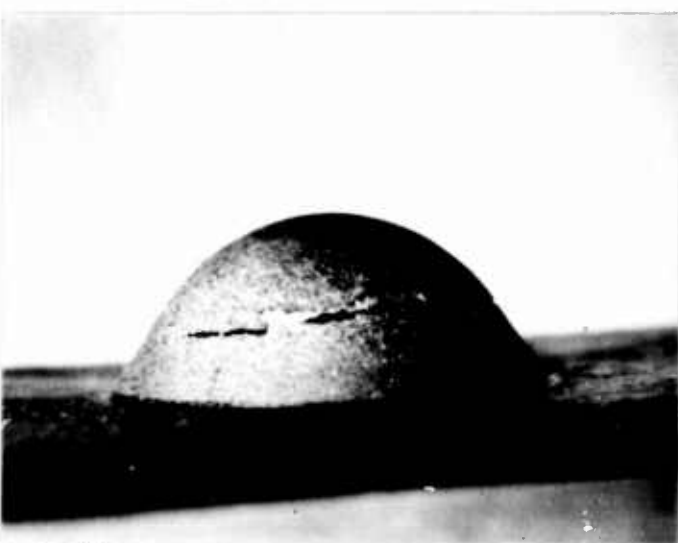
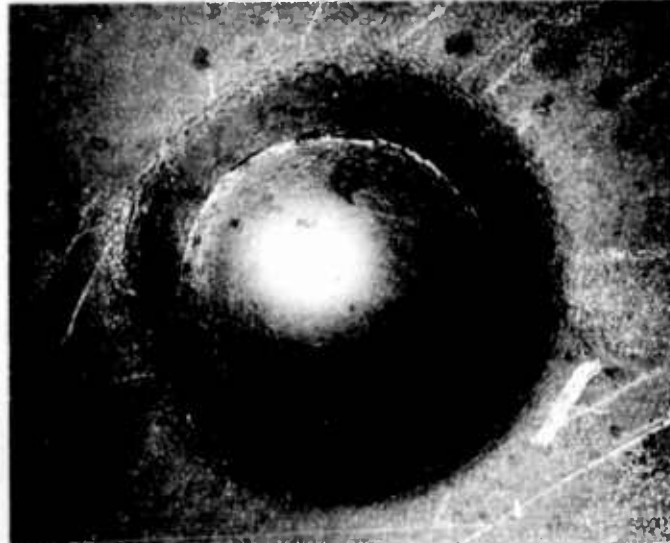
A steel free from metallurgical defects presents very smooth surfaces on the outside and inside of the Olsen cup, see Figures 3A and B. When a decarburized steel is subjected to the cupping test, a network of fine cracks similar to those formed in the bend test appears on both the outside and inside surfaces of the cup giving it a rough appearance, see Figures 3C and D. Figure 3D also shows the characteristic mottled surface appearance frequently associated with decarburization. Steel containing martensite laminations below the surface fracture in a very characteristic manner, see Figures 3E and F.

Steel A - Schluter Lot 48A, Sharon Heat 72312. Decarburized steel. Appearance of cup after fracture. Surface cracking and jagged fracture typical of decarburized steel. Magnetic traverse - 15.0".

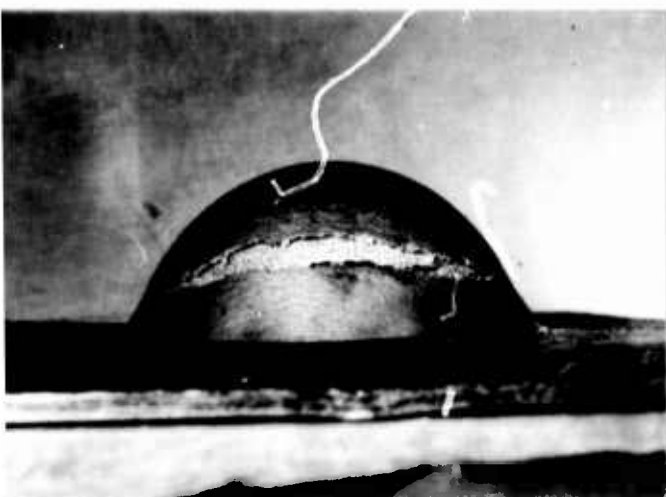
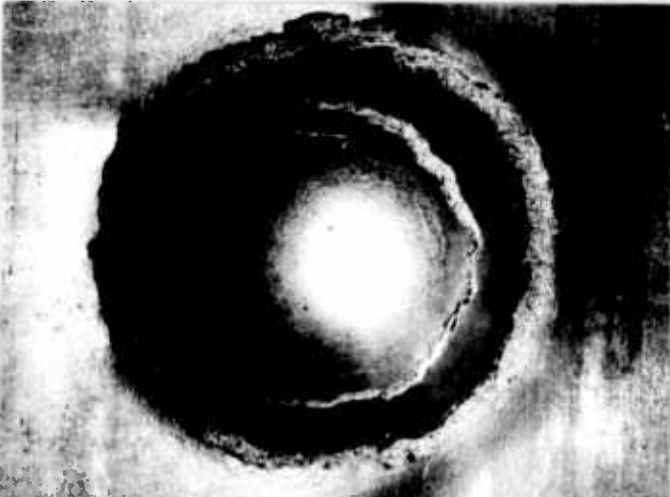
Steel C1 - Schluter Lot 37B, Sharon Heat 72044. Laminated steel. Appearance of cup after fracture. Cracking and separation of steel along lamination. Magnetic traverse - 17.0".

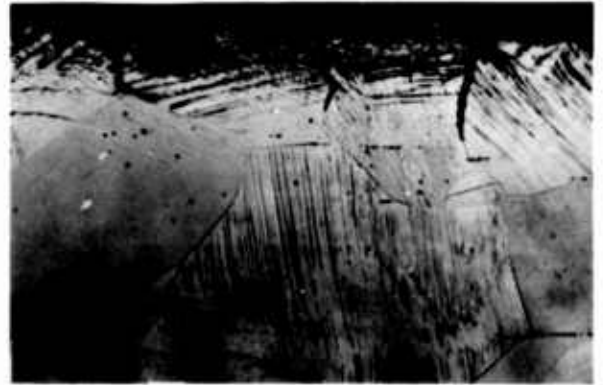
The cracked helmets examined in this investigation present two distinct metallurgical defects—surface decarburization, and undissolved grain boundary carbides. Of the helmets examined, M1 and D4 were badly decarburized, Figures 4A and B, and helmets D6, E1, E2, F5, F6, and F8 contained varying amounts of undissolved grain boundary carbides, Figures 4C and D. Small cracks which frequently occur in the martensitic layer of cold-worked decarburized helmet steel are shown in Figure 4B. The carbide grain boundary networks are believed to be the result of either too low an austenitizing temperature or too short a time at temperature, resulting in incomplete solution of the carbide in austenite. Exactly similar microstructures have been produced at this arsenal by quenching helmet stock from 1475°F.\*

-B- X250  
Helmet D4. Typical cracks in  
martensite layer resulting from  
deformation of brittle  
constituent.

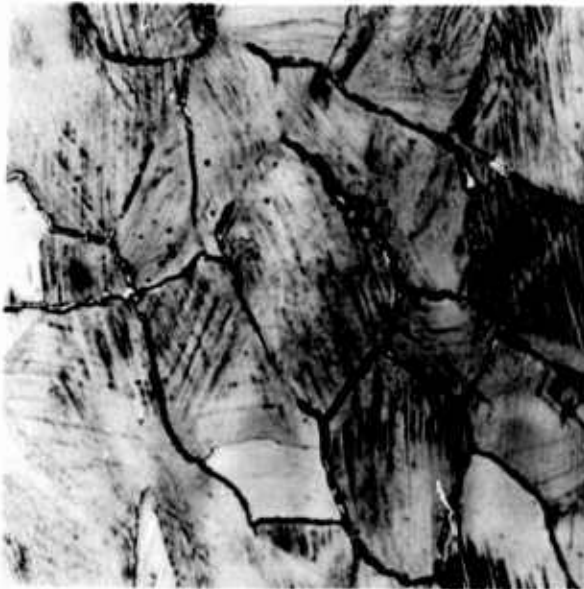
-C- X1000  
Helmet E1, McCord Lot 541C, Sharon  
Heat 72203. Network of undissolved  
carbides at grain boundaries.  
Magnetic Traverse - 3.0".

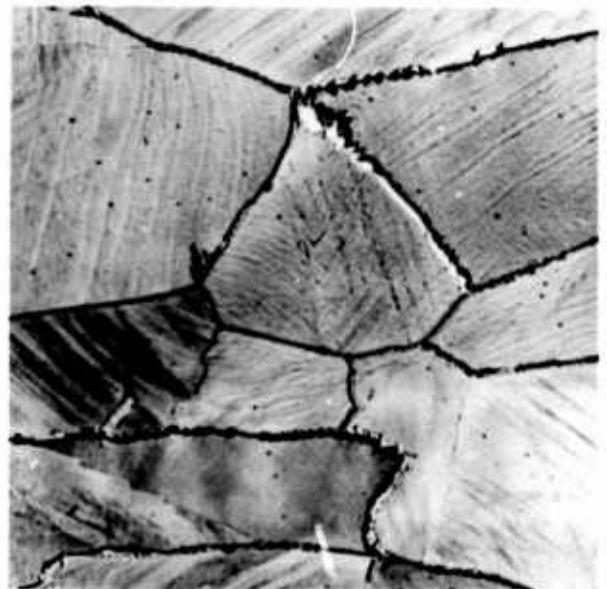
-D- X1000  
Helmet E2, McCord Lot 549B, Sharon  
Heat 72198. Undissolved carbides.  
Magnetic Traverse - 1.0".

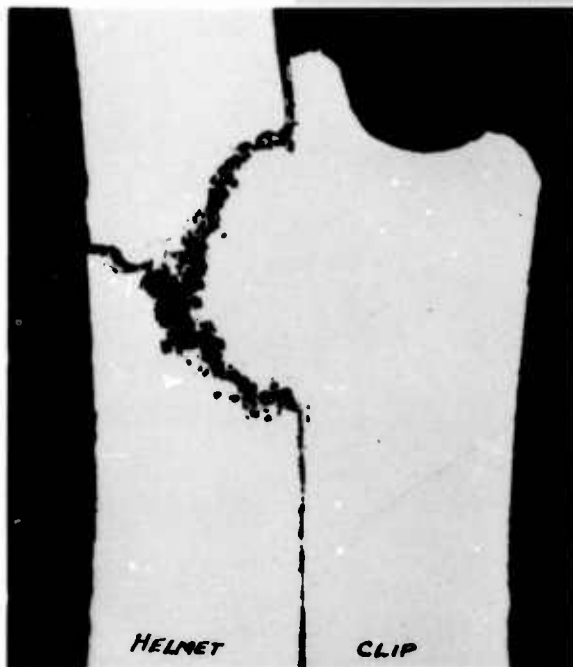
The eight spot welds on helmets 01 and 04 were prepared for microscopic examination. Without exception, all of the welds examined exhibited severe fusion zone cracking. Photomicrographs shown in Figures 6A, B, and C illustrate the extremely poor welds. The cracking was entirely confined to the austenitic steel, occurring at the boundary between the base metal and the molten pool of the weld.

Unetched -A- X25  
Helmet C4, McCord Lot 549B, Sharon  
Heat 72198. Severe fusion zone  
cracking in the Hadfield Steel.  
Very poor weld.

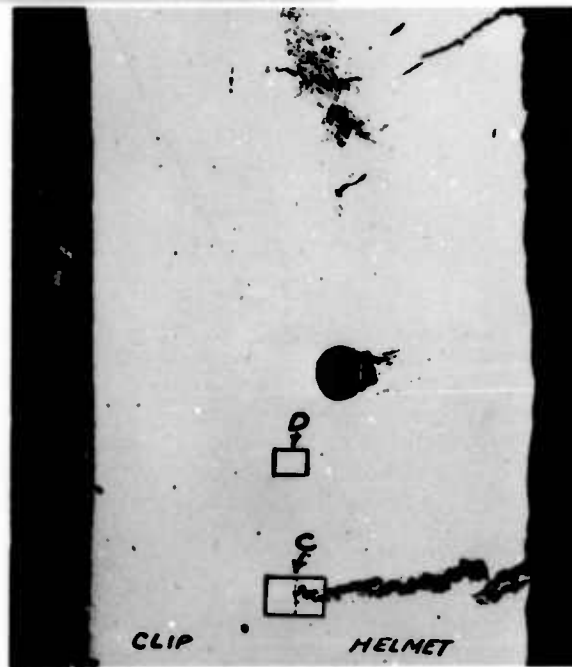
Unetched -B- X25  
Helmet C1, McCord Lot 533A, Carnegie  
Heat 186917. Weld porosity and  
fusion zone cracking.  
Unsatisfactory spot weld.

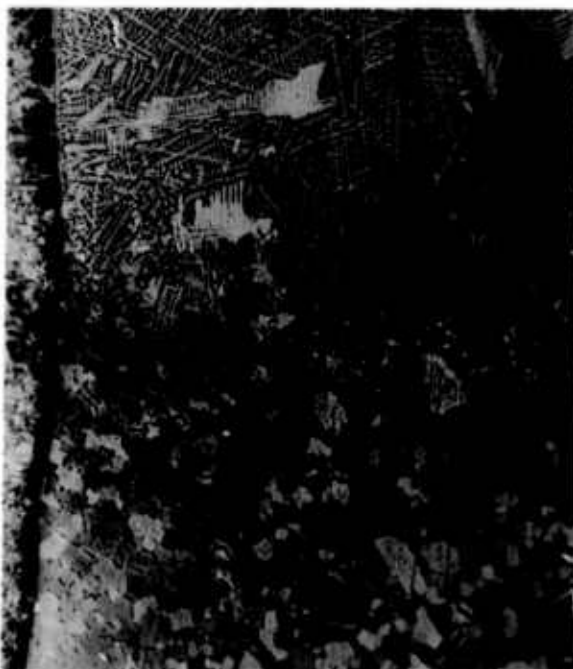
Nital -C- X100  
Helmet C1. Area shown in -B-.  
Severe cracking at boundary of base  
metal and zone molten during spot  
welding. Dendritic structure in  
molten region.

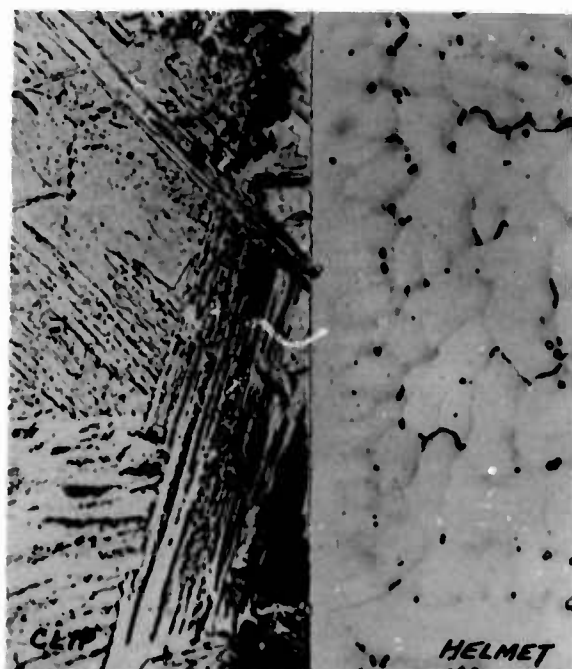
Nital -D- X1000  
Helmet C1. Ferrite, pearlite, and  
martensite in magnetic steel clip.  
Cast structure showing coring in  
austenitic steel.
