ARMORED VEHICLE COMPONENTS

Metallurgical Examination of  
Armored Vehicle Components (Armor Attachment Bolts  
and Welded Armor Sections) from a German PZKW III Tank.

Report No. 710/472  
Watertown Arsenal  
Problem B-26

January 2, 1943

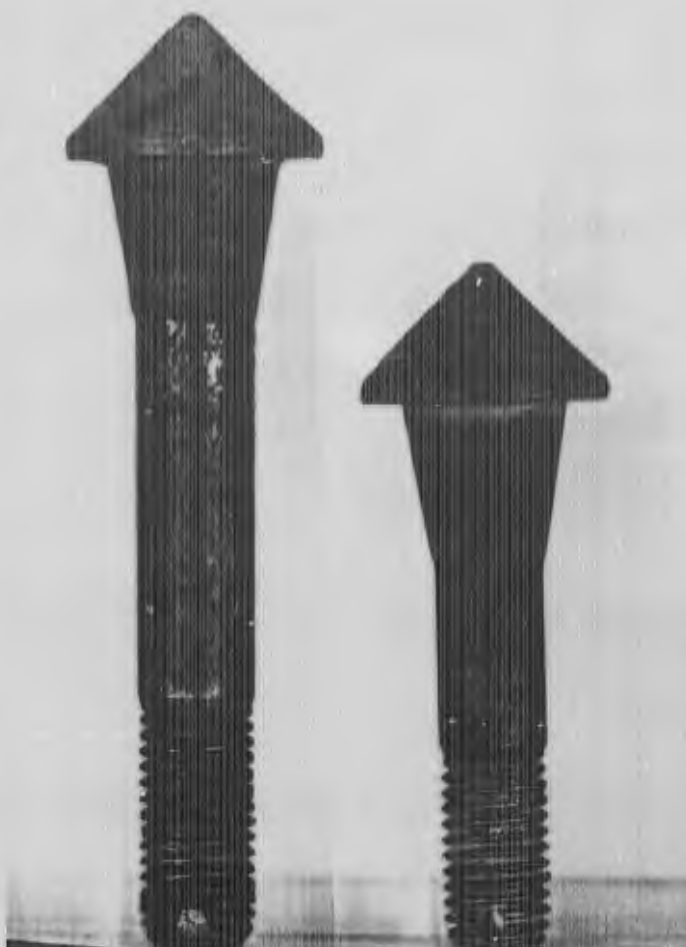
FIGURE 1

The bolts were painted completely with a dull black paint, and no visible markings were observed. The sizes of the bolts were 4"x.625"D and 2-3/4"x.546"D for the large and small bolt respectively, see Figure 1.

ARMOR ATTACHMENT BOLTS FROM A GERMAN PzKw III TANK  
NOVEMBER 5, 1942 WTN. 710-1951

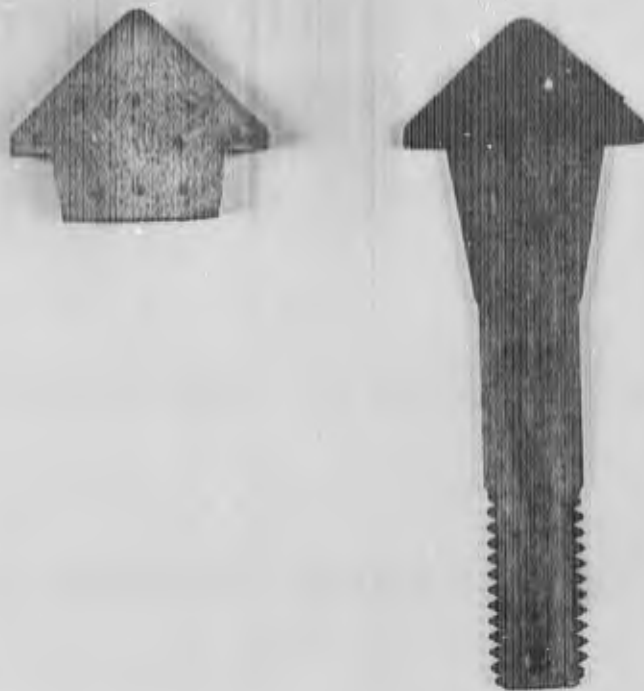
FIGURE 2

In Figure 2 is shown the macroetched longitudinal sections of the bolts on which the hardness impressions are still visible. The bolts were both forged (as observed from the grainflow) from relatively poor quality bar stock. They were then machined and the threads formed by rolling (indicated by the deformation adjacent to the threads) prior to heat treatment.

MACROETCHED LONGITUDINAL SECTIONS OF ARMOR  
ATTACHMENT BOLTS FROM A GERMAN PZ KW III  
TANK. NOVEMBER 18 1942 WTN.710-1958

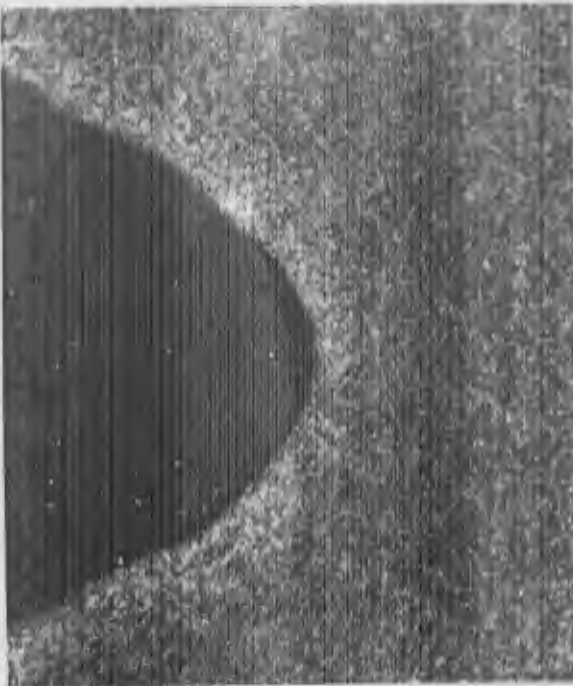
In Figure 3E is shown the cross section of a thread revealing the slight decarburization and the local deformation of the metallic and nonmetallic segregations resulting from the thread "rolling" operation. This offers further evidence that the bolts were forged, machined, threaded, and heat treated in that order.

X100 -E- Picral Nital  
Small Bolt: Decarburization and cold work at root of rolled threads

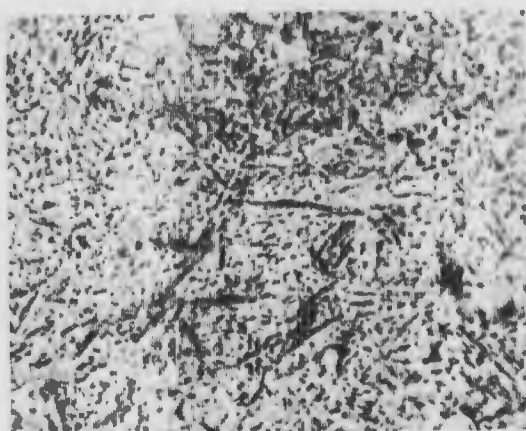
The weld metal is composed of a low carbon martensite of fairly high hardness. The base metal fragments attached are also martensitic but of a much higher hardness. Heat affected zone B (Figure 5D) which was analyzed, contains undissolved carbides in martensite. The other heat affected zone (Figure 5C) consists of an acicular martensite having very little undissolved carbide present.

X1000 -C- Picral-Nital  
Heat affected zone A: Martensite

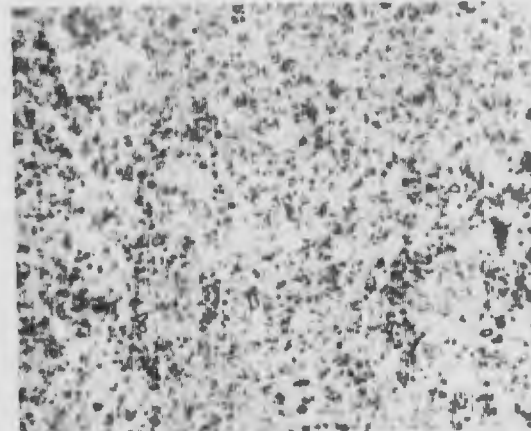
X1000 -D- Picral-nital  
Heat affected zone B: Martensite  
and undissolved carbides

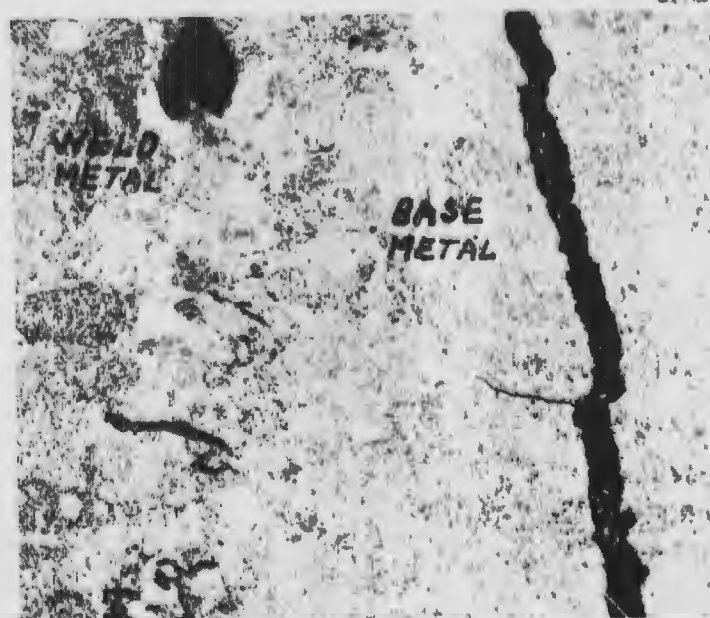
The weldment, which was probably a hurried field repair job, was very unsatisfactory. Weld metal was porous and did not adhere well to the base metal. The extreme hardness in the heat affected zones indicated that no attempt was made to either preheat or postheat the weld and thereby reduce its susceptibility toward cracking.

X100 -E- Picral-Nital  
Fusion zone B: Porosity in weld and crack  
in heat affected zone

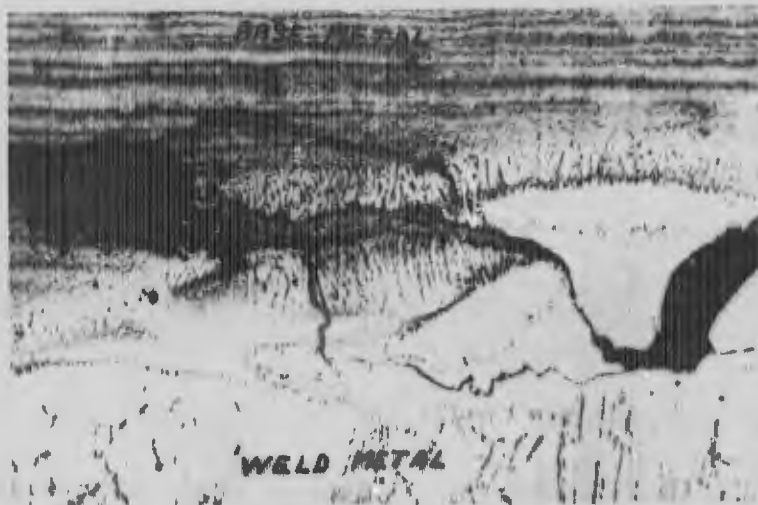
Several cracks were observed in the heat affected zones of the base metal in an area adjacent to the high alloy weld metal. See Figures 8A and B. The extension of one or two of these cracks was associated with the line of fusion of the high alloy weld metal. The low alloy weld metal, on the other hand, formed a very good bond with the base metal and it was difficult to distinguish the line of fusion between the two. There was also a satisfactory bond between the two types of weld metal although, in one case, a crack formed in the first pass of the low alloy weld metal. See Figure 8C. Another defect observed was the lack of fusion at the toe of welds and the general poor quality of the welding technique as a probable result of welding under field conditions.

X100 -B- Picral Etch  
Fusion Zone at 2. High alloy weld bead.  
Cracking in Heat affected zone.

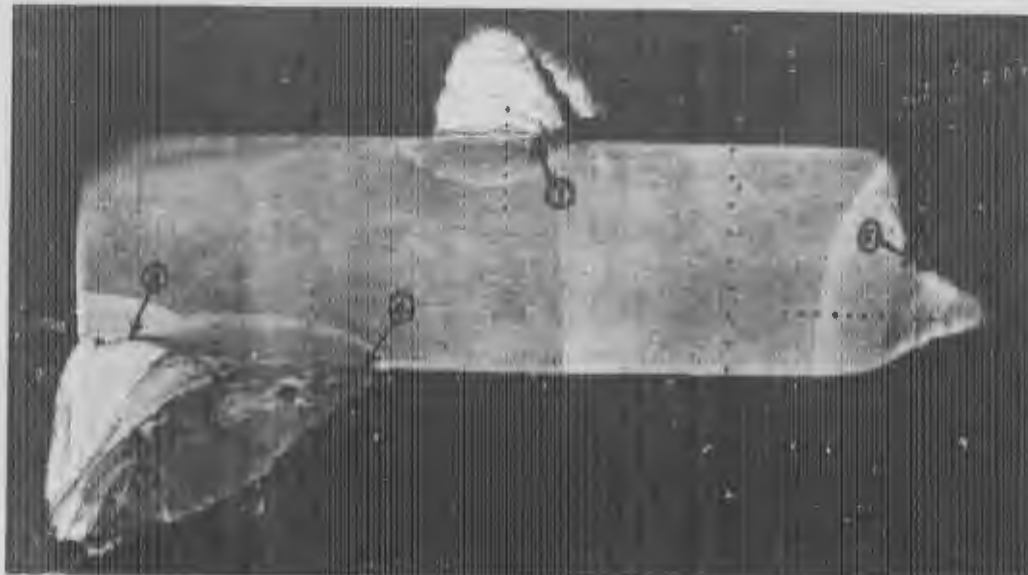
Hardness surveys were obtained every .03" across the heat affected zones as shown in Figure 8D and 9A. Subsequent readings were taken on other specimens to verify the original surveys.

Section A-A in Figure 6: Position of the vickers surveys and photomicrographs

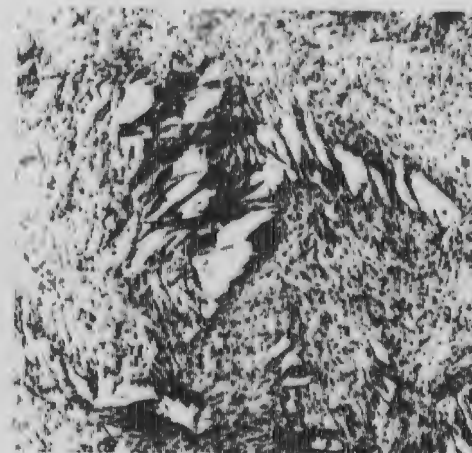
The low alloy weld metal was almost completely martensite with small amounts of retained austenite. See Figure 8F and H. The high alloy Cr-Mn weld metal was almost entirely austenite with bands of an acicular transformation product, probably bainite. See Figure 9C and E. The presence of austenite was substantiated by x-ray diffraction.

Martensite and austenite in low alloy weld at 5.

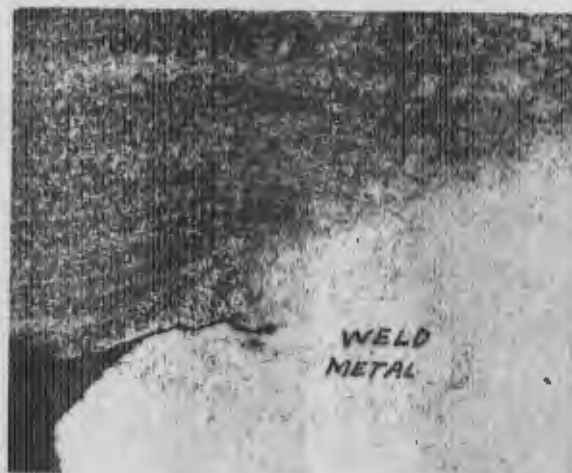
Fusion zone at 4. Low alloy weld bead showing very good fusion except at the toe.

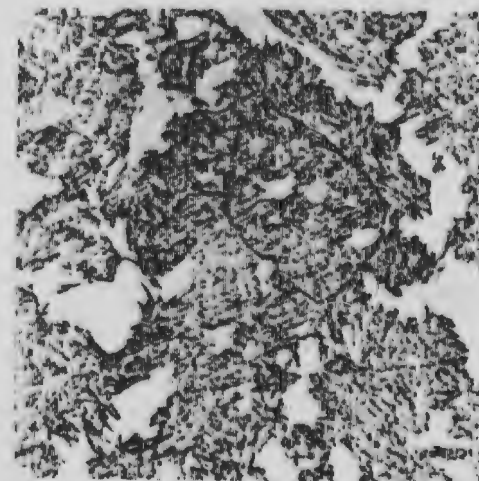
Martensite and austenite in low alloy weld at 4.

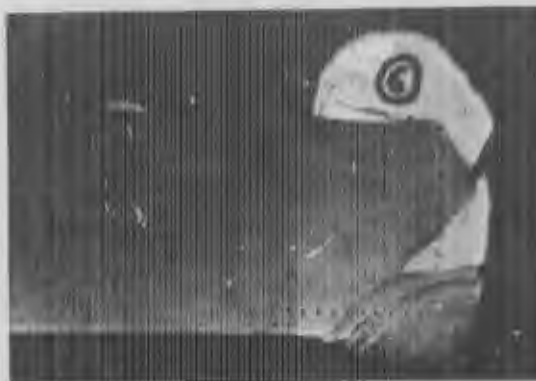
X3 A Nital Etch  
Section B-B in Figure 6: Position  
of Vickers surveys & photographs

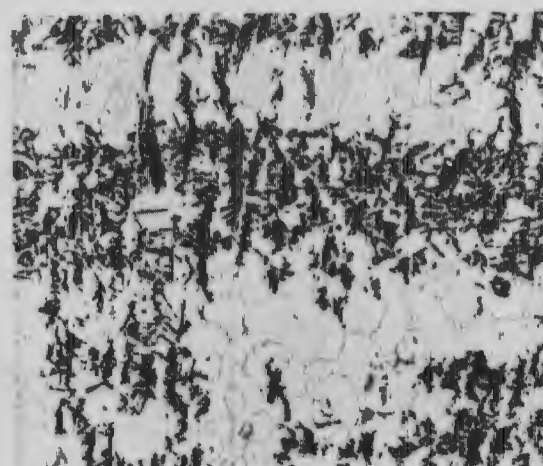
X100 C Chromic acid Etch  
Weld metal at 6: Bainite in high  
alloy weld

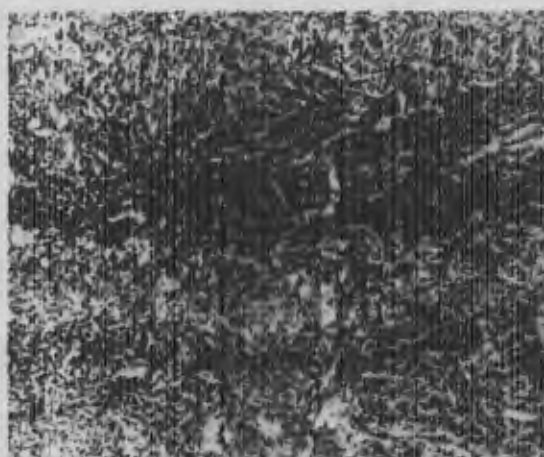
The structure of the base metal is a typical tempered martensite, Figure 9D, containing some undissolved carbides and indicating incomplete heat treating. At low magnification banding or alloy segregation is observed. The similarity of the etching characteristics in both the longitudinal and transverse directions indicates that the steel was cross-rolled. The distribution of nonmetallics in the longitudinal direction is shown in Figure 9B. The general freedom from nonmetallic segregations observed here is typical of German armor which has been previously studied at this Arsenal\*.

X1000 D Picral Etch  
Base metal: Martensite and undissolved carbides
