Investigation of Salvaged M1 Helmets

WATERTOWN ARSENAL LABORATORY  
MEMORANDUM REPORT No. WAL 710/774  
Final Report on Problem E-7.23

23 August 1945

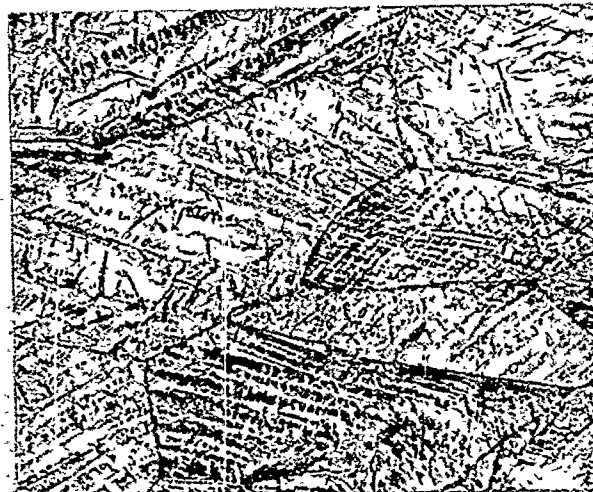
Metallographic examination of the burnt areas of several of the helmets indicated that some of them had been heated to well over 600°F. Above approximately 600°F., austenitic manganese steel is unstable with respect to precipitation of carbides along slip planes and grain boundaries. Carbide precipitation results in severe embrittlement of the steel. Excellent data

Figure 1B shows the microstructure of the burnt zone of helmet SB7. Very extensive carbide precipitation is evident. The microstructure of the portion of the helmet which was unaffected by the heat consists of the normal cold-worked austenitic structure free of carbides.

Nital Etch. -B- Mag. X1000  
 Microstructure of burnt zone of above helmet.  
 Carbides precipitated at grain boundaries  
 and along slip lines.

In view of the possibility that any burnt helmet may have been heated to a sufficiently high temperature (above approximately 600°F.) to cause carbide precipitation and consequent embrittlement, it is deemed inadvisable to attempt the salvage of any burnt helmet. Helmets should never be allowed to undergo combat service.
