FTC-TR-73-3

**AIR FORCE FLIGHT  
EVALUATION (SYSTEMS)  
OF THE  
A-10A PROTOTYPE AIRCRAFT**

**TECHNICAL REPORT No. 73-3**

**MARCH 1973**

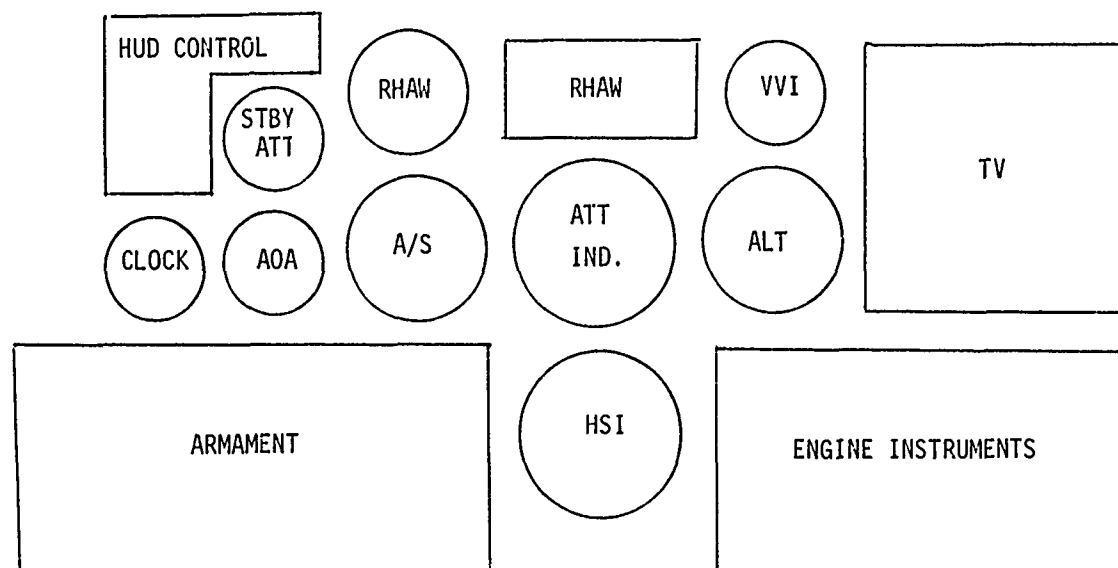
(2) Place the VVI above the altimeter in the position reserved for the RHAW system. Replace the HUD control panel with the RHAW system. Redesign the HUD control panel to use the space presently occupied by the AOA indicator, the fire detect and bleed air leak check button and the fire agent discharge switch. Remove the fire detect and bleed air leak check button from the front panel and relocate it on the lower edge of the caution light panel next to the caution light panel test button. This would improve the functional grouping of light test buttons. Redesign and relocate the fire agent discharge switch to the edge of the glareshield between the fire handles. This would improve functional grouping.

The second method is preferred and should be considered since it would result in a much better arrangement of all switches and indicators. The following diagram shows the new arrangement which would comply with MIL-STD-1472A, para. 5.2.1.3.6. and 5.2.1.3.7.
