DDC
07
2
REPORT NATF-EN-1135

EVALUATION OF BAK-14 HOOK-CABLE
SUPPORT-SYSTEM MODIFICATIONS

Waldemar Wastallo
Recovery Division, Engineering Department
Naval Air Test Facility
Naval Air Station
Lakehurst, New Jersey 08733

FINAL REPORT

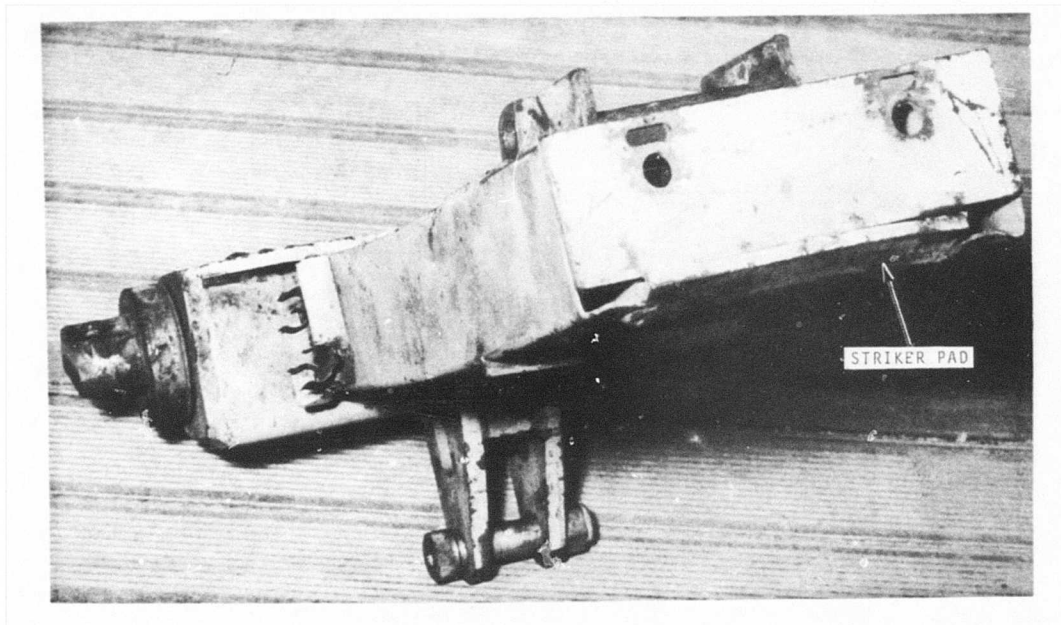
FIGURE 5 - BAK-14 TEST-CONFIGURATION SUPPORT ARM

L. TEST CONFIGURATION SUPPORT ARM (see Figure 5): The test configuration support arms were exposed to a total of 136 aircraft tests in runway support-box locations 1, 6, and 7, and to 114 aircraft tests in locations 2, 3, 4, and 5. Support-arm bending caused by high inertial loads developed in the torsion spring-loaded support arm from impact of the aircraft tire was the most serious problem encountered during the tests. The principal effect of the bending was to disable the latch-actuating mechanism and air cylinder by causing interference between the pivot assembly and air cylinder. The permanent bend damage is probably the result of metal fatigue which was first detected after event 59. The physically identical group of support arms used in these tests was previously exposed to approximately 302 aircraft tests (references (d) and (e)).

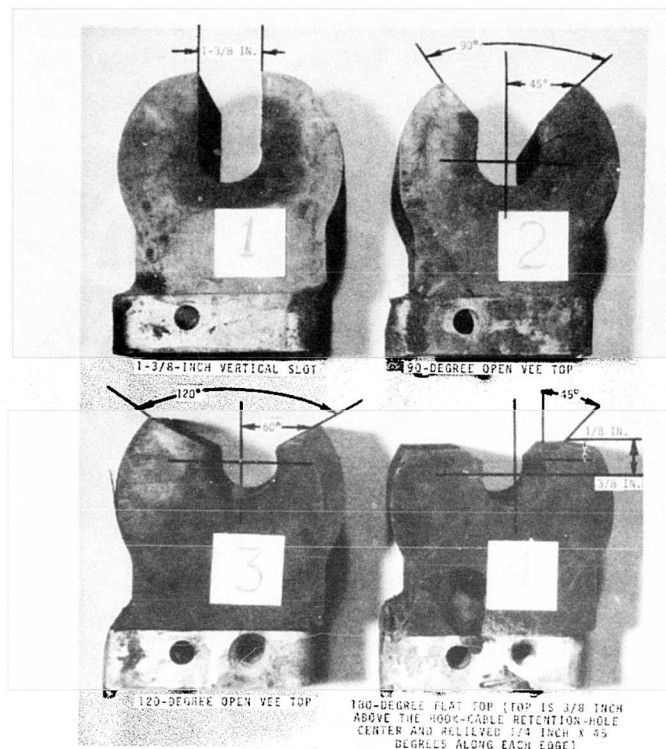
FIGURE 6 - MODIFICATIONS OF THE STANDARD SUPPORT BLOCK

1. MODIFIED SUPPORT BLOCKS: The modified support blocks (Figure 6) were designed to decrease block damage when the supported hook cable is extracted during aircraft arrestments at extremely low temperatures, and to hold the restrained hook cable in the support blocks when the system is cycled (raised and lowered). The modifications consisted of the removal of the neoprene rubber from the top of the block with the aid of a band saw to reduce block grip on the hook cable. Support blocks were fabricated incorporating four modifications in which the hook-cable openings on the blocks were progressively increased from a vertical slot to a wide-open flat top.

The most desirable modification would be the support block with the widest-angle open top that retains the hook cable during aircraft tramples and functional-cycle operation of the system when the hook cable is secured with the nylon cord restraint.

B. Install and evaluate support-block modification No. 4 under extremely low temperature conditions.

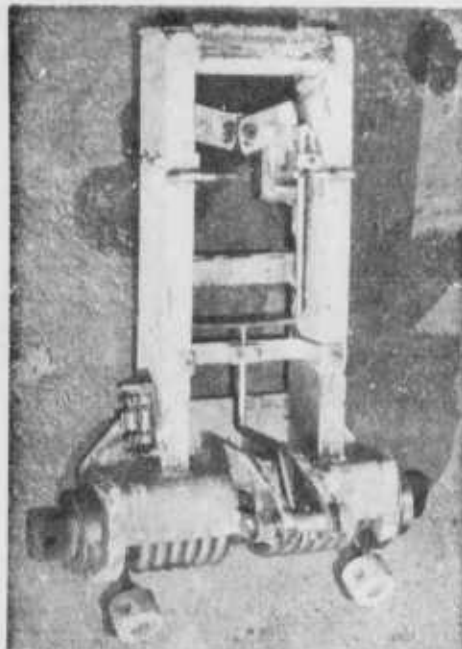
FIGURE 9 - SUPPORT ARM WITH FINAL LATCH MECHANISM INSTALLED

I. FINAL LATCH MECHANISM (see Figure 9): The final latch mechanism was initially assembled for a functional checkout in the shop on a reinforced support arm. It was found that maximum axial movement of the forked rod did not sufficiently actuate the latches due to excessive lost motion of the latch-drive pins. Installation of the assembled latch-mechanism support-arm into runway support box No. 3 was prevented by interference of the end of the forked rod with the pusher block on the air-cylinder piston rod. For these reasons, the final latch mechanism was not tested in the BAK-14 system.

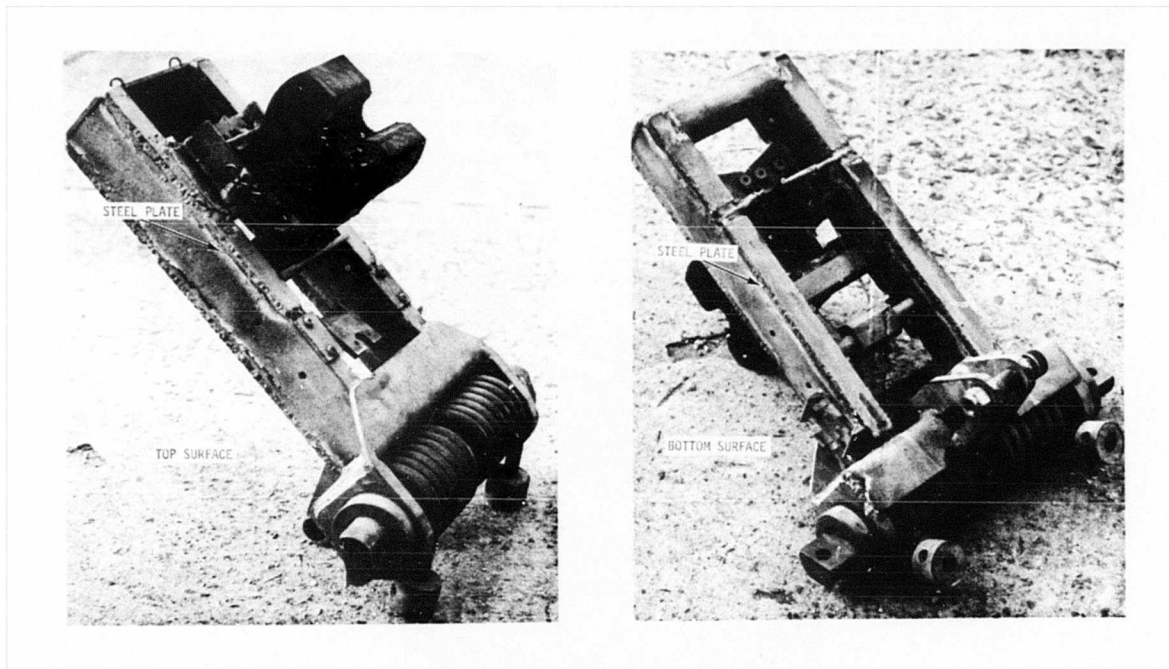
FIGURE 11 - REINFORCED SUPPORT ARM

6. REINFORCED SUPPORT ARM (Figure 11): The reinforced support arm was designed to prevent bending of the rectangular tubing of the test-configuration support arm (identical to the standard support-arm tubing) by aircraft and trample loads. The reinforcement consisted of 3/16-inch-thick mild steel plate welded to the top and bottom surfaces of the rectangular tubing of the support arm.

K. REINFORCED SUPPORT ARM (see Figure 11): The reinforced support arms were deliberately exposed to a series of 12 high-speed tramples with the A-4 aircraft at speeds of 88 to 154 knots and 10 arrestments of the A-4 aircraft at engaging speeds of 96 to 134 knots. Inspection of the reinforced support arms after completion of the aircraft tests disclosed no bending or impact damage.

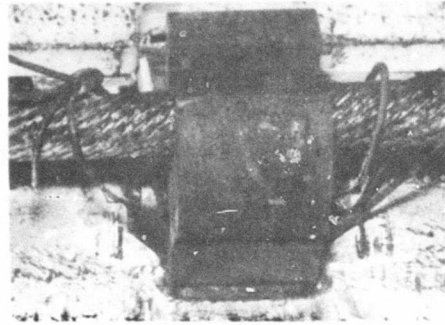
FIGURE 12 - CHAFED COATED RESTRAINT WITH THE STANDARD SINGLE-LOOP REEVE

1. STANDARD SINGLE-LOOP-REEVE RESTRAINT (Figure 12): The axial movement of the hook cable caused by the aircraft trample shifted the looped cord away from the side of the support block. The extended loop was then exposed to chafing contact against the support-box cover when the support arm was depressed by the aircraft trample. Seven single-loop-reeve restraints failed or were damaged in this manner during the 18 aircraft tramples.

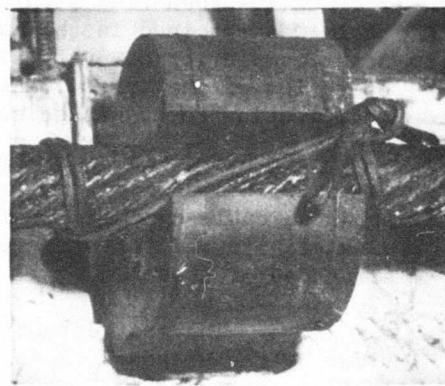
FIGURE 13 - DUAL-LOOP-REEVE RESTRAINT SHIFTED OUT OF POSITION

2. DUAL-LOOP-REEVE RESTRAINT (Figure 13): Two failures occurred during completion of 30 aircraft tramples with the dual-loop-reeve restraint; namely, a failure of the restraint cord, and a failure to retain the hook cable in the modified open-top support block although the restraint was still intact. Both failures may have been caused by the decreased strength and the increased elasticity of the dual-loop reeve which divides the hook-cable restraint load among four cords compared to eight cords in the standard single-loop reeve and the cross-loop reeve.

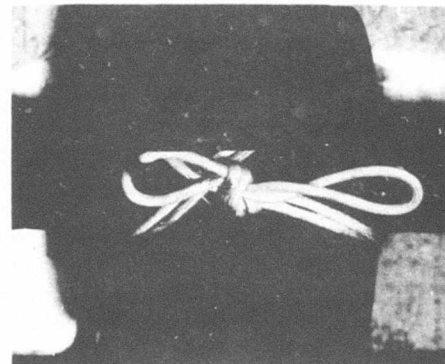
FIGURE 14 - CROSS-LOOP-REEVE RESTRAINT AFTER ELEVEN TRAMPLES

3. CROSS-LOOP-REEVE RESTRAINT (Figure 14): The cross-loop-reeve restraint was not shifted out of position by the axial movement of the hook cable as was the standard single-loop-reeve restraint. It, therefore, was not subject to chafing by the support-box cover. By comparison, only minor chafing damage was experienced during the completion of 77 aircraft tramples with this restraint configuration. High-speed motion-picture coverage indicates that the most effective restraint and retention of the hook cable was provided by the cross-loop reeve.
