TECHNICAL REPORT 4842

DYNAMIC ANALYSIS OF THE SAFING AND ARMING SYSTEM FOR PD FUZE M572E2

EDWIN B. ENTIN

MARCH 1976

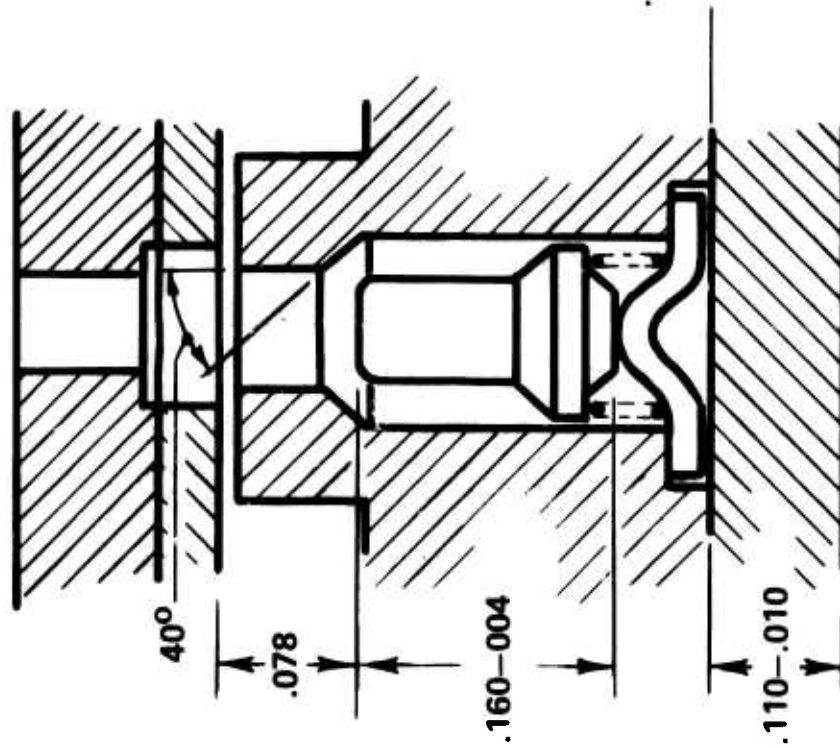
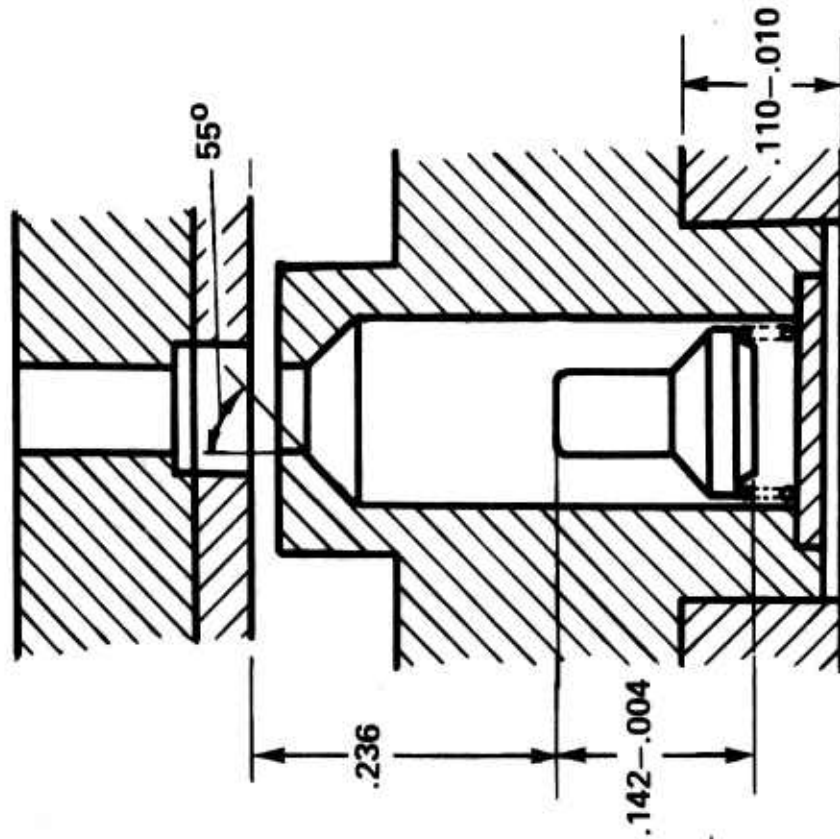
Fig 4 Setback pin and cavity area

1972 ET/ST DESIGN
(.078 DISPLACEMENT)
33 G SETBACK SPRING
STEEL SETBACK PIN

1973 ET/ST DESIGN
(.236 DISPLACEMENT)
20 G SETBACK SPRING
TUNGSTEN SETBACK PIN

1. A setback pin made from a heavier material (tungsten) and featuring a larger base diameter with a corresponding lower center of gravity, was substituted for the original steel setback pin. The heavier material permits the use of a more readily producible setback spring. The center of gravity was lowered to increase the centrifugal holding force of the setback pin toward the sidewall and avoid rapid tilting motion of the pin whenever the shell might experience sudden lateral displacements down bore.

5. The aluminum-dimple configuration retainer plate at the cavity base was removed and replaced by a soft-aluminum flat disc to further dampen any axial bounce of the setback pin.

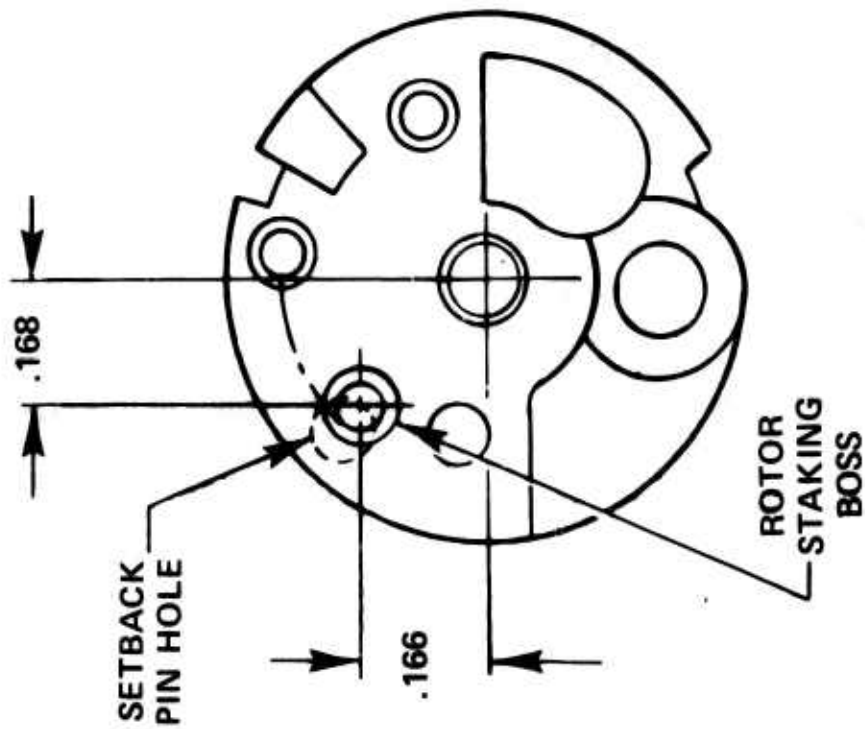
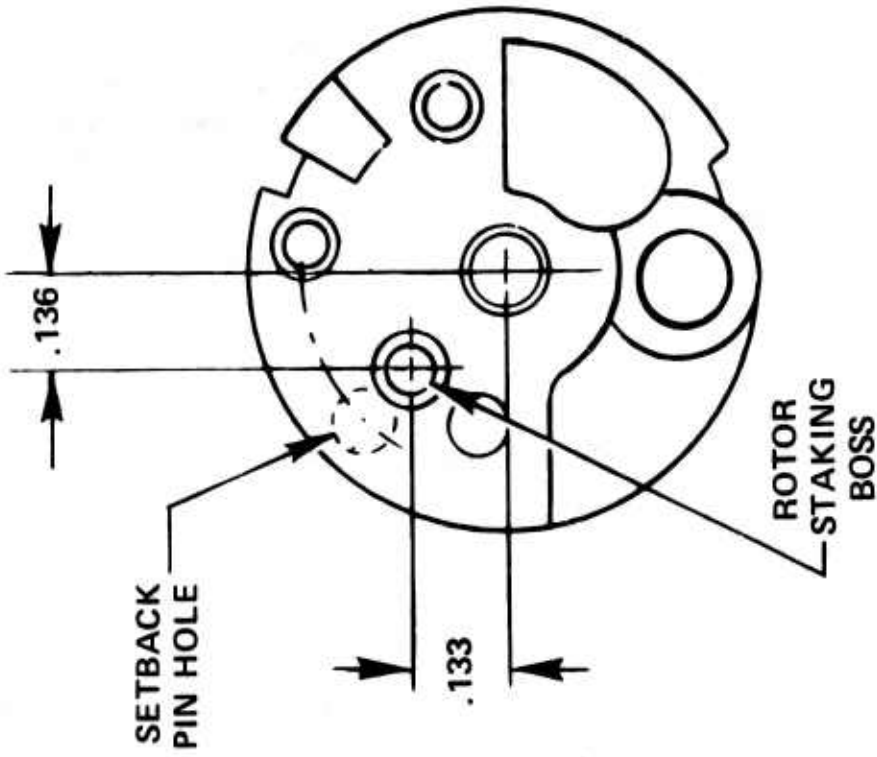
Fig 5 Relocated rotor gear stake

1972 ET/ST ROTOR BODY

1973 ET/ST ROTOR BODY

6. The hole and staking for the rivet pin, which holds the rotor gear to the rotor, were relocated inboard to prevent interference of the rotor and setback pin.

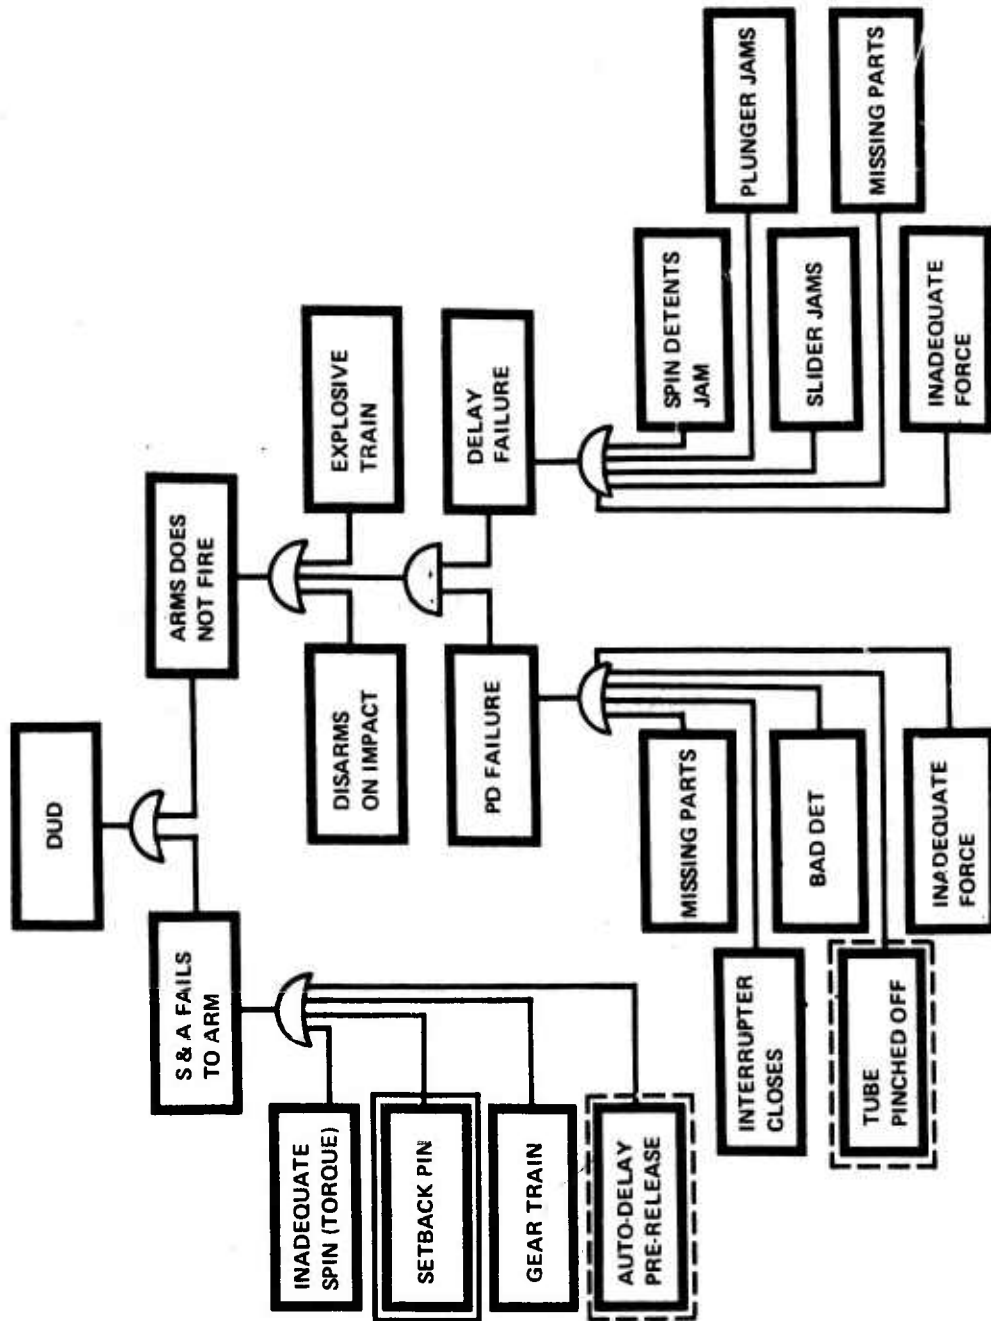
Fig 8 Failure diagram

The failure diagram used in the preliminary analysis which identified the failure causes is shown in Figure 8. The primary failure mode (setback-pin failures) applicable to the S&A failures in low-zone howitzers, addressed by this report, is enclosed by a solid line. The two secondary failure modes, not covered in this report, are enclosed by broken lines.

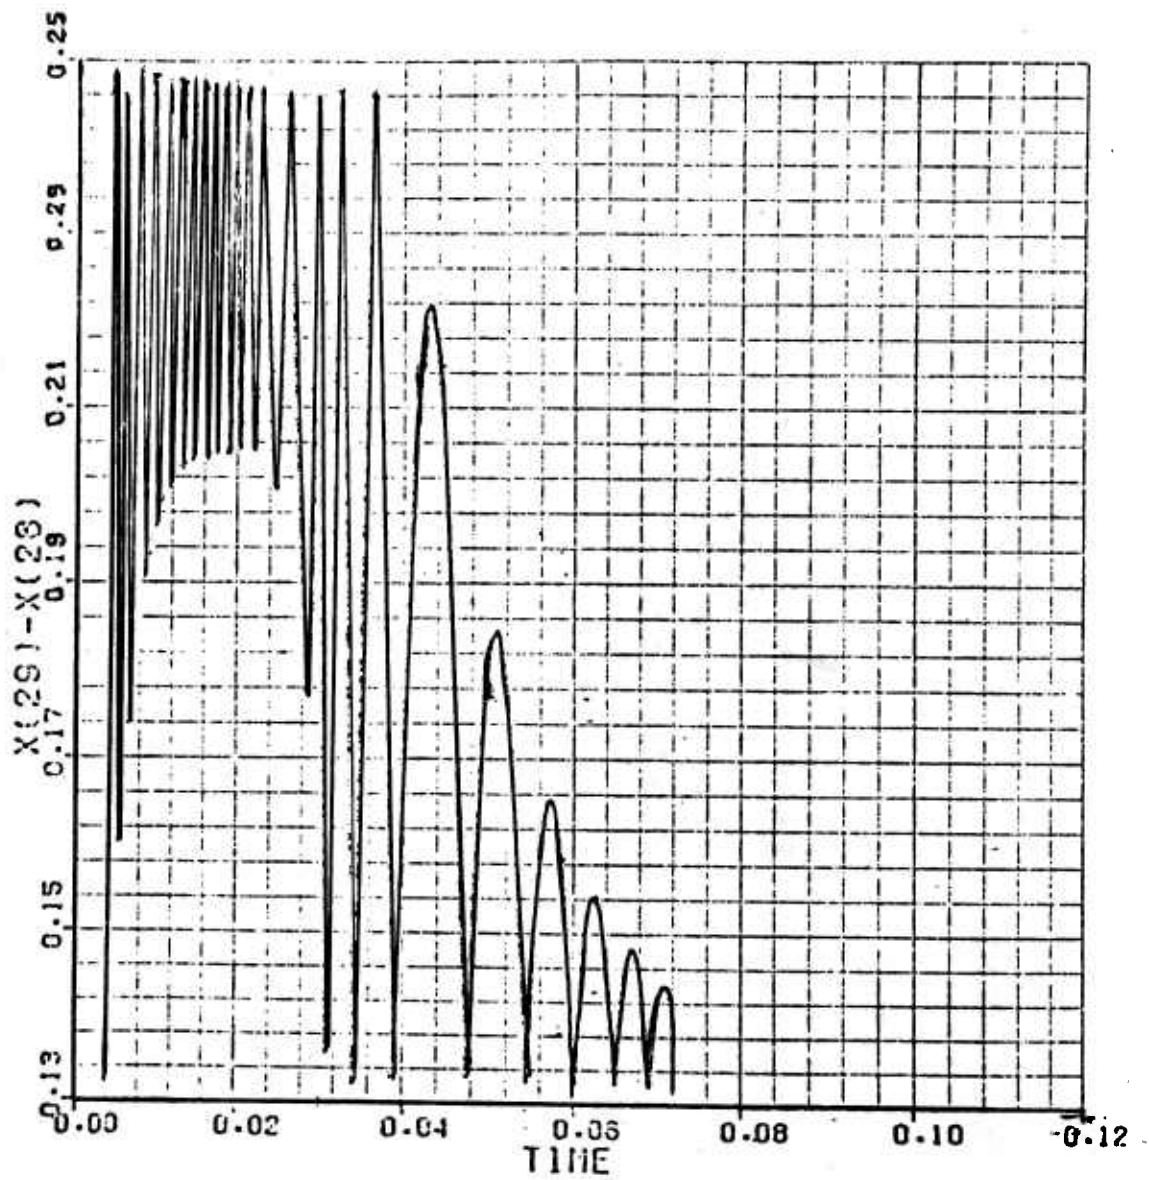
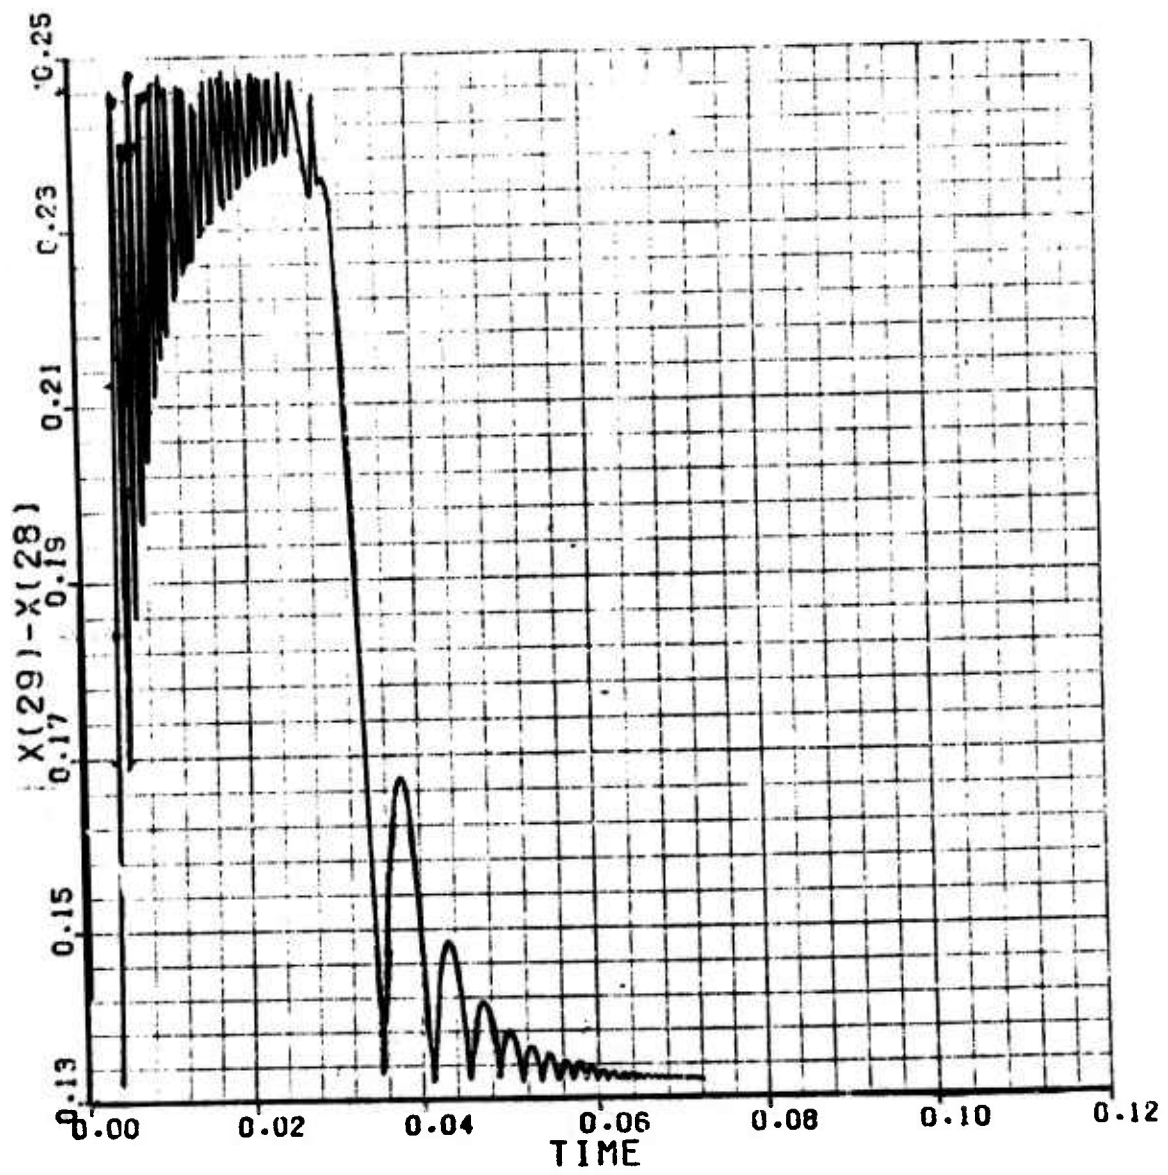
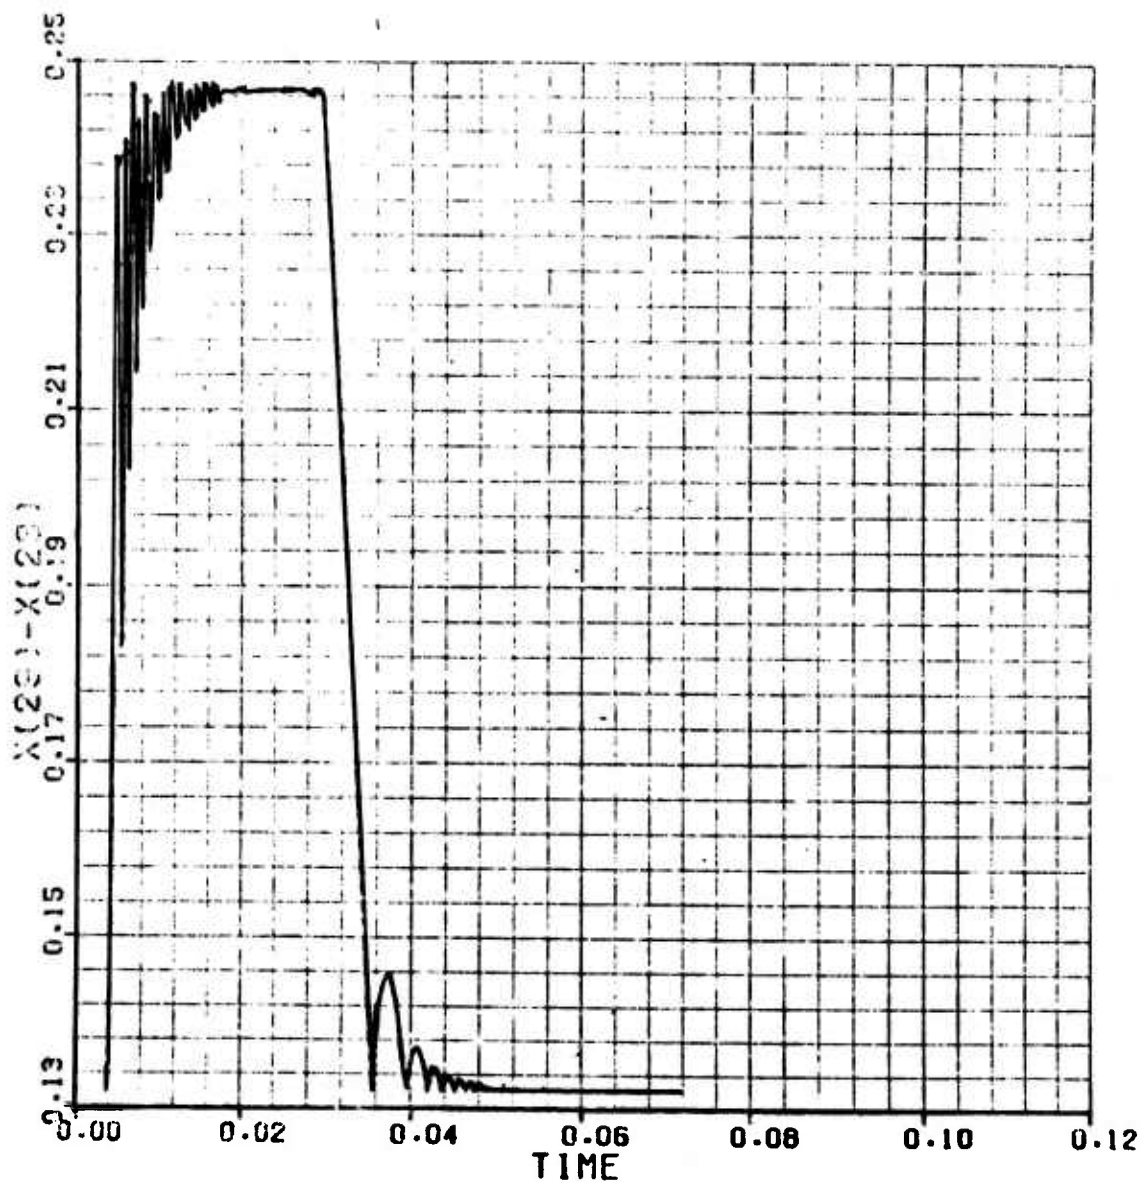
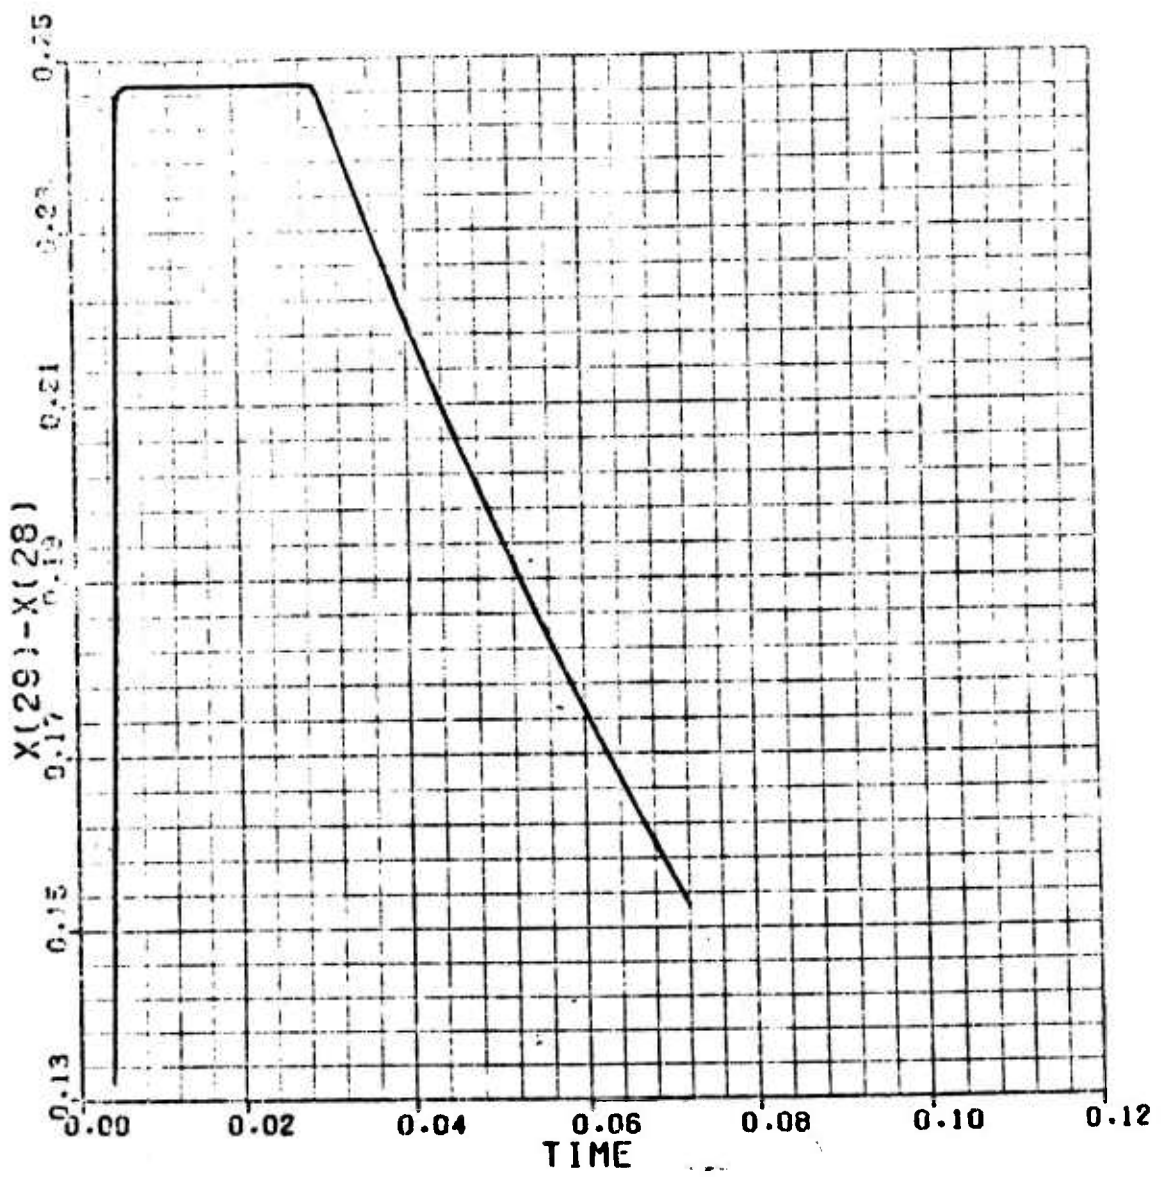
Five runs were made with increased damping for the setback-spring motion between boundaries, while keeping boundary collisions with zero damping (perfectly elastic). This was recognized to be a very conservative assumption. The rationale involved searching for a positive fix to the problem which would effect a solution under the worst conditions. (These conditions included perfectly elastic rebounding and continuous lateral alignment.) Relative damping ratios of 25-, 50-, 100-, 1,000-, and 10,000- percent critical were investigated. The time for initial reseating ranged from almost immediately after muzzle exit for 25 percent critical, to about five milliseconds for 100 percent, to about 54 milliseconds for 1,000 percent. One of the pertinent results demonstrated by these solutions is that if the pin comes to a position of alignment for any of the reasons discussed above, even without rebounding motion, the setback-pin spring itself can cause reseating shortly after muzzle exit. The 25-, 50-, 100-, and 1,000-percent critical conditions are illustrated in Figures 14, 15, 16, and 17, respectively, where muzzle exit occurs at 29.5 millisecond (0.0295 time). The ordinate "0.25" represents pin bottoming, and the ordinate "0.13" represents seating of the pin in the rotor. For pin motion unrestrained by friction forces along the cavity wall, it was apparent that significant dash-pot type damping is required to guarantee successful operation after the shell leaves the muzzle.

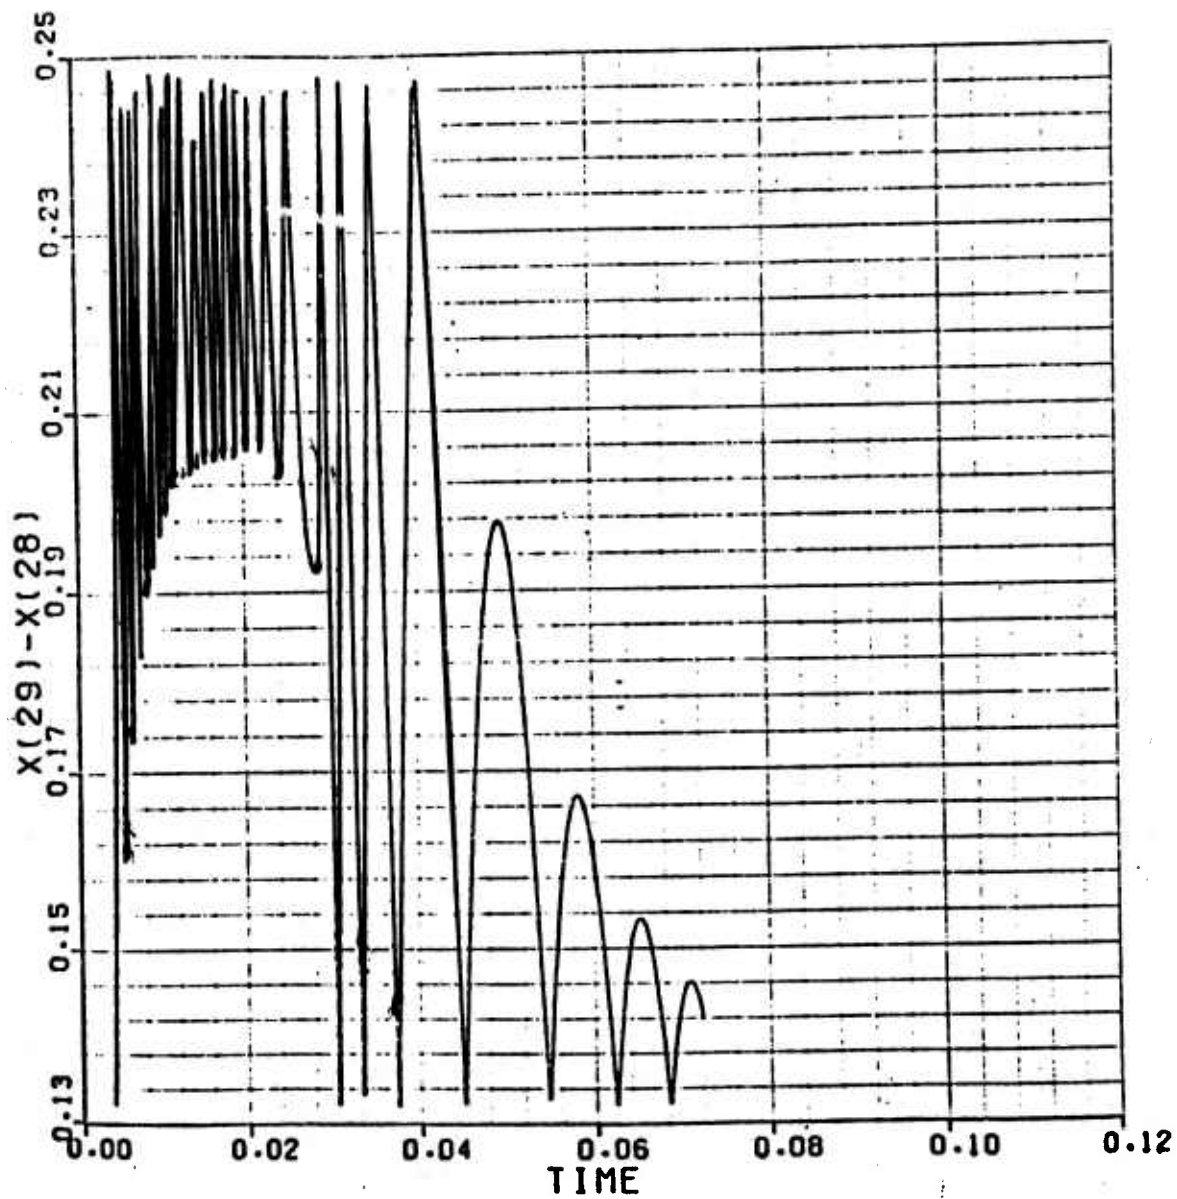
Fig 18 Setback-pin response $\zeta = 25$ percent, $k \rightarrow 20$ g's

Two setback-pin springs, 20G and 5G, were investigated as possible replacements for the then-current 36G spring to determine the effect of setback-spring stiffness. The setback pin has its initial reseating after about a millisecond for the 20G setback-pin spring (Fig 18) and eight milliseconds for the 5G setback-pin spring. The damping utilized in this investigation was 25-percent critical relative to the 36G system. The reseating delay is associated primarily with the higher relative damping and the effects of the velocity shocks; although the lower stiffness helped, its effect was not very significant.

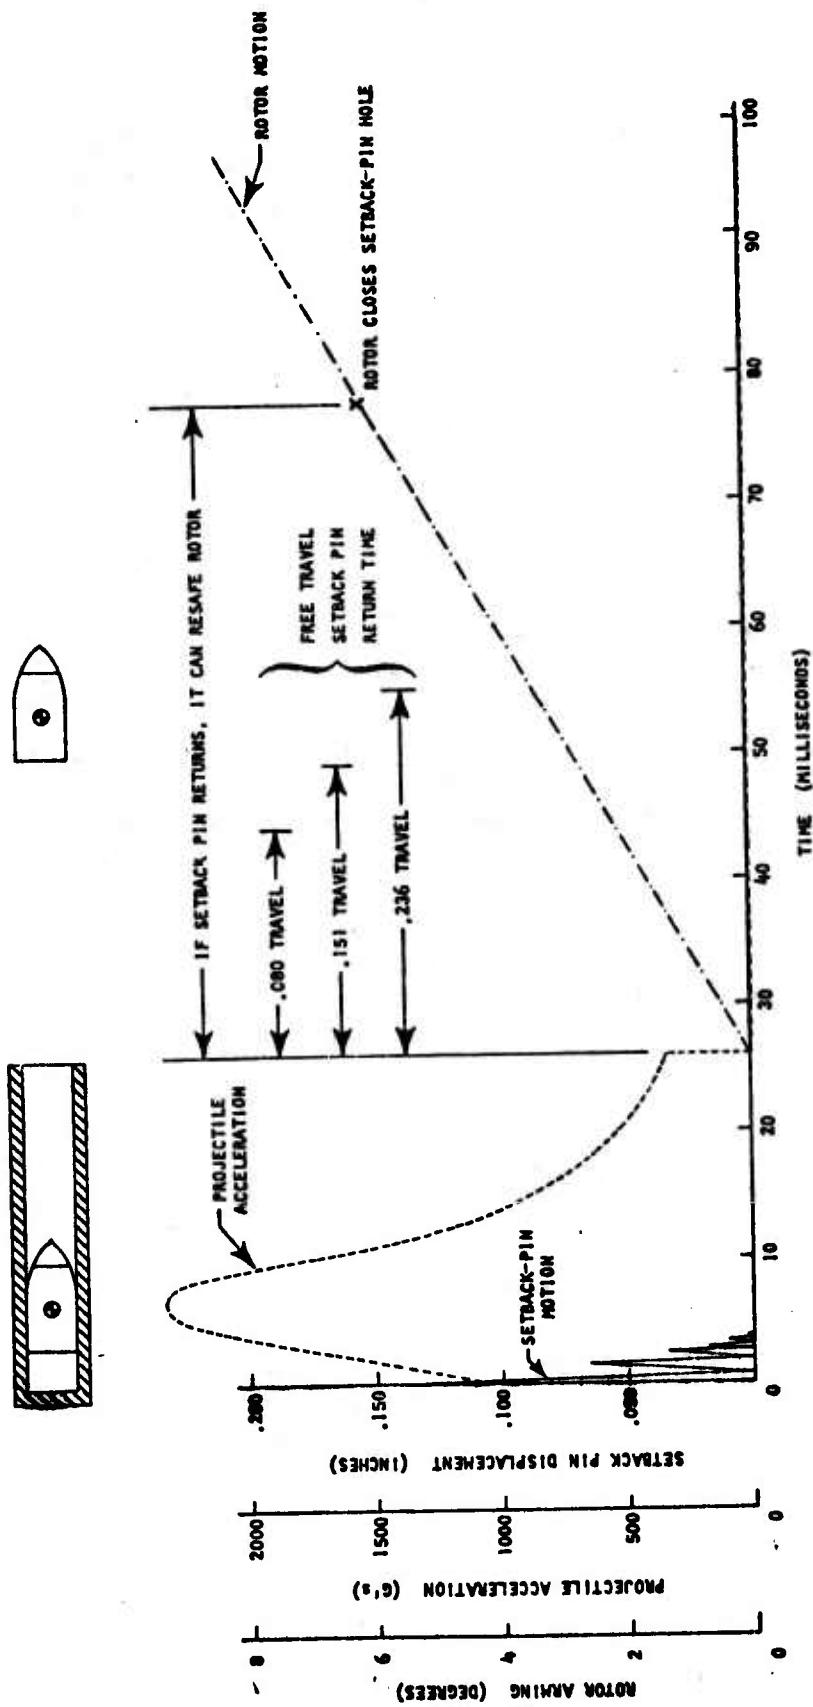
Fig 19 Low G setback-pin response to 8-inch zone 1 firing

Experimental data on rotor response indicates that the position of the rotor is such that pin reinsertion could occur up to 80 milliseconds after firing (Fig 19). Thus, the dynamic behavior of the pin was studied over this period of time and the assumption accepted that, should the pin move forward to a point where its tip crossed the lower plane of the rotor, the condition of failure would be achieved.
