NWC TP 5942

# F-14A Fire Protection Test Program

by  
George E. Moncsko  
and  
Herman J. Hoffman  
*Systems Development Department*

FEBRUARY 1977

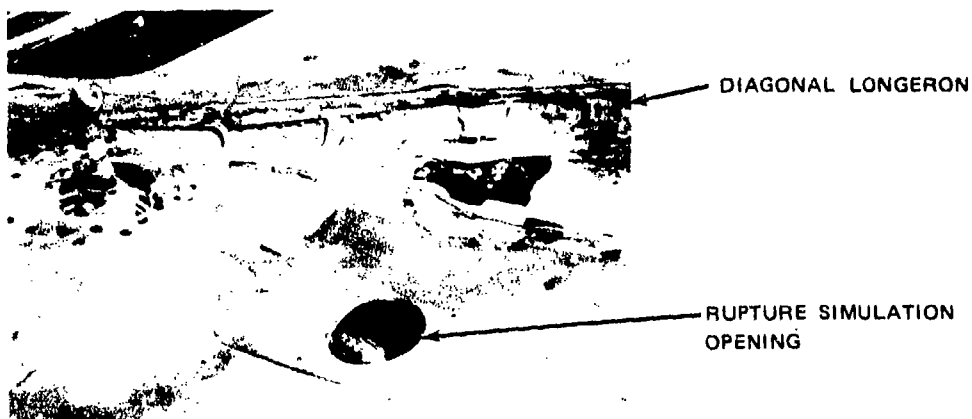
FIGURE 36. Fire-Damaged Diagonal Longeron.

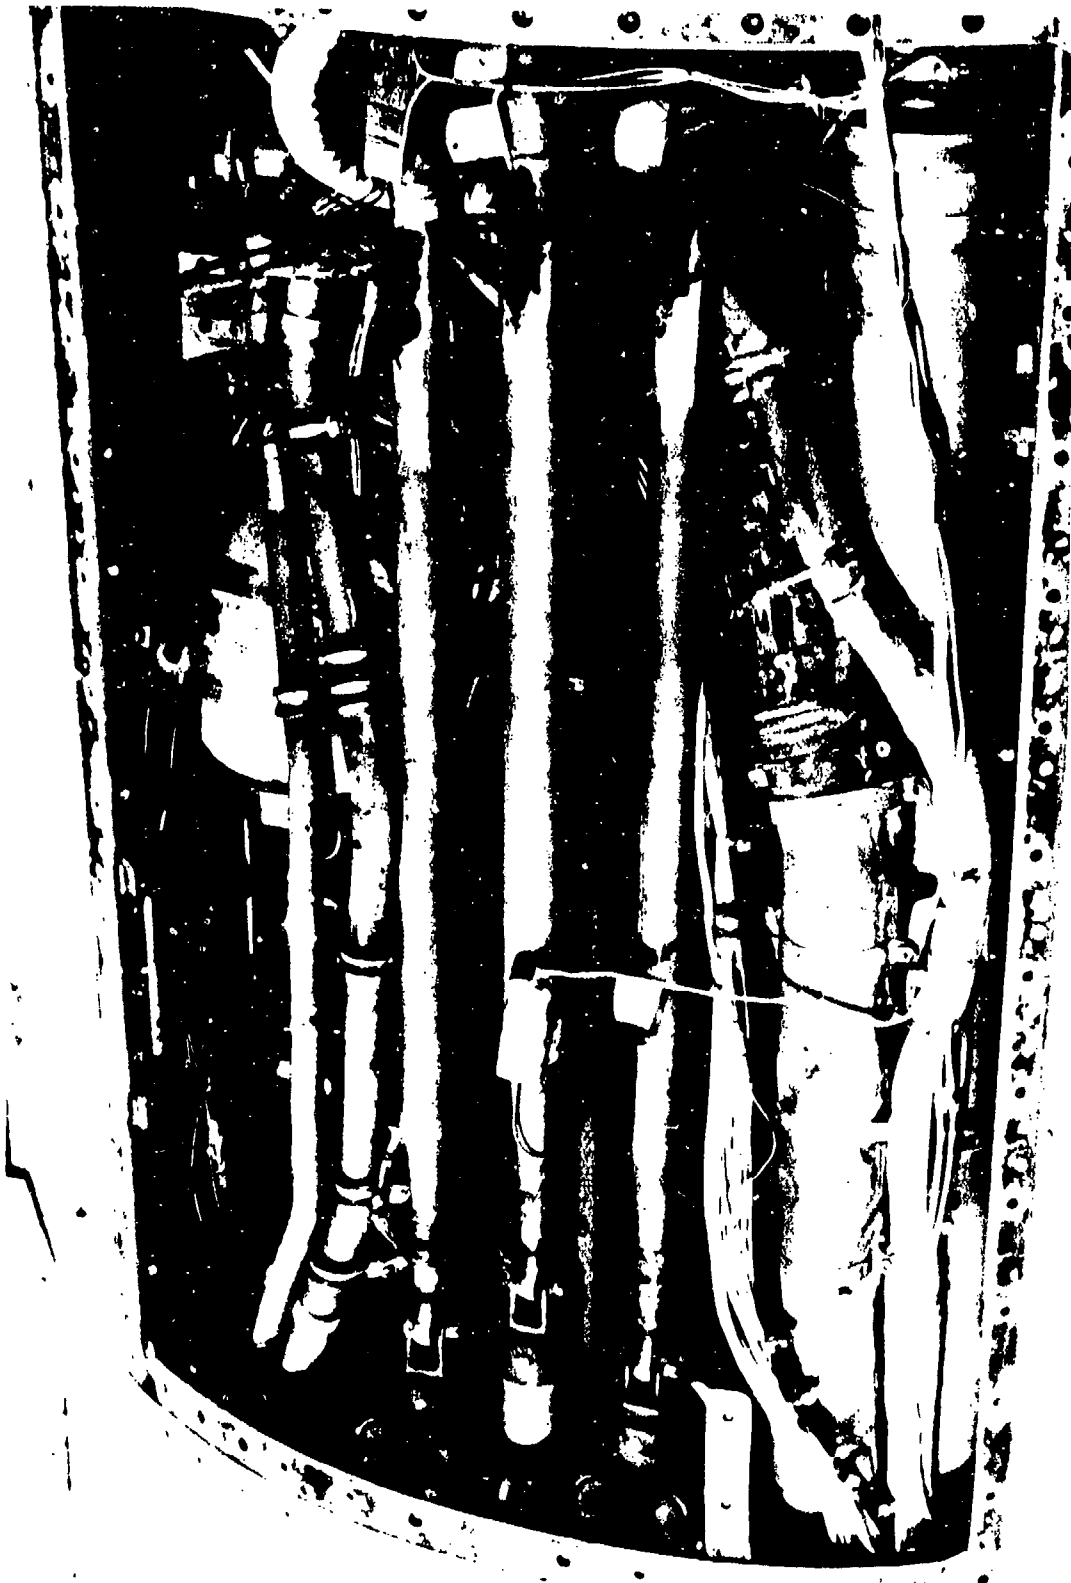
FIGURE 38. View of Center Trough After Fire Test No. 1.

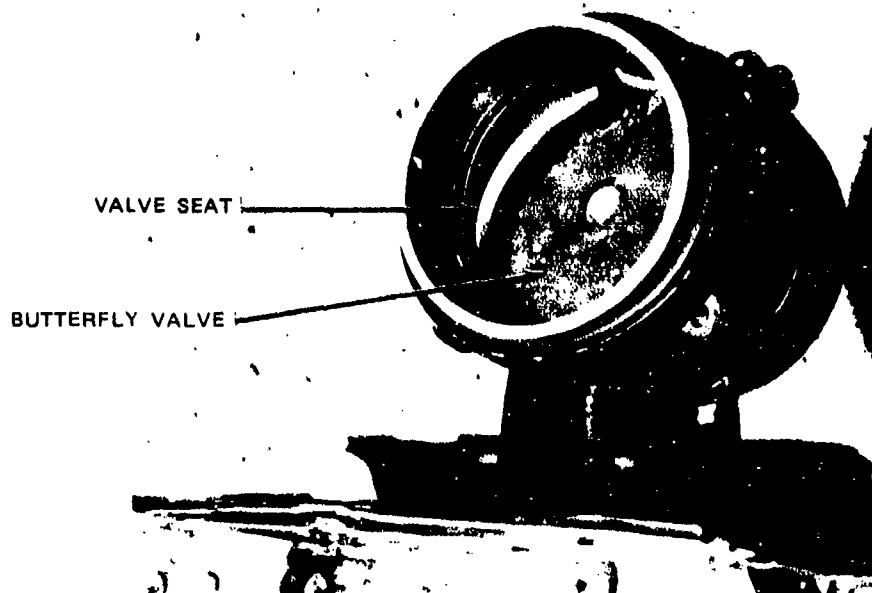
The fuel valve was removed from the nacelle and shipped to GAC for analysis of the failure. Grumman found the mechanical stops that normally inhibit the travel of the valve past shutoff had been severed. This valve failure was the direct cause of the long burn duration resulting from continued fuel leakage from the aircraft. This failure mode had been reported as occurring before, and an engineering change (ECP 854, see footnote 3) was proposed to modify the valve. ECP 854 proposed to change the shaft materials to steel and strengthen the stops, plus several other small changes all designed to prevent the valve failure experienced in this test.

FIGURE 40. Fuel Shutoff Valve Showing Butterfly Overtravel Malfunction.

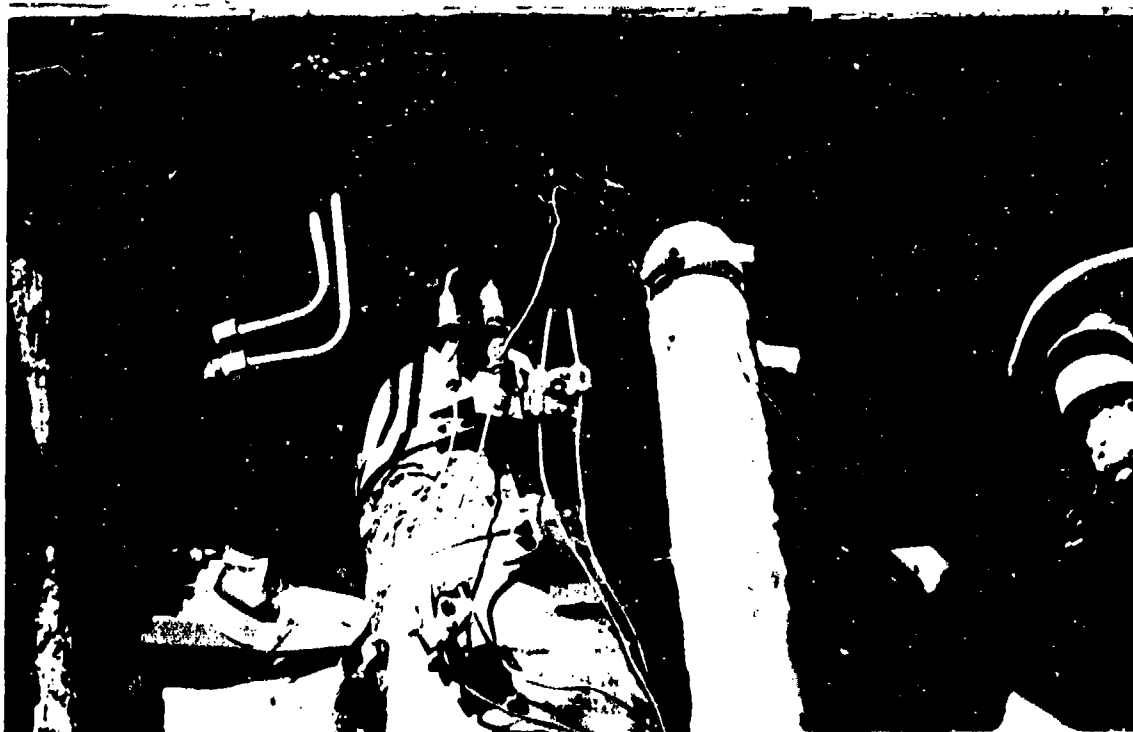
FIGURE 42. Silicone - Ablative Coated Fire Barrier After Fire Test No. 2.

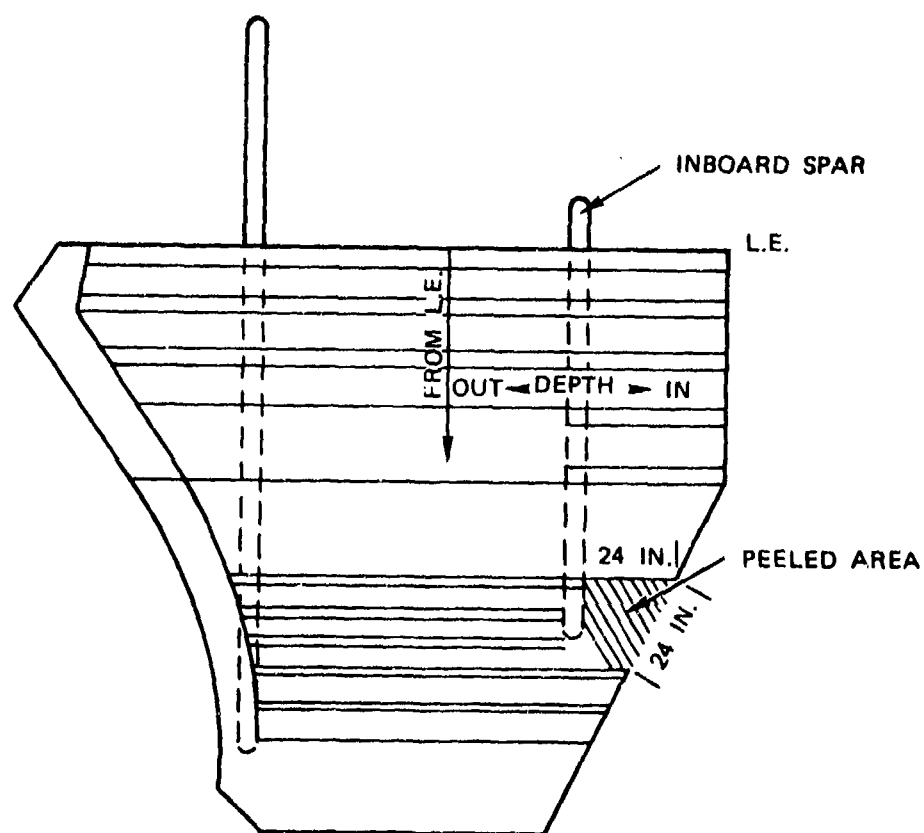
## DAMAGE ASSESSMENT MEASUREMENTS

leading edge of the overwing fairing was charred and the center section showed surface buckling and heating effects. Damage assessment measurements for the underside of the overwing fairing are given in Figure 43. The measurements shown are from the leading edge to the center of the damaged area.
