LOW-COST AIRCRAFT STRUCTURAL REPAIR AND MAINTENANCE STUDY

ROCKWELL INTERNATIONAL
LOS ANGELES AIRCRAFT DIVISION
LOS ANGELES, CALIFORNIA

FINAL REPORT FOR PERIOD AUGUST 1974 - MAY 1976
TECHNICAL REPORT AFFDL-TR-76-63

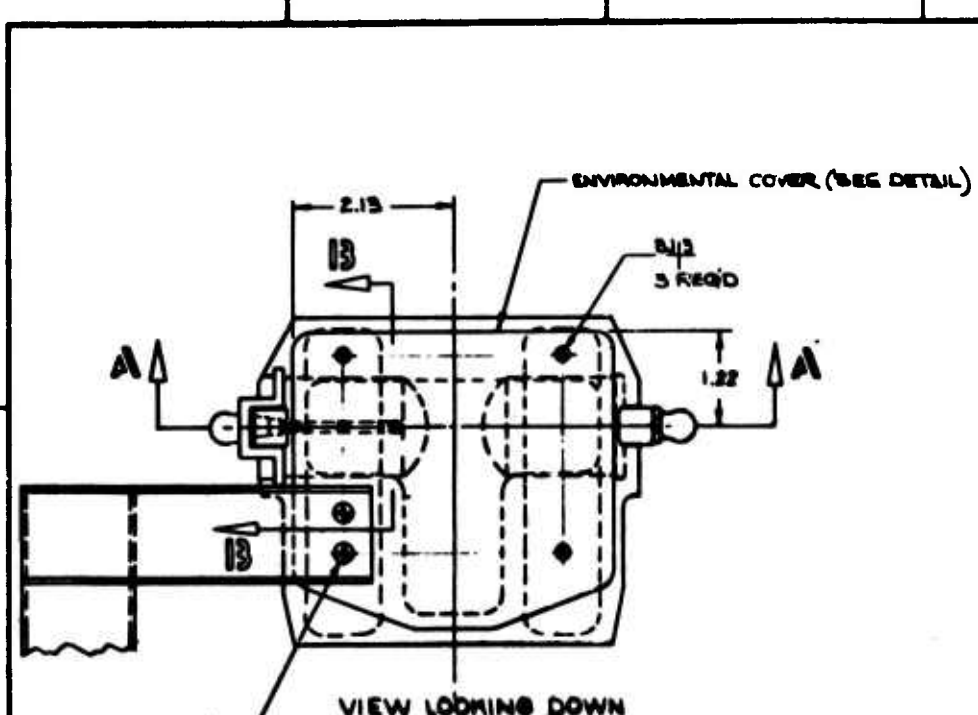
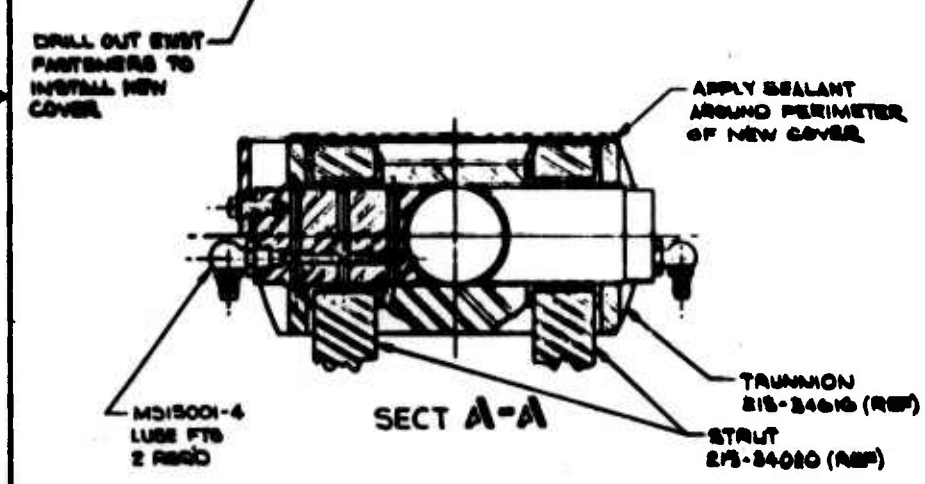
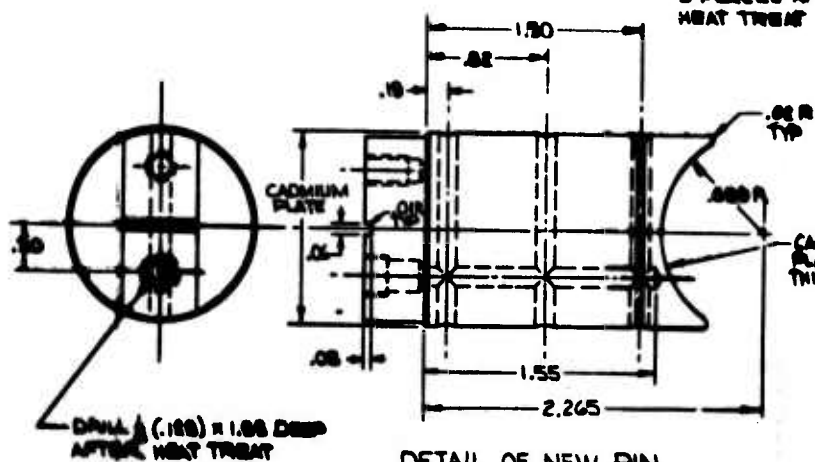
Galling and corrosion of pin on lower trunnion bearing surface.

DETAIL OF NEW PIN
SCALE: 2/1 ~ MATL: 4340 STL
(SEE CV21-564502 FOR DIMENSIONS & HOLE SIZES NOT SHOWN)
