TECOM PROJECT NO: 6-EE-TRC-117-005

PUBLICATION NO: USAEPG-FR-922

6 PRODUCT IMPROVEMENT TEST

RADIO TERMINAL SETS AN/TRC-117/151 AND AN/TRC-145

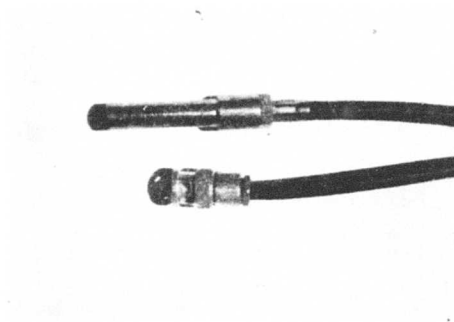
Figure 7. Old connector (left)  
and new connector (right)

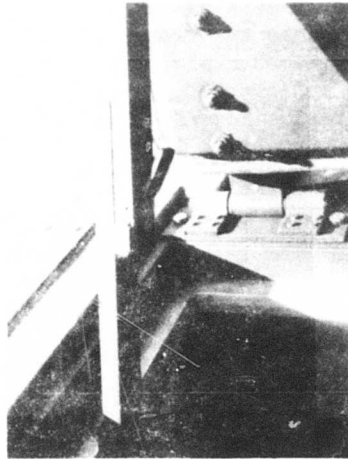
Figure 9. Door locked with  
locking device.
