Report No. 131500-603  
14 January 1977

INTERIM TEST REPORT  
ON THE SHOCK-DROP TEST  
OF THE  
AN/TRN-41 TACAN NAVIGATIONAL SET

✓ Contract No. F19628-75-C-0200  
CDRL Item A00Y

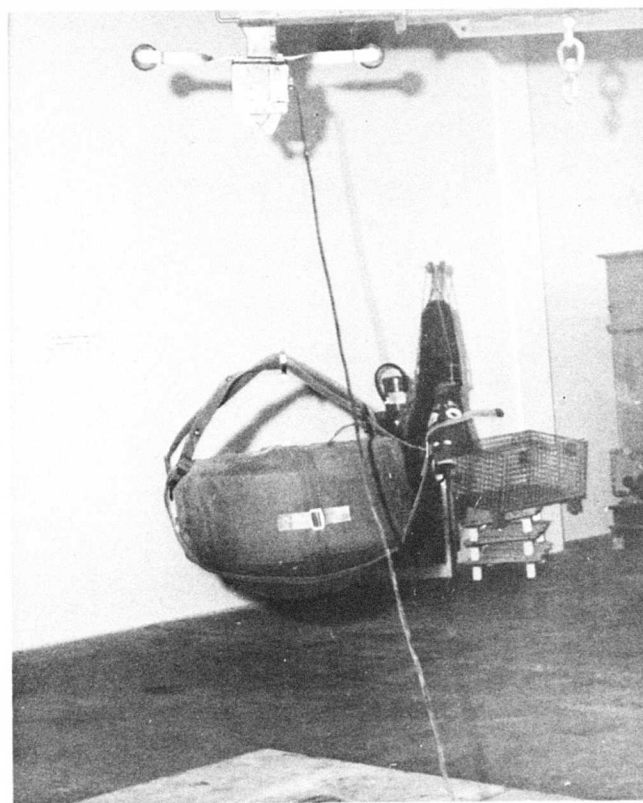
ANTENNA 48" DROP TEST

(1) The upper radome cracked.

(2) The lower radome cracked.

(3) Damage was done to the 15 Hz and 135 Hz rotating drums, caused from making contact with the radome.

(4) Pedestal base broke.

b. Antenna Unit. The antenna unit incurred damage with two types of drops. First, an angular drop on the upper radome such that the radome was deformed, damaging the 15 Hz and 135 Hz rotating drums. Second, the angular drop on the lower portion cracked the pedestal and lower radome.

The antenna pedestal was redesigned by removing the compass and reducing its height. A nylon ring was added to the top of the radome to mount the compass during alignment. At all other times, the compass will be with the ancillary equipment. The design of the compass will change from the north seeking type to a 360° type - it will be the same compass that is used in the AN/TRN-26 system. The reduction in height of the pedestal allows the packing to be arranged so that the center of gravity is closer to the man's back.

The smaller pedestal is packed so that the drop shock is not concentrated on the flange of the pedestal, but distributed over the lower section of the antenna.

The upper radome was strengthened by adding two plies of fiberglass across the sides and top of the radome. This strengthening now prevents the radome from touching the 15 Hz and 135 Hz rotating drums.

The packing design effectively increases the density of the pack around the antenna. This was accomplished by sandwiching 1/2-inch polyethylene with polyurethane. Around the base, the polyethylene was 1-inch thick. In addition, a 1/2-inch polyethylene sheet was placed completely around the circumference of the antenna replacing the existing polyurethane. The interior dimensions remained the same and the same canvas pack was used.

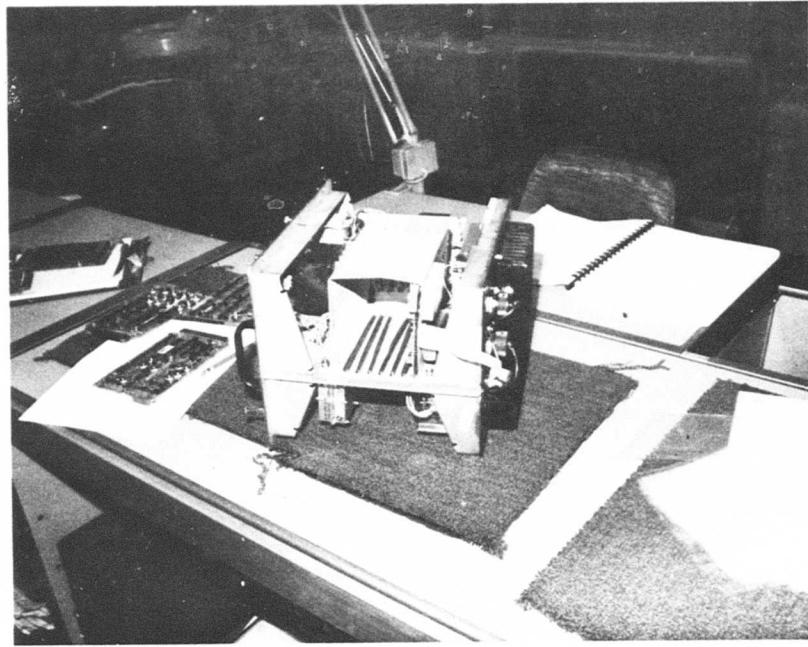
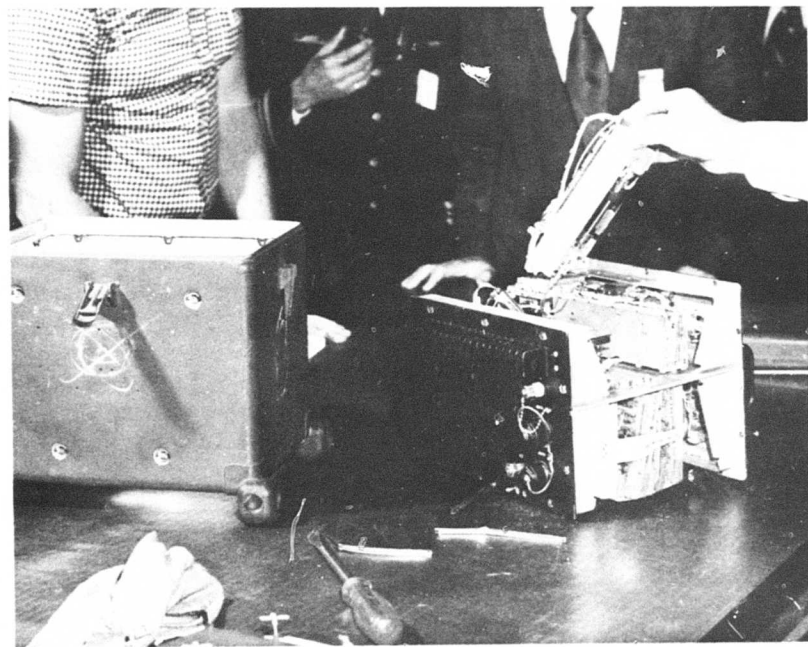
RT AFTER 48" DROP TEST

(1) Rubber bumper blocks. These blocks failed to protect the RT on the rear heat sink side. The blocks were not large enough, which allowed the heat sink to hit the floor, causing a severe shock to the RT.

(2) Card Rack. The card rack securing the seven circuit card assemblies deformed badly. All of the connectors used in securing the circuit cards broke; the card guides became twisted and deformed, and all circuit cards became loose.

(3) Synthesizer Chassis. The mounting flanges on this assembly broke off; therefore, this assembly became loose and caused major secondary damage.

a. Receiver-Transmitter (RT) Unit. The RT unit incurred major damage when it was dropped on the rear surface that mounts the heat exchanger. The rubber bumpers permitted the heat exchanger to strike the plywood floor with enough force to have an imprint of the exchanger on the floor. This severe shock deformed the rear of the case, broke the mounting of the synthesizer allowing it to float in the unit, and deformed the card cage so that the printed circuit cards became loose.

The rubber bumper blocks originally provided 1/8 inch clearance to the heat exchanger. This clearance has been increased by 1/2 inch and the area of these bumpers increased from 3.5 square inches to 9.0 square inches. The increase in depth and surface areas will prevent the heat sink from bottoming during drops.

The card rack has been redesigned to provide more rigidity so that the rack does not spring out of shape, allowing the cards to become loose and breaking the connectors. To increase the rigidity of the case, the aluminum composition and temper were changed, the rear connector plate was redesigned to one piece fastened to the side and top of the case, and the new front cover adds rigidity to the case by fastening to the sides at four places, in addition to supporting the printed circuit cards.

The synthesizer casting was redesigned to provide more rigidity and support at the top of the unit. The thickness of the mounting flange was increased to 1/16 inch and two bosses were added at the top of the casting to fasten to the braces. Braces were installed at the top of the unit from the front to the rear to provide support for the synthesizer and receiver.
