AFML-TR-78-160  
Volume I

## **COST EFFECTIVE REPAIR TECHNIQUES FOR TURBINE AIRFOILS**

GENERAL ELECTRIC COMPANY

TECHNICAL REPORT AFML-TR-78-160, Volume I

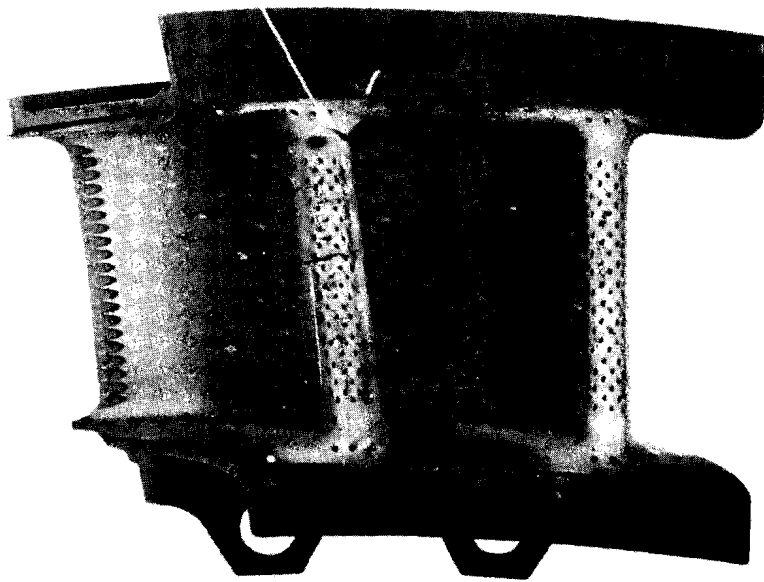
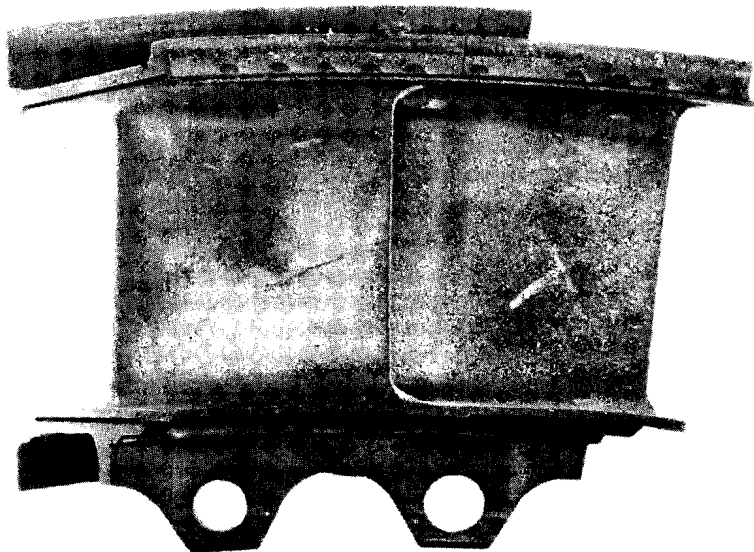
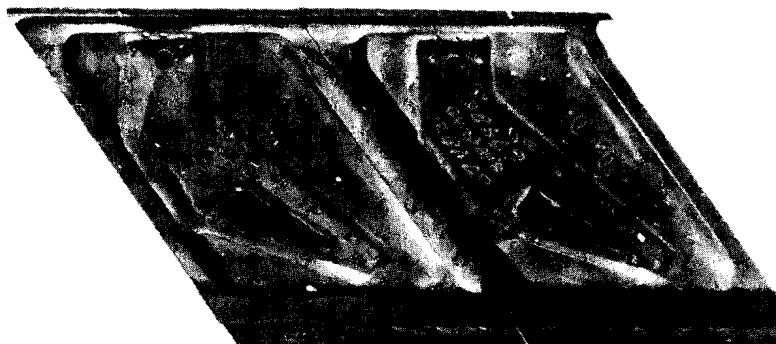
Figure 10. TF39 Stage 1 HPT Vane at Incoming Inspection

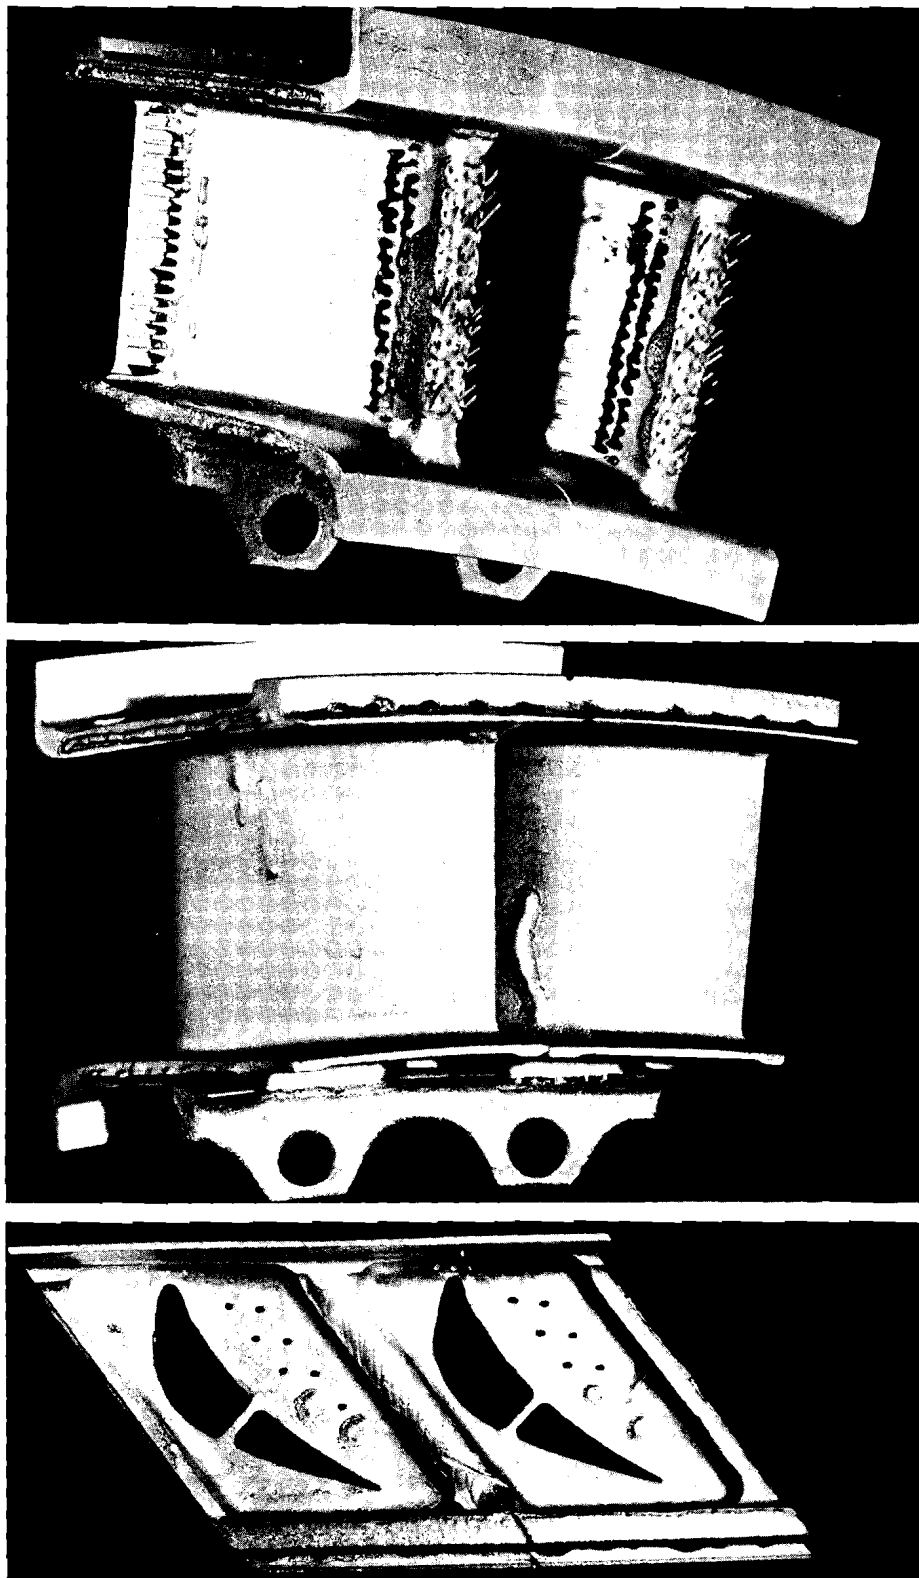
- TOP VIEW - VANE LEADING EDGE. (NOTE QUARTZ PINS IN LEADING  
EDGE COOLING HOLES)
- MIDDLE VIEW - VANE TRAILING EDGE (NOTE FLANGE BUILDUP)
- BOTTOM VIEW - VANE OUTER PLATFORM (NOTE FLANGE BUILDUP)

Figure 12. As ADH Repaired Condition of X-40 Engine Run  
TF39 Stage 1 HPT Vanes

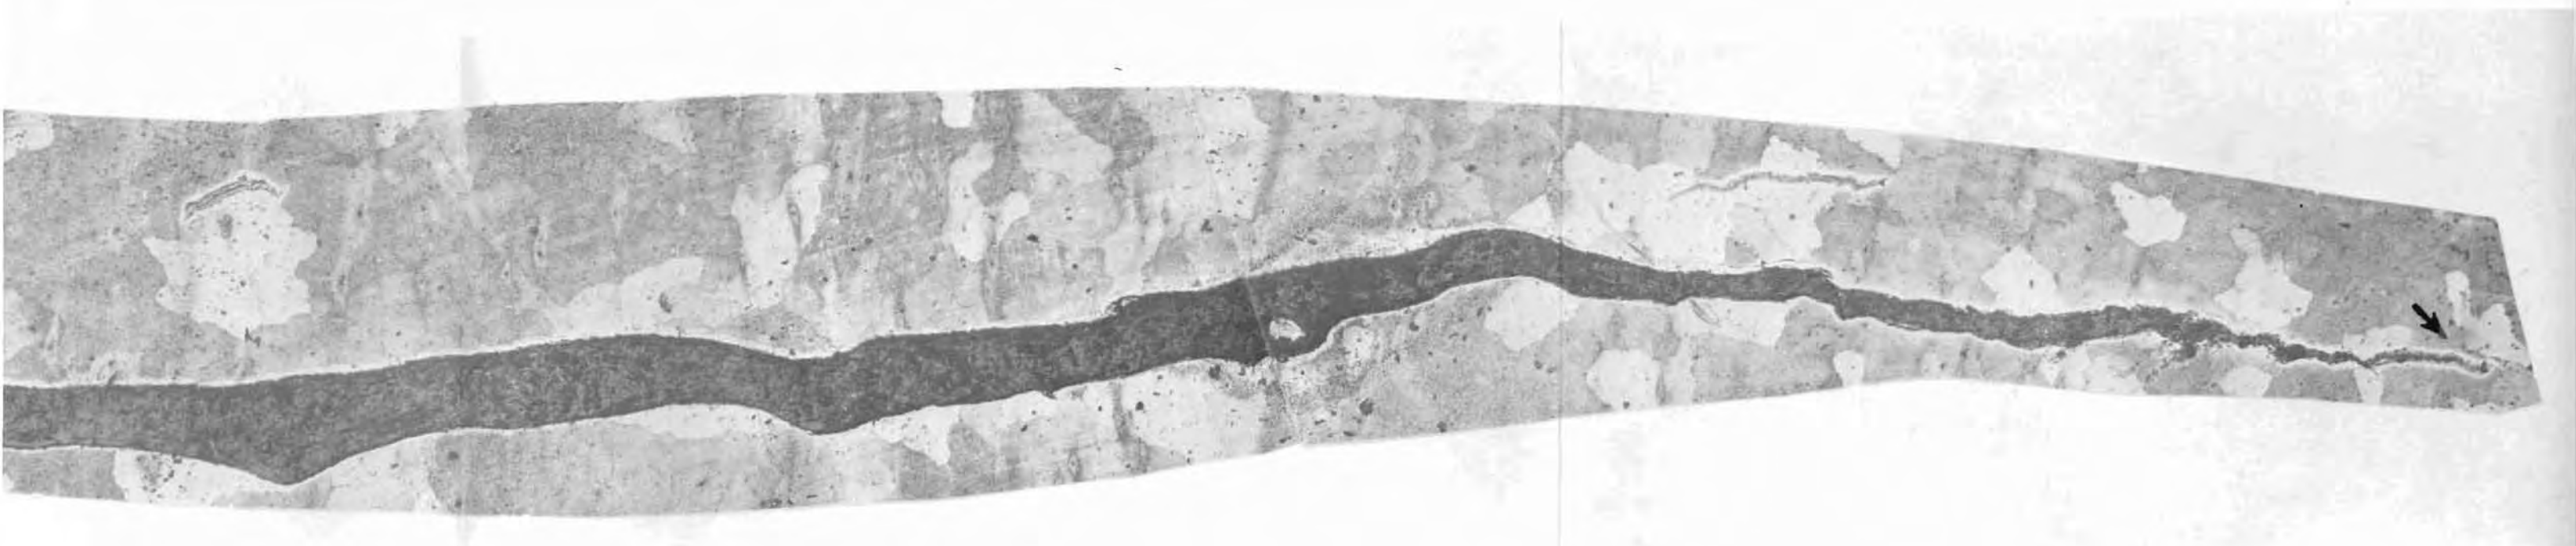
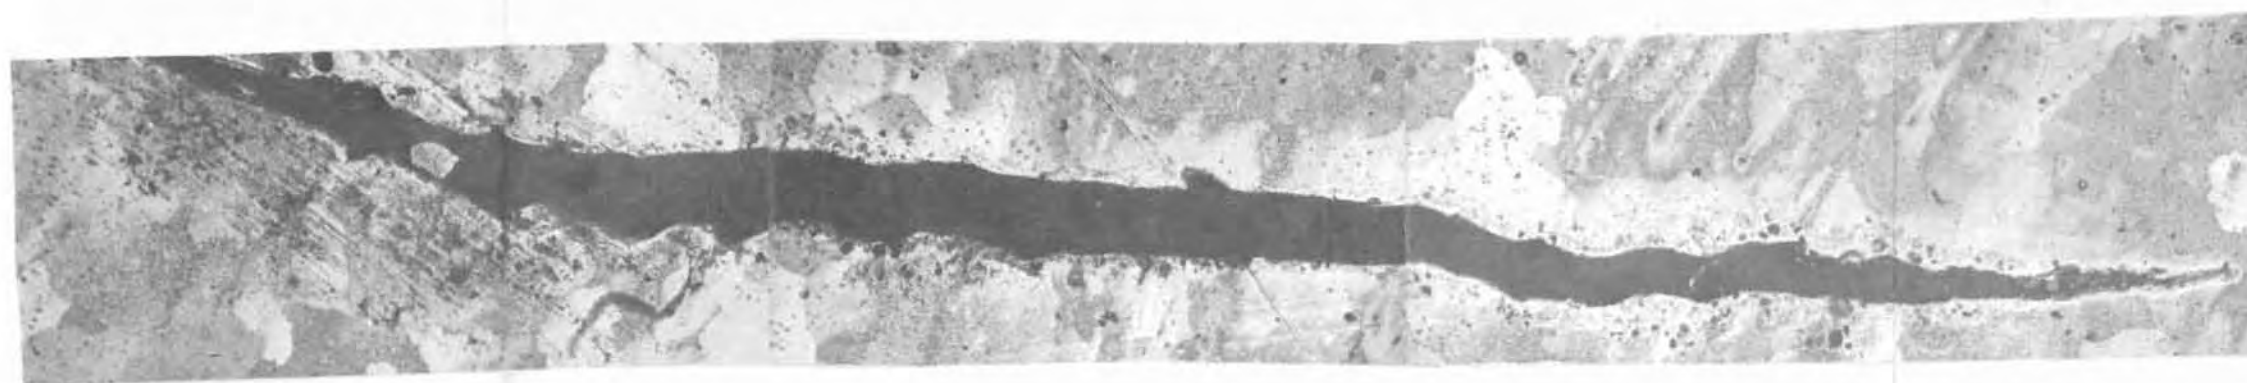
Figure 19. Photomicrograph of Rene' 80 Airfoil Crack After Fluoride Ion Cleaning at 1800°F/1 Hr

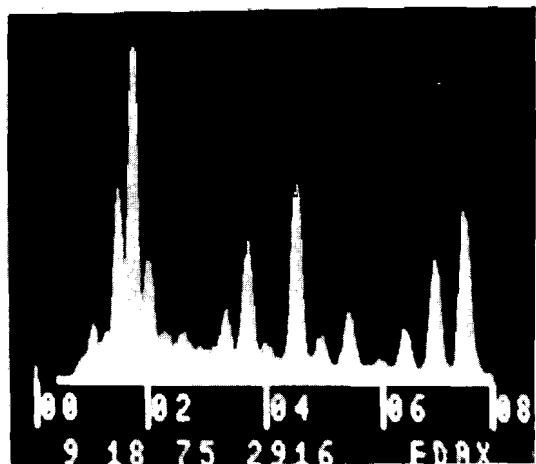
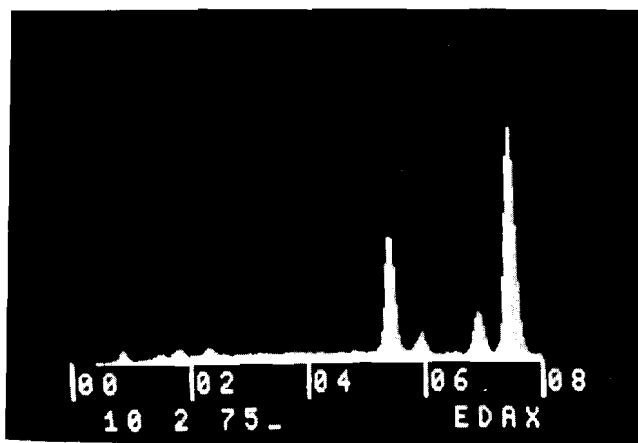
RENE' 80 CRACK SURFACE APPEARANCE. LEFT: AS ENGINE RUN,  
RIGHT: FLUORIDE ION CLEANED

Figure 25. SEM Analysis of Rene' 80 Crack Surface Before and After  
Fluoride Ion Clean
