USAAVSCOM TR-84-D-7

**OIL DEBRIS DETECTION SYSTEM (ODDS)**

**Wayne A. Hudgins**

**Final Report**

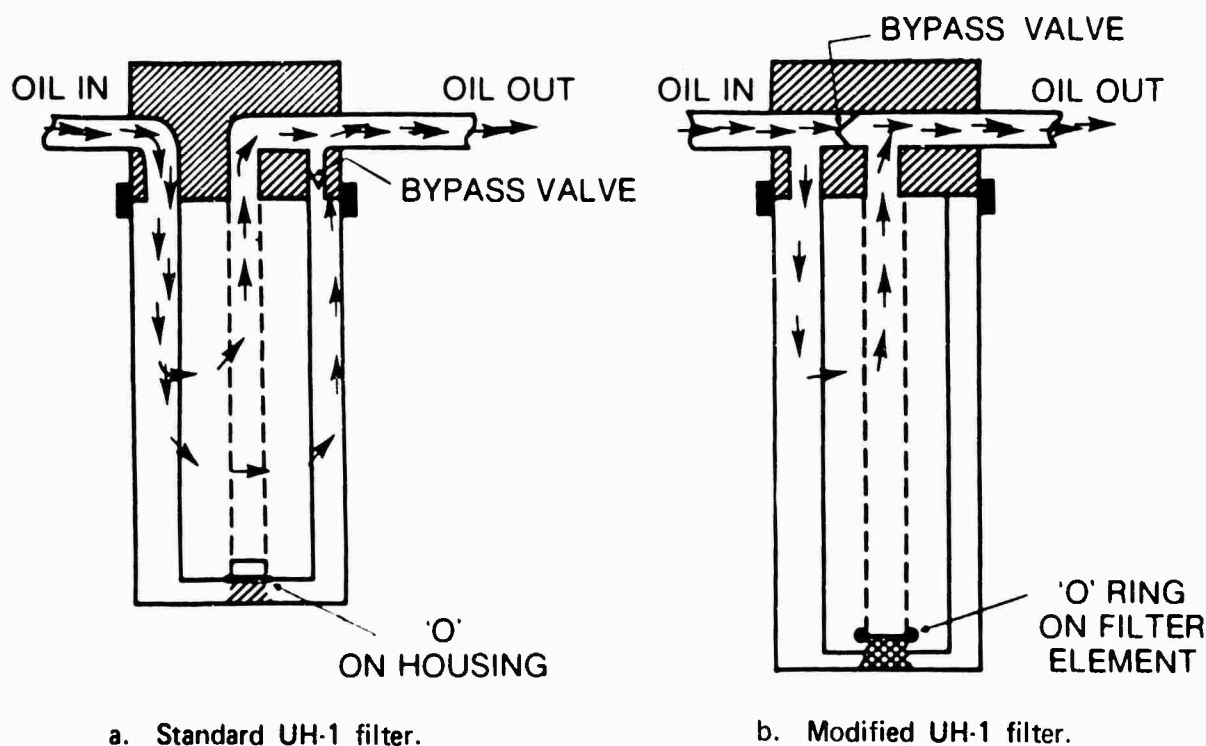
Chip light illuminations were being caused by an inadequate design of the filter housing bypass system which allowed debris to be reintroduced into the engine and transmission. This required substantial modification of the filter assembly; therefore, a separate study was performed to evaluate its characteristics. This evaluation showed that the filter housings allowed the cold-start bypass flow to pick up debris from the filter bowl and sweep it back into the system (see Figure 11). New filter housings with improved bypass design were procured and installed on the test fleet.

Figure 11. Filter improvement.

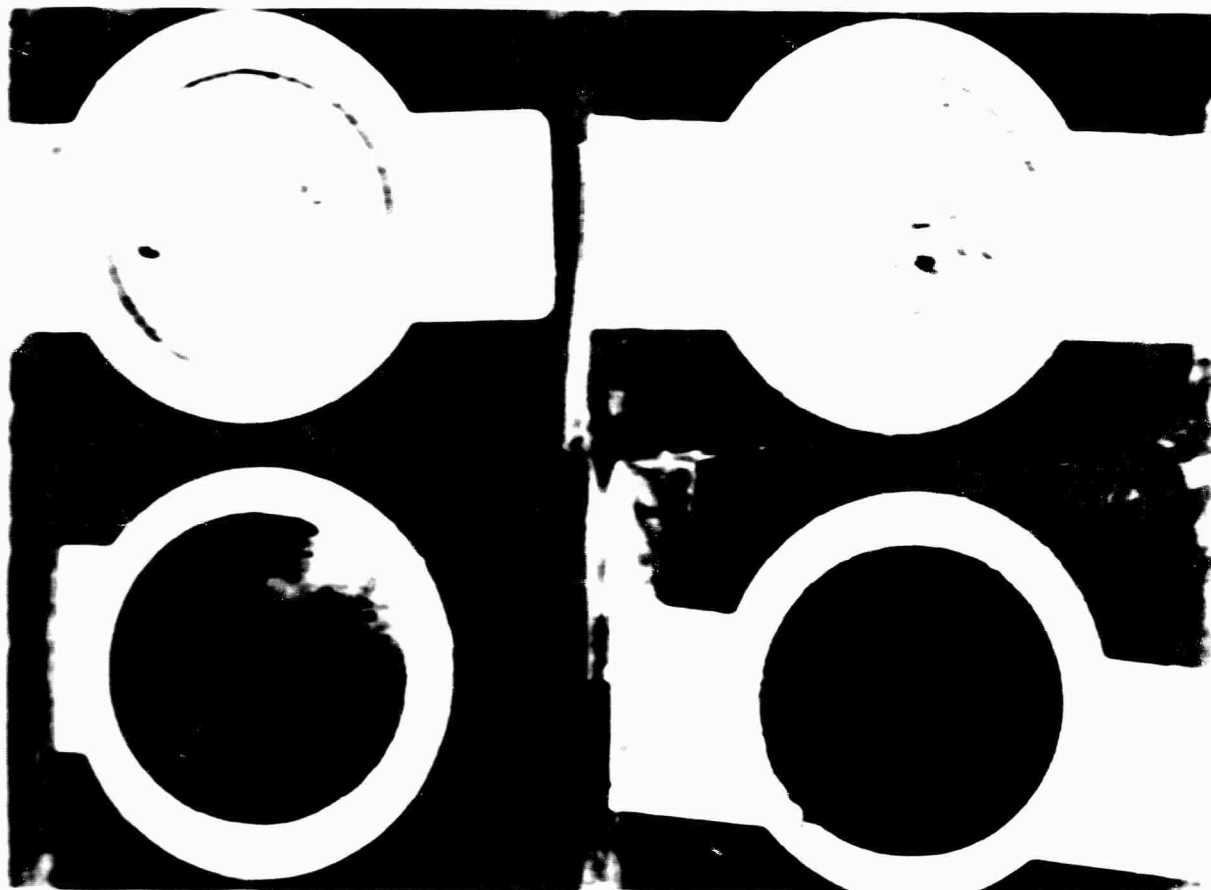
In several engines, it was found that the No. 21 engine bearing cage had failed. These engines were removed for inspection due to multiple chip light indications. Although the burn-off detector plugs did not reveal massive quantities of metal, special oil samples taken from the filter were microscopically examined and found to contain bronze particles; therefore, the engines were removed for metal contamination and inspected. Microscopic examination of oil samples was an established procedure when uncertainty existed with regard to quantity of particles on the detector. An example of a microscopic debris slide is shown in Figure 12.

Figure 12. Membrane filter debris slides.

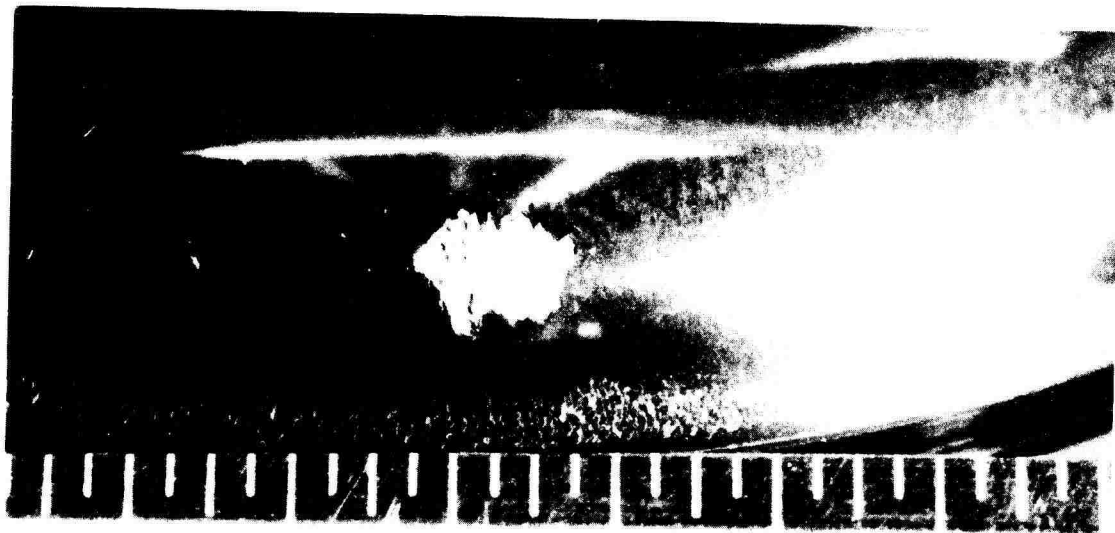
| DIR No. | Reason for removal | Component condition | Remarks |
|---|---|---|---|
| 6 | CD indications | Triplex bearing spalled | CD hit |

Figure A-1. Inner bearing race from DIR No. 6.

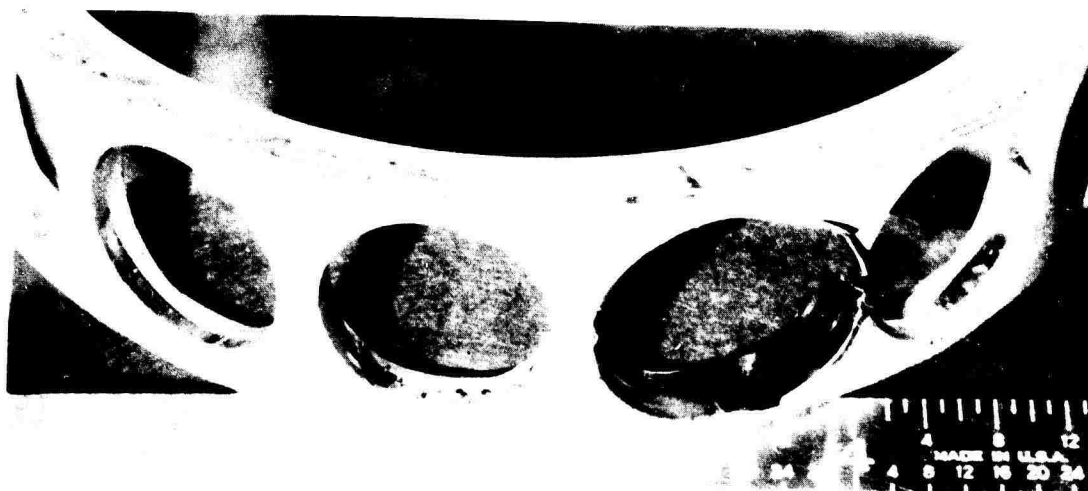
Figure A-2. Bearing retainer from DIR No. 6.

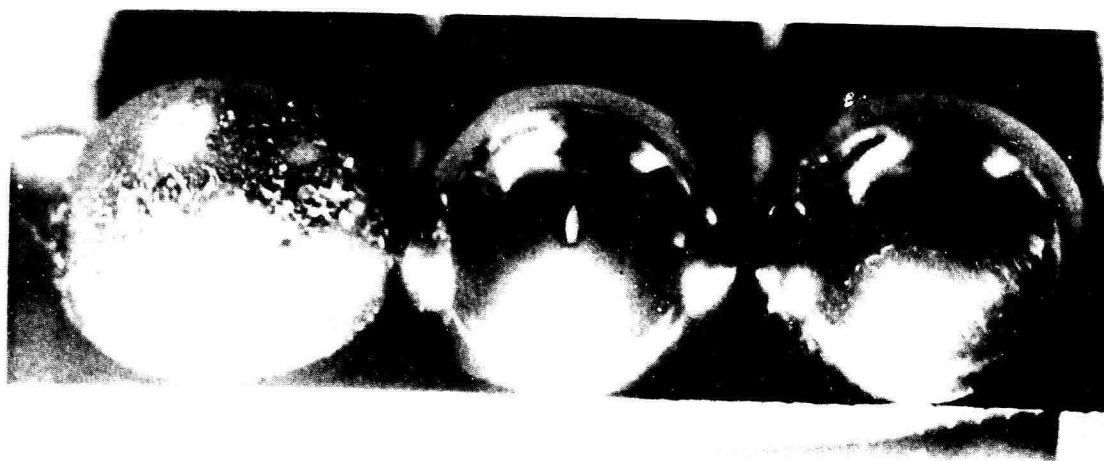
Figure A-3. Balls from bearing of DIR No. 6.

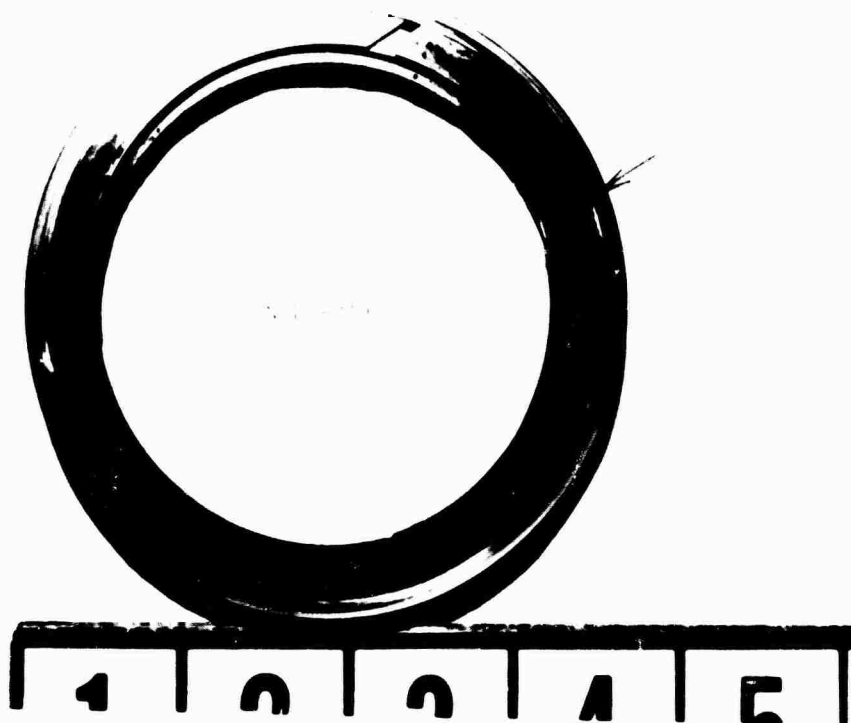
Figure A-7. No. 3 shaft seal from DIR No. 31.
