NRL Memorandum Report 5697

# Projectile Impact Effects on Aircraft Wire Harnesses

January 8, 1986

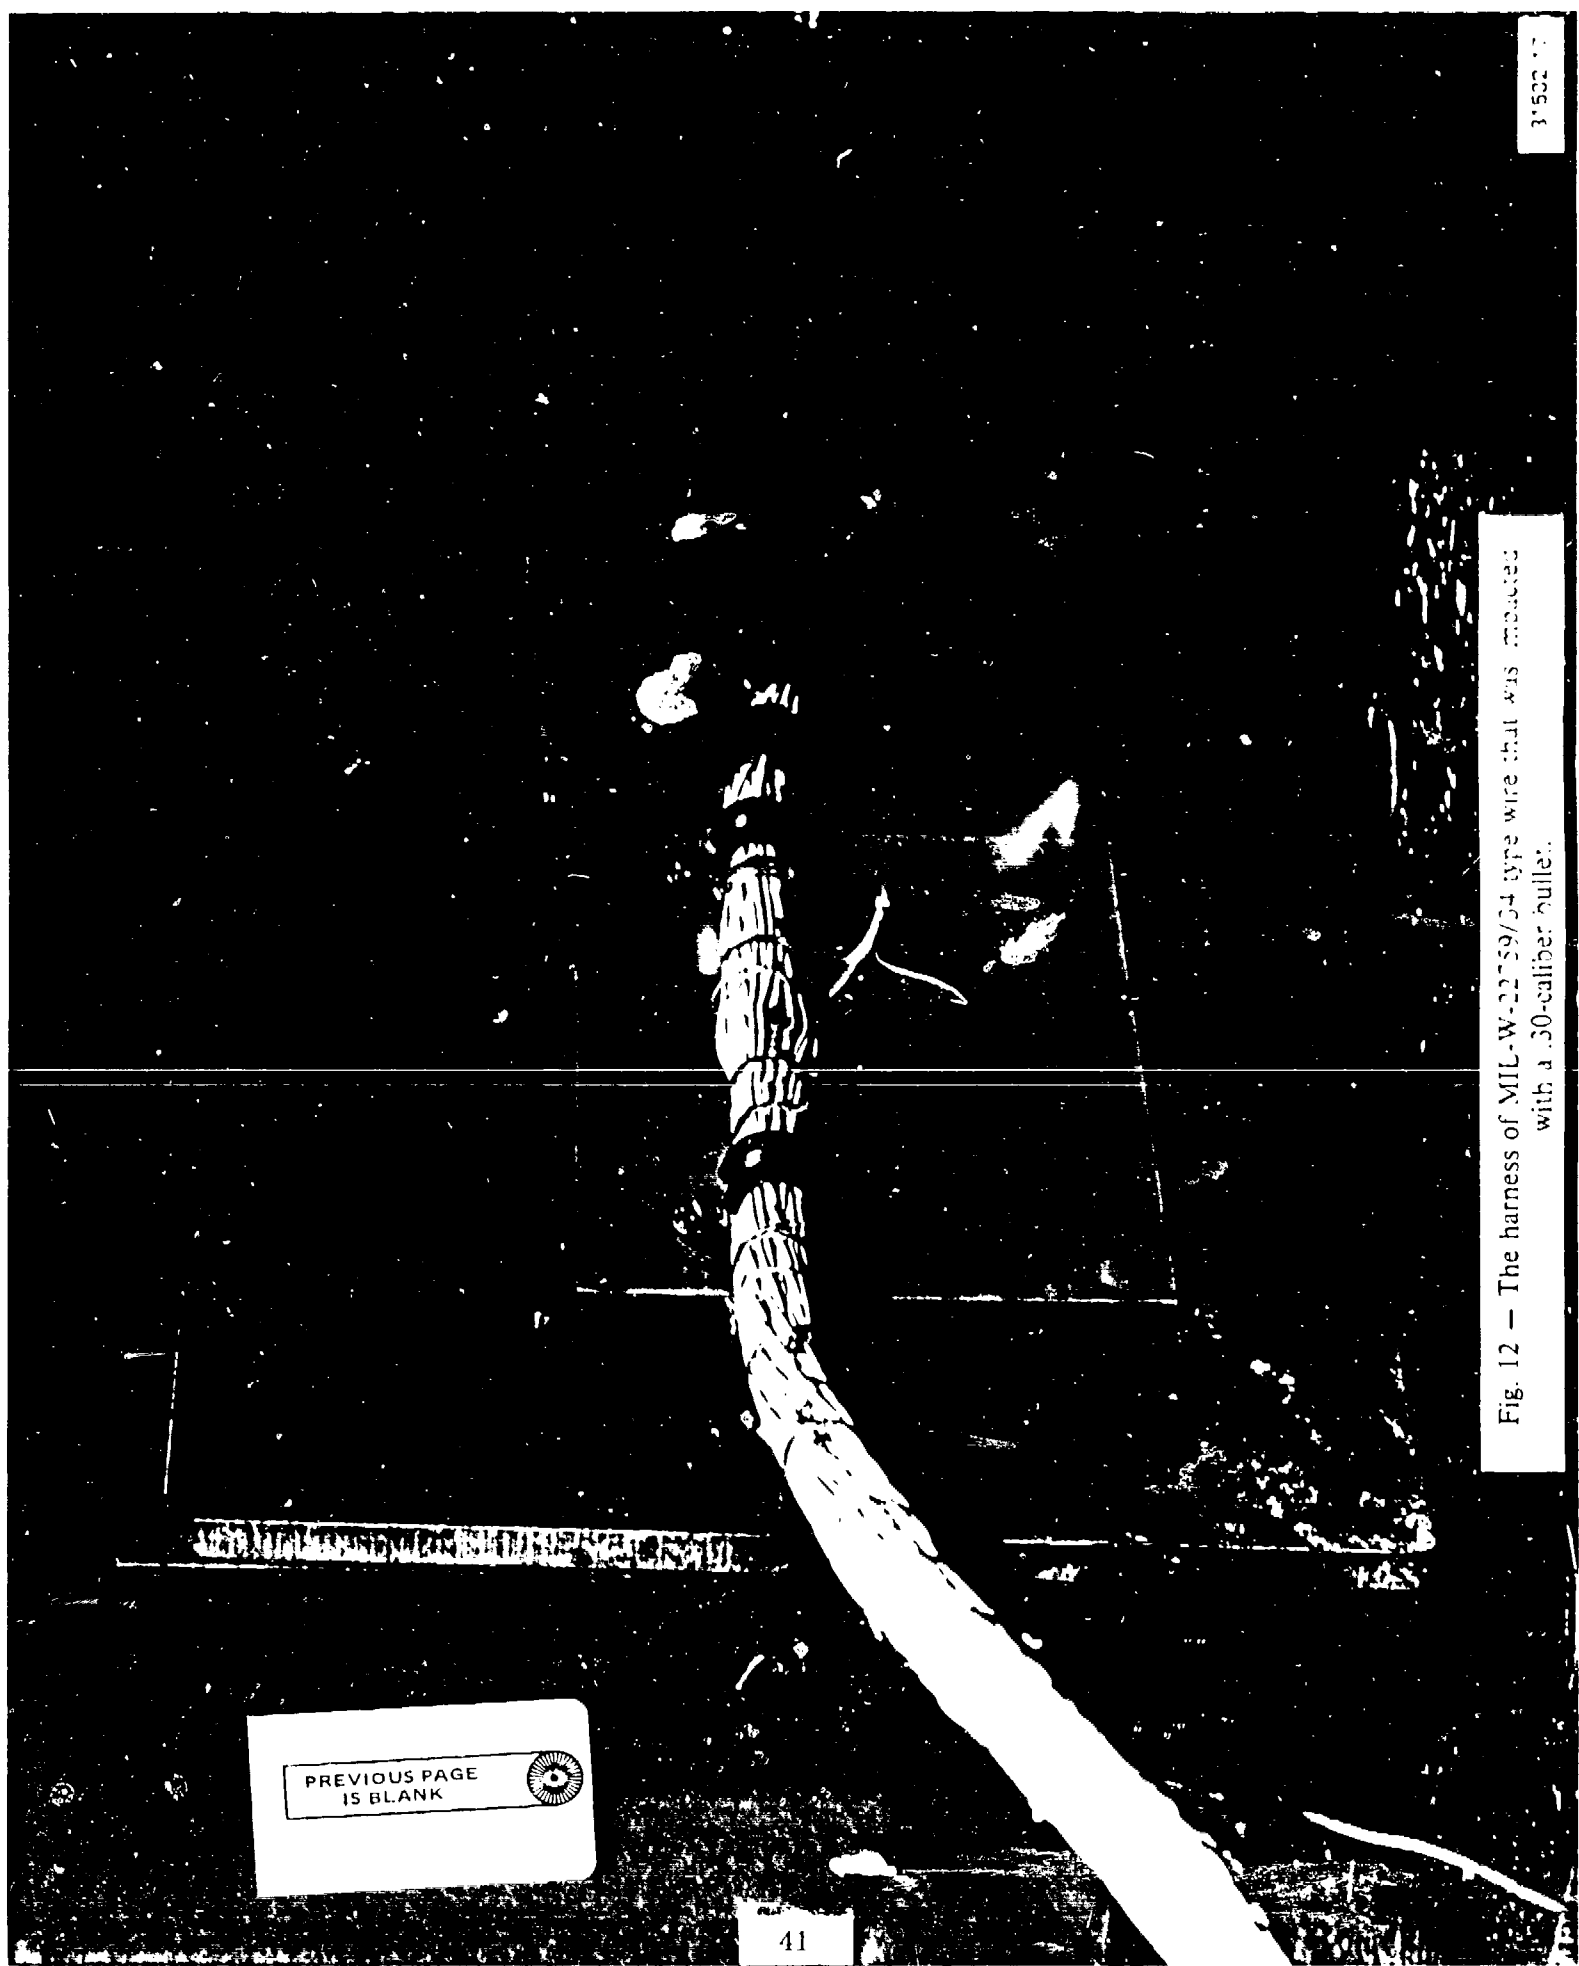
The projectile hit the midline of the harness. At the point of impact shown in Figure 12 it can be observed that at least one wire was severed, but no carbon formation can be seen and no circuit breakers were tripped.

Fig. 12 — The harness of MIL-W-2259/34 type wire that was impacted with a .30-caliber bullet.
