AFWAL-TR-89-2012

# IMPROVED FATIGUE LIFE BEARING DEVELOPMENT

June 1989

Final Report for Period September 1984 - December 1988

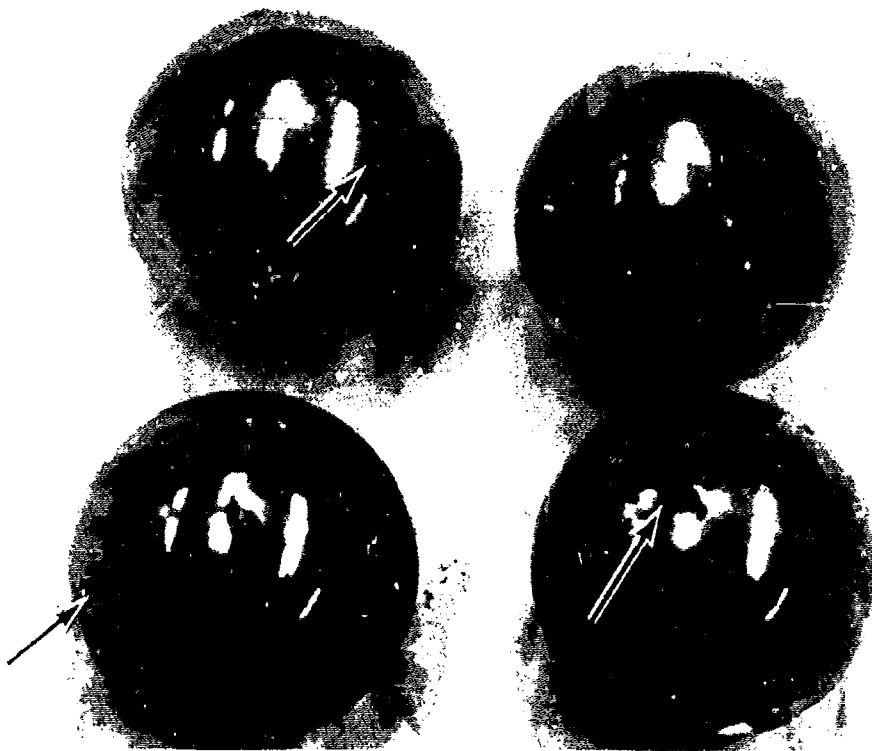
Figure 53. Balls from Bearing No. 6 After Corrosion Test.

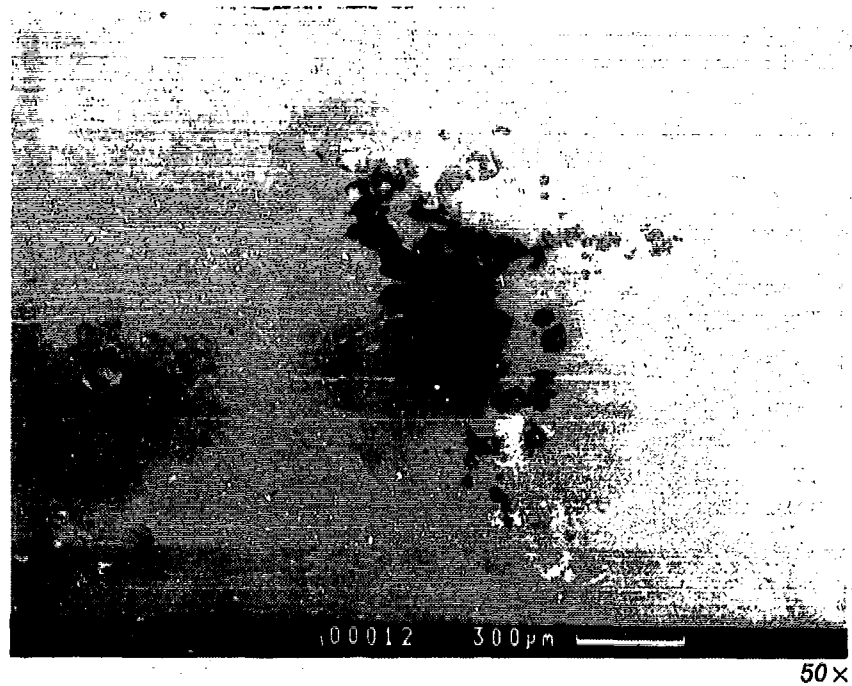
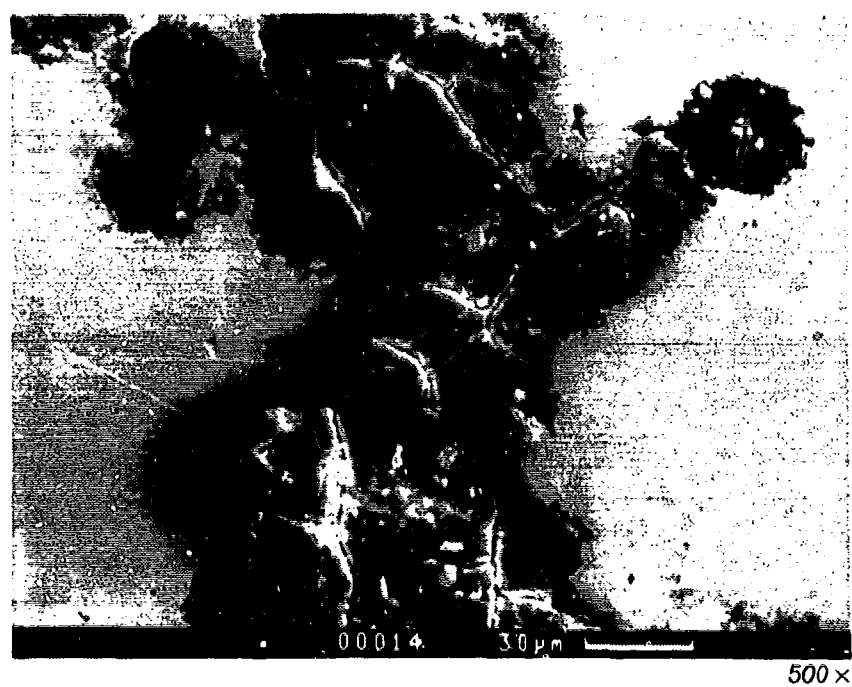
Figure 55. Corrosion Pitting on Ta<sup>+</sup> Implanted M50 Ball (Bearing No. 9 After 347 Hours). Note typical "mudcracking" in lower photo.

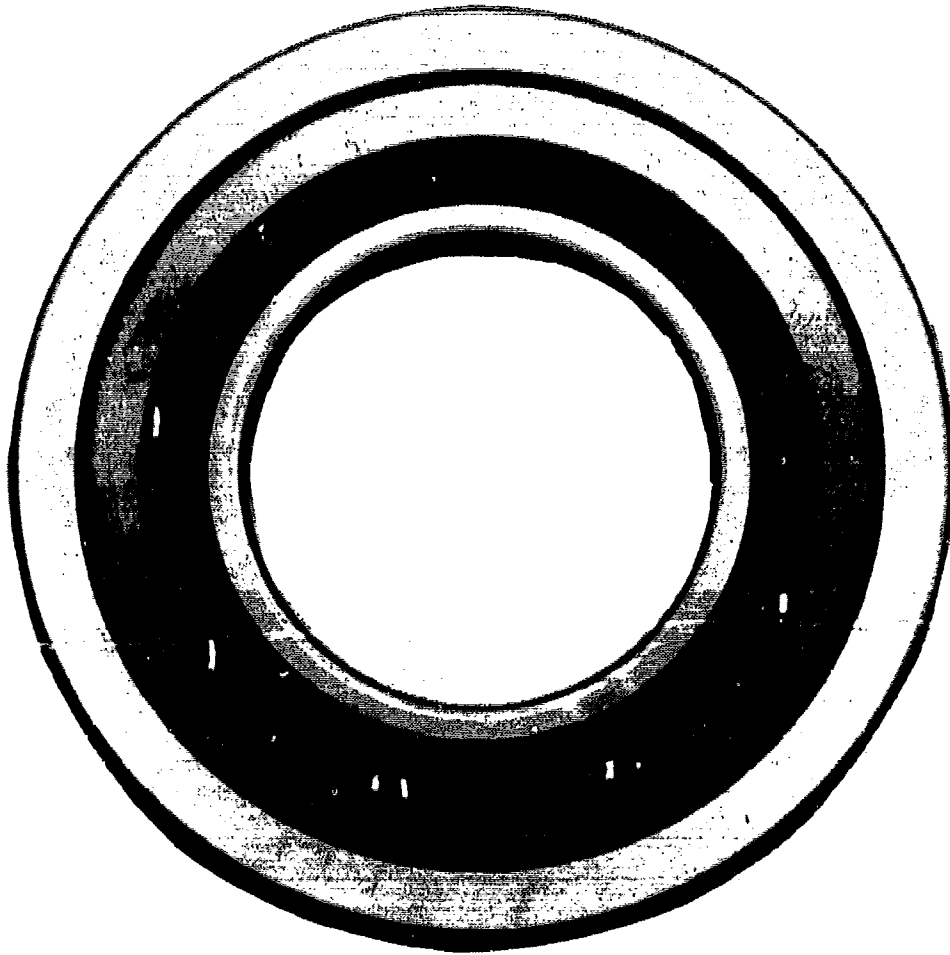
**Figure 57. Bearing No. 12 After Corrosion Test.**

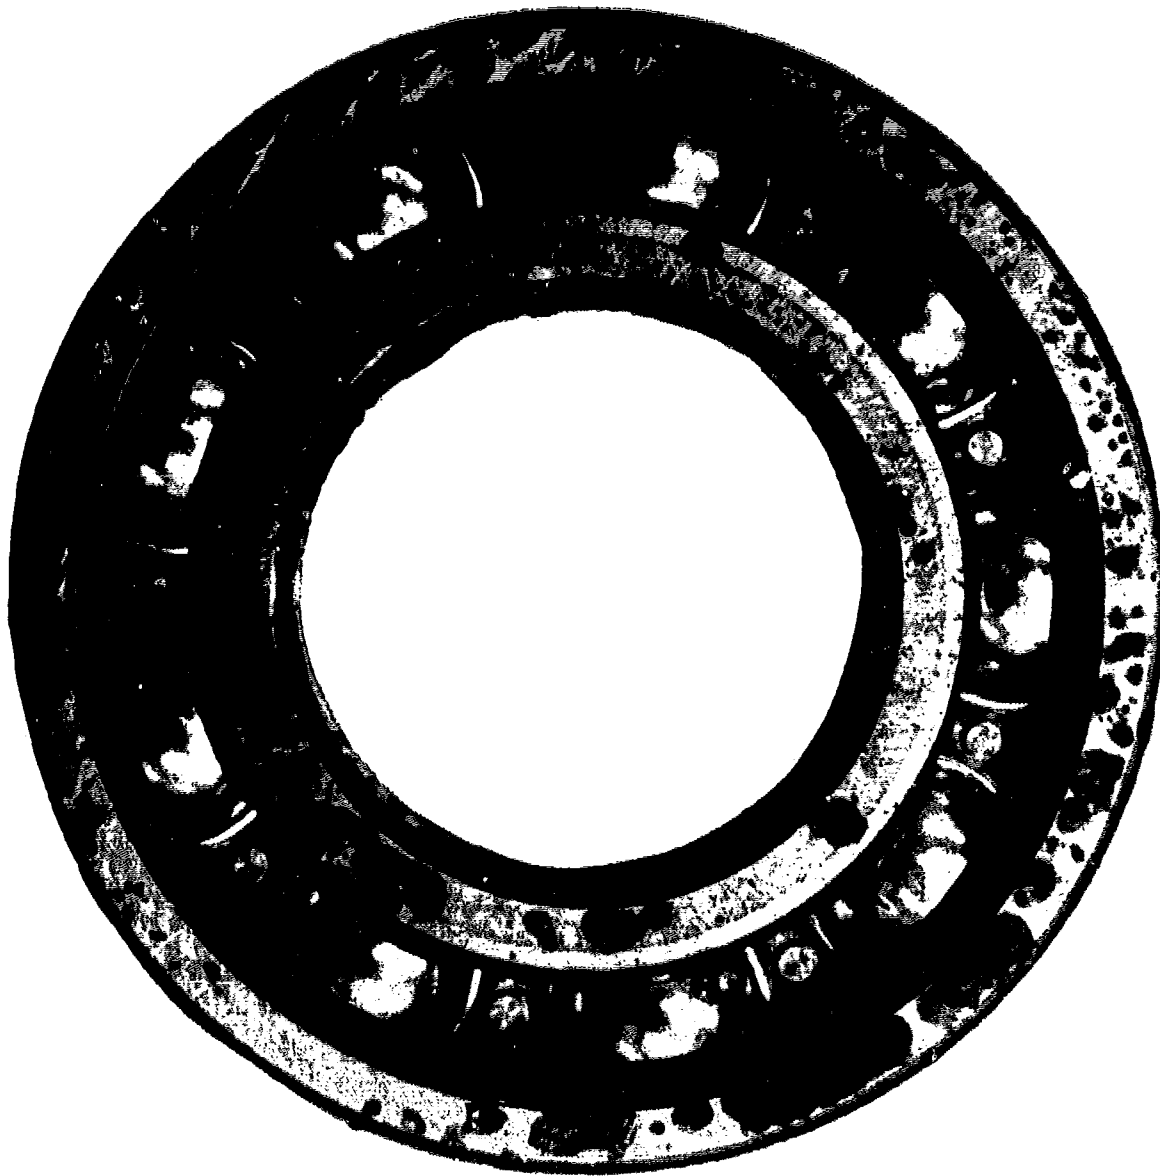
Figure 64. New, Uncoated Control Bearing After Corrosion Test.

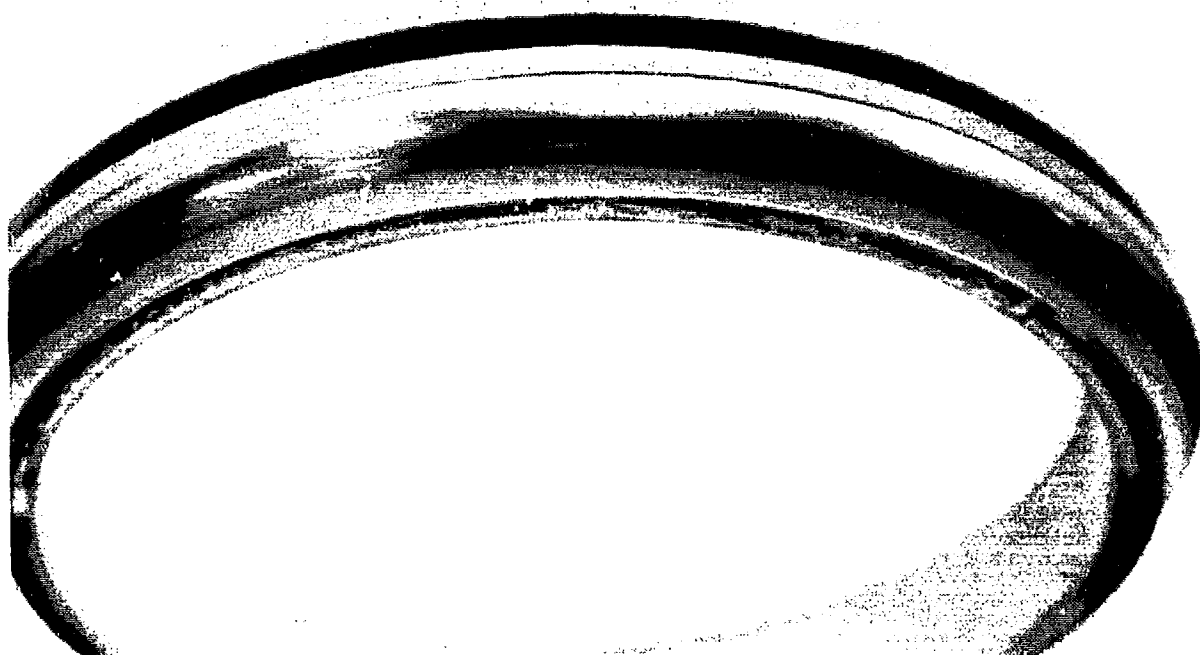
**Figure 75. Loaded Inner Ring (TDC Coated) of 133-mm Bore Bearing After Component Test.**
