NASA CR-72228

## 260-SL-3 MOTOR PROGRAM

VOLUME I: 260-SL-3 Motor Internal  
Insulation System

FINAL PHASE REPORT

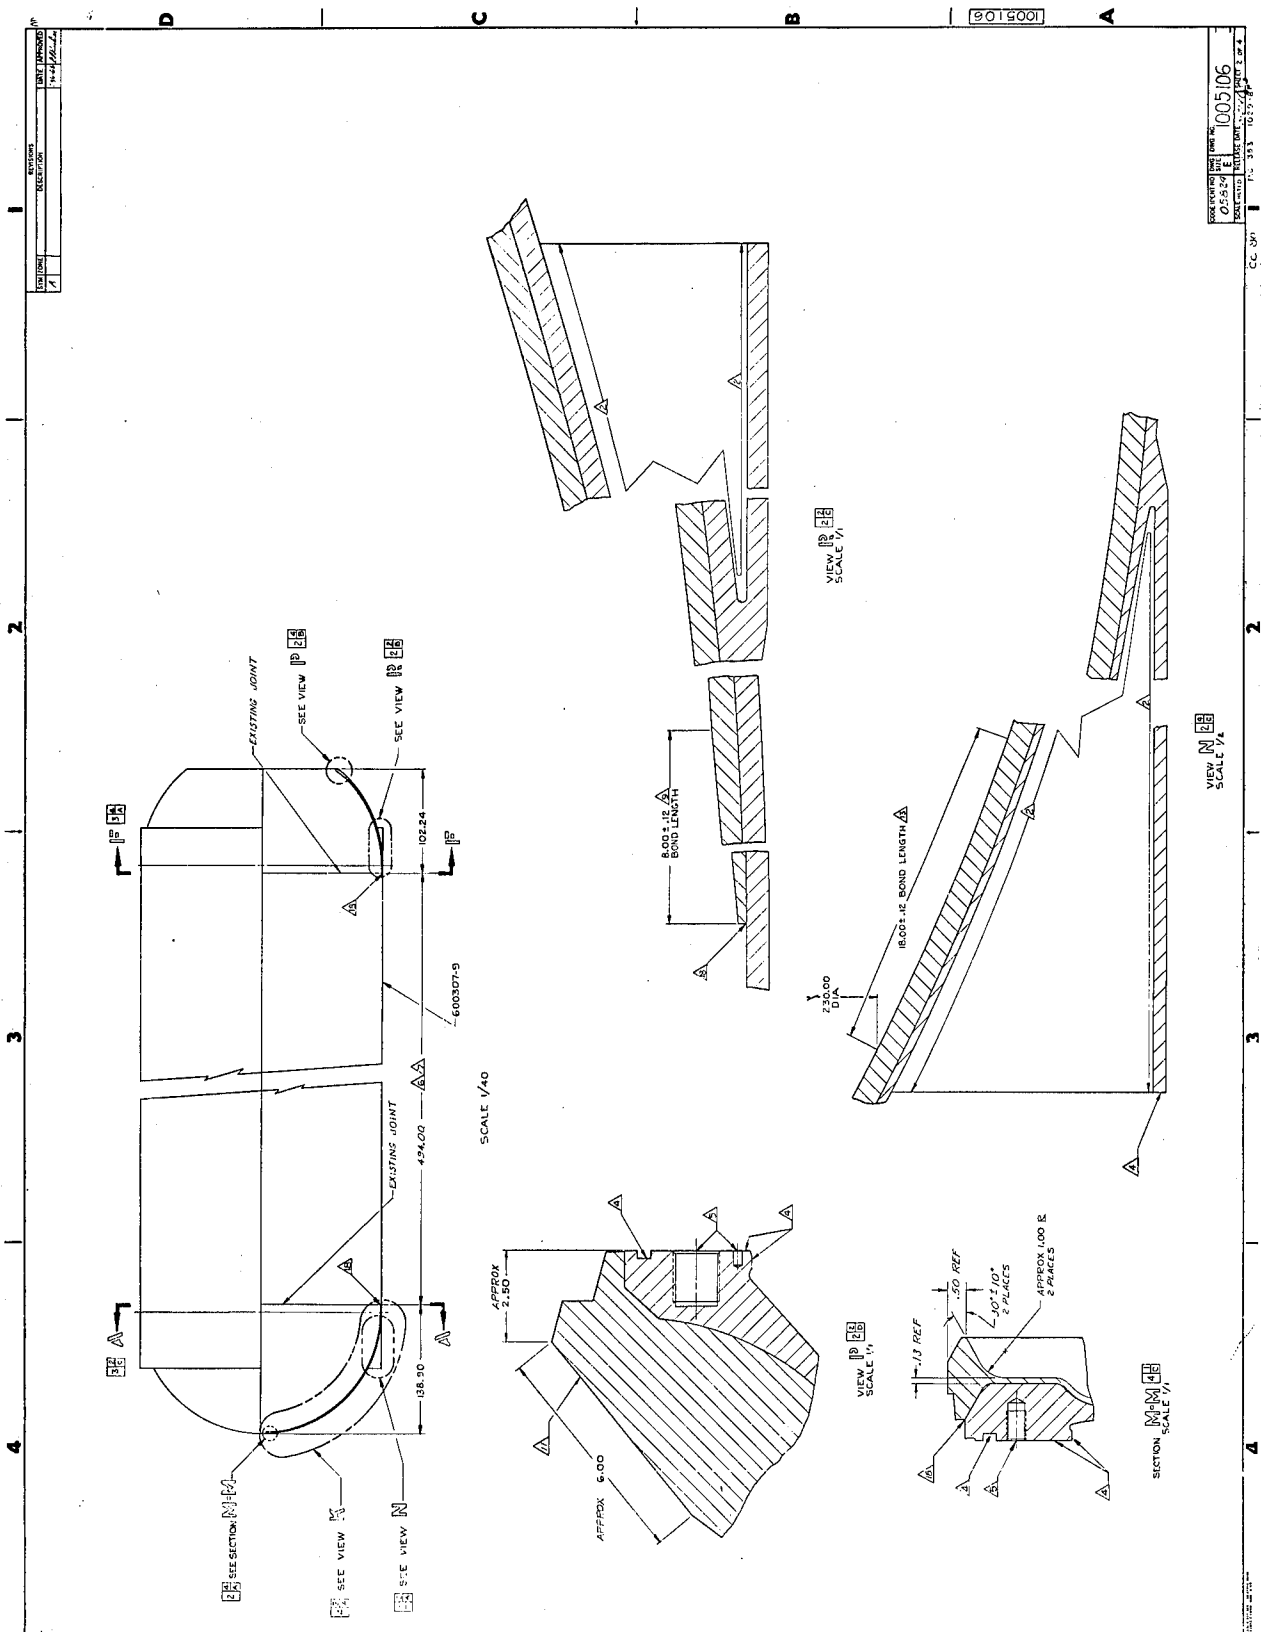
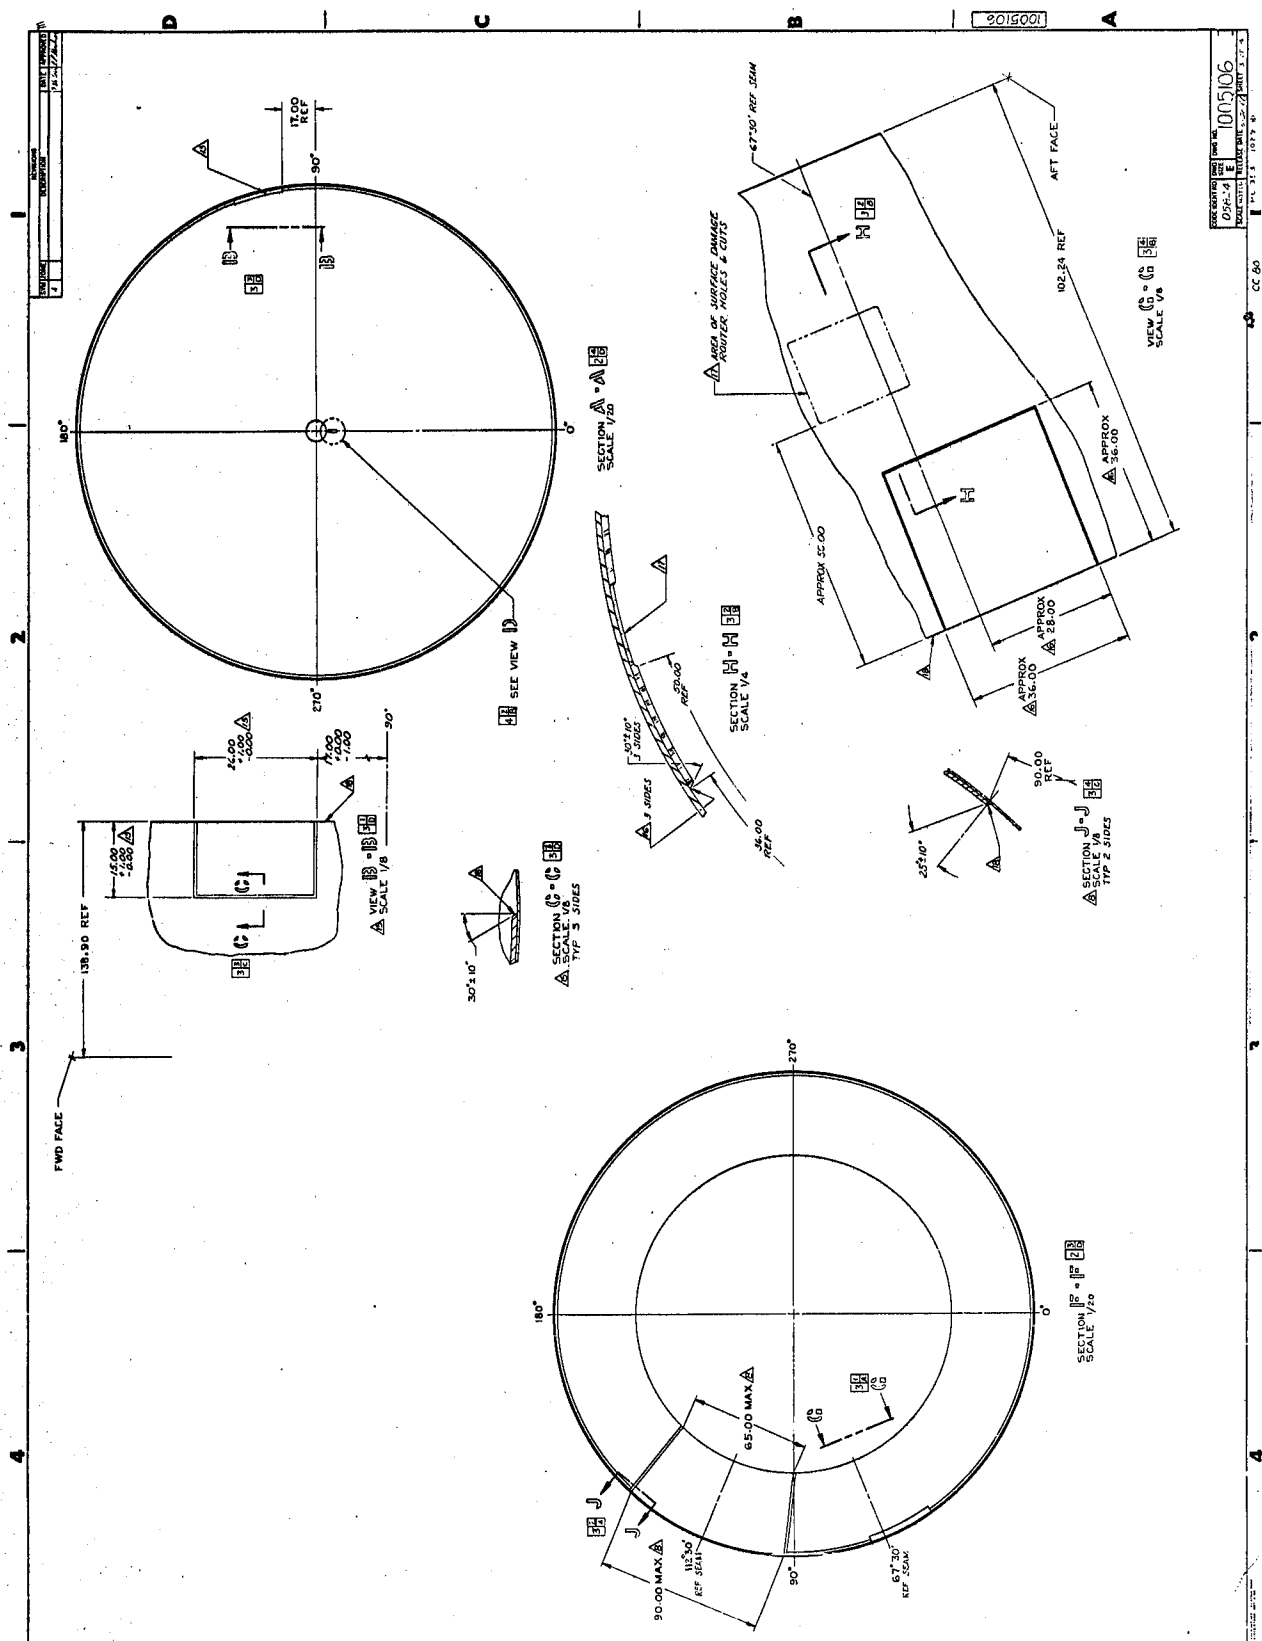
Figure 9, Sheet 2 of 4

Rehabilitated 260-SL Motor Case (S/N 001) for Motor 260-SL-3

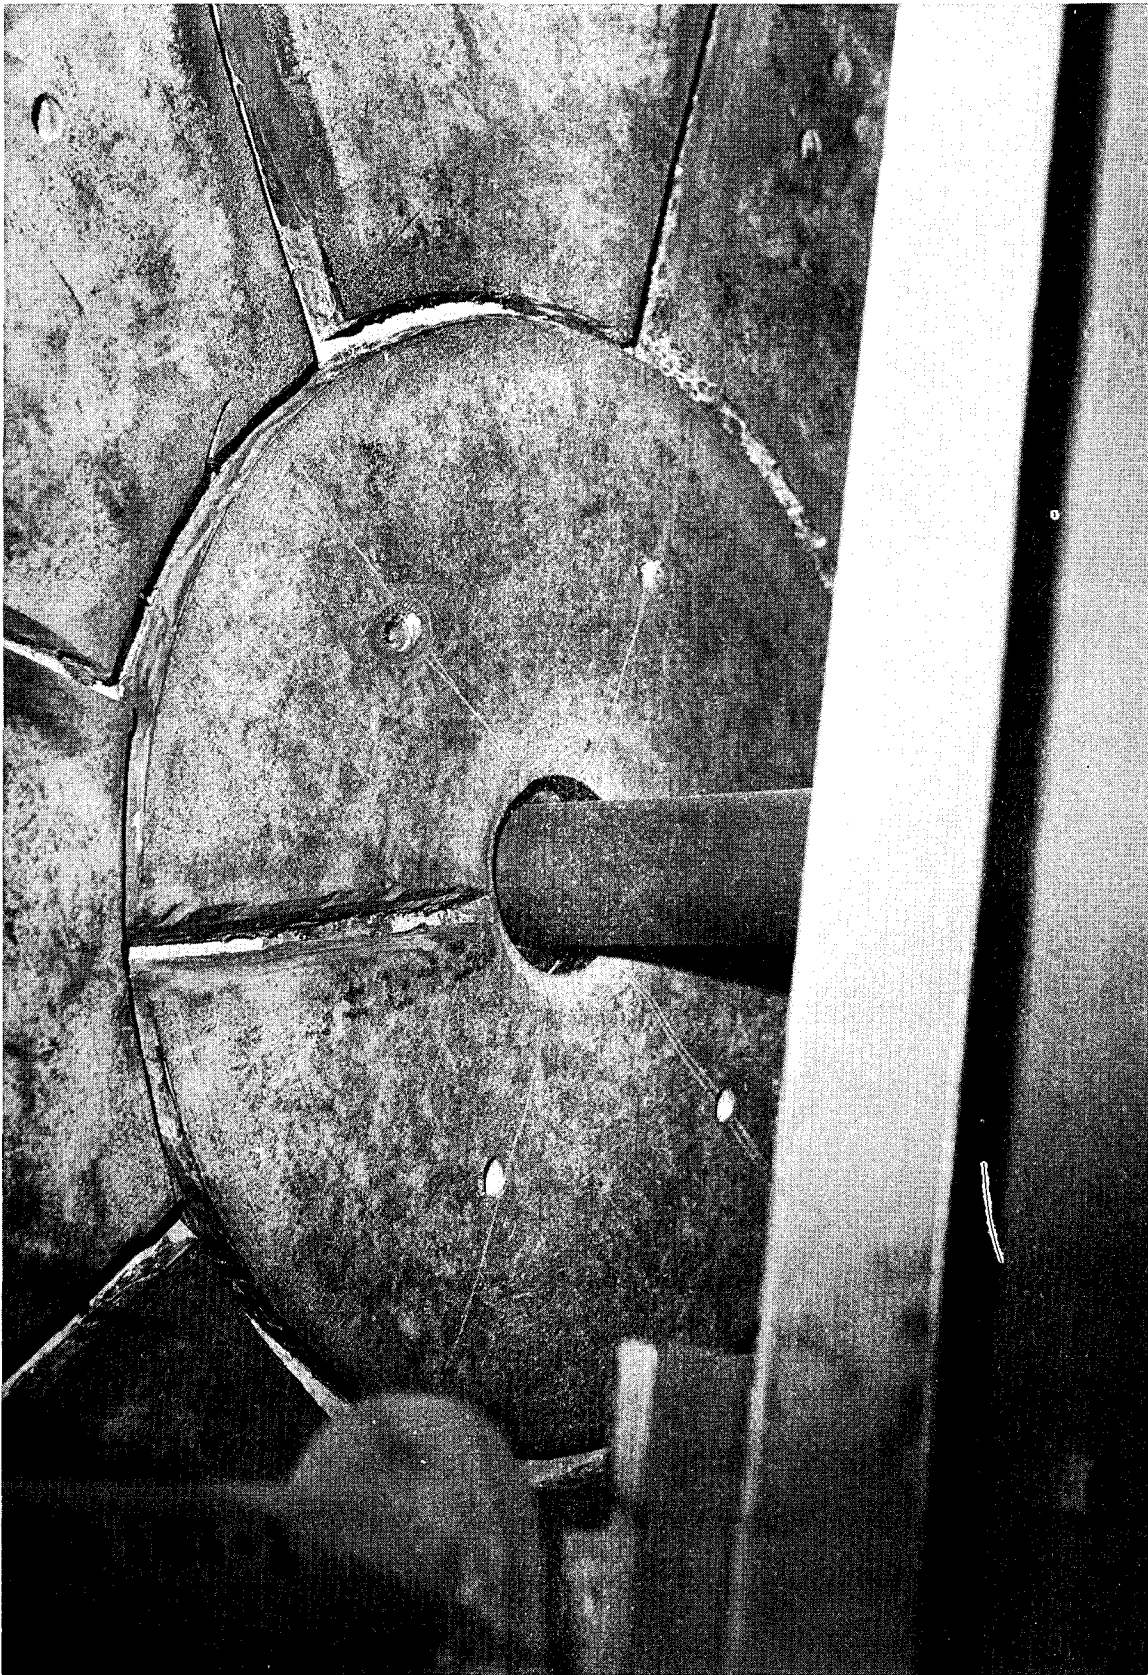
Figure 10

The first operation after the chamber was returned to the General Processing area was to remove the V-61 potting insulation from the forward and aft insulation segment V-grooves. This proved to be the most difficult operation. To use routers would be time consuming, and the use of electric saws presented the hazard of inadvertently contacting the metal surface. Hence, the material was manually removed by using rubber mallets and aluminum chisels. This technique resulted in cuts and gouges in the sides of the rubber V-groove, and total removal of the V-61 was not possible. A power sander was equipped with an aluminum saddle, extending approximately 0.13-in. beyond the abrasive wheel. The aluminum saddle was indexed on the chamber wall at the base of the V-groove and prevented the abrasive wheel from contacting the metal surface. This method was successful in removing almost all of the V-61 in the grooves. In inaccessible areas close to the chamber wall or where the V-groove base was narrow, traces of V-61 remained. Completed forward V-grooves are shown in Figures 10 and 11. After acceptance of V-61 removal, the metal at the base of the V-grooves was gritblasted to remove the primer, cleaned, and reprimed with Fuller 162-Y-22. In this limited access area, the primer was brush-applied to prevent contamination of the adjacent rubber.

Forward Insulation V-Grooves After V-61 Removal

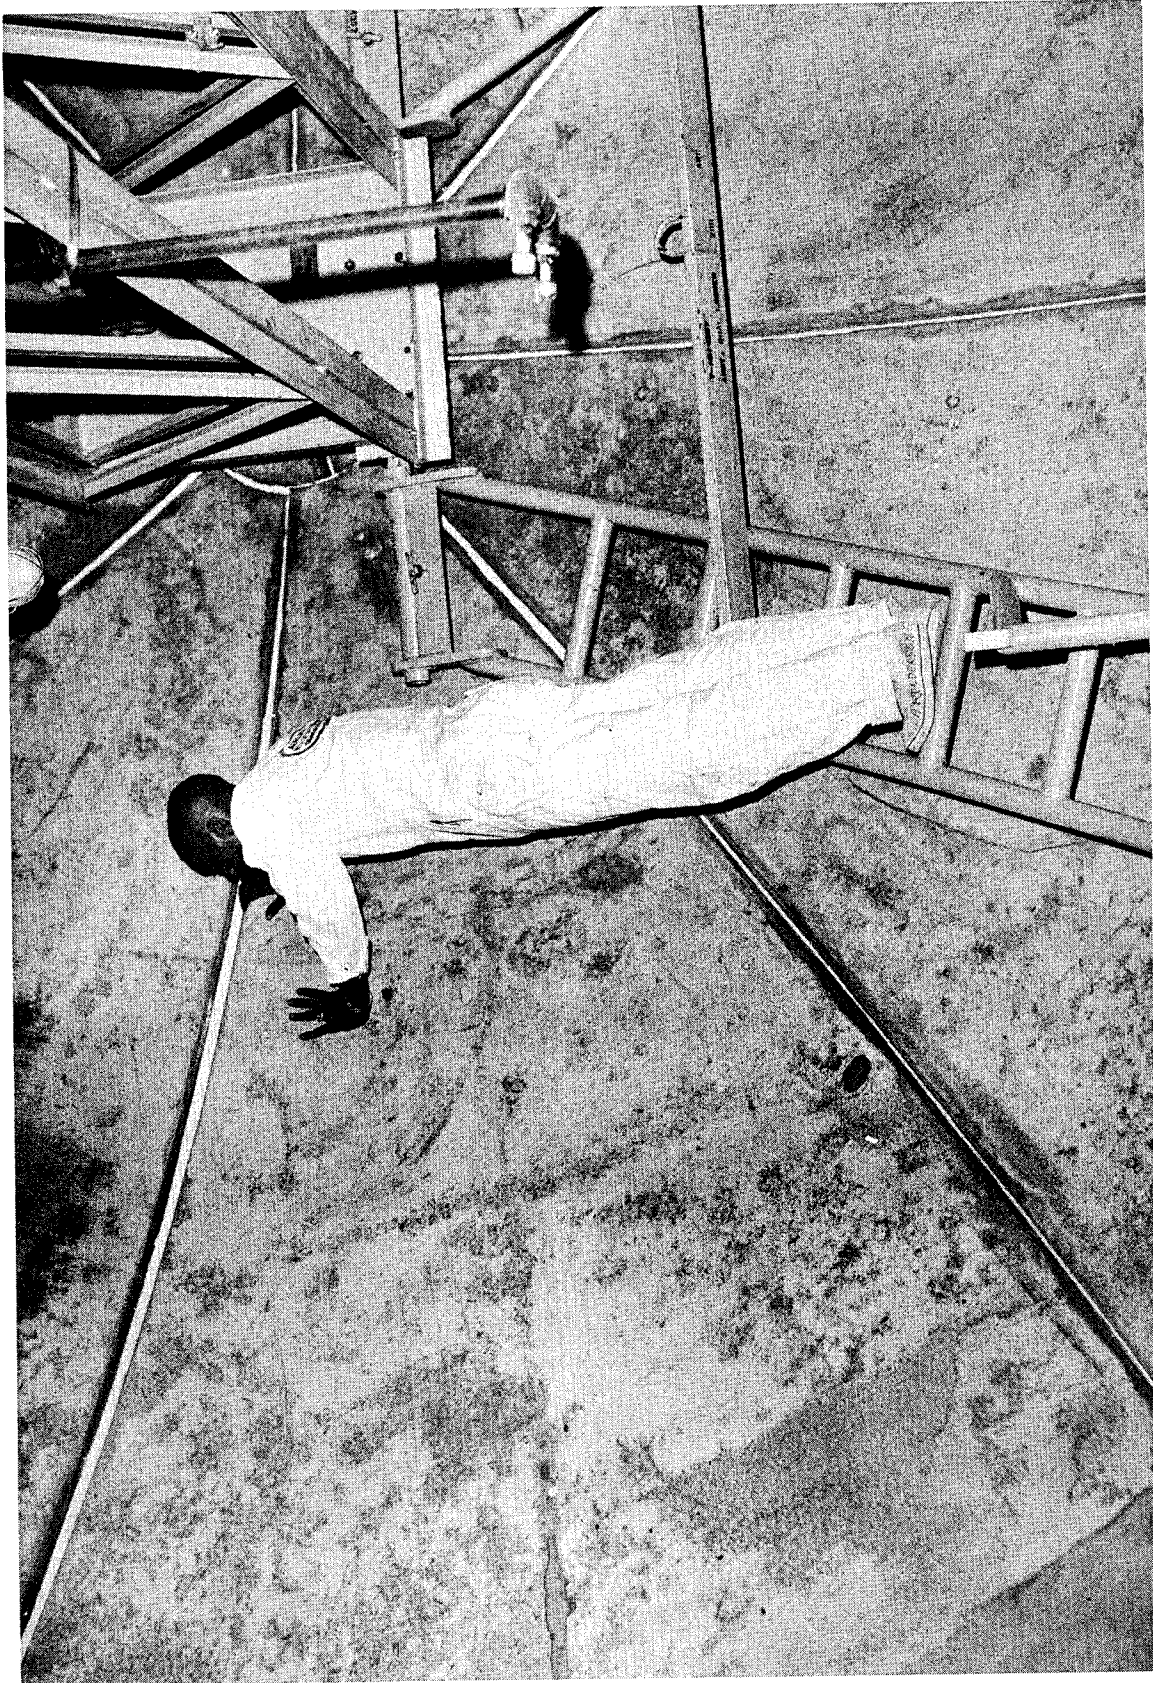
Figure 11

Forward Insulation V-Grooves After V-61 Removal

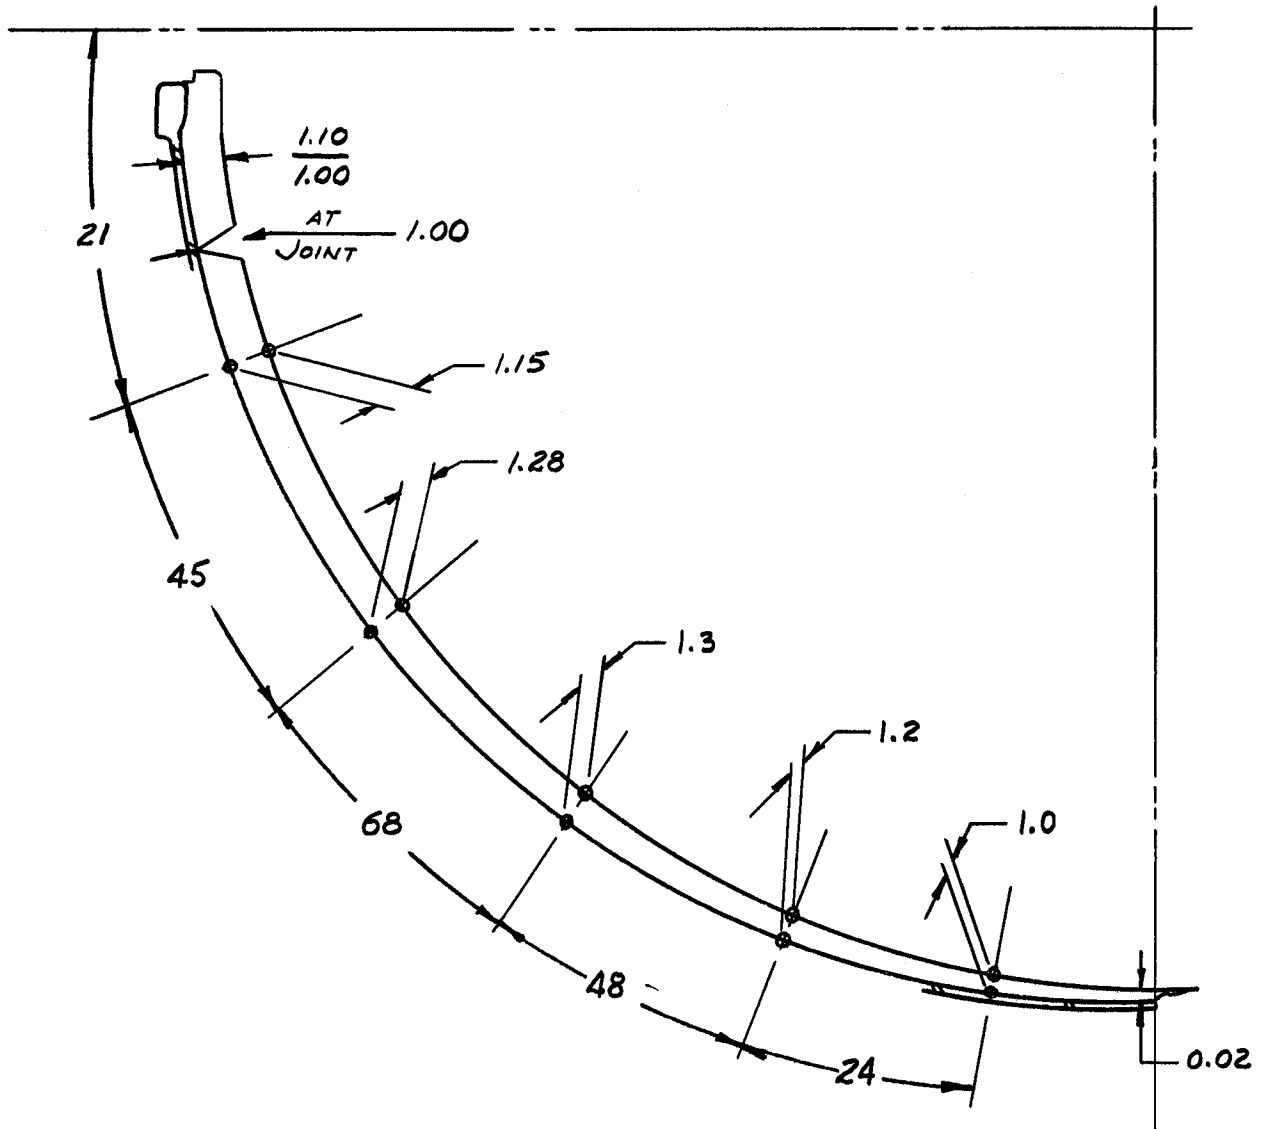
Figure 12

Final 260-SL-3 Rehabilitated Forward Insulation Contour

The areas in the forward and aft insulation where damaged rubber had been removed were repaired with V-44 strips. Residual cylindrical-section strips were cut to the required dimensions and bonded into the areas with Epon 948.2 adhesive. Additional insulation sheets were bonded over the initial layer until the area being repaired was built up flush with the adjacent insulation surfaces. The laminated steps were buffed to eliminate sharp corners and smooth out the contour. A router was used to grind out the surface defects in the aft insulation.

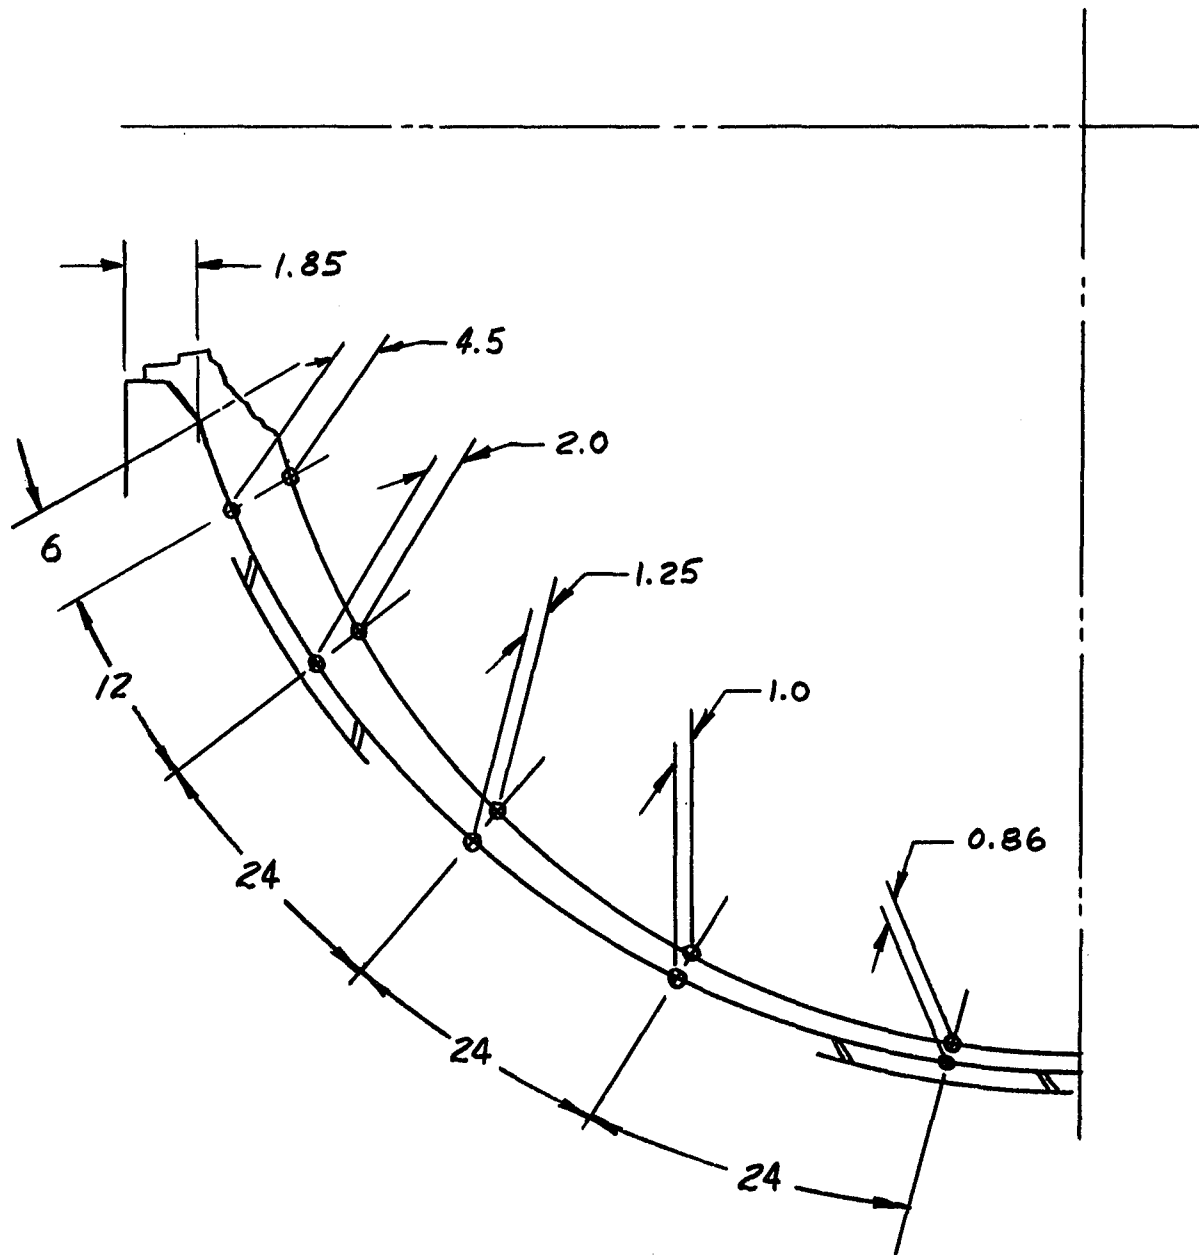
Figure 13

Final 260-SL-3 Rehabilitated After Insulation Contour

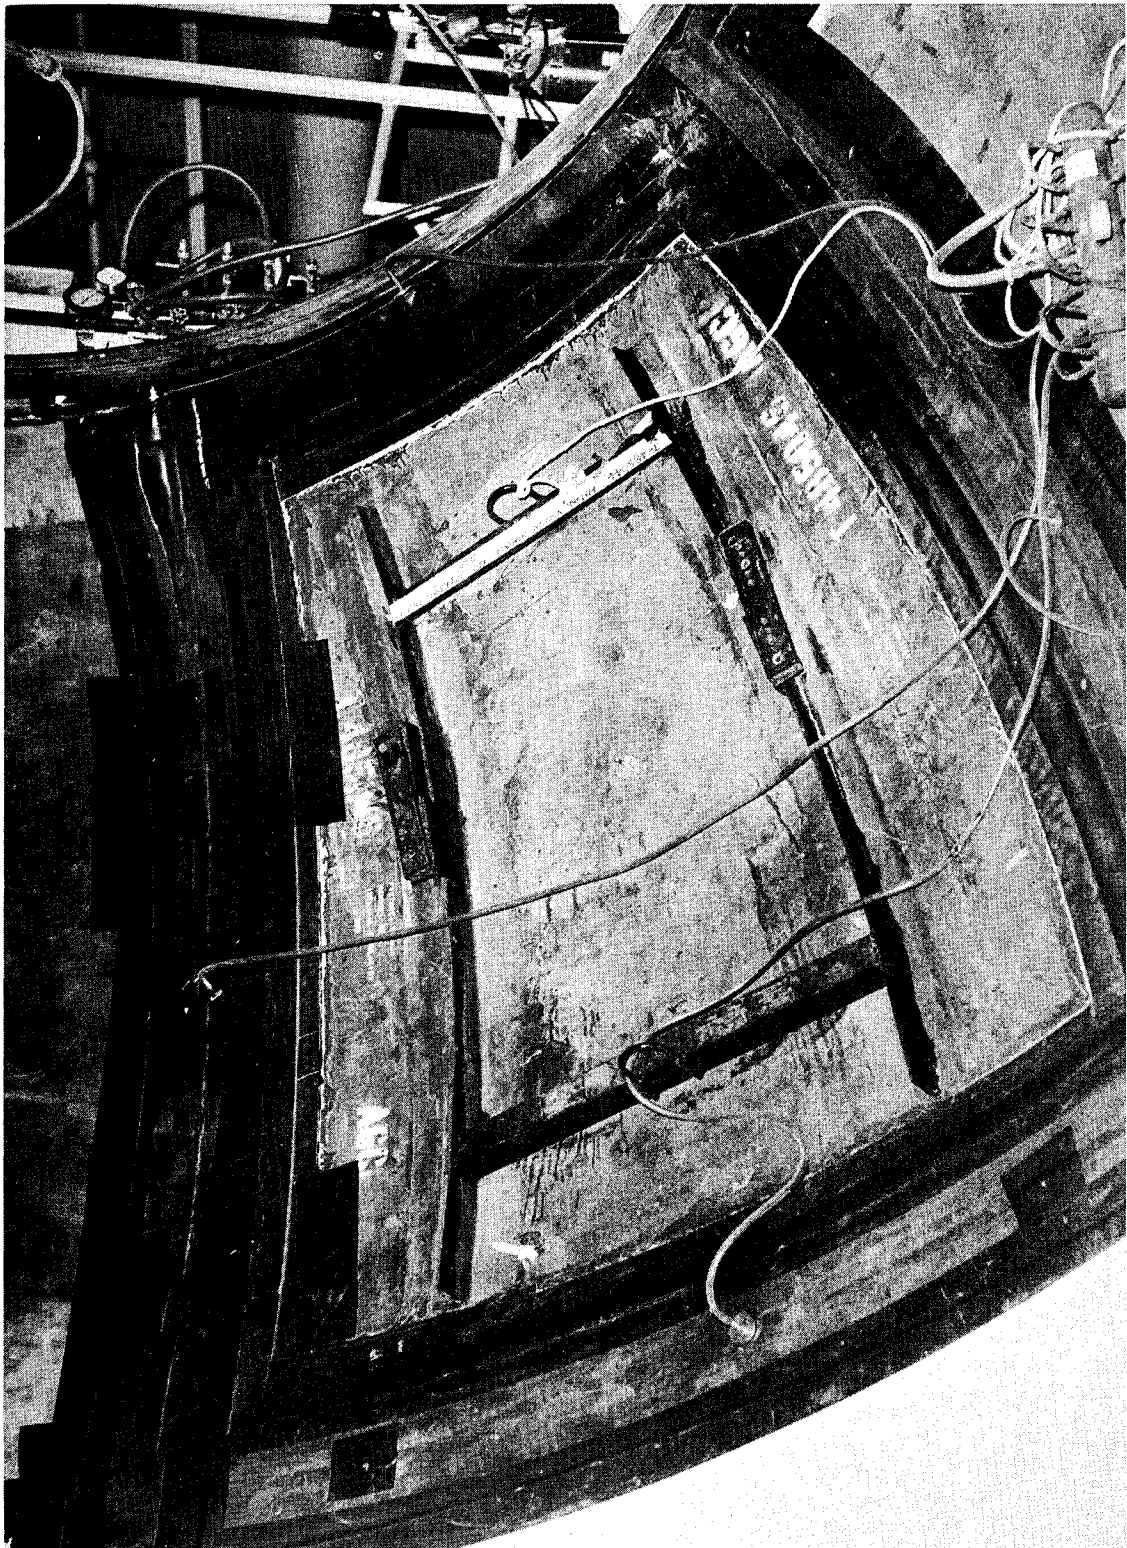
Figure 14

Replacement Aft Insulation Segment Under Vacuum Cure

Installation of the replacement segment, S/N 260A-6, was accomplished as planned. A heavy-gage aluminum-foil template was laid up in the area where the segment was to be installed. The template was removed, placed over the replacement aft insulation segment, and the segment was trimmed to the template configuration. The trimmed segment was moved into the chamber and checked for final fit. The sides of the segment were retrimmed where necessary, skived to 30 degrees using a power sander, and the bonding surface was abraded. Fifty lb of Epon 948.2 was mixed and applied to both the segment and chamber bonding surfaces. No. 1502 cotton bleeder cloth was applied to the chamber epoxy surface, and the segment was installed. Blankets were installed and dealed around the periphery, and vacuum was drawn. The adhesive was cured for 12 hr under 25-in.-Hg vacuum, as shown in Figure 14.

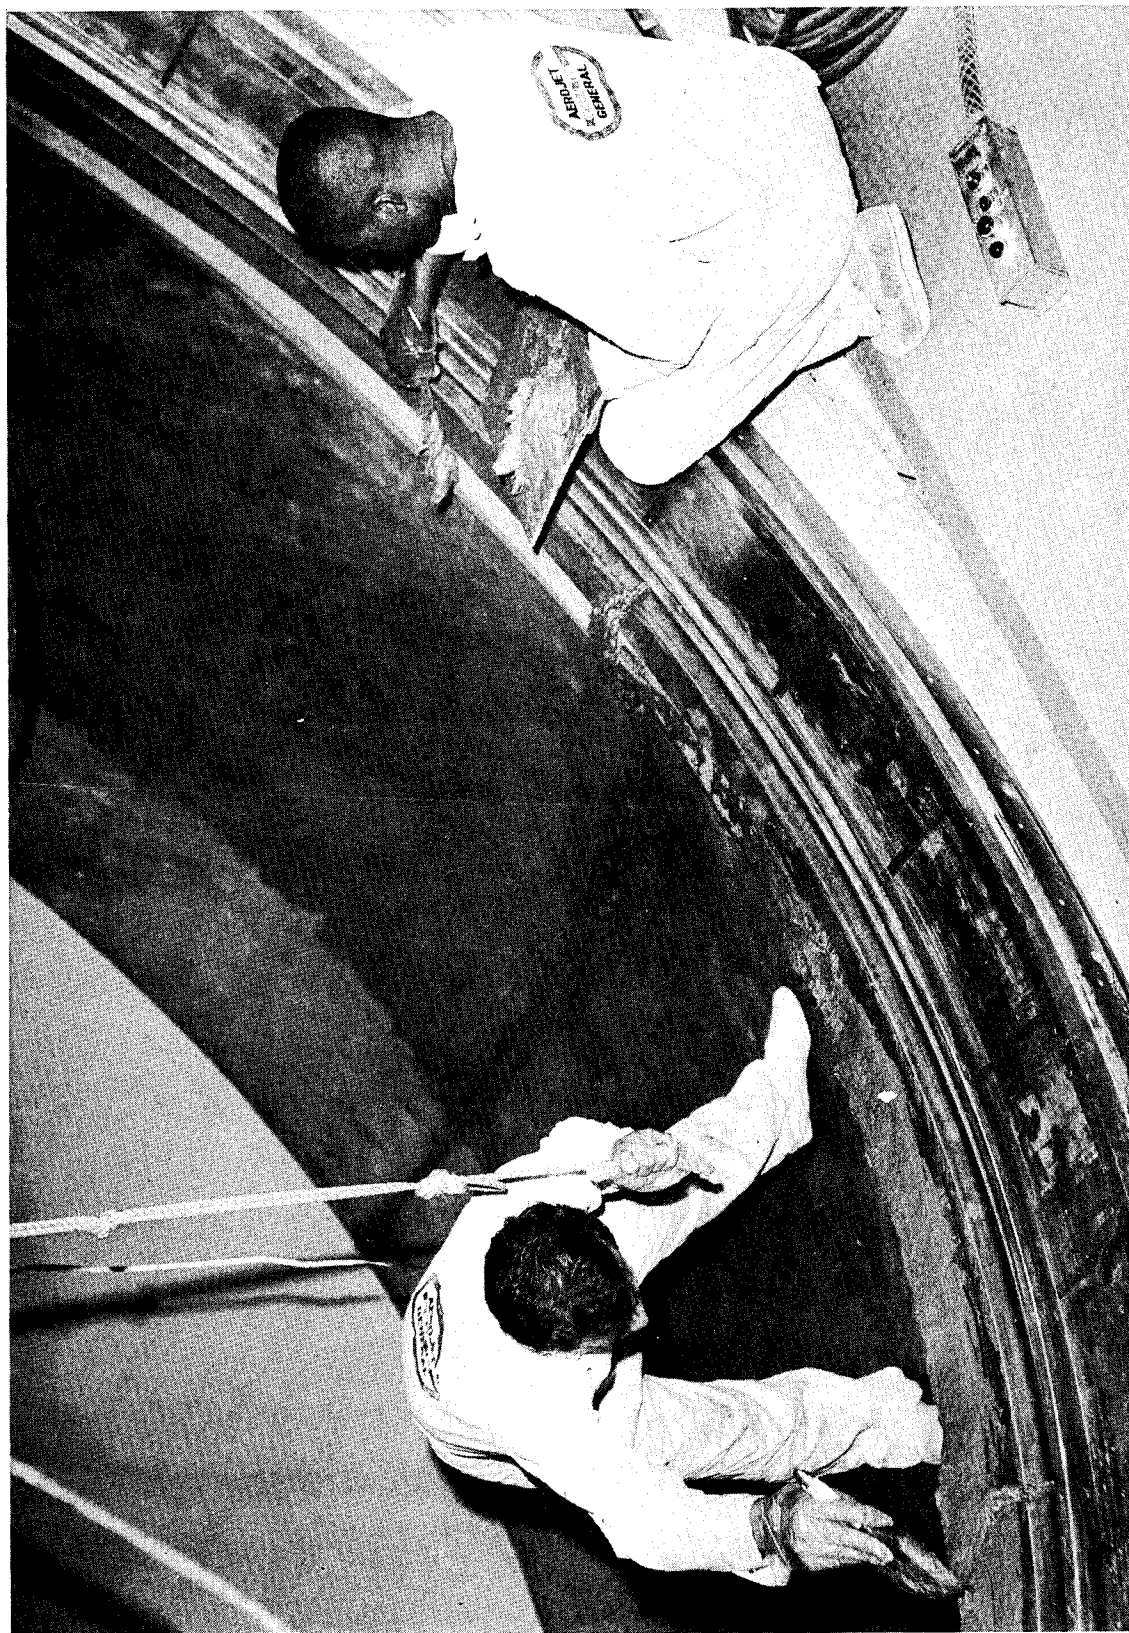
Figure 15

original or thin configuration (2.76-in. thick at the step-joint) used in motor 260-SL-2. The existing aft insulation in the S/N 001 chamber was 4.26-in. thick at the step-joint. Since the step-joint of the existing insulation was to be built-up to the original thickness with V-61, the decision was made to use the available aft segment as a replacement and to build-up its contour with V-61 material.

Aft Step-Joint Build-Up with V-61 Potting Insulation
