# NATIONAL ADVISORY COMMITTEE FOR AERONAUTICS

No. 1095

MARINE EXPOSURE TESTS ON STAINLESS STEEL SHEET

By Willard Mutchler

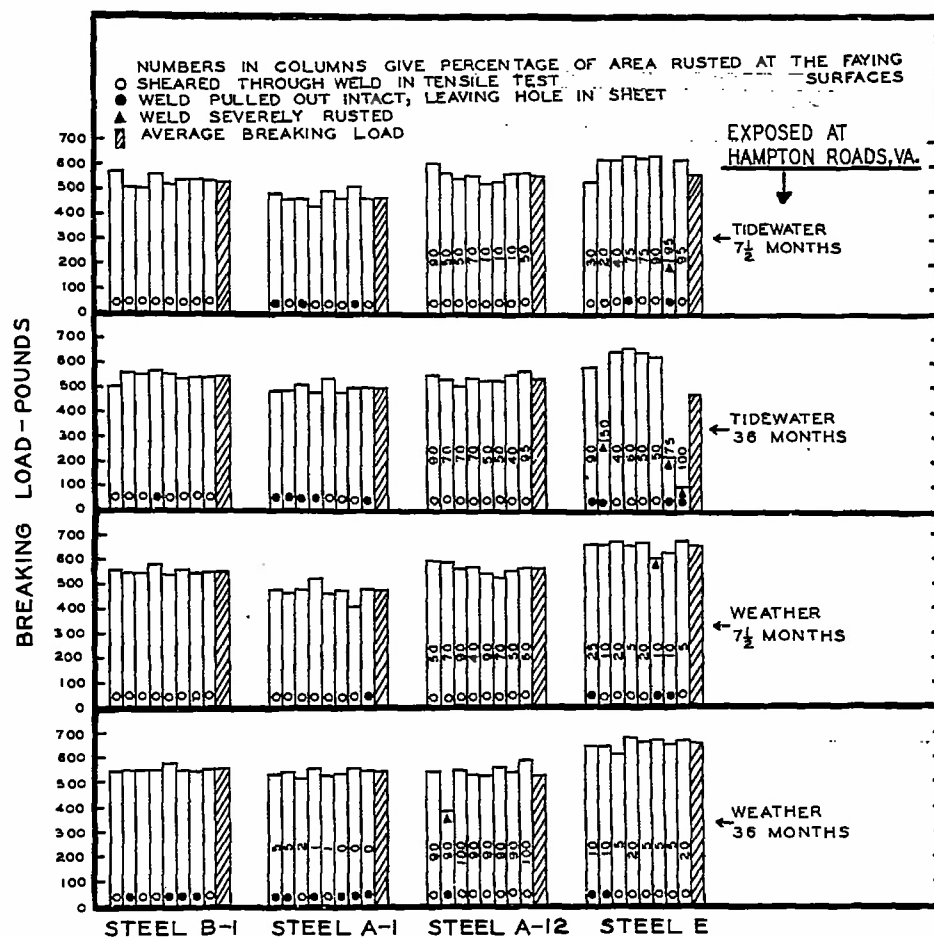
Representative results of the tensile tests on a few of the steels (fig. 24) reveal that, except for isolated instances on corroded welds, the range in breaking loads for the single welds was within narrow limits. The highest values were obtained on steel E. Tests made at the E. G. Budd Manufacturing Company on similar welds in this 16:1 type steel, showed that they would withstand a twist of only  $10^\circ$  before failure; whereas welds in the 18:8 type steels withstood a twist of  $90^\circ$  before failure. Shot welds in alloys corresponding to steel E probably would not prove as satisfactory as the austenitic type alloys for highly stressed structures.

Figure 24.- Results of tensile tests on individual shot-welds from representative panels after exposure at Hampton Roads, Va.

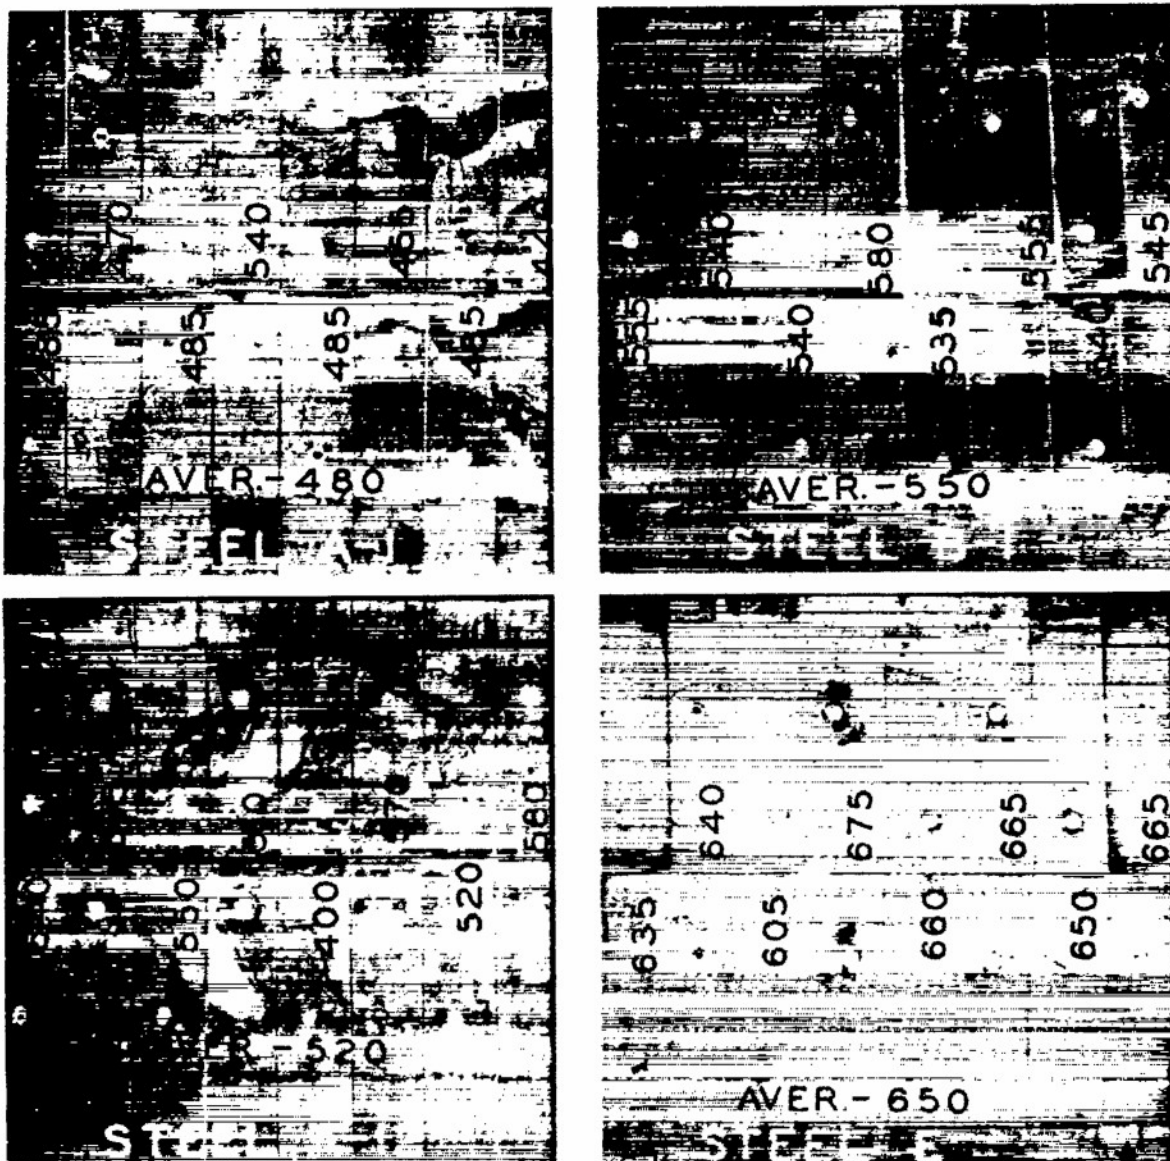
Figure 26.- The faying surfaces of panels, comparable to those shown in figure 25, but exposed to the weather for three years at Hampton Roads, Va. Surfaces to which no grease was applied prior to welding (Steel A-12) exhibit considerable rust. x 3/4.

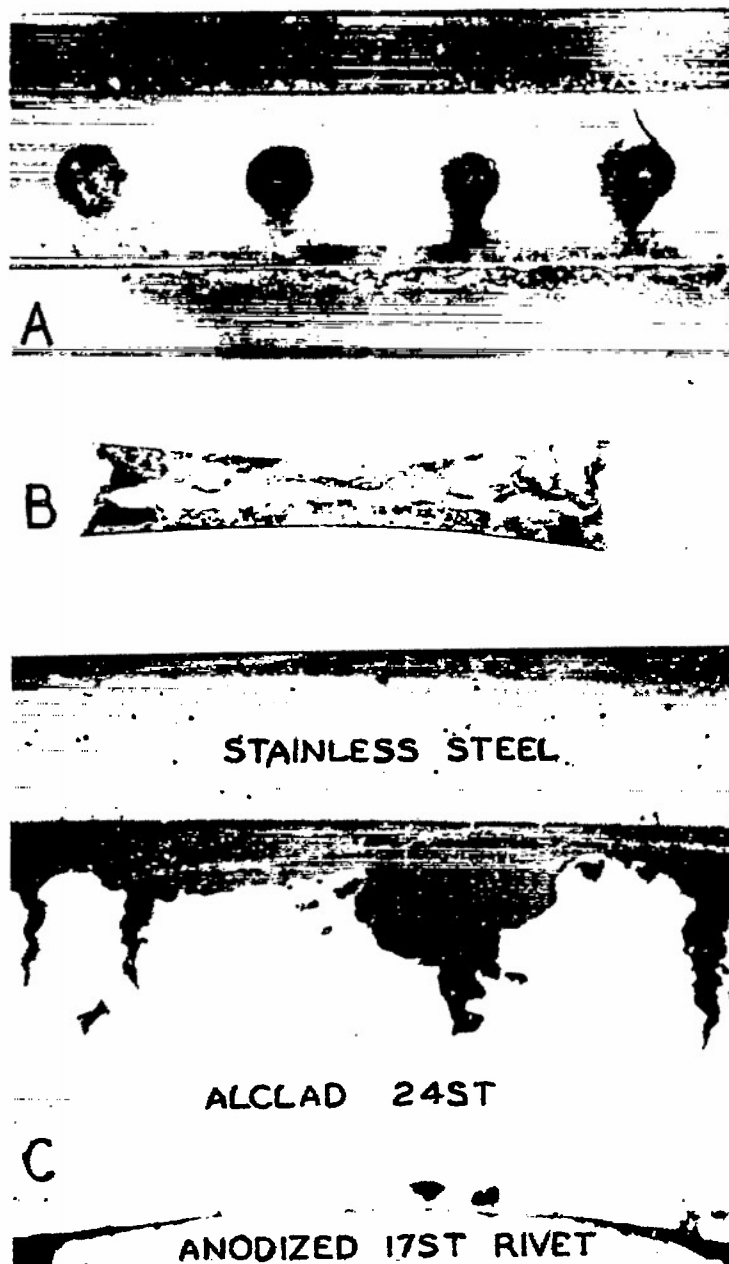
Figure 31.- Examples of stress corrosion on panels having stainless steel coupled with light metal alloys.  
 A, Crack on stainless steel strip joined to a magnesium alloy panel, Dowmetal M. Exposed two years to the weather, earthward surface. x 1. B, Cross-section showing the large amount of corrosion products at the faying surfaces of (A). x 2-1/2. C, Cracks in Alclad 24ST strip attached to a stainless steel panel, exposed to tidewater for two years. x 50.

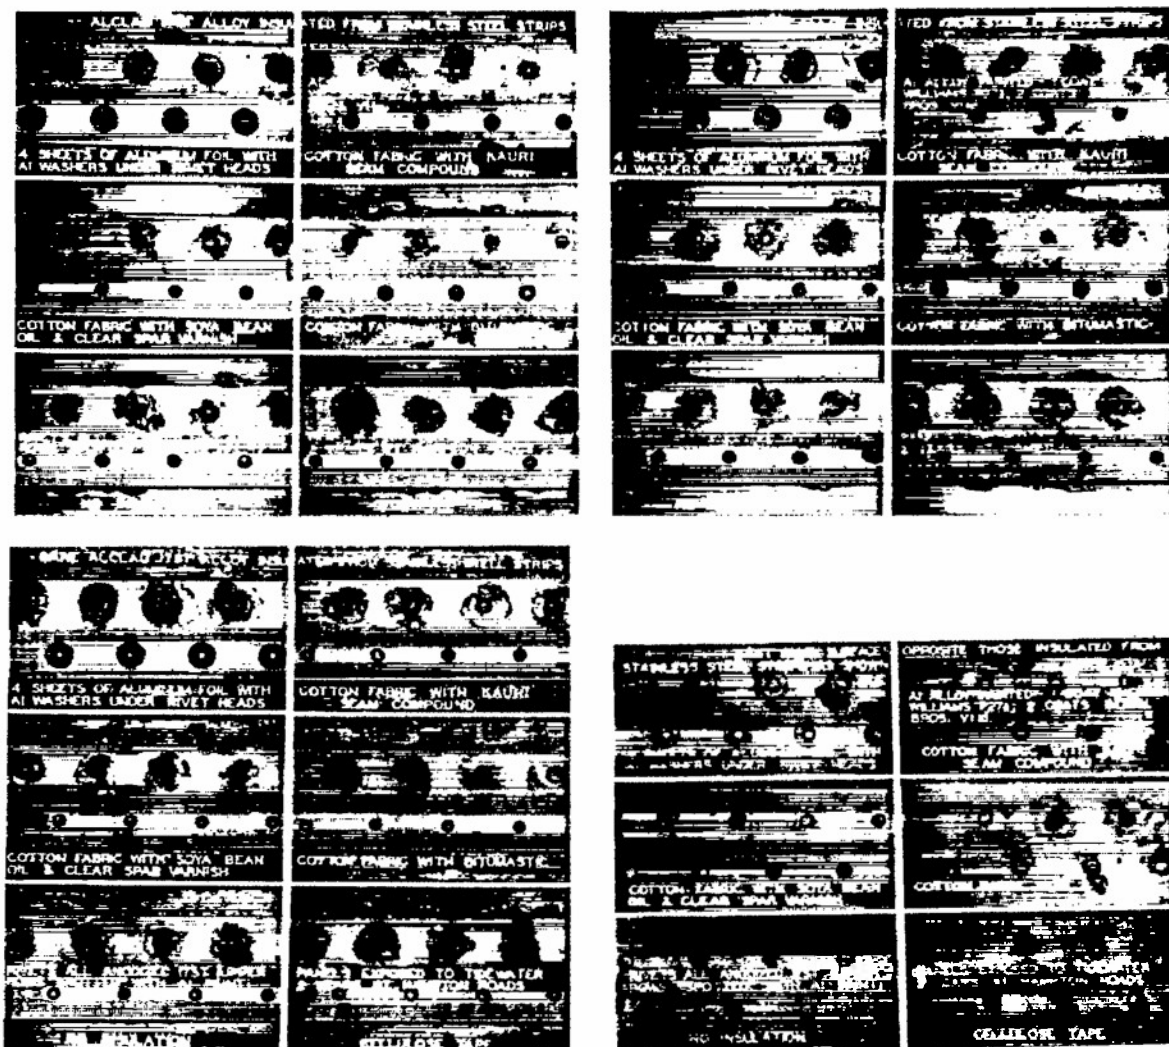
Figure 32.- Panels of aluminum alloys joined to stainless steel strips and exposed to tidewater at Hampton Roads, Va. for two years with the various insulators between the strips and the panels. The upper rows of rivet heads were painted with an aluminum pigmented varnish. Note the absence of corrosion products along the edges of the strips insulated by aluminum foil. x 2/5.

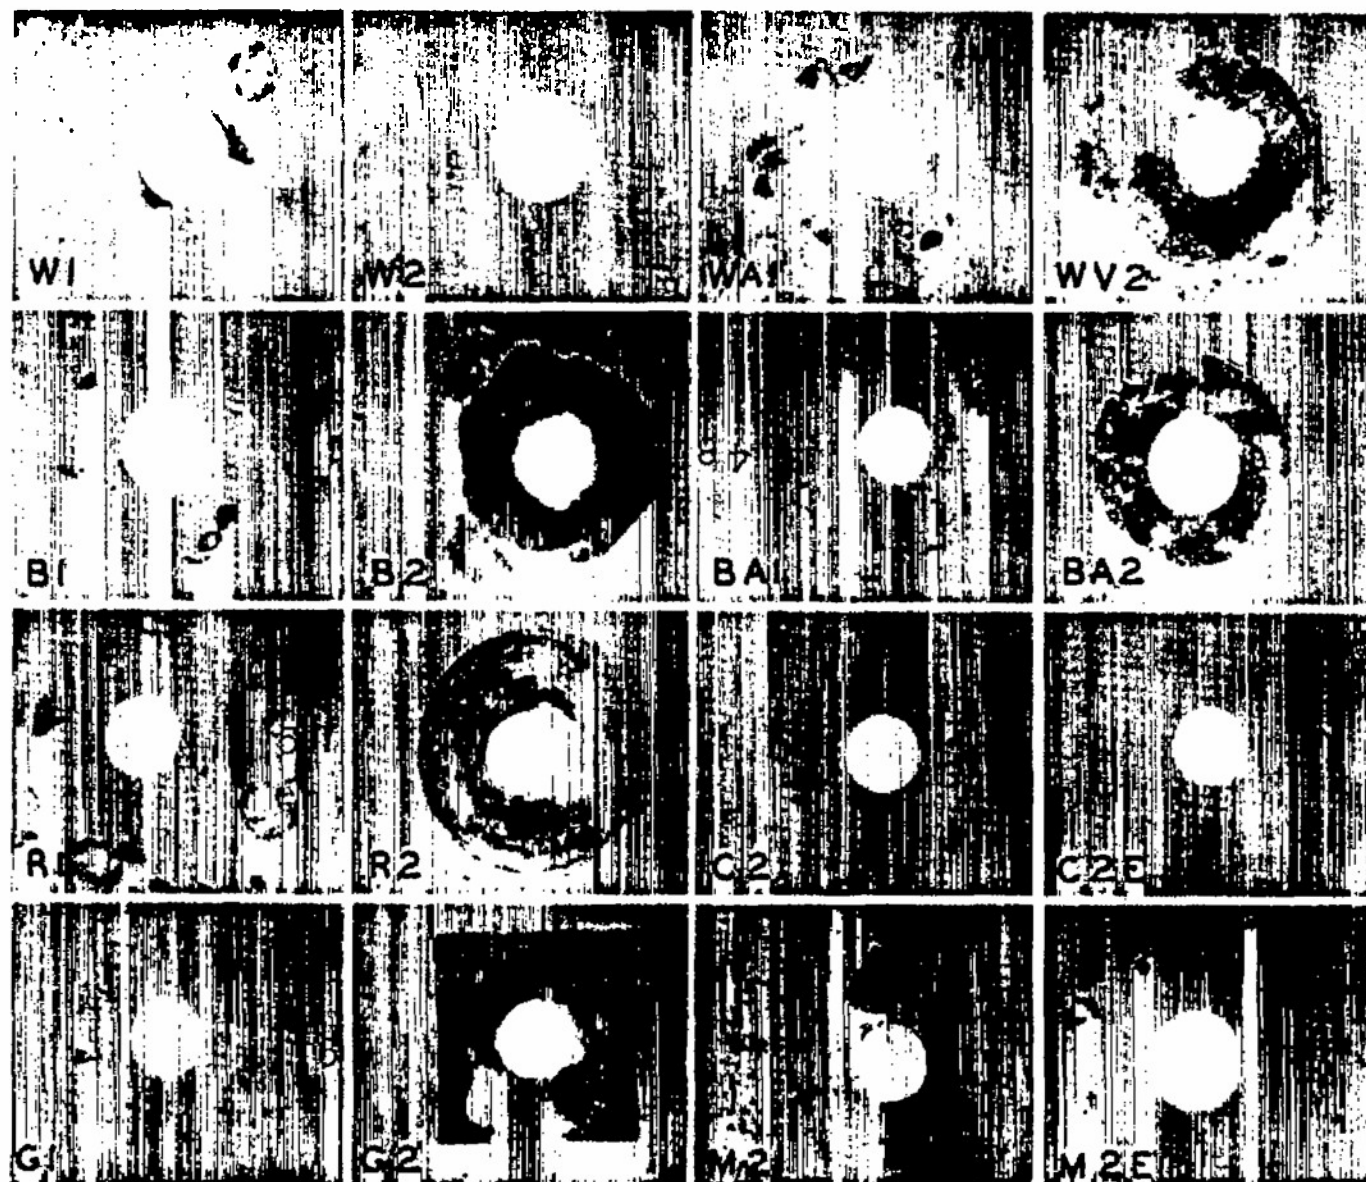
Fig. 36

Figure 36.- The four-point method of supporting panels in the tidewater racks served to prevent corrosion caused by contact with the supporting medium. The symbols:- W, wood, cypress; B, bakelite; R, hard rubber; G, glass; C, copper; M, monel metal; A separator painted with aluminum varnish; V, separator painted with clear varnish; E, mounted to permit an electric circuit; 1, four-point contacts; 2, solid contact of 1 square inch area.
