**UNANNOUNCED**  
Watertown Arsenal Laboratory  
Report No. WAL 739/48  
Problem No. R-1.5

8 August 1944

BAYONETS

Metallurgical Examination of Eight M1 Bayonets Submitted by  
Springfield Armory

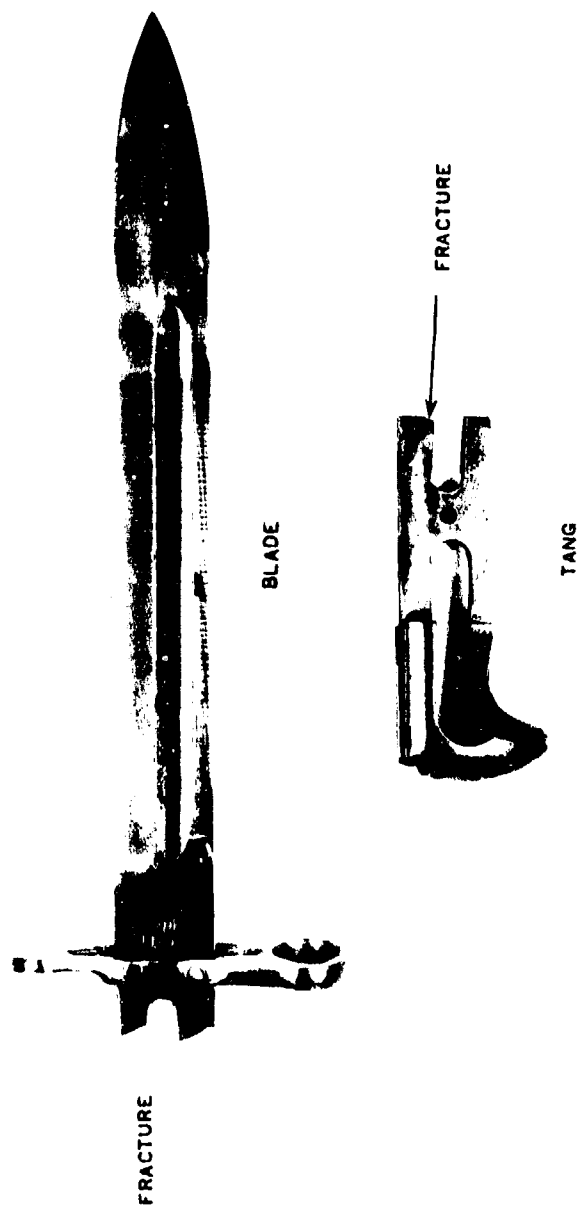
FIGURE 1

The eight (8) bayonets in the as received condition were found to be stamped on their tangs with the following numbers: 1, 5, 9, 12, 14, 16, 19, and 21. The blade of each bayonet was found to be stamped just below the guard with the following identification: "AFH US".\*\* Bayonet No. 19 was received in two pieces. Breakage occurred in the tang immediately to the rear of the bolster which supports the guard as shown in Figure 1. This location has been previously referred to as the critical section (Report No. WAL 739/37).

PHOTOGRAPH OF BROKEN M1 BAYONET NO. 19 SUBMITTED BY SPRINGFIELD ARMORY  
17 MAY 1944 MAG. X 1/2 WTN.693-62

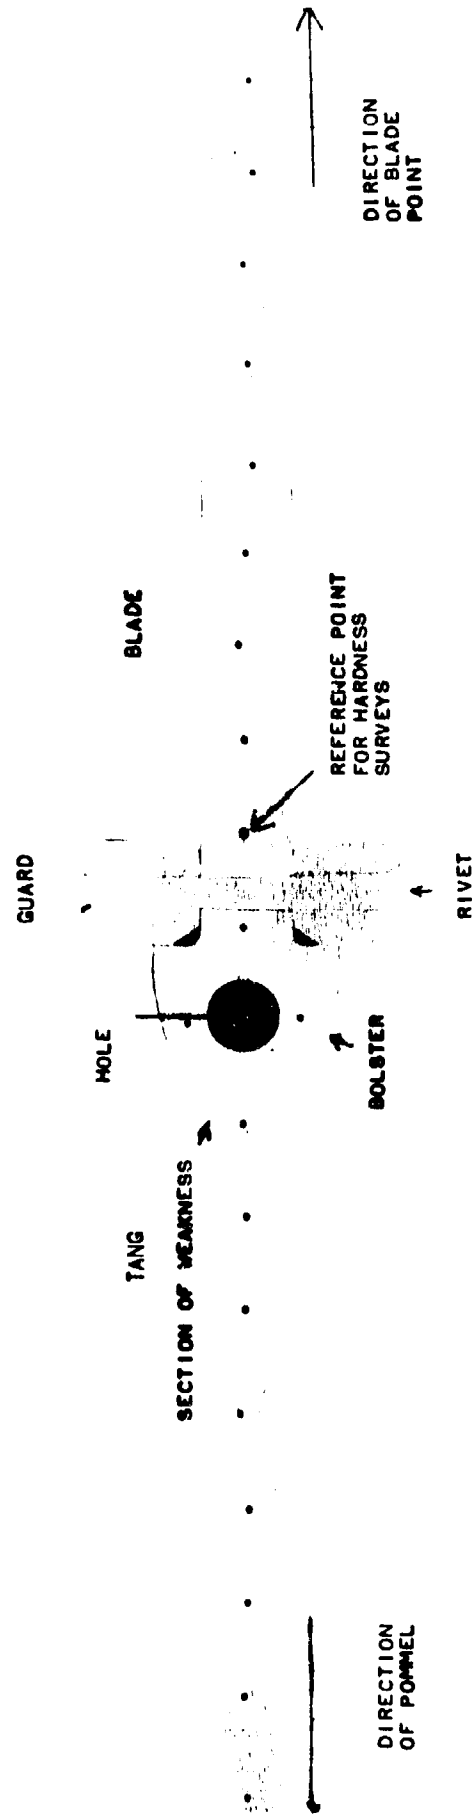
FIGURE 2

The results of Rockwell "C" hardness surveys taken on longitudinal sections of the eight bayonets are given in Appendix C and summarized in Table III. The sections chosen included the tang up to the pommel and three inches of the blade as measured from the front of the guard. A typical section is shown in Figure 2. Each section was ground parallel to and for a distance of  $3/16$ " from the flat edge or back side of the blade. Hardness readings were taken  $1/4$ " apart starting at a reference point in line with the front of the guard. In reporting the results of the hardness surveys, the direction of the blade point is noted as positive while the direction of the pommel is noted as negative.

As shown in Table III, Bayonets No. 12, 14, 16, 19, and 21 possess fairly uniform hardness throughout their lengths, whereas Bayonets No. 1, 5, and 9 possess transitional zones of lowered hardness in the region of the guard. The hardness level of both the tang and blade of Bayonet No. 9, Rockwell "C" 43-46 is below that of the other seven bayonets, Rockwell "C" 47-52.

LONGITUDINAL SECTION OF BAYONET IN VICINITY OF GUARD SHOWING HARDNESS SURVEY. ROCKWELL  
HARDNESS READINGS WERE TAKEN 1/4" APART STARTING AT A REFERENCE POINT IN LINE WITH  
THE SIDE OF THE GUARD NEAREST THE BLADE POINT.  
MAGNIFICATION X 2  
WTN.693-60  
3 JAN: 1944
