Watertown Arsenal Laboratory  
Report No. WAL 739/47  
Problem No. R-1.4

### BAYONETS

#### Metallurgical Examination of Six Lots of T2 Bayonets

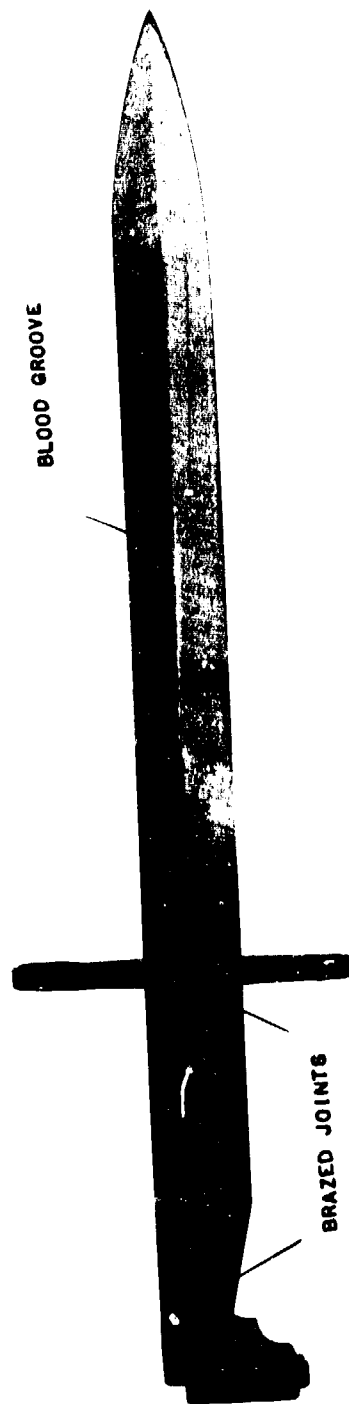
FIGURE 1

PHOTOGRAPH OF T2 BAYONET SHOWING LOCATION OF BRAZED JOINTS AND BLOOD GROOVE  
29 JULY 1944  
MAG. X  $\frac{1}{2}$   
VTN.693-63

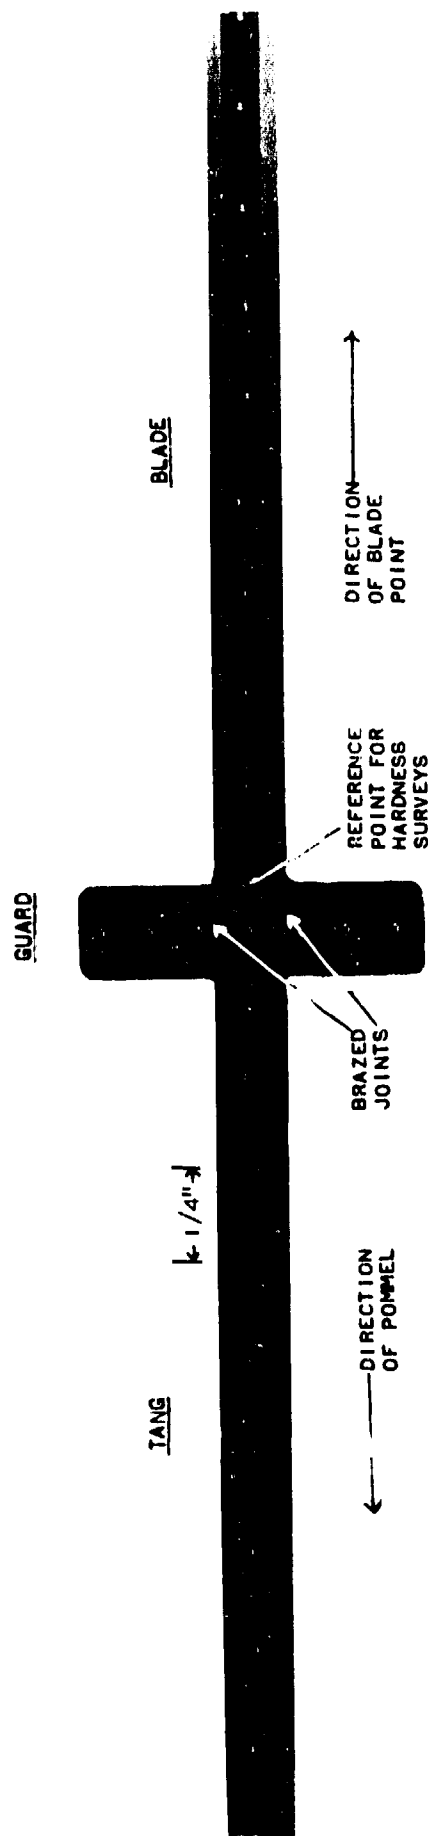
FIGURE 2

The results of Rockwell "C" hardness surveys taken on longitudinal sections of the T2 bayonets in the vicinity of the guard are given in Appendix B and summarized in Table III. The section chosen included the tang up to the pommel and three inches of the blade as measured from the front of the guard. A typical section is shown in Figure 2. Hardness readings were taken 1/4" apart along the tang and blade starting at a reference point in line with the front of the guard. In reporting the results of the hardness surveys, the direction of the blade point is noted as positive while the direction of the pommel is noted as negative.

The results of Table III show that the hardness levels of most of the T2 bayonet blades fall within the limits specified in U.S. Army Specification No. 52-4-1B (Amend. -3) Rockwell "C" 46-52. The blades of bayonets Nos. A3, B4, and F2 possess a hardness level of Rockwell "C" 41-43 which is below the lower specification limit. The hardness levels of the T2 bayonet tangs are all within Rockwell "C" 40 to 53. Most of these tangs are nonuniform in hardness, varying as much as 10 points from pommel to guard. Transitional zones of lowered hardness were found to exist in the vicinity of the guard of all with the exceptions of Bayonets Nos. B4, E2 and E4. These zones all fall in a region extending from 1" in back of the guard (pommel direction) to 1-1/2 inches in front of the guard (blade point direction). The minimum hardnesses found in these zones are in the range of Rockwell "C" 38-44.

LONGITUDINAL SECTION OF T2 BAYONET IN VICINITY OF GUARD SHOWING HARDNESS SURVEY.  
 ROCKWELL "C" HARDNESS READINGS WERE TAKEN  $\frac{1}{4}$ " APART ALONG BLADE AND TANG. MAG. X 2  
 29 JULY 1944 WTN.003-65

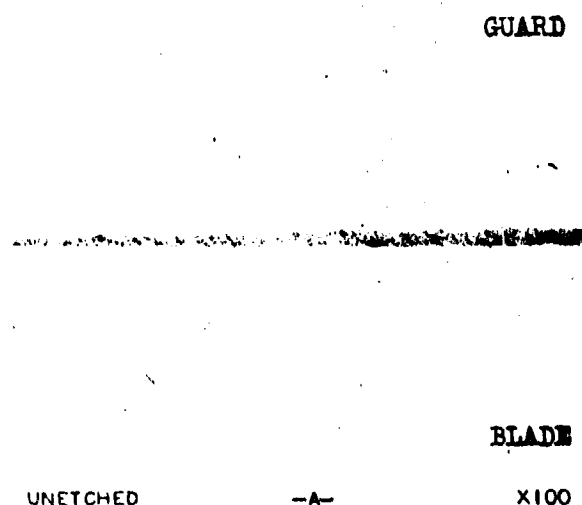
UNETCHED -A- X100  
BAYONET F2 JOINT. UNIFORM BRAZE METAL LAYER .001" IN THICKNESS.

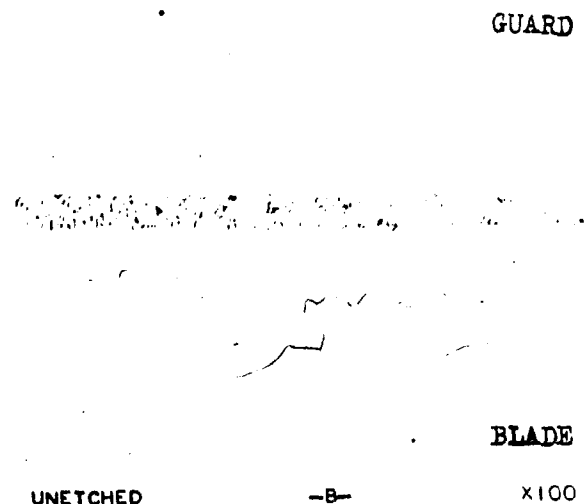
UNETCHED -B- X100  
BAYONET E5 JOINT. NETWORK FORM OF BRAZE METAL ON BLADE SIDE. CRACKS PRESENT IN BLADE.

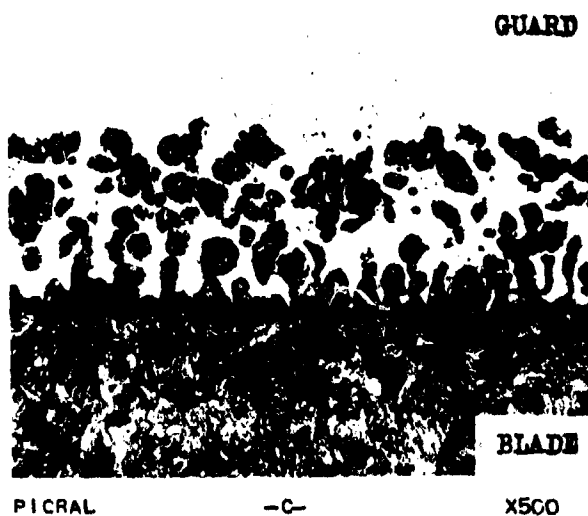
PICRAL -C- X500  
BAYONET E5 JOINT. PENETRATION OF BRAZE METAL ALONG GRAIN BOUNDARIES OF BLADE.

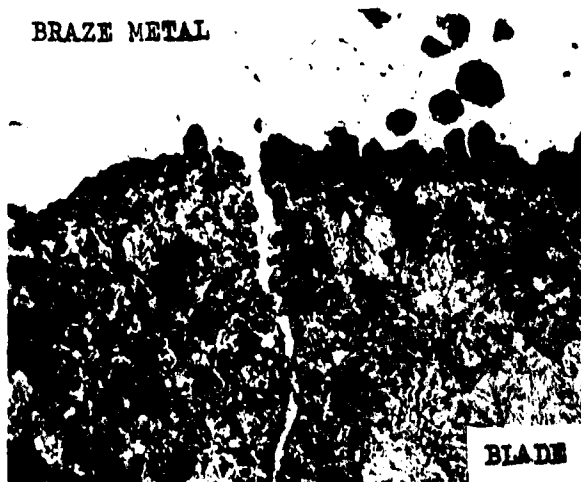
The results of microexamination of the brazed joints between blade and guard of the longitudinal sections used for hardness surveys are given in Table VII. Photomicrographs illustrating the conditions indicated in Table VII are shown in Figures 4 and 5. The thickness of brazed joint was found to be fairly uniform in each of more than half of the joints examined. The maximum thicknesses of all the brazed joints were found to be in the range of .0005" to .0060". A typical example of a uniform brazed metal joint is shown in Figure 4, -A-. In Bayonets Nos. B1 and E5, the braze metal penetrated along the grain boundaries of the blade, -B- and -C-. This indicates that a higher temperature was reached and probably applied during the brazing of guards to these bayonets than in the case of the others. Cracks which connect with the brazed joints were found in the blades of Bayonets Nos. B1 and E5, -B- and -D-. These cracks were found to be almost completely filled with braze metal, which indicates that they were present during the time the braze metal was in a molten state and could penetrate. The absence of any decarburization in the vicinity of the cracks, Figure 5, -A-, is an indication that these cracks did not exist prior to

the brazing operation. In view of the foregoing evidence, it is believed that the cracks in the blades resulted from too rapid a heating rate during the brazing operation. The high carbon content of the blades would be expected to render them susceptible to cracking during rapid heating.

PICRAL -A- X500  
BAYONET E5 JOINT. CRACK FILLED WITH  
BRAZE METAL IN BLADE. NO DECARBURIZATION  
IN VICINITY OF CRACK.

On the whole, the effect of the brazing operation on the blade near the guard is not considered detrimental. The cracks found in the blade which originated from the brazed joint of two bayonets could be eliminated if better control of the rate of application of heat was exercised during the brazing operation. The cracks found in the blade are less serious than ordinary cracks in view of the fact that they are filled with braze metal which would be expected to retard their further propagation. The brazed-on guard affects the adjacent blade by acting to slow down the rate of heating and quenching this region of the blade. The lowered hardness which results would not be considered detrimental provided that the minimum value is above about Rockwell "C" 40. By selection of proper hardening temperature and time of heating and quenching uniformly, adequate hardness should result in the region of the guard.

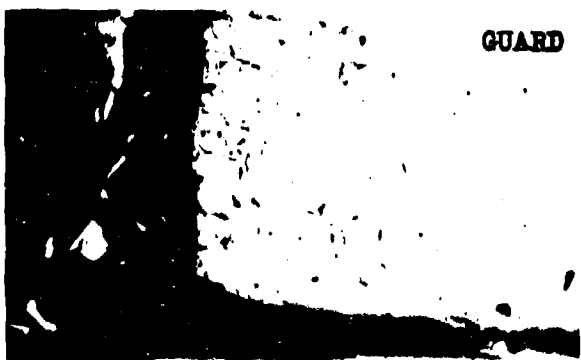
Examples of poor joints found in those bayonets indicated in Table VI as possessing voids to an appreciable extent are shown in Figures 5, -B- and -C-. Evidence of oxidation was found in the guard near the brazed joint, indicating the need for more adequate protection against oxidation during the brazing operation. The absence of braze metal at the corners between blade and guard, -C-, was observed in several bayonets. In most cases, however, a considerable amount of braze metal was found at the corners as shown in the case of Bayonet B1, -D-. The crack in the blade of this bayonet, shown in -D-, originated at the corner of the blade and guard and is believed to have resulted from too rapid heating during the brazing operation.

UNETCHED -C- X100  
BAYONET E1 JOINT. ANSENCE OF BRAZE  
METAL AT CORNER. OXIDES PRESENT IN  
GUARD.

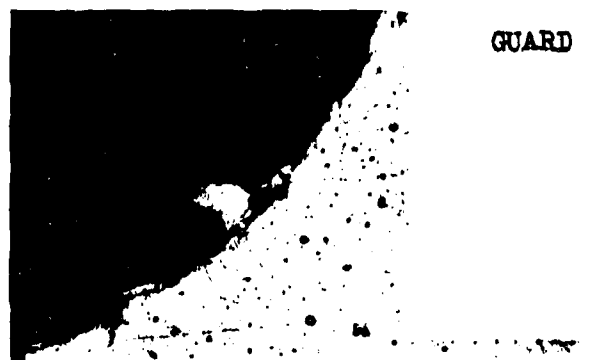
UNETCHED -D- X100  
BAYONET B1 JOINT. CORNER FILLED WITH  
BRAZE METAL. CRACK EXISTS IN BLADE.
