TITLE: The Utilization of Advanced Composites in Military Aircraft  
(L'Emploi des Matériaux Composites de Pointe pour les Avions Militaires)

FLIGHT SERVICE ENVIRONMENTAL EFFECTS  
ON COMPOSITE MATERIALS AND STRUCTURESH. Benson Dexter  
NASA Langley Research Center  
Hampton, VA USA 23665-5225

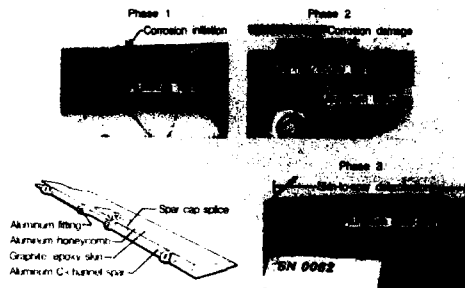
Figure 7. Corrosion of B737 graphite/epoxy spoilers.

A typical corrosion damage scenario for a splice between the center hinge fitting and spar is shown in figure 7. The corrosion damage can be characterized by three phases of development. Phase 1 involves corrosion initiation at an aluminum fitting or at the aluminum spar splice. The corrosion initiates due to moisture intrusion through cracked paint and sealant material. If the corrosion products are not removed and new sealant applied, the damage progresses to phase 2 where moisture penetrates under the graphite/epoxy skin along the aluminum C-channel front spar. Normal service loads combined with moisture contribute to crack growth and subsequent corrosion. If the phase 2 corrosion is not repaired, the damage progresses to phase 3 where extensive skin-to-spar separation takes place. Phase 3 corrosion can result in significant strength and stiffness loss. It takes about 2 years for the corrosion to progress from phase 1 to phase 3. Design changes and improved sealing methods could prevent corrosion damage in composite-metal interfaces.

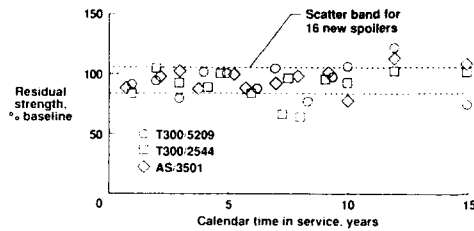
Figure 8. Residual strength of B737 graphite/epoxy spoilers.

Residual strength tests were conducted on 37 graphite/epoxy spoilers to establish the effects of service environments. The spoilers were tested with compression load pads on the upper surface to simulate airloads. Trailing edge tip deflection was measured as a function of applied load for each spoiler tested. The test results are compared with the strength of 16 new spoilers in figure 8. The strength for each spoiler through 6 years of service generally falls within the strength scatter band for the baseline spoilers. However, spoilers with significant corrosion damage which were tested after 7 and 8 years of service, respectively, indicated a 35 percent strength reduction. An additional T300/2544 spoiler with no corrosion damage was tested after 7-1/2 years of service, which verified that the 7 year strength reduction was related to corrosion damage. Three spoilers tested after 9 years of service with little or no corrosion damage exhibited strengths equal to the strength of the baseline spoilers. An AS/3501 spoiler with 10 years of service and known corrosion damage failed at 78 percent of the average strength of the baseline spoilers. Two other spoilers with 10 years of service with no corrosion damage failed within the baseline strength scatter band. Spoilers tested after 12 years of service failed at or above the average strength of the baseline spoilers. One spoiler that had known corrosion damage after 15 years of service failed at about 75 percent of the strength of baseline spoilers.

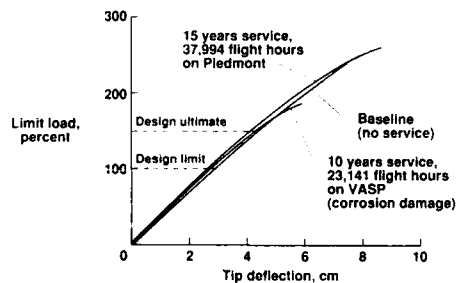
Figure 9. Load-deflection response of AS/3501 graphite/epoxy spoilers for B737 aircraft.

Load-deflection response of spoilers with 10 years and 15 years of service time are compared with the response of baseline spoilers in figure 9. The 10 year spoiler with known corrosion damage failed at about 78 percent of the baseline strength. However, the 15 year spoiler with almost 38,000 flight hours failed at about 8 percent above the baseline strength. Additional details of service experience with the spoilers can be found in reference 7.

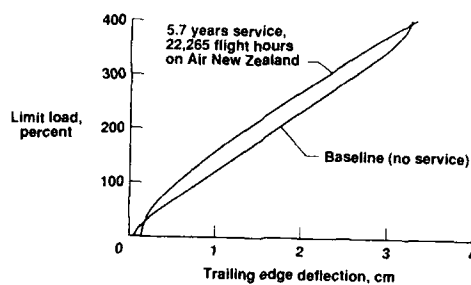
Figure 13. Load-deflection response of T300/5208 graphite/epoxy rudders for DC-10 aircraft.

A graphite/epoxy rudder was removed from service for residual strength testing after 5.7 years and 22,265 flight hours on Air New Zealand. The load-deflection response shown in figure 13 indicates that the 5.7-year rudder had an initial stiffness higher than the baseline rudder, but the overall response is similar for the two rudders. The baseline and the 5.7-year tests were stopped at approximately 400 percent limit load because of an instability of the loading apparatus. Although the rudders are designed by stiffness considerations and only one residual strength test has been conducted, the overall response of the rudder indicates that no degradation has occurred as a result of over 22,000 flight hours.

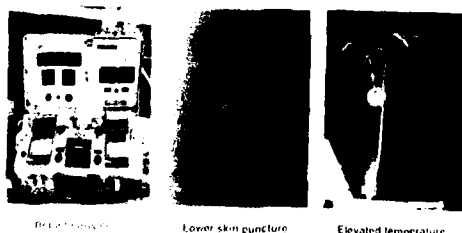
Figure 15. In-service repair of B737 graphite/epoxy horizontal stabilizer.

There have been three reported damage incidents on the B737 horizontal stabilizers. De-icer impact damage was induced on the upper surface panel of both stabilizers on one aircraft. These impacts were minor and damage was limited to the skin, not affecting the stiffener elements. The third stabilizer was damaged when a broken fan blade penetrated the lower surface of the stabilizer. The penetration missed the stiffener elements and damage was limited to a small area of the skin panel. All three of the stabilizers were repaired on the aircraft using wet lay-up cure techniques per specifications developed by Boeing. Figure 15 shows details of the in-service repair process.
