**TITLE:** An Analysis of the 120mm M829 Screening in Operation Desert Storm

Robert E. Dillon, Jr., Lieutenant Colonel, USA  
Dept. of Civil and Mechanical Engineering  
US Military Academy, West Point, New York

## AN ANALYSIS OF THE 120mm M829 SCREENING IN OPERATION DESERT STORM

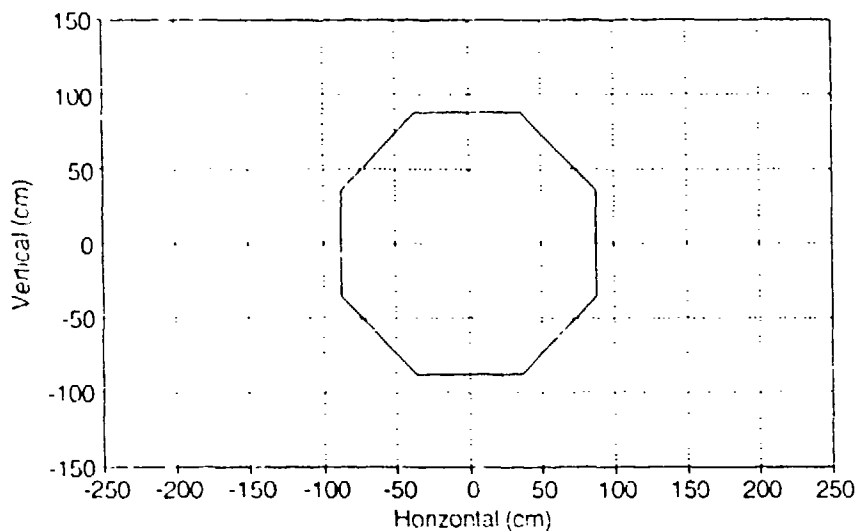
All the tanks in the battalion fired M829 at screening panels placed at 1500 meters. Figure 1 shows the 1500 meter screening panel. Initially, each tank was boresighted and applied the fleet CCF for the M829 round and attempted to fire for confirmation. Each hit was measured and the distance from the center of the panel to the hit was recorded. Figure 2 shows the mean point of impact (MPI) of the shots fired from the fleet CCF. Not shown on the figure are the locations of all the hits nor the 17 shots that missed the target short, one that missed to the right and three that flew over the target.

Figure 1. 120mm 1500 meter screening panel.

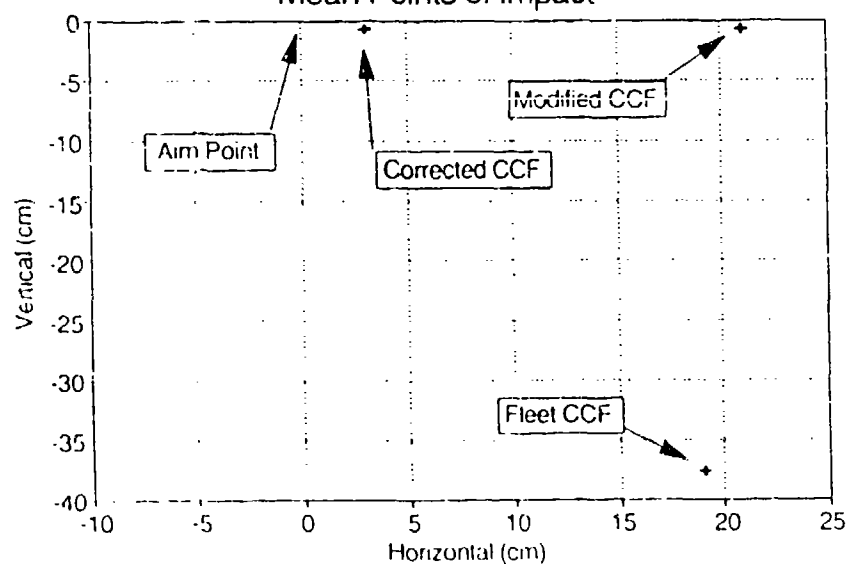
After a closer look at the strike of all the rounds a more precise computation of the MPI was computed. From these data a corrected CCF was found to be L0.01, U0.34. This would be the CCF for these rounds fired for this screening occasion. Compared to our field estimate CCF of L0.13, U0.30 we came close to the true mean point of impact for the vertical jump be since we ignored horizontal jump we were off roughly one tenth of a mil. Table 1 compares the fleet CCF with the modified CCF computed at the range and the corrected CCF computed in this report. The MPI based on the corrected CCF is also shown on figure two and the proximity of the MPI with the aim point is

evident. As an added comment, the crews whose shot hit close to the center were very comfortable with the screening process. However, those crews whose shot hit 80 cm from their aim point had considerably less confidence in their ability to hit a hostile target even though reference 1 said they were "properly screened".

Figure 2. Mean Points of Impact.

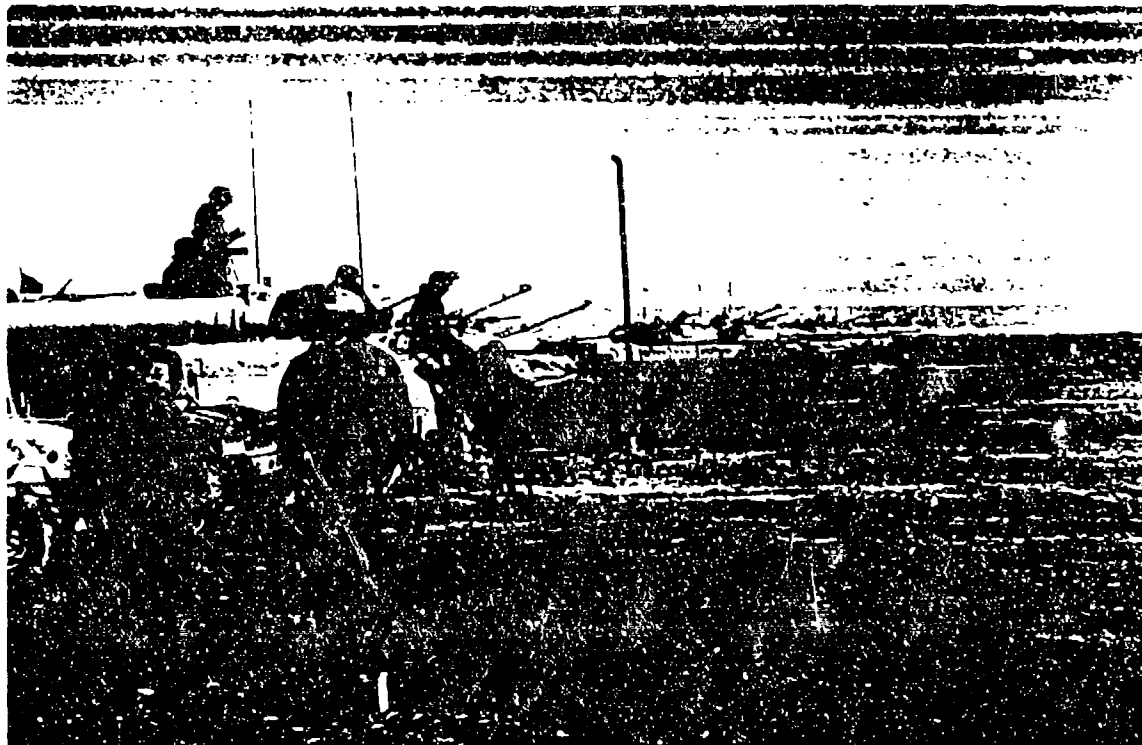
At the firing range, figure 3, our immediate concern was to find the cause of the poor accuracy of some of the M829 rounds. One source of error we considered was optical path bending. The high temperatures in the desert and the convex curvature of the range from the firing line to the target area caused considerable heat striations distorting the image of the targets. If the gunners were aiming at the apparent center of the target, this could explain the poor accuracy. We tested this hypothesis by firing some available M865 rounds from tanks that failed the M829 screening. All these tanks hit very close to the aim point with M865. This narrowed our alternatives to two possible causes: 1) the M829 CCF was not correct, 2) the M829 ammunition was faulty. To narrow our alternatives down we reasoned that the CCF for the M829 was correct and our history of wet rounds gave us some insight into the cause of the low hits. Based on this experience and after some lengthy discussion at the range we assumed one or two things were happening. One was some of the M829 ammunition had absorbed enough water to slow the round down to the point that the lost muzzle velocity would cause the round to hit low. The other was the lower muzzle velocity would cause the slower round to arrive at the muzzle late which would cause the projectile to exit the tube with different horizontal and vertical velocities and displacements due to gun dynamics. We thought this could have a very large and random effect on dispersion. We were not in a position to do anything about narrowing down the source of error(s) but we did have to come up with a solution and fast. The time and ammunition constraints we faced prohibited us from zeroing 30 tanks. Our modified CCF was our interim solution. Our modified CCF allowed all tanks in the battalion to pass screen except two which had to be zeroed.

Figure 3. Tanks at the Screening Range
