- *Title:* Technology Showcase: Integrated Monitoring, Diagnostics and Failure Prevention.  
Proceedings of a Joint Conference, Mobile, Alabama, April 22-26, 1996.

# PREVENTION OF CRANKCASE EXPLOSIONS IN RECIPROCATING COMPRESSORS

V. A. Cox

Shell Research Ltd  
Thornton Research Centre  
P.O. Box 1  
Chester CH1 3SH  
United Kingdom

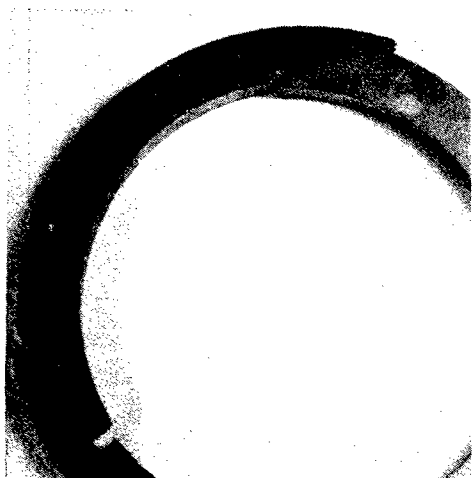
Examination of the elements from the piston rod wiper packings found unusual markings on those taken from one cylinder but not on the others. Damage observed on the mating faces of the oil scraper rings is shown in Figure 2. No damage was seen on the faces adjacent to the containers, nor on the containers themselves. Metallographic examination of a cold-mounted section of a typical damaged wiper element showed shallow areas of microstructural transformation typical of the localised pitting that results from electrical discharge. Such transformation indicated that the local temperature had been raised to at least 240°C. A

Identical damage was later identified on wiper packing elements of two sister reciprocating compressors.

Figure 2. Appearance of damaged rings

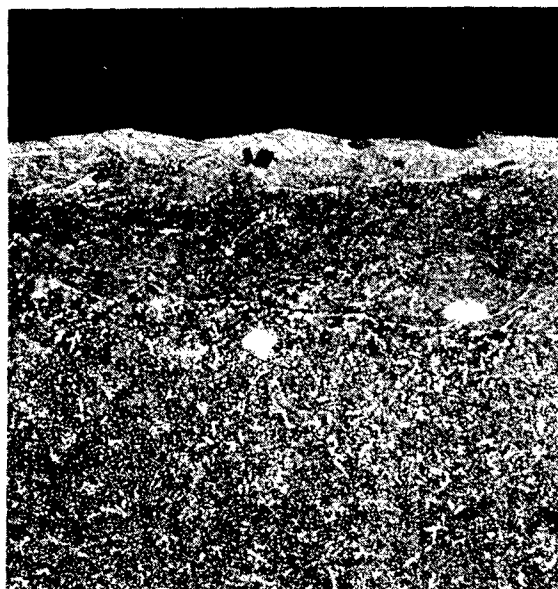
micrograph of this area is shown in Figure 3. Confirmation that this microstructure was typical of electrical arcing was obtained by comparison with laboratory-induced arcing on an undamaged ring.

Figure 3. Microstructure of a damaged area.

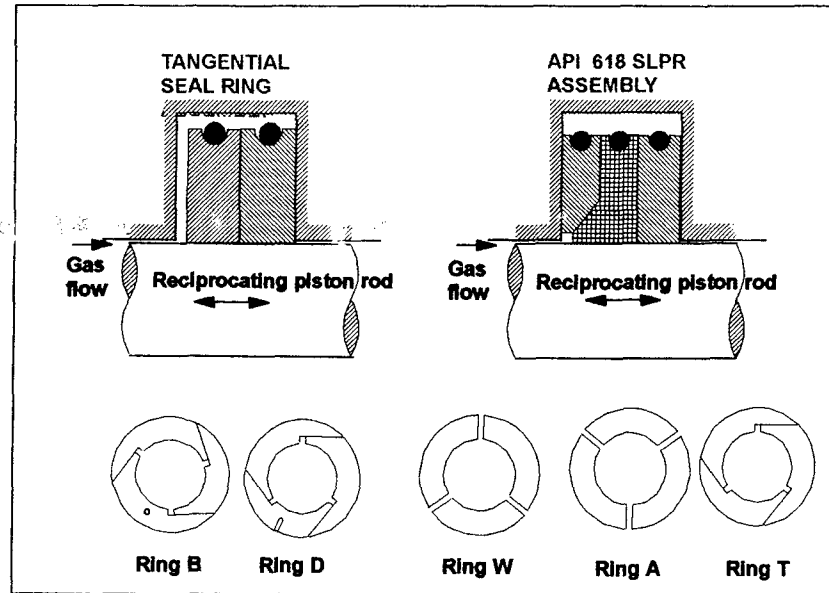
The source of gas within the distance piece and crankcase was considered to be inefficiency of the low-pressure (LP) axial seals. All four LP seals fitted in the locations shown in Figure 1 were of the type shown in Figure 4(a).

The double tangential seal is designed to operate with a small axial clearance, which allows the ring to reciprocate slightly with rod motion. The volume displaced by a ring on each stroke equals the product of the ring's cross sectional area and the axial clearance, 1244 mm<sup>3</sup>. Provided that a differential pressure exists across the seal, gas will pass it solely due to the effects of reciprocating motion. Leakage of gas to the crankcase by this mechanism could total 134 litres/hour when all six cylinders are taken into consideration.

Small pressures, typically between .15 and .4 bar.g., had been recorded in both the pressure packing and distance piece vent lines, due to backpressure resulting from long piping runs. The resulting pressure gradient between pressure packing and crankcase enabled a significant flow of gas into the crankcase, where it mixed with air already present. This is the explanation for the presence of an explosive mixture in the crankcase.

Figure 4. Low-pressure axial seal types, (a) double tangential, (b) SLPR

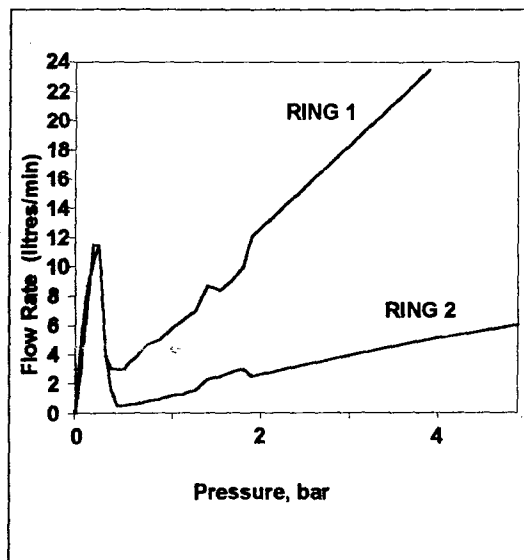
Initial testing was concentrated on the evaluation of commercial quality, LP seals. The early findings were that sealing performance was very dependent upon the quality of manufacture. As shown in Figure 6, whereas some rings sealed with reasonable efficiency others, of apparently equivalent manufactured quality, performed poorly. Immediate improvements to the surface finish of all rings were agreed with the manufacturer.

Also shown in Figure 6 is an important finding of this phase of the work. The performance of all seals was poor at the range 0 to 0.5 bar, i.e. the very range within which it would be called upon to operate in practice. This is believed to be a function of friction between the seal and

rod, which allows the seal to shuttle from one side of the container to the other, effectively "pumping" gas downstream. As an interim measure it was proposed to inject nitrogen into the space between the intermediate packing and the gas seal of the wiper packing at a pressure of 1 bar. A sketch of the arrangement is shown in Figure 7. No provision was made for nitrogen gas to exit the void, unlike a typical purge. The primary intention of this modification was to energise the seals and to overcome the frictional drag effects of the rod, a buffer of increased pressure being a secondary advantage. A nitrogen blanket, or any high capacity inert system, was not possible in the application for logistic reasons.

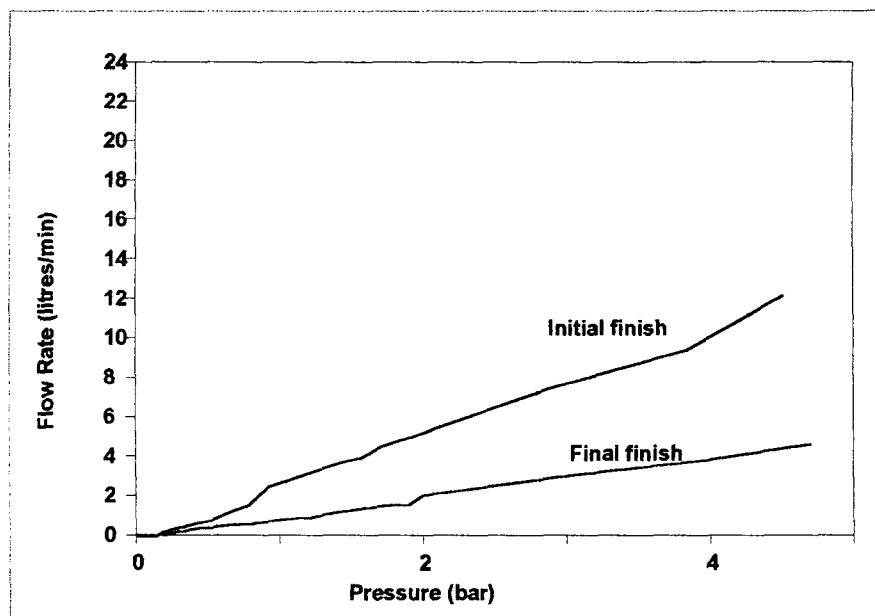
The test rig was next used to evaluate API 618 SLPR type seals, with a view to replacing the LP seals. The first rings tested were made to the finish standards of those in service in other applications, but these were found to have leakage rates considerably exceeding those of the later LP seals. Examination of these rings after testing showed the main cause to be coarseness of the turned finish of the 45 degree face. The least grooving that remained after machining led to friction between rings, inhibiting the even and constant conversion of radial spring tension to axial thrust. Discussions were held with the manufacturer to define the best repeatable commercial finish that could be provided on sealing surfaces. Agreement was reached that the chamfer faces would be fine-turned to a very high standard and that all radial seal faces would be lapped to 6-12 micro-inch CLA. A second set made to this standard was evaluated, giving the improved results shown in Figure 8.

Figure 8. Leakage of leaded bronze SLPR rings to vent.
