## FAILURE ANALYSIS OF A PITCH LINK SELF-LOCKING NUT MS 17825-10

Scott Grendahl

U.S. Army Materials Research Laboratory  
Aberdeen Proving Ground, MD 21005-5059

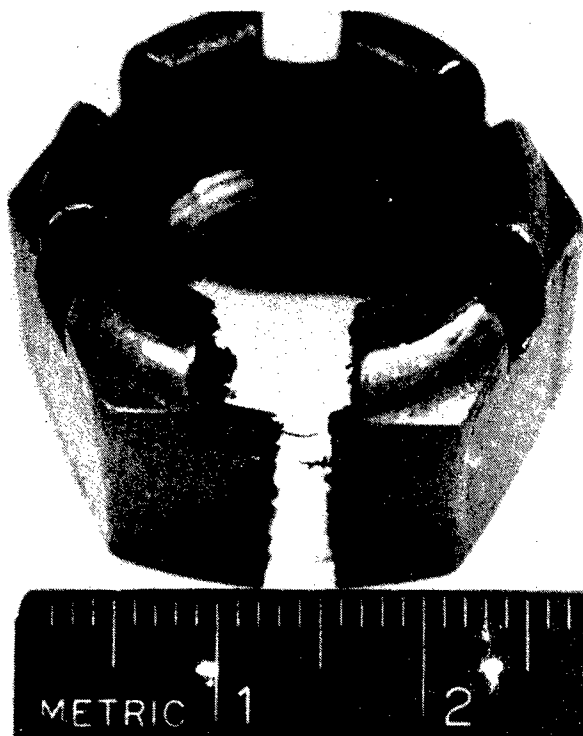
**Light Optical Microscopy:** The self-locking nut received was split open approximately 1/8 of an inch along its longitudinal axis as shown in Figures 1. The cadmium plating was relatively intact with no evidence of general corrosion or pitting observed. The fracture surface contained slight discoloration from post fracture corrosion. This discoloration from corrosion can be seen in Figures 2 and 3. Upon sectioning, it was determined that the crack originated from a slightly subsurface area of the nut near the O.D. as seen in Figures 4 and 5 (arrows denote origin and inclusion band). The radial lines and chevron pattern converge to an area adjacent to the O.D. of the nut opposite the castellated end. A long narrow band was noted on the fracture surface traveling parallel to the O.D. edge of the nut opposite the threads as shown in Figures 2 - 5 (arrows denote band). This region displayed a distinctly different appearance from the remaining fracture. It was decided that this artifact was a result of an elongated inclusion from primary processing. The inclusion encompassed the entire length of the nut. The fracture likely progressed under uniform loading conditions as evidenced by the lack of distinct crack arrest marks in the origin area. The fracture surface morphology was generally ductile throughout with a considerable amount of inclusions aligned along the longitudinal axis, remnant of the extruding direction of the part. There was a shear lip on the thread tips and on the castellated end of the nut which indicated final fracture.

Figure 1. As received condition of failed component, scale in centimeters.

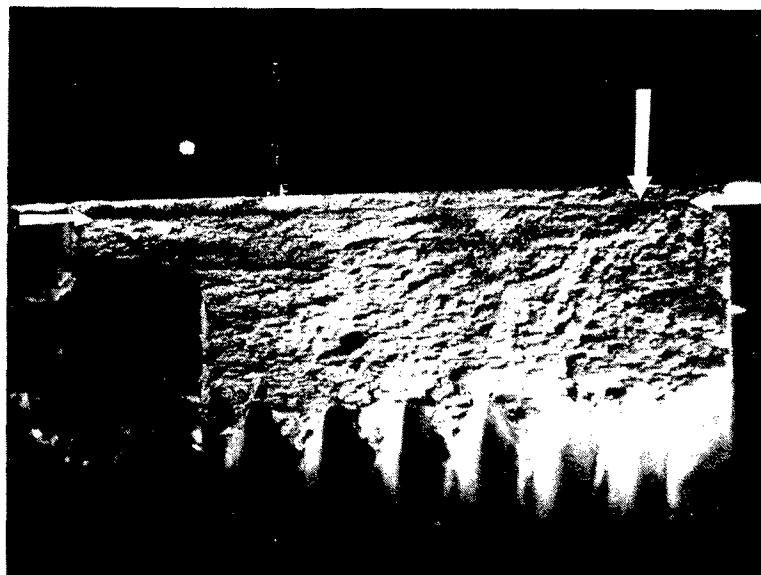
Figure 4. Micrograph of fracture half "A", arrow denotes origin. Mag. 10x

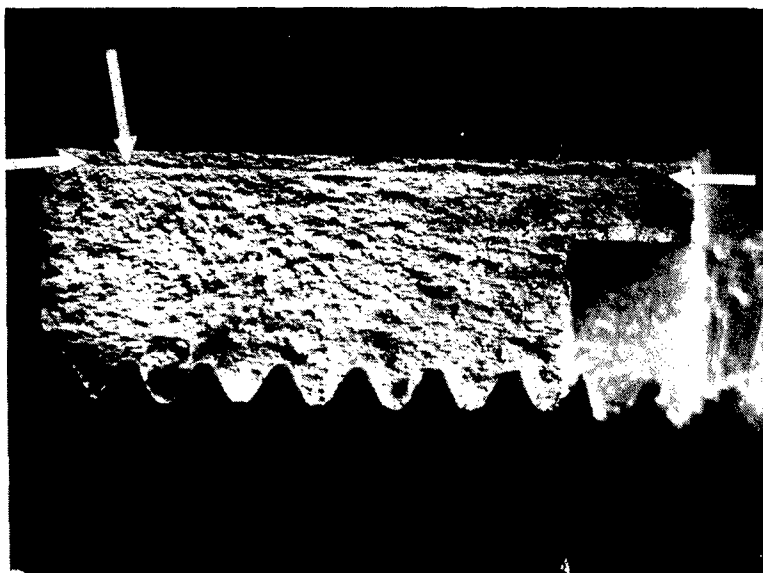
Figure 5. Micrograph of fracture half "B", arrow denotes origin. Mag. 10x

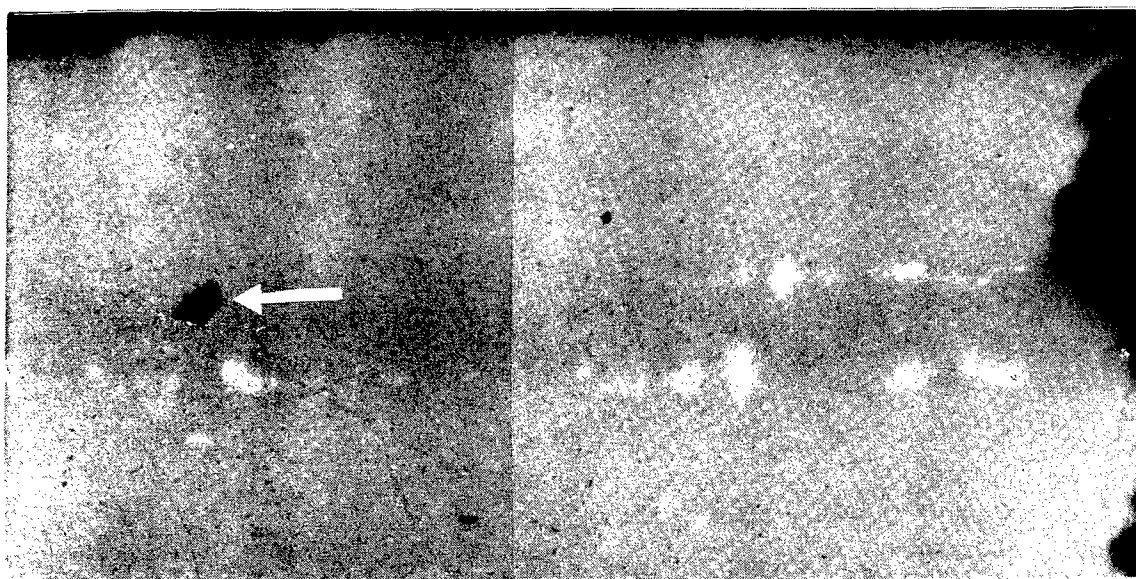
Figure 6. Micrograph of failure inclusion size and depth. Mag. 200x

The failed part has a thread size of 0.625 inches and therefore falls under the above criteria. A cross-section of the inclusion from the failed part can be seen in Figure 6. This section was taken from an area 0.025 inches from the fracture surface at the end opposite the origin. The inclusion depth at this location is 0.010 inches as measured from the photomicrograph per ASTM-B-487. This is within the limit set forth in MIL-N-25027G. It is important to note that the governing specification is probably not referring to inclusions of the type that caused this failure in setting the limits on depth. The specification is most likely referring to abnormalities or discontinuities open to the surface that can not be labeled as laps or seams. Inclusions of this severity are indeed rare since proper primary processing techniques usually eliminate them. The maximum depth of this inclusion was contained on the fracture surface and can be seen in the Scanning Electron Microscopy section of this report. Mn-S stringer inclusions are very common in steels of this type, however the inclusion that caused this failure was approximately 100 times larger in cross sectional area than normal inclusions of the same type.

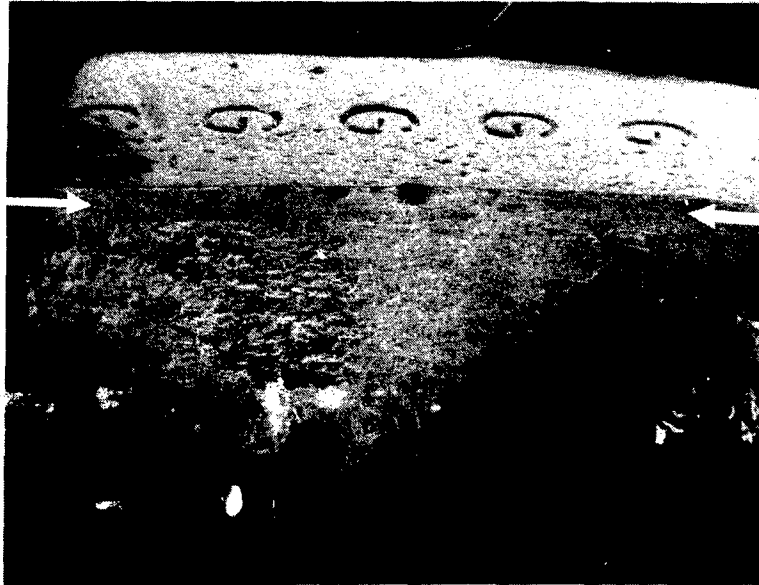
**Scanning Electron Microscopy and Energy Dispersive Spectroscopy:** The fracture surface of the failed nut was characterized utilizing Scanning Electron Microscopy (SEM) and Energy Dispersive Spectroscopy (EDS). The surface, with the exception of origin area and the inclusion that caused the failure, was composed entirely of ductile dimples (D) with elongated stringers characteristic of an overload failure of an extruded part. The fracture surface is shown in Figure 7, note the inclusion band that caused failure denoted by arrows. Figure 8 shows the origin area (arrow denotes origin). It can be observed at higher magnification in Figure 9 and 10. The Mn-S stringer

Figure 7. SEM fractograph of the nut, arrows denote line of inclusions. Mag. 10x

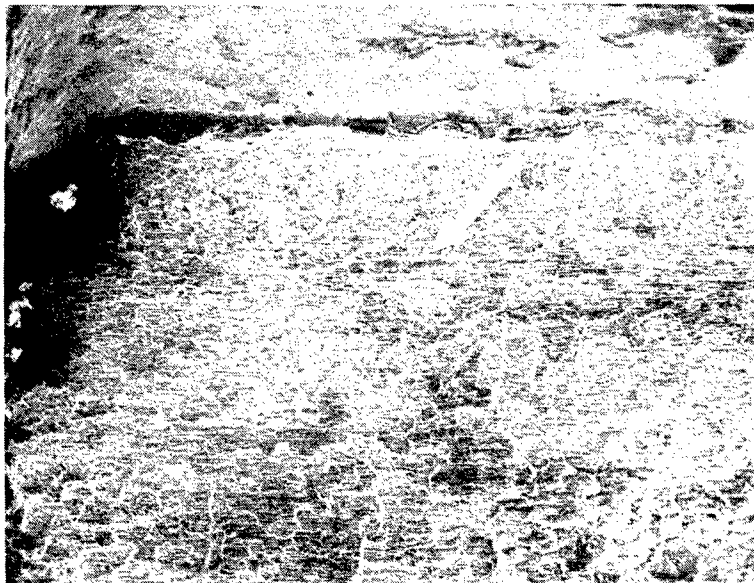
Figure 8. SEM micrograph of the origin area, arrow denotes origin. Mag. 75x

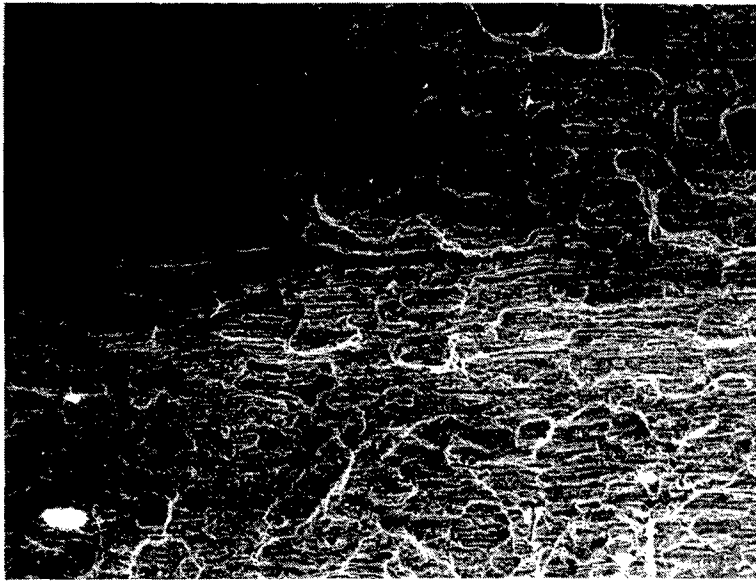
Figure 9. SEM micrograph of the inclusion that caused failure. Mag. 200x

that caused this cavity was not present at the origin but the inclusion must have measured at least 0.0015 inches in diameter as is approximately 0.013 inches in depth from the surface. Fracture morphology near the origin was mixed-mode, both transgranular (T) and ductile (D) modes of fracture are shown in Figure 11. Cadmium rich areas were found along the Mn-S stringer that caused failure indicative of a path open to the outside surface may have existed while the nut was in the plating bath. These cadmium deposits are shown in Figure 12 denoted by arrows. Figure 13 depicts the fracture surface morphology of the majority of the nut and the ductile dimples aligned along the extrusion direction. Shear lips (SL) were also noted on the tips of the threads and the castellated end indicating that these areas were the last to fail. The fracture morphology of the shear lips is shown in Figure 14. The inclusions on the fracture surface were identified to be manganese-sulfide through Energy Dispersive Spectroscopy (EDS) utilized in conjunction with the SEM. Inclusions of this severity can be deleterious to the mechanical properties of the material. Inclusions of the magnitude of the one causing this failure may obviously be catastrophic to the component. Figure 15 maps out the entire fracture surface morphology indicating the respective fracture modes. EDS aided in determining the fact that the inclusion band contained cadmium. This provided evidence that the defect may have been open to the surface during the cadmium plating process and occurred as a result of primary processing operations as opposed to a service or installation related anomaly. The use of EDS also helped identify that the nut contained lead as verified by chemical analysis.

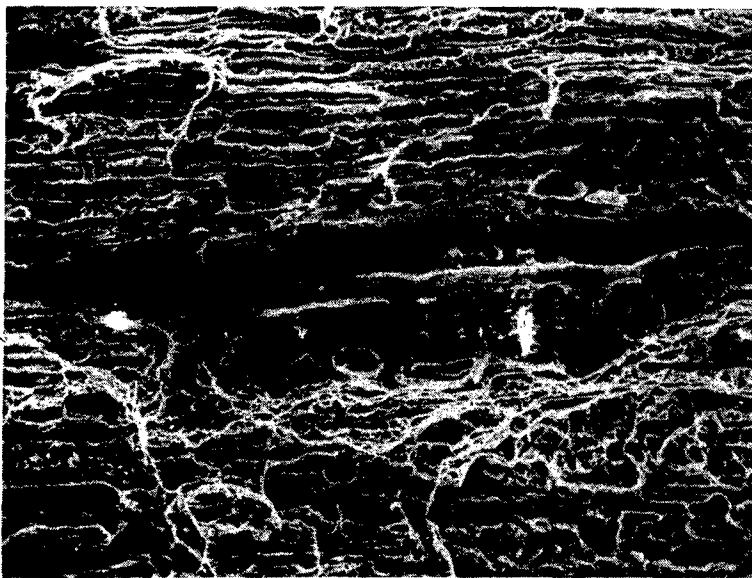
Figure 10. SEM micrograph showing Figure 9 at high magnification. Mag. 500x

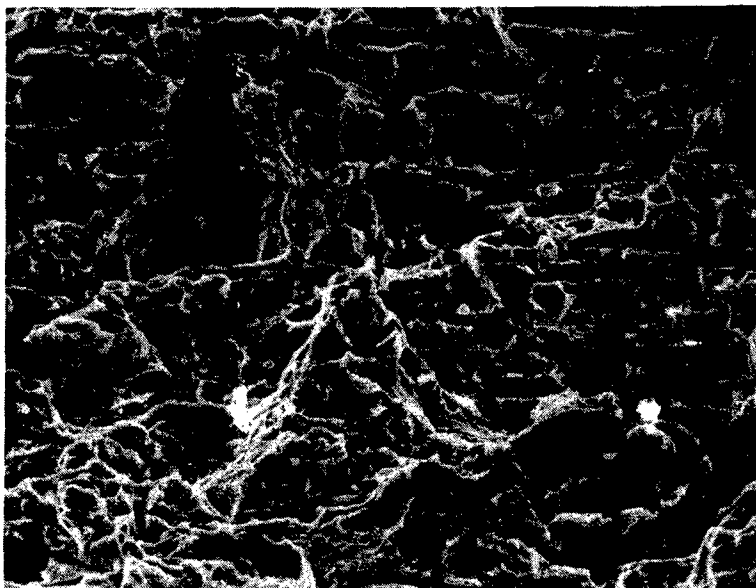
Figure 11. SEM micrograph of transgranular-ductile morphology at origin. Mag. 1000x

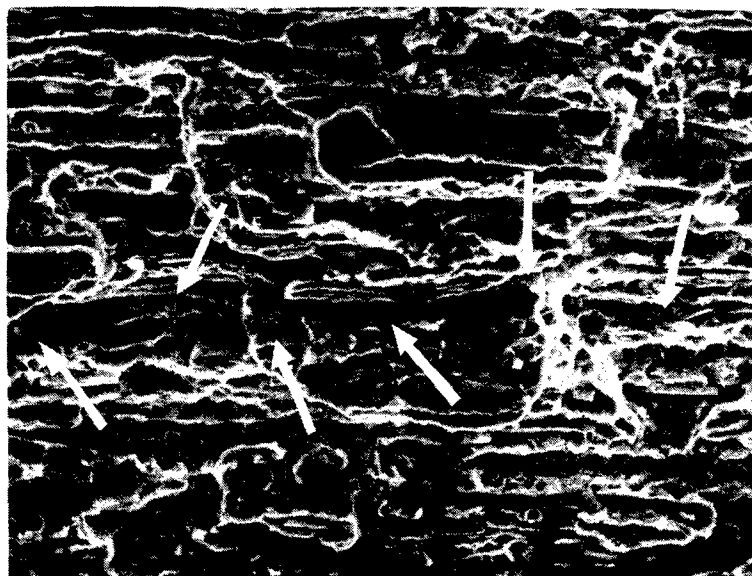
Figure 12. SEM micrograph of cadmium line along inclusion line. Mag. 1000x  
Arrows denote existence of cadmium.

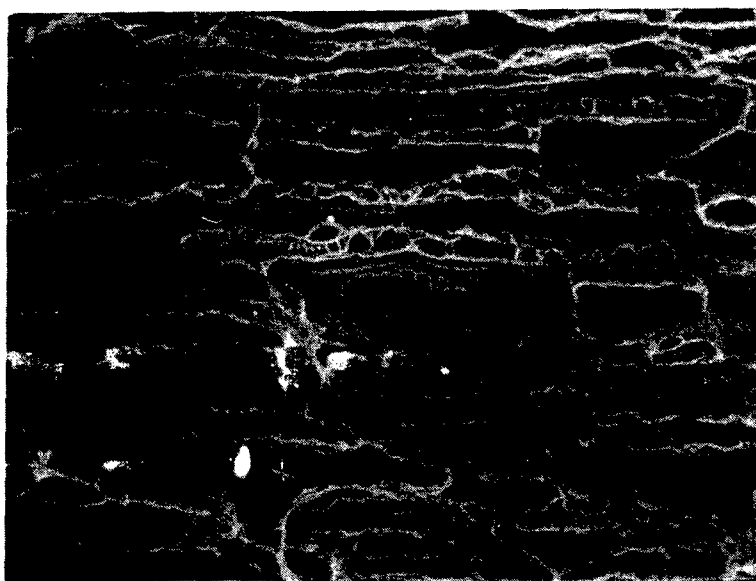
Figure 13. SEM micrograph of the elongated ductile morphology. Mag. 1000x

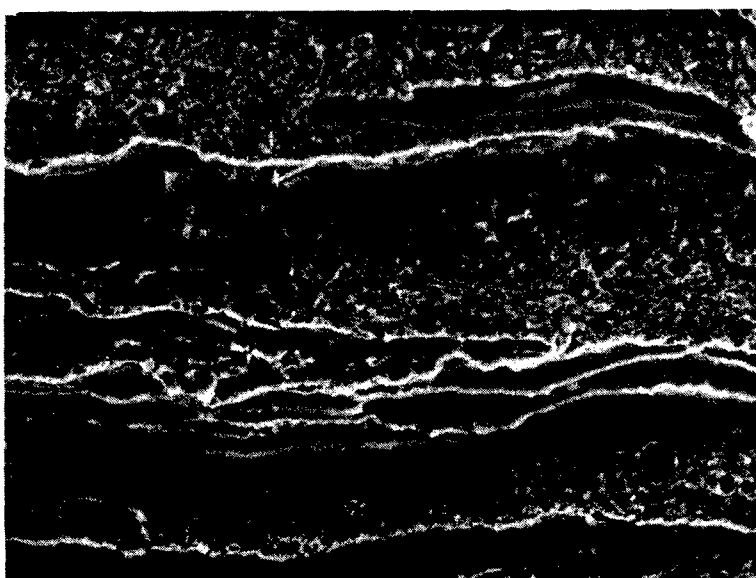
Figure 14. SEM micrograph of the morphology of the shear lip region. Mag. 1000x

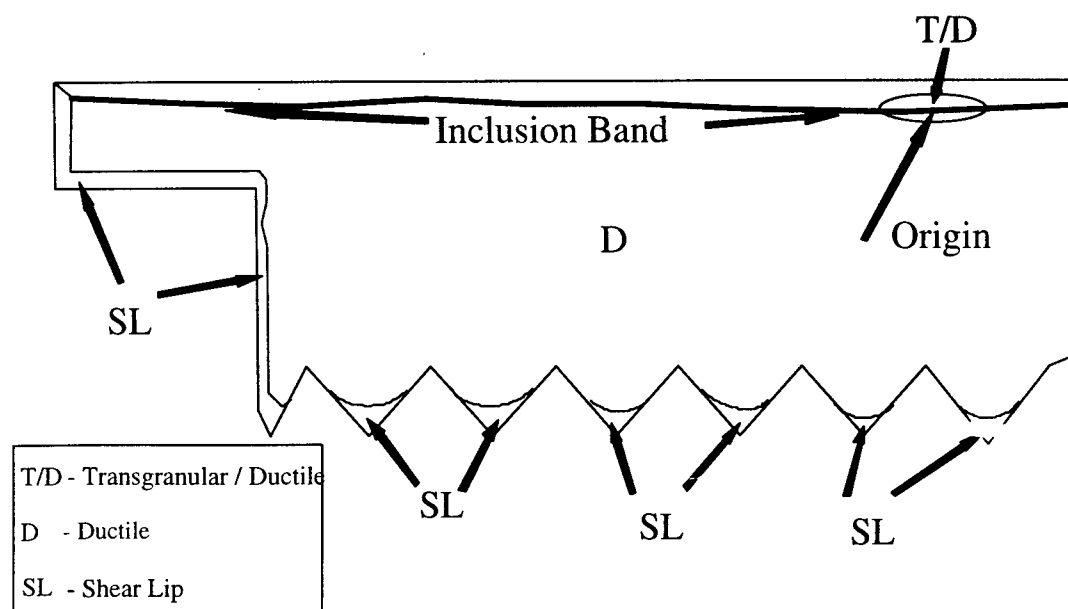
Figure 15. Map of fracture surface morphology for the failed component.
