## FAILURE ANALYSIS OF MODULAR LIFT LINK, LUG MOUNTING, SELF-LOCKING NUTS

Scott Grendahl

U.S. Army Research Laboratory  
Aberdeen Proving Ground, Aberdeen, MD

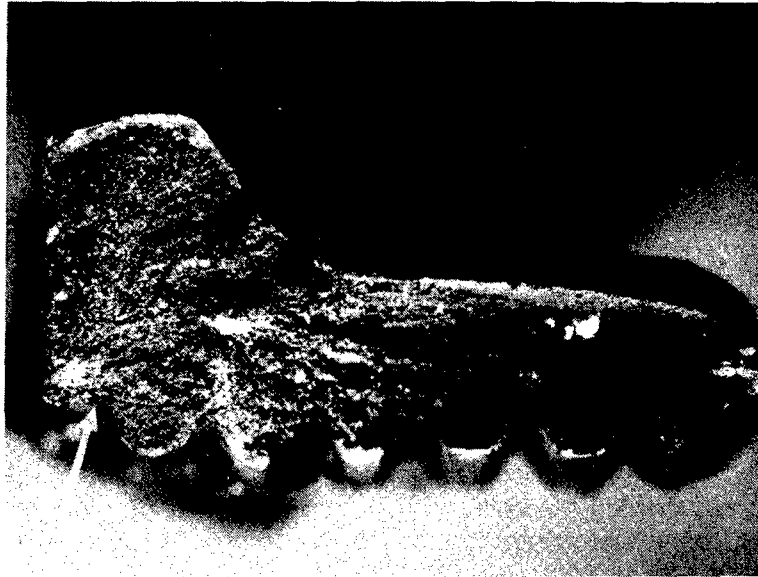
Figure 1. Micrograph of the fracture surface of Nut "A". Mag. 20x

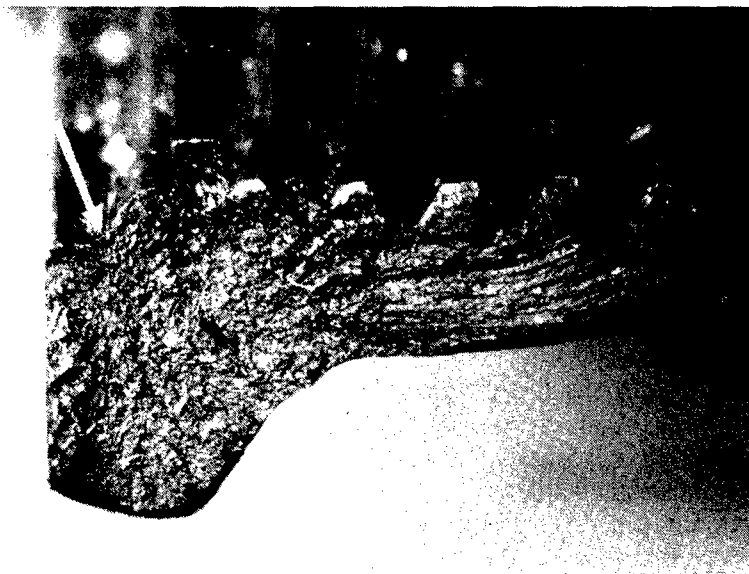
Figure 2. Micrograph of the mating fracture surface of Figure 7. Mag. 20x

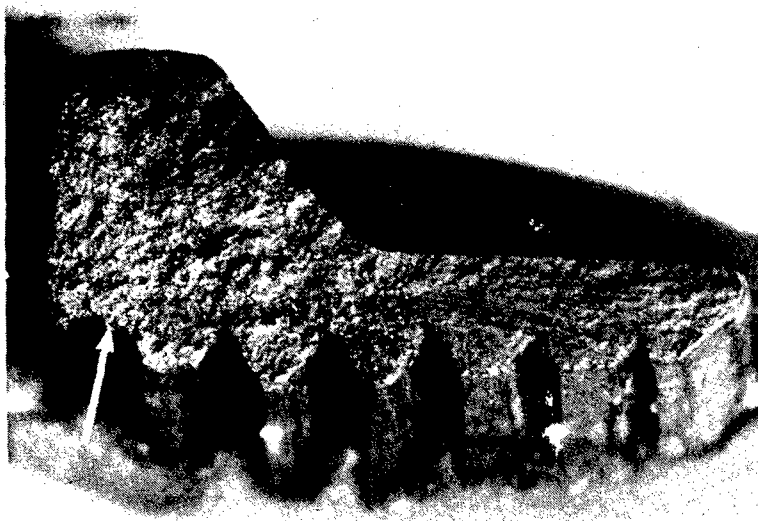
Figure 3. Micrograph of the fracture surface of Nut "B1". Mag. 20x

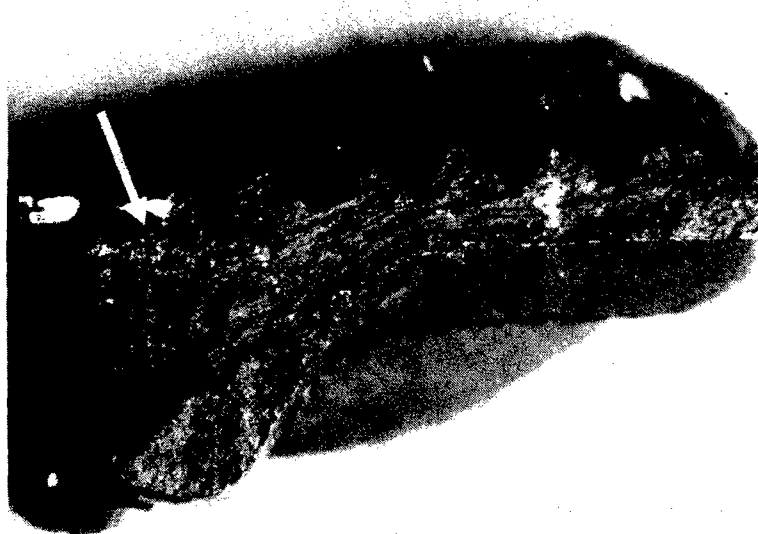
Figure 4. Micrograph of Nut "B" fracture surface "B2". Mag. 20x

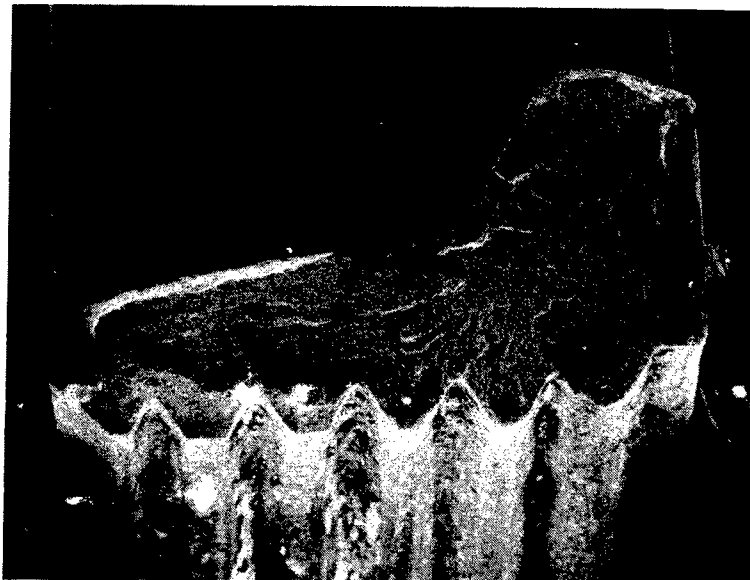
**Scanning Electron Microscopy and EDS:** The fractures of Nut "A" and Nut "B" were classic cases of HAC with service stress related failure. SEM fractographs of Nut "A" and "B" failures are shown in Figures 5, 6 and 7, 8 respectively. The fracture morphologies at the crack origins of Nuts "A" and "B" were intergranular (I) as shown in Figures 9 and 10. These SEM micrographs show the traditional "rock candy" features, as well as some secondary cracking. X-ray mapping (utilizing energy dispersive spectroscopy) of the entire fracture surfaces did not reveal a layer of cadmium on or near the fracture origins. The absence of a cadmium film suggests the cracking most likely occurred in service rather than in the plating bath. The intergranular regions transitioned to large mixed-mode (D/I) regions consisting of intergranular decohesion and ductile dimples covering nearly half of the fracture surfaces. These mixed mode morphologies are shown in Figures 11 and 12. The mixed-mode morphologies transitioned abruptly to ductile dimples (D) as shown in Figures 13 and 14. This abrupt change in morphology represents the areas of fast fracture beyond the third or fourth threads. Figures 13 and 14 also show the ductile dimples aligned in the extrusion direction of the components. Shear lips (SL) were also noted on Nut "A", indicative of the last region to fail. Light optical and scanning electron microscopy did not reveal any gross anomalies at the fracture origin. The schematics shown in Figure 15 and 16 outline the different

Figure 5. SEM micrograph of the fracture surface of Nut "A". Mag. 15x

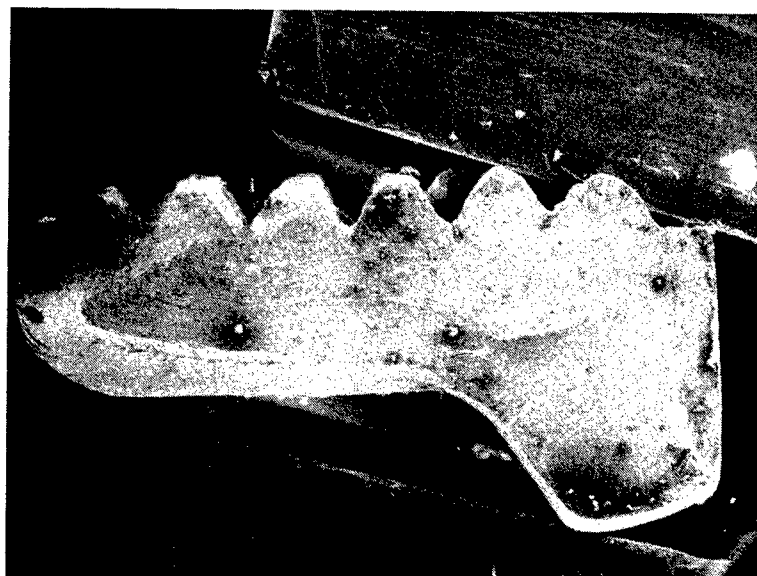
Figure 6. Mating fracture surface of Nut "A" Figure 19. Mag. 15x

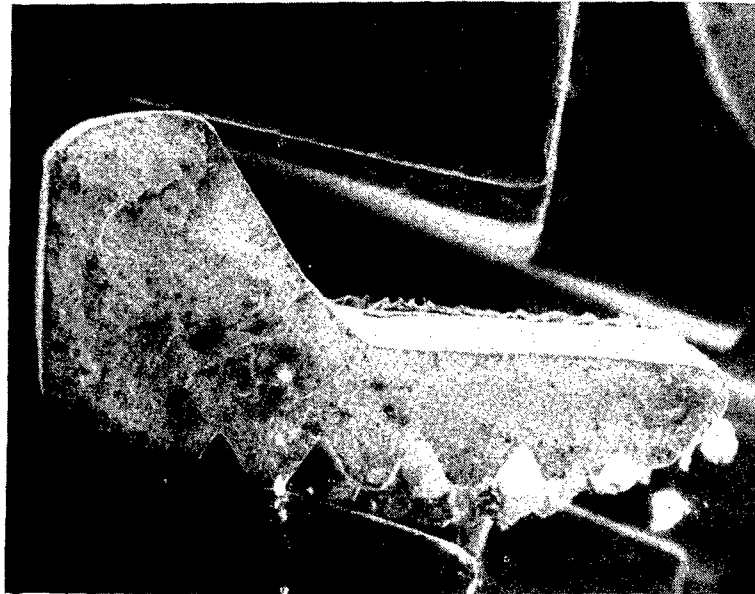
Figure 7. SEM micrograph of the fracture surface of specimen "B1". Mag. 15x

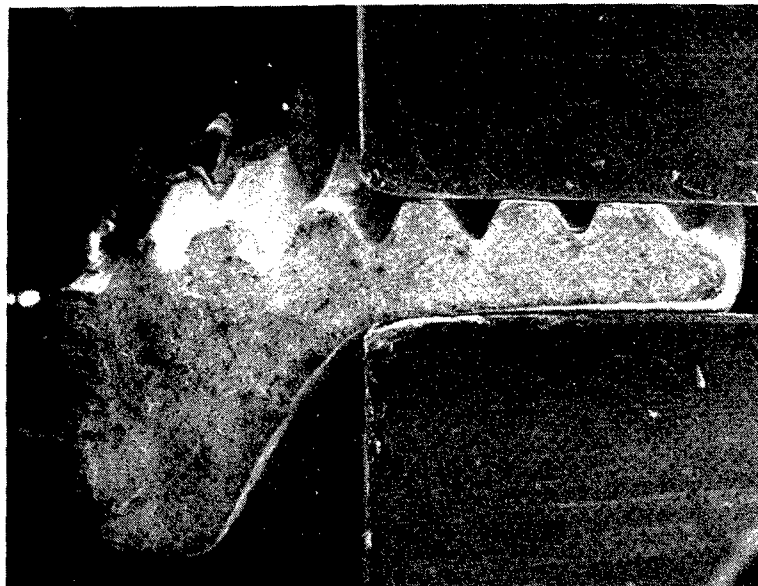
Figure 8. SEM micrograph of the fracture surface of specimen "B2". Mag. 15x

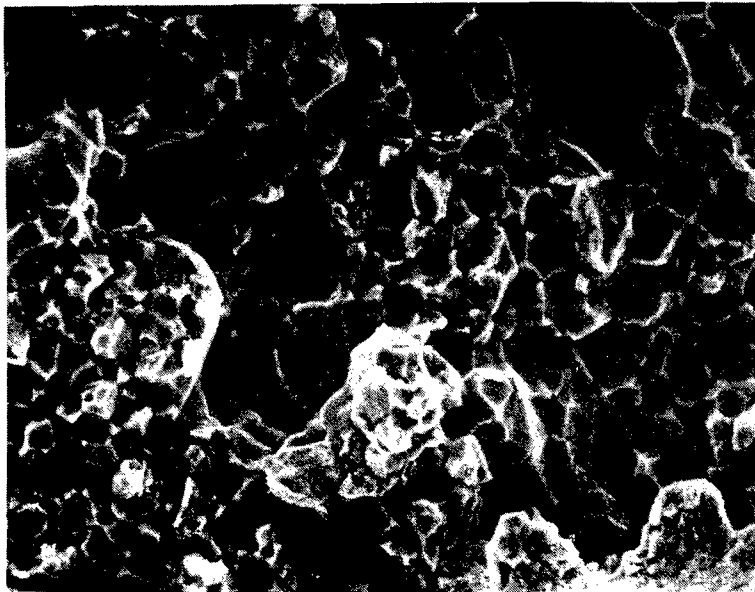
Figure 9. SEM fractograph of morphology at the origin of Nut "A". Mag. 1000x

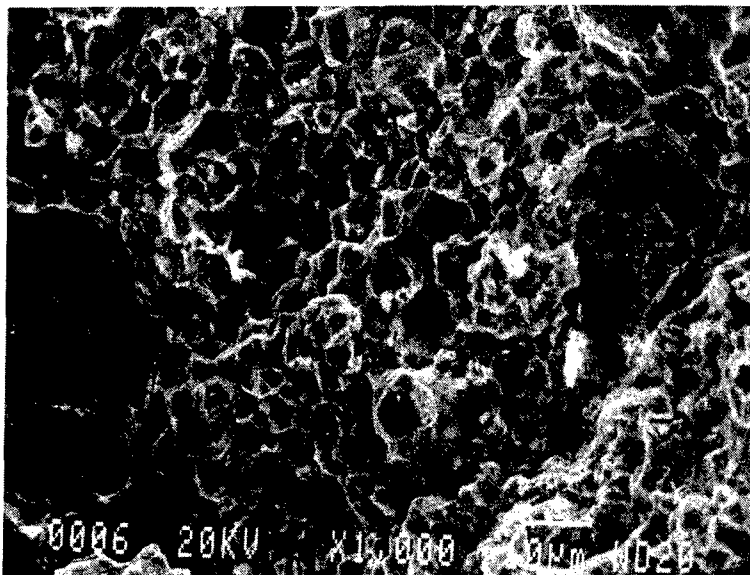
Figure 10. SEM fractograph of morphology at the origin of Nut "B". Mag. 1000x

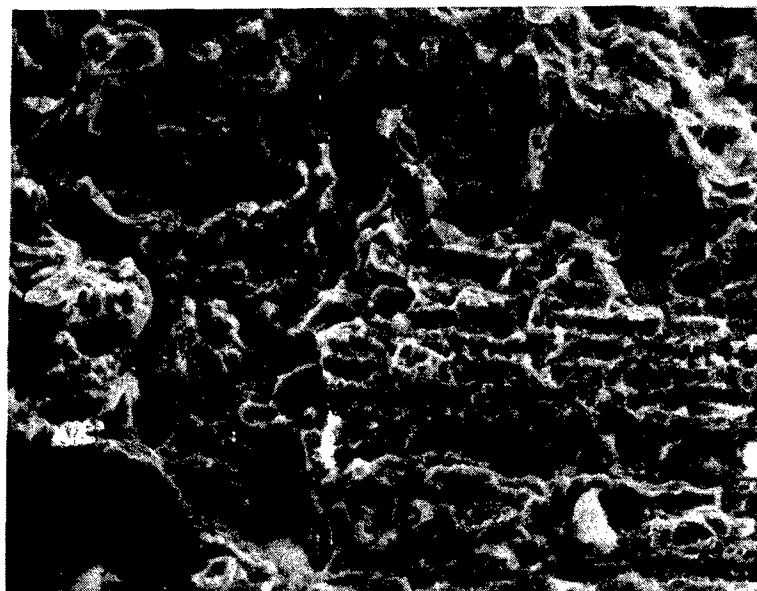
Figure 11. SEM fractograph of mixed-mode morphology of Nut "A". Mag 1000x

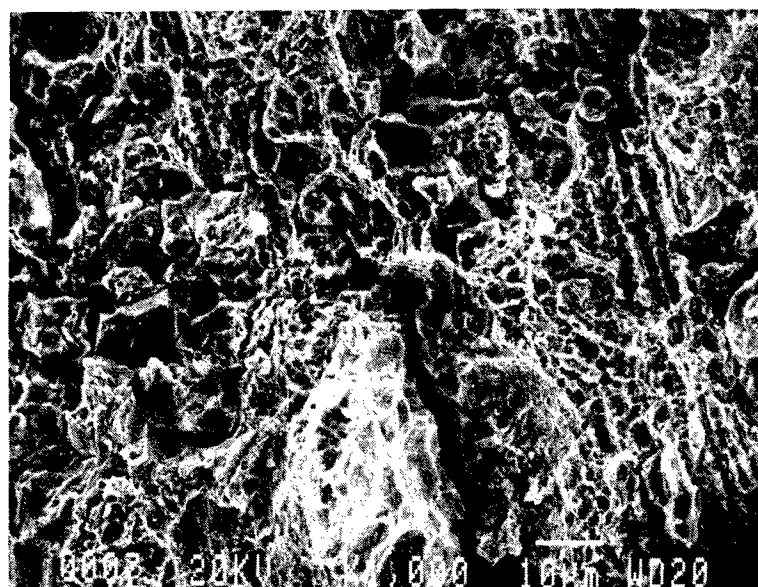
Figure 12. SEM fractograph of mixed-mode morphology of Nut "B". Mag 1000x

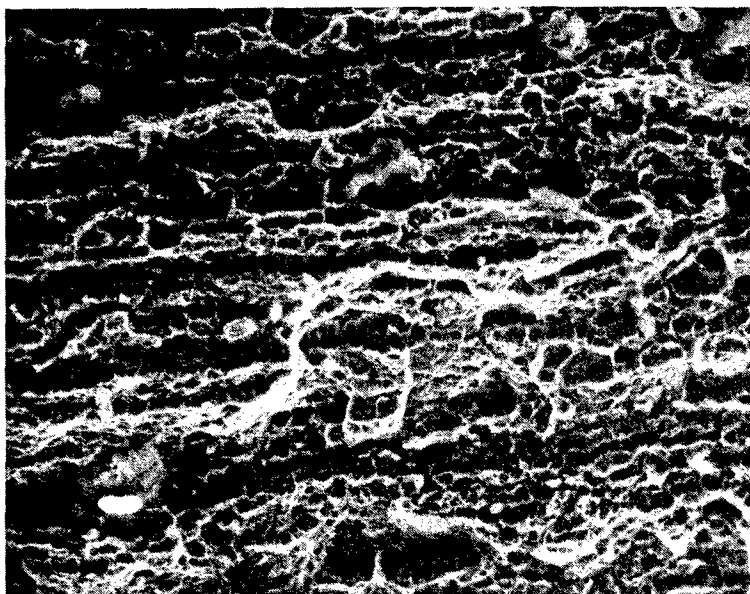
Figure 13. SEM fractograph of ductile dimple morphology of Nut "A". Mag 1000x

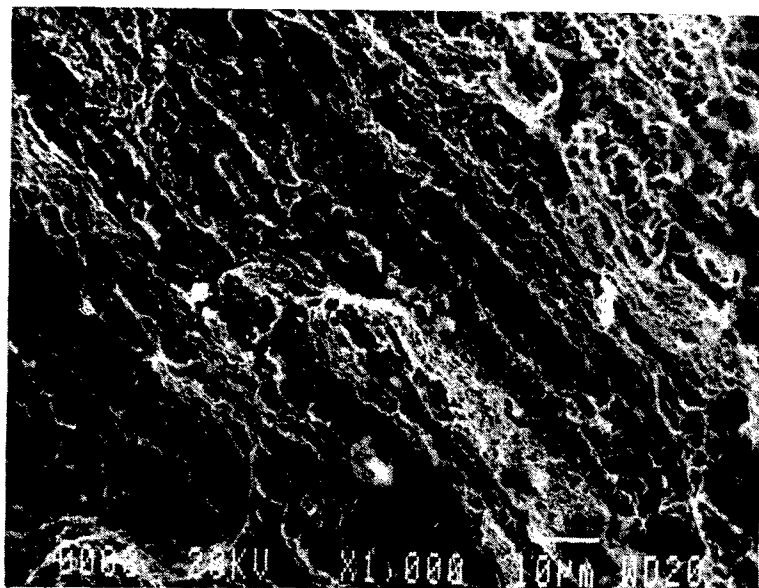
Figure 14. SEM fractograph of ductile dimple morphology of Nut "B". Mag 1000x

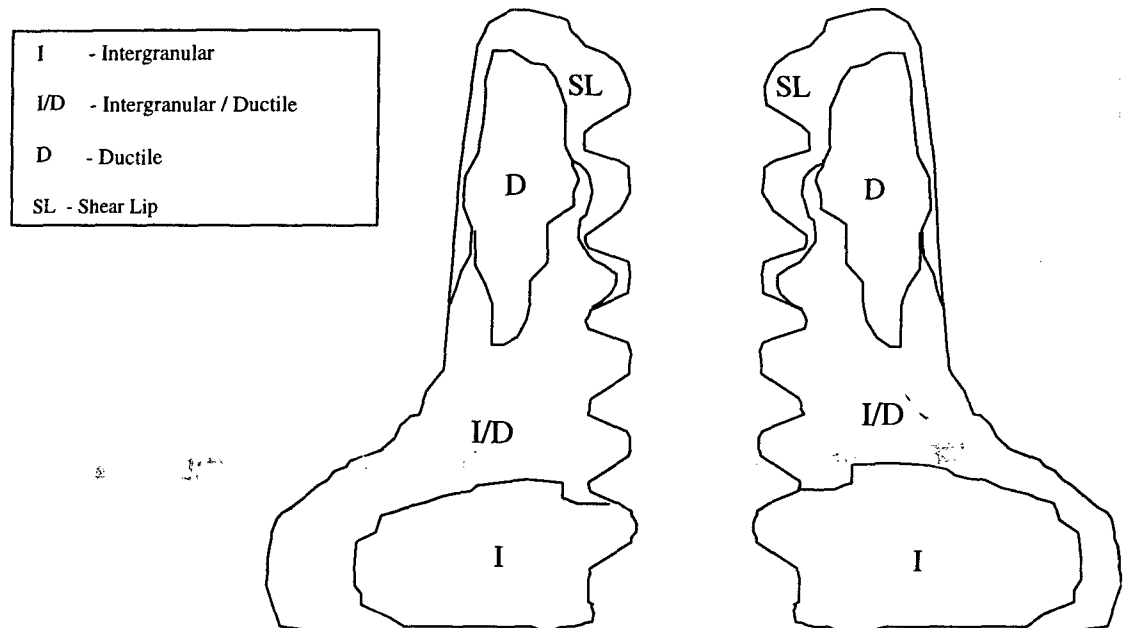
morphologies noted on the mating fracture surfaces of Nut "A" and the two different fracture surfaces of Nut "B", respectively.

Figure 15. Map of failure modes for mating fracture halves of Nut "A"

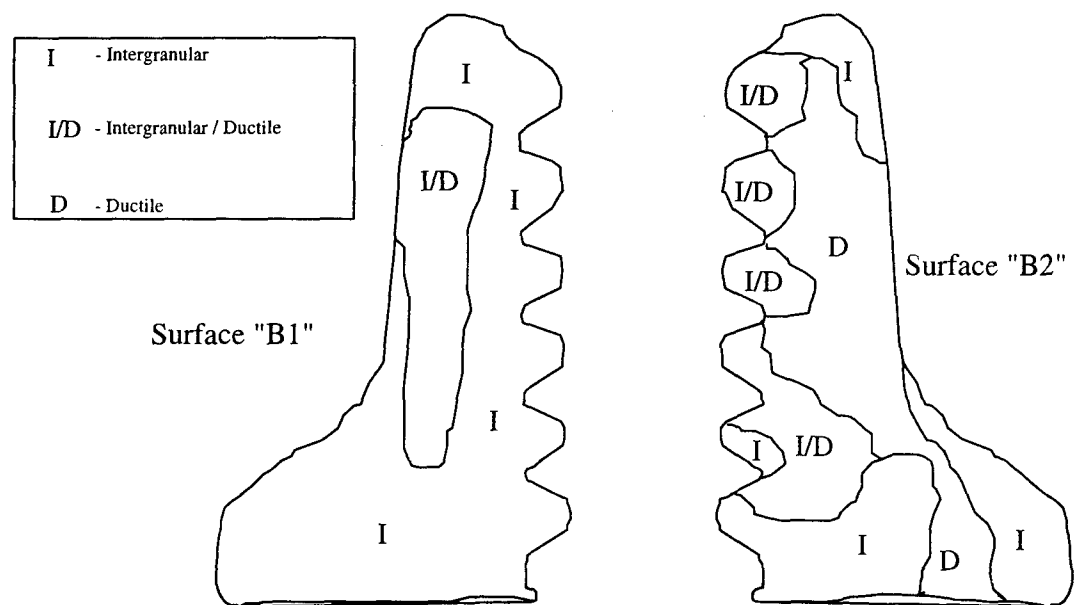
Figure 16. Map of failure modes of fracture surfaces of Nut "B"
