## METALLURGICAL EXAMINATION OF A FAILED SPIRAL BEVEL GEAR

Marc Pepi  
U.S. Army Research Laboratory  
Materials Directorate  
Aberdeen Proving Ground, Maryland 21005

### Abstract

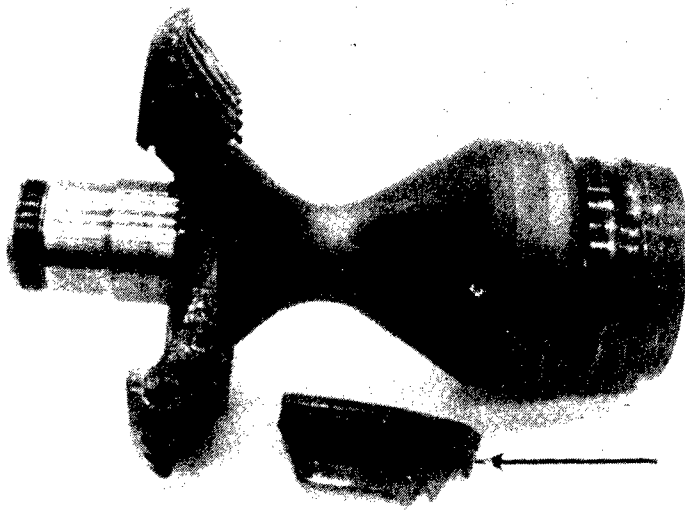
A spiral bevel transmission gear (Figure 1) from an Army cargo helicopter failed during a training flight leading to an immediate landing. Inspection of the number 2 engine transmission revealed that an 8-tooth segment (out of a 35-tooth gear) had fractured and penetrated the transmission housing. The failed component was fabricated from X-2M steel (a modified H11 tool steel), and

Figure 1 Optical Macrograph of the failed spiral bevel gear and the fractured eight-tooth segment (denoted by the arrow). Reduced 70%.

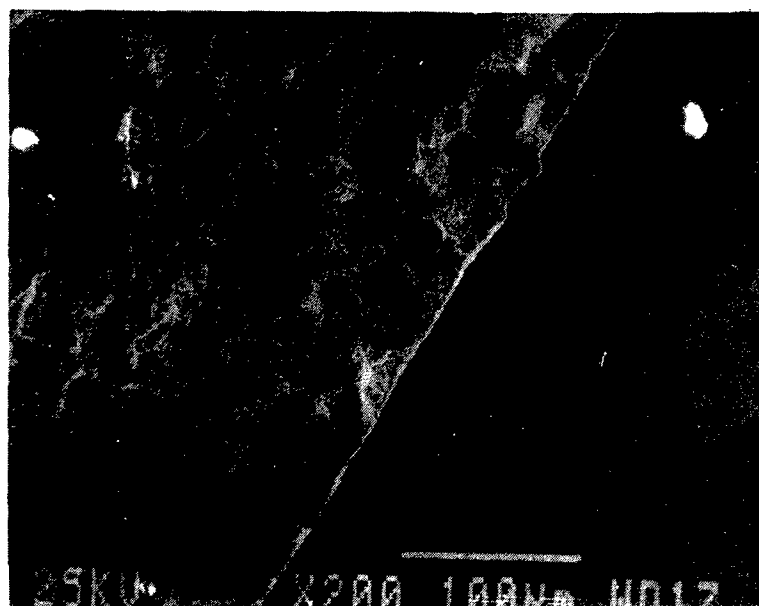
Fractographic examination of a secondary through-fracture revealed an intergranular morphology within the case of the damping ring groove area (see Figure 6). The remaining morphology consisted of ductile dimples, indicative of overload fracture. No evidence of fatigue was noted in this section. This finding was evidence that a grinding crack had propagated along the continuous carbide networks.

Figure 6 Secondary fracture sample from the damping ring groove area found to contain an intergranular morphology. A grinding crack most likely propagated along the carbide networks. Mag. 200x.
