# The Inadequacy of Safe-Life Prediction: Aero-Engine Fan and Compressor Disk Cracking

**B.J. Wicks, R.A. Antoniou, S.L. Slater and J. Hou**

Aeronautical and Maritime Research Laboratory  
Defence Science and Technology Organisation  
Department of Defence  
Box 4331 GPO  
Melbourne 3001  
Australia

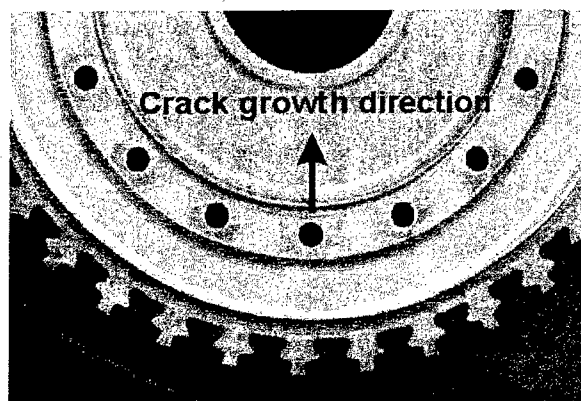
Following the detection of a crack emanating from a bolt-hole in an engine disk, an investigation was undertaken to determine the subsequent crack growth behaviour. The disk geometry and observed crack direction are shown in Figure 1. The radial crack emanating from the bolt-hole was cut from the disk and opened, revealing the crack face shown in Figure. 2. The cracking was found to be due to fatigue which had started within the bore of the hole and away from the corner. The crack markings were examined using both optical and scanning microscopy and the crack growth rate was predicted using both numerical and analytical methods and compared to the measured growth rate.

Figure 1: Disk geometry and crack growth direction.

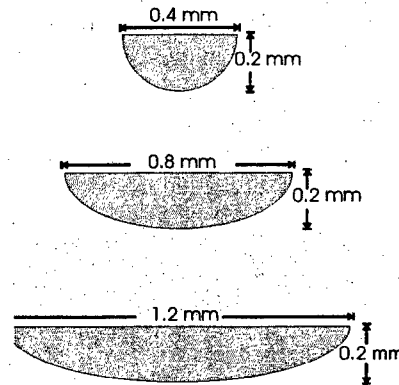
Semi-circular and semi-elliptical surface cracks with a depth of 0.2 mm were inserted perpendicular to the front snap radius at the peak stress location, 25 degrees from the radius

runout (Figure 8). Stress intensity factors (SIF's) were then calculated using the J-integral method. The SIF values at the both free surface ends increase with crack length whilst the crack depth remains constant (Figure 9). Therefore, a crack initiated at the front snap radius is expected to grow preferentially in the circumferential direction and to grow at a slower rate in the radial direction.

Figure 8 Initial crack profiles used in the analysis

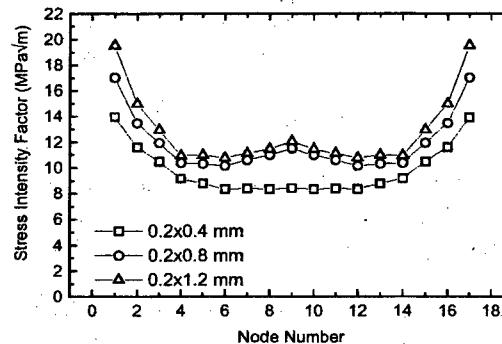
Figure 9: Stress Intensity Function distributions for initial crack profiles.
