TITLE: Rehabilitation of TCE-Contaminated Underground Storm Water System Using Trenchless Technology

# REHABILITATION OF TCE-CONTAMINATED UNDERGROUND STORM WATER SYSTEM USING TRENCHLESS TECHNOLOGY

Michael A. Turco, P.E., DEE and Eric E. Huss  
Brown & Root Environmental  
993 Old Eagle School Road, Ste. 415  
Wayne, PA 19087-1710  
(610) 971-0900  
(610) 971-9715 telefax  
bbrf716@barms061.b-r.com

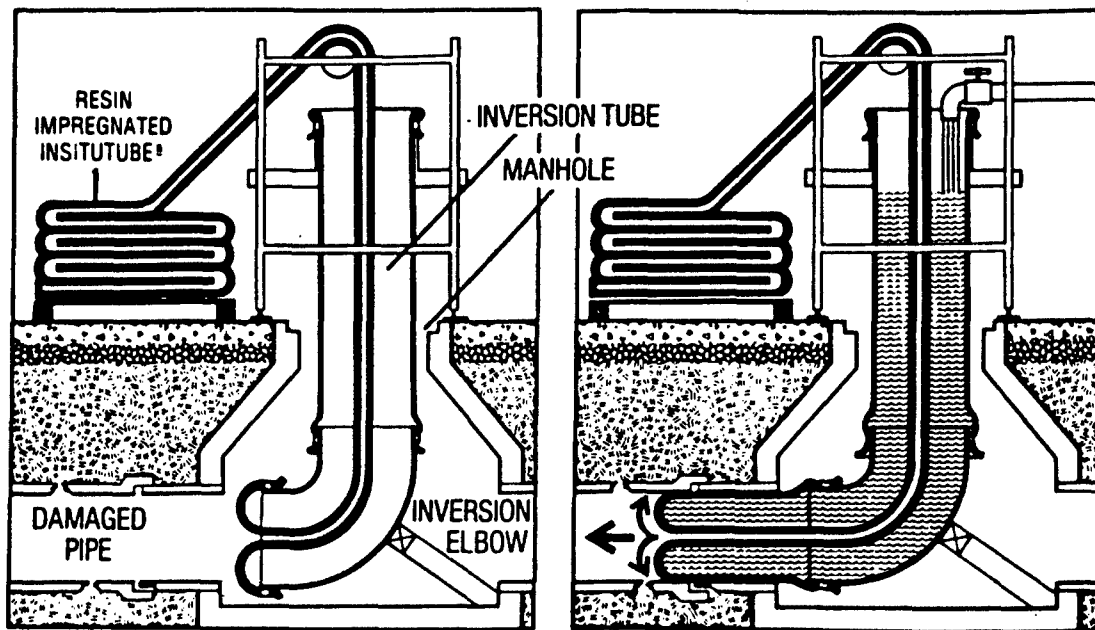
Figure 2. Set Up and Placement of Insituform<sup>®</sup> CIPP

The CIPP technology selected for the NAWC Trenton storm water system rehabilitation was provided by Insituform<sup>®</sup> of North America. The set up and installation is depicted in Figures 2 and 3. A plastic-coated, needled felt tube is custom engineered and prefabricated to the desired length and diameter that is required to fit the deteriorated line(s). It is impregnated with a liquid thermosetting resin and shipped to the installation site. A support scaffold with an inversion tube and elbow is set up over a manway leading to the damaged pipe. One end of the prefabricated tube is banded to the lower end of the inversion tube elbow. The inversion tube is then filled with water. The weight of the water inverts the felt tube and forces it to expand inside the damaged pipe. The tube turns inside out and is pressed by the water against the inside walls of the old pipe. The smooth, coated side of the felt tube becomes the new interior surface of the pipe. (Figure 2).

The inversion process results in no relative movement between the felt tube and the old pipe, minimizing damage to the flexible tube material. Also, any incoming or standing water is forced ahead of the inverting tube and out of the pipe. No water that could inhibit proper curing of the resin or alter the shape of the finished pipe is trapped behind the new tube.

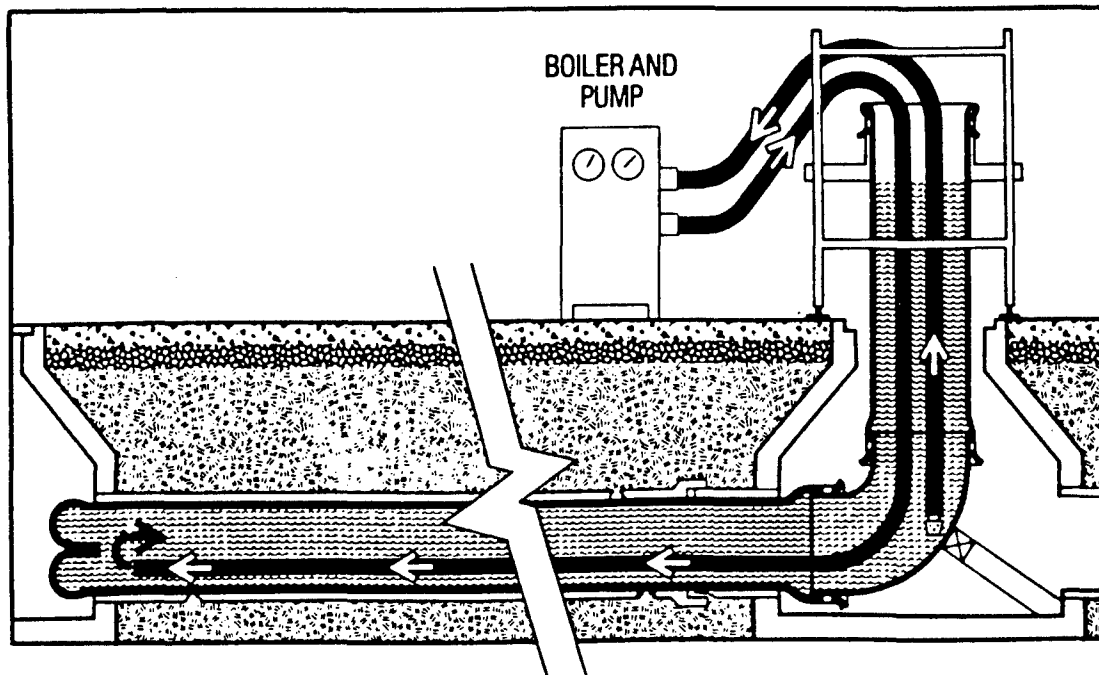
Figure 3. Curing of Insituform® CIPP

After the tube is fully inverted through the old pipe, the water used for inversion is circulated (via a hose attached to and drawn into the tube while it is inverting) through a heater to a temperature of approximately 160° F. The hot water causes the thermosetting resin to cure within a few hours. This changes the the pliable felt tube into a hard pipe-within-a-pipe. (Figure 3). The latter has no joints or seams and should be as strong or stronger than the pipe it replaces. The ends of the hardened pipe are cut off and sealed. The inversion tube and scaffolding are removed. Lateral connections to the pipe are restored by a camera-equipped, remotely controlled cutting device.
