J-47 JET ENGINE COMPRESSOR FAILURES

1 June 1950 - 31 December 1951

Office of The Inspector General, USAF  
Norton Air Force Base, California

7 April 1952

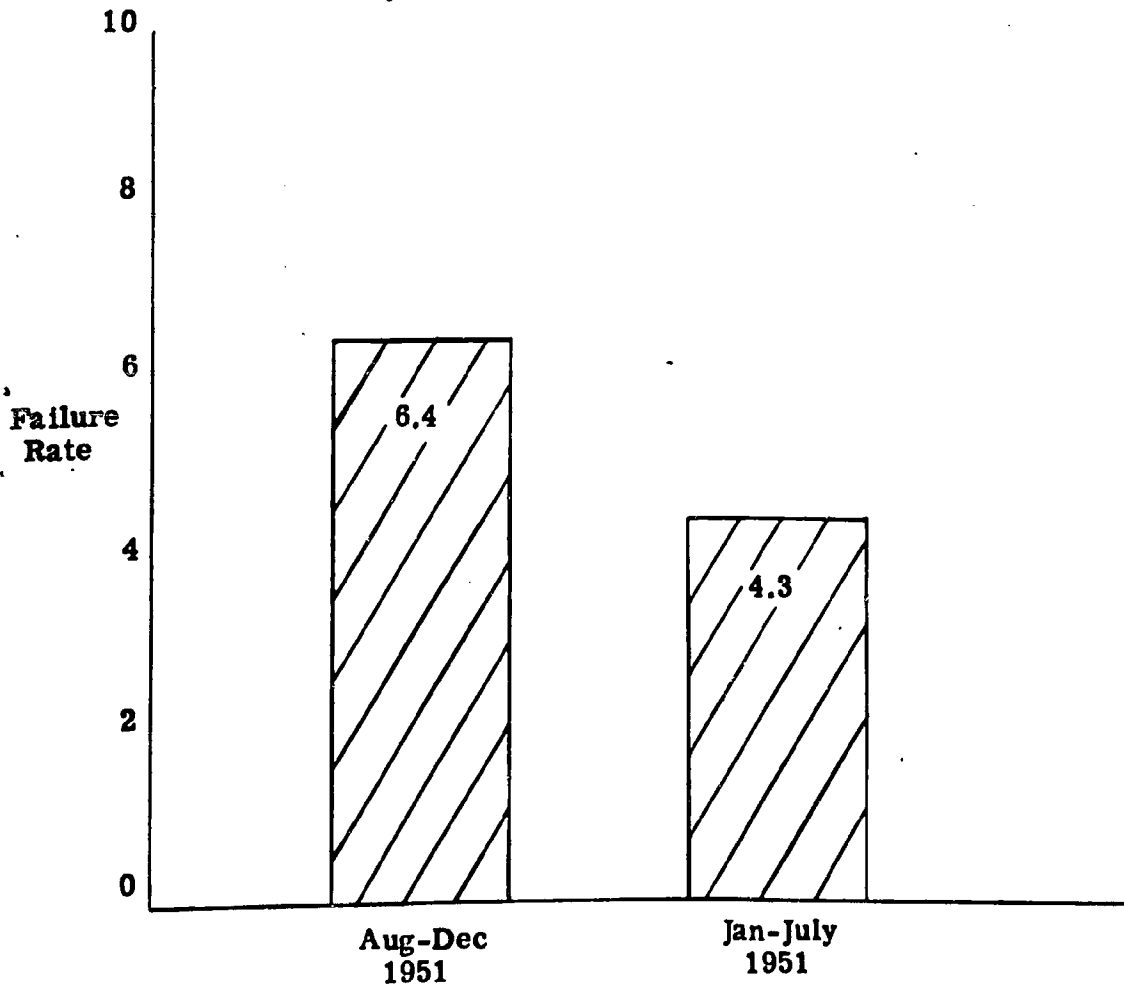
TABLE III

1951 COMPRESSOR ACCIDENT RATES PER 100,000 ENGINE HOURS

JAN-JULY VS AUG-DEC
