PROGRESS REPORT NO. 35

15 SEPTEMBER 1953 to 15 DECEMBER 1953

RTV-N-12a VIKING

Engineering Report No. 6164

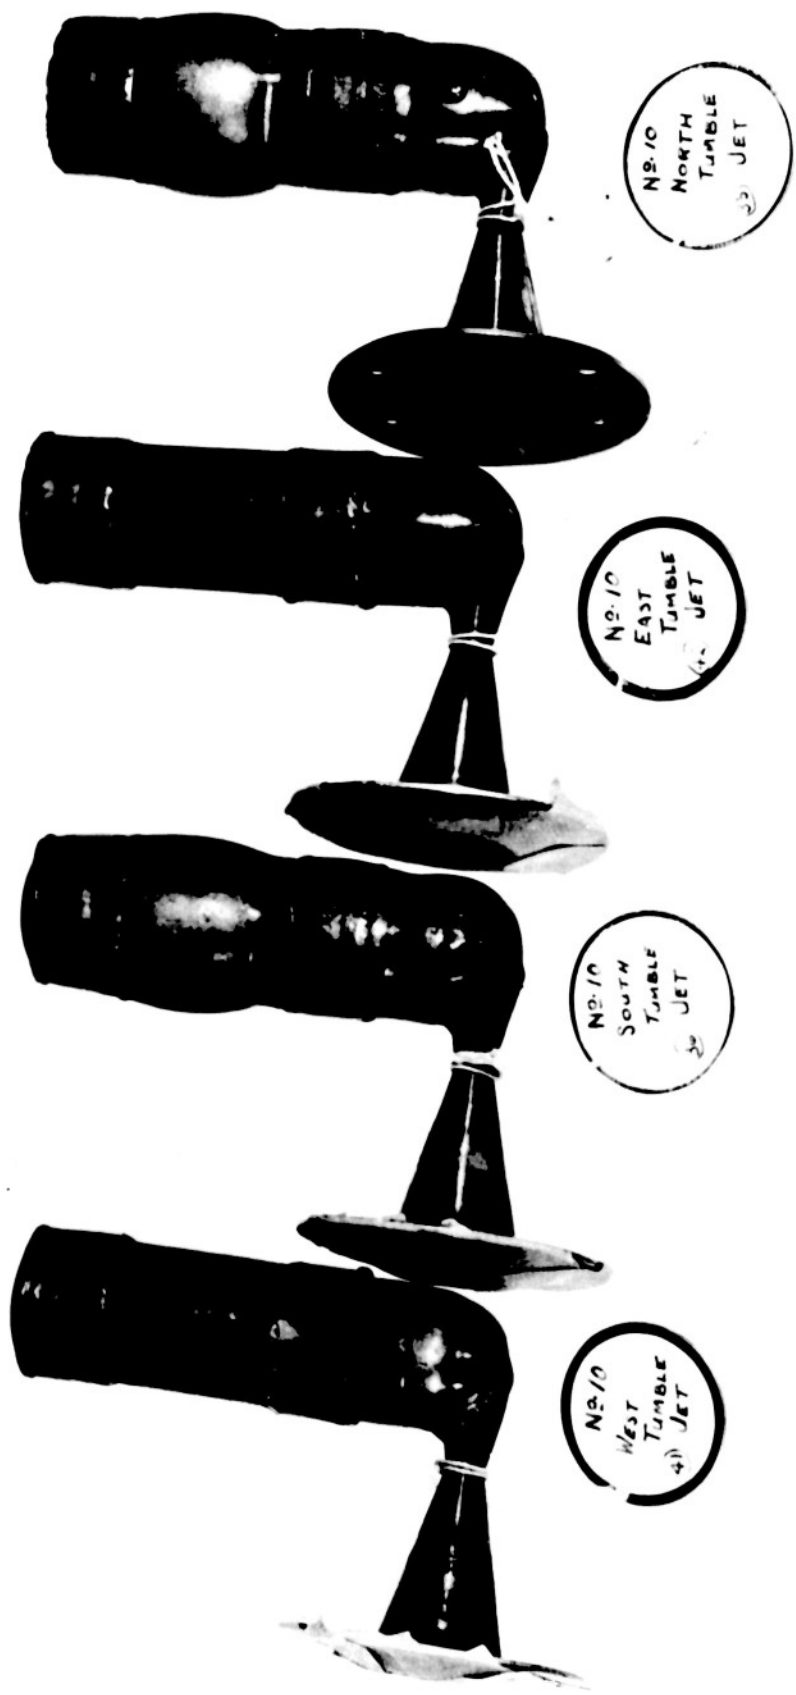
All of the  $H_2O_2$  motors which had been installed on Viking 10 at the time of the aborted flight firing were returned to GLM with the rocket. These were subsequently removed and subjected to a functional test. Performance of the roll system motors was acceptable; however, when the pitch/yaw units were operated, a malfunction in the form of high pressure surges was encountered. This anomaly resulted in damage of varying degrees to all four motors. In the case of motor No. 35, the head of the unit actually ruptured (Fig. 1). The pitch/yaw motors which are located in the tail section of the rocket apparently had sustained critical fire and water damage when the tail section of the rocket exploded and burned during a scheduled flight operation on 30 June 1953 (GLM ER 6001). This was evidenced by the large quantities of oxidization found on the catalyst screen ends, when the motors were later opened.

Fig. 1. Hydrogen Peroxide Motors from Viking No. 10 Damaged During Retest
