ARMOUR RESEARCH FOUNDATION  
of  
ILLINOIS INSTITUTE OF TECHNOLOGY  
Technology Center  
Chicago 16, Illinois

RESEARCH AND DEVELOPMENT OF LAMINATED  
GLASS AIRCRAFT WINDSHIELDS

Report No. 36

September 26, 1952

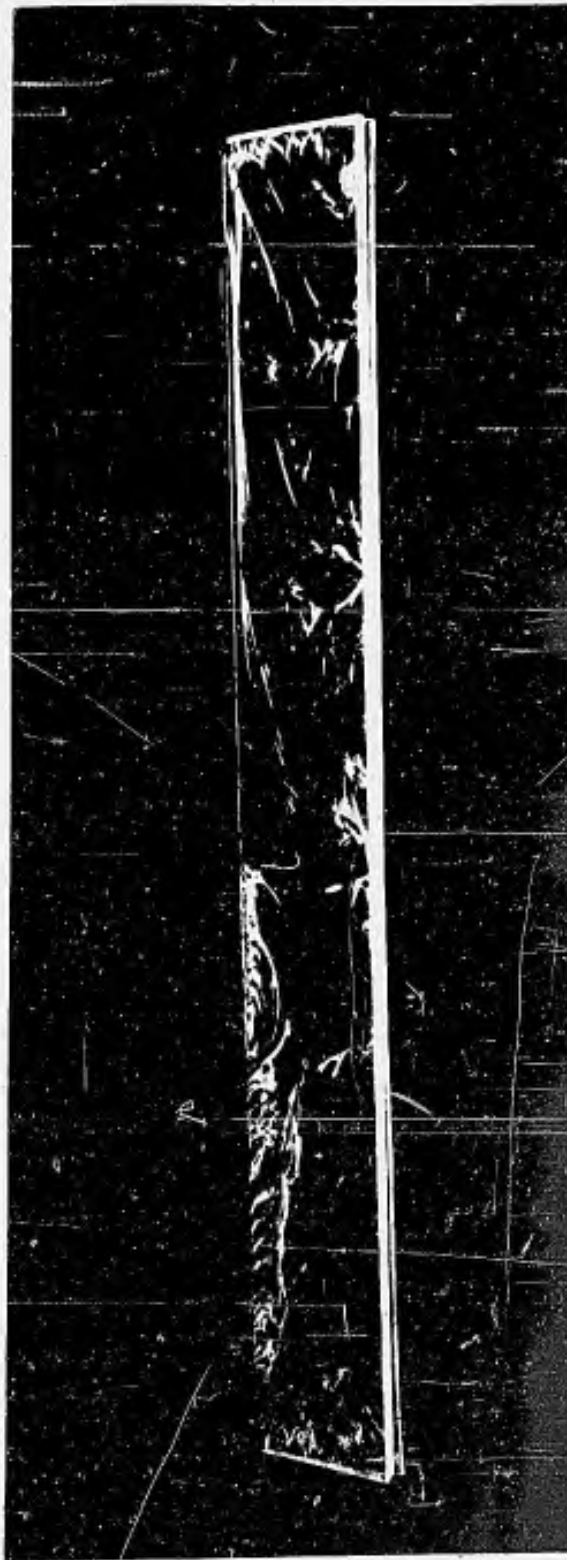
FIG. A-5 TWO-PLY (GLASS-PLASTIC) BEAM (SPECIMEN NO. 1)

AFTER FAILURE

In the low temperature test of the beam (Specimen No. 1), failure occurred at a temperature of -25° F. The failure consisted of a single crack in the glass near one corner of the beam, just above and parallel to the glass-plastic interface (Fig A-10). By lowering the temperature of the specimen it was possible to cause the crack to propagate into the interior of the beam. At approximately -40° F, another crack appeared

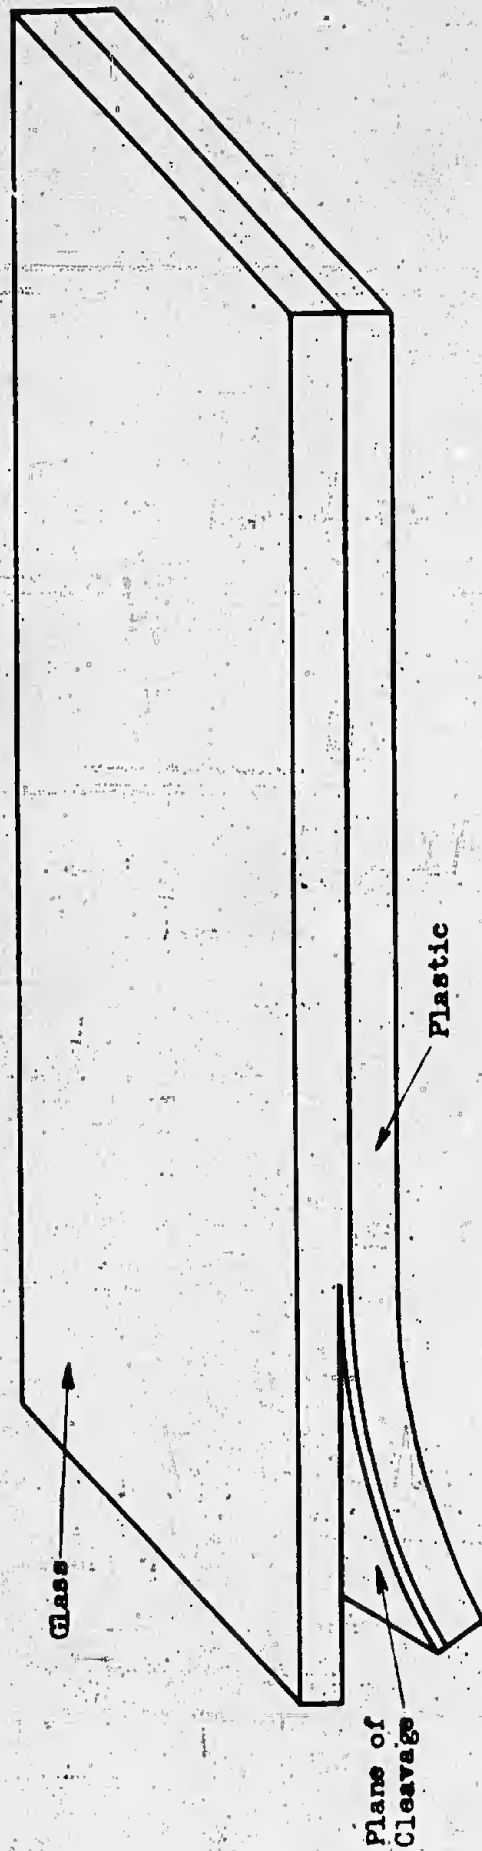
FIG. A-10 SKETCH OF BEAM (SPECIMEN No. 2) SHOWING PLANE OF CLEAVAGE

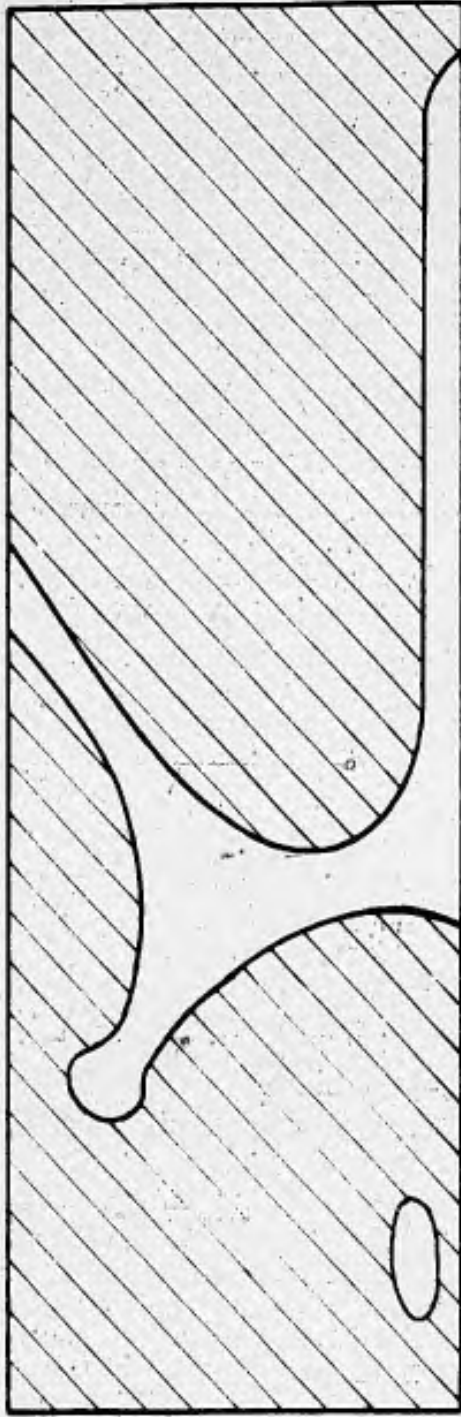
FIG. A-11 SHADED AREA SHOWS EXTENT OF CRACK AT  $-50^{\circ}$  F IN BEAM

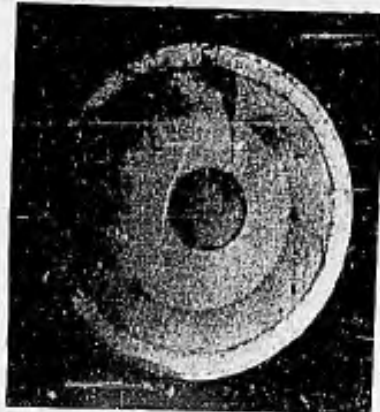
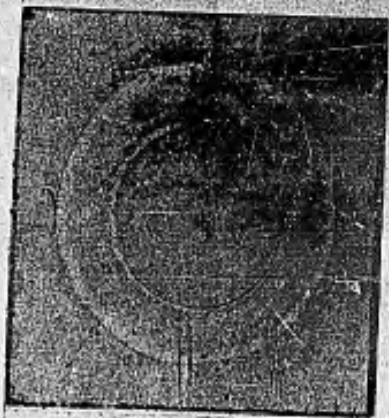
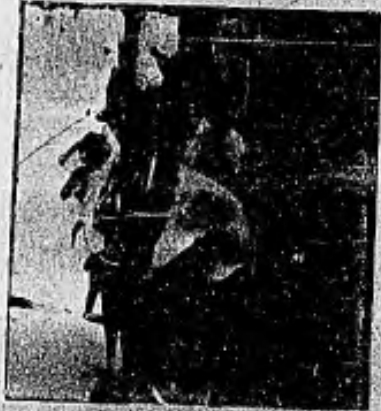
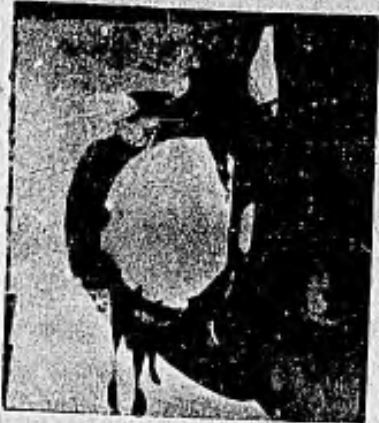
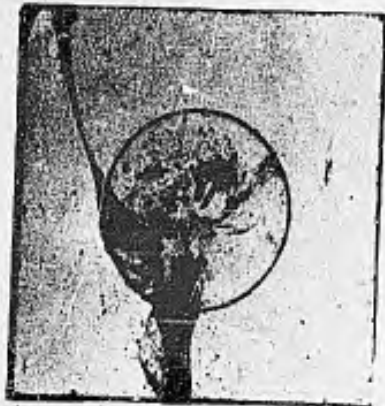
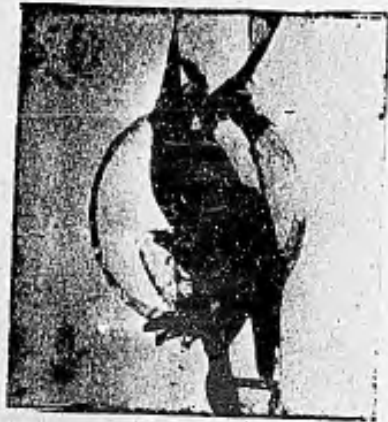
Photographs of the fractured specimens are shown in Fig. C-4 and an enlarged photograph of specimen No. 5 appears in Fig. C-5. It will be

FIG. C-4: FRACTURED SPECIMENS

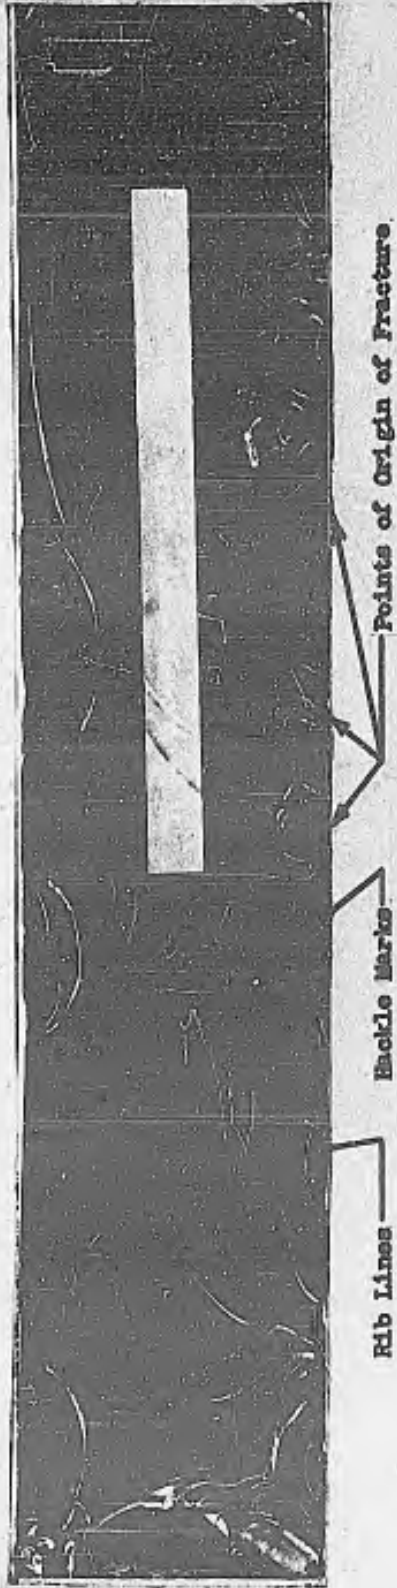
FIG. D-3 PHOTOGRAM OF FRACTURE SURFACE OF ANNEALED GLASS PANE (SPECIMEN NO. 1, TEST NO. 1)

the edge of the glass. Some delamination between glass and plastic is apparent near one edge.

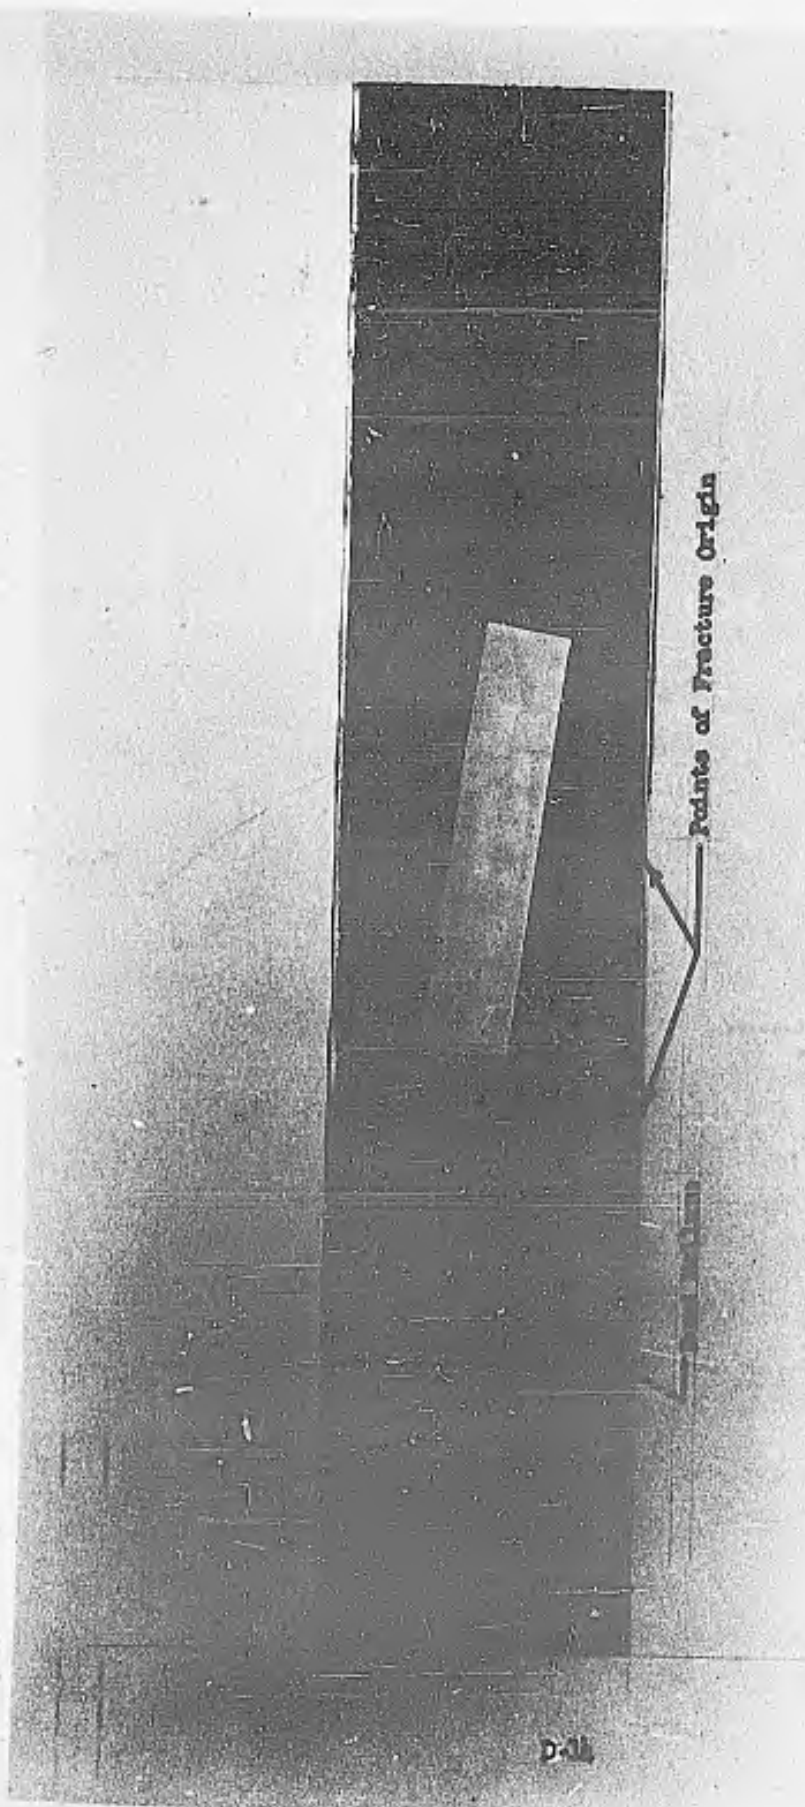
FIG. D-4. PHOTOGRAPH OF FRACTURE SURFACE OF FILMED GLASS PANE (SPECIMEN NO. 2, TEST NO. 1).

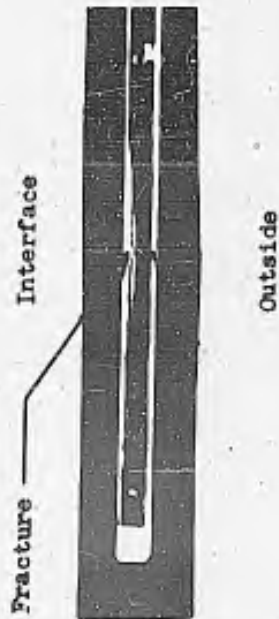
Photogram through Edge of Damage Glass Pane --  
Deep Fracture (Specimen No. 13-A, Test No. 3)

Edge Chipping  
Deep Fracture (Specimen No. 4,  
Test No. 3)

FIG. D-7 DEEP FRACTURE AND EDGE CHIPPING DAMAGE

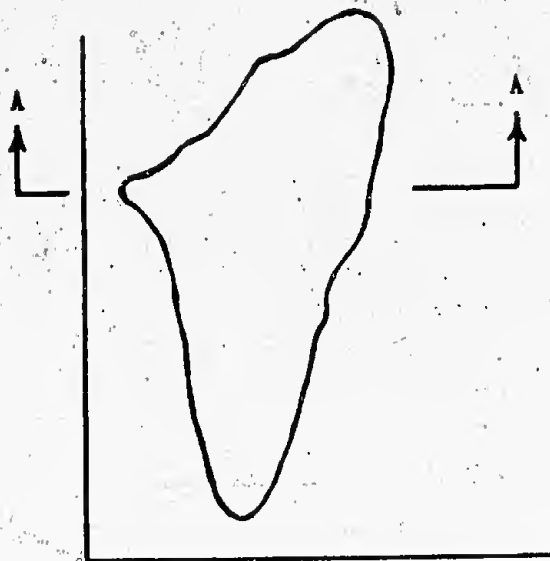
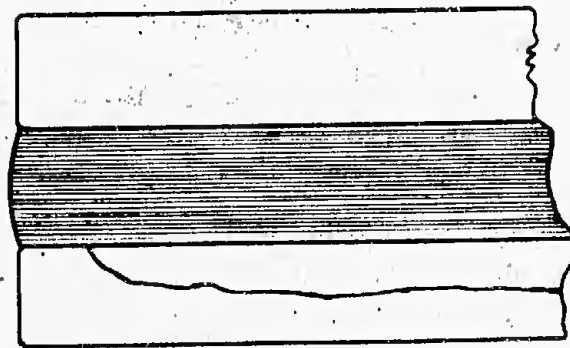
Fig. D-8 DEEP FRACTURES IN ANNEALED GLASS --- TYPE 3 FAILURE

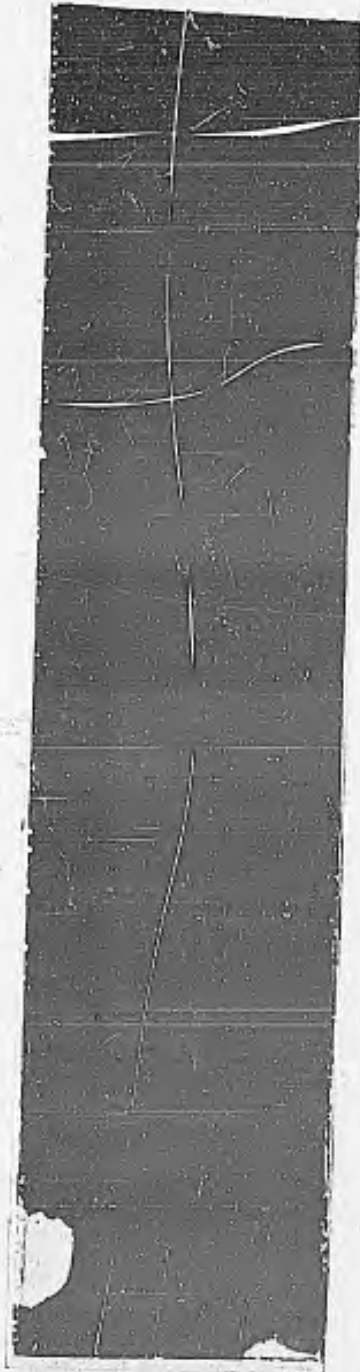
Fig. D-9 TRANSVERSE FRACTURES IN ANNEALED GLASS -- TYPE 4 FAILURE  
(SPECIMEN NO. 7, TEST NO. 3)

Note Extensive Edge Cracks

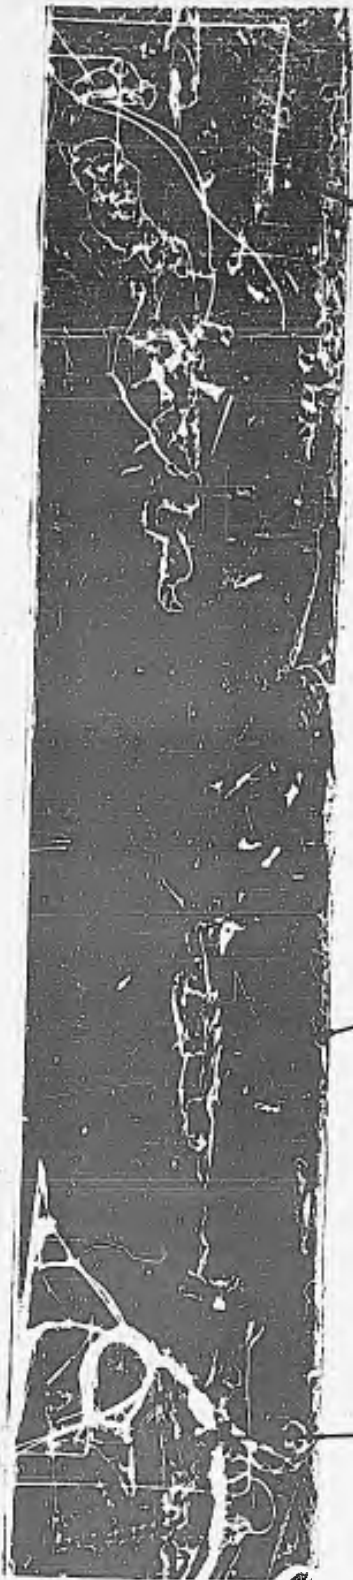
Chipping of Glass at Interface

Edge Chipping

Photogram of Filmed Glass Pane (Specimen No. 8, Test No. 3). The Coated Surface of Glass at the Interface. Note Extensive Chipping under Bus Bars at the Left End of the Pane.

Glass Chips Remaining on Plastic

FIG. D-10 FAILURE AT THE INTERFACE THROUGH THE BOND -- TYPE 5 FAILURE

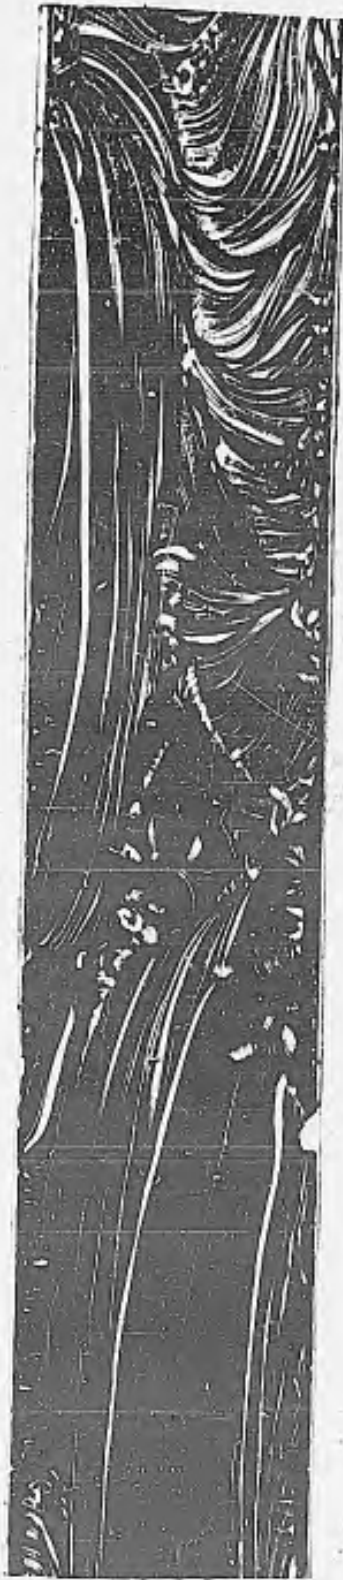
FIG. D-11 CHIPPING FAILURE IN ANNEALED GLASS -- TYPE 6A FAILURE  
(SPECIMEN NO. 9, TEST NO. 3)

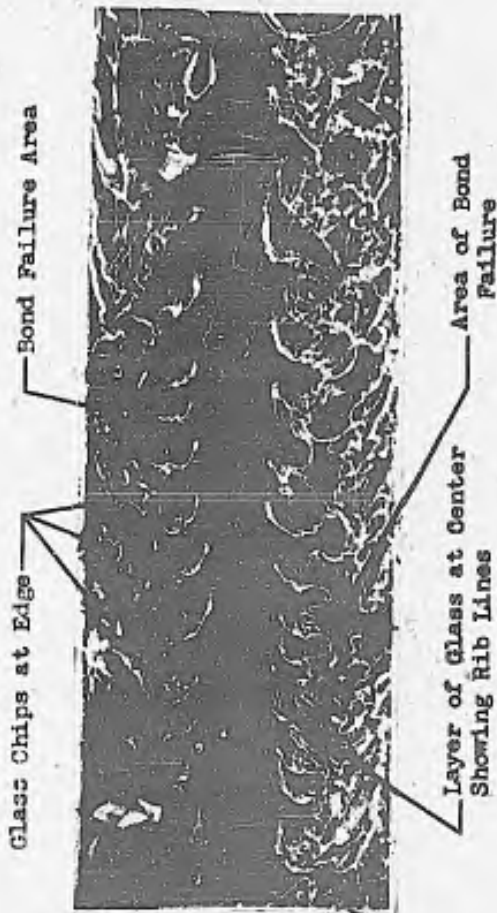
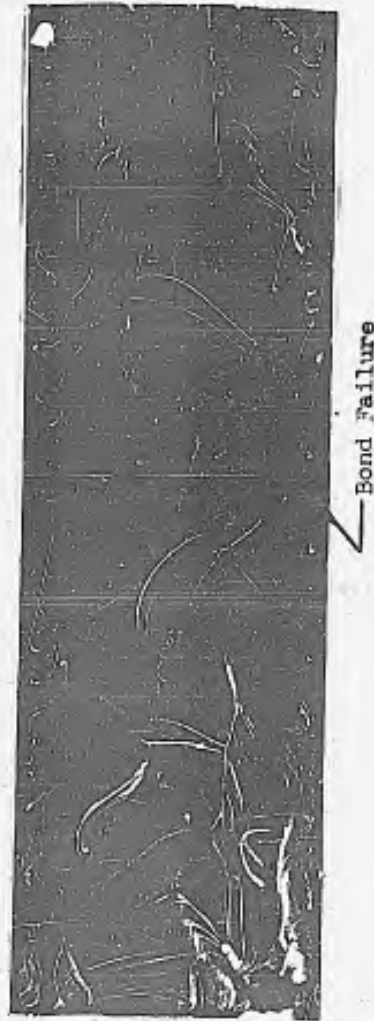
Photomicrograph of Surface of Plastic Interlayer (Specimen No. 16, Test No. 3) Interface Near Filmed Surface Shown.

Photomicrograph of Tempered Glass Pane (Specimen No. 15, Test No. 3)

FIG. D-13 FAILURE THROUGH GLASS PARALLEL AND CLOSE TO INTERFACE -- TYPE 6B FAILURE

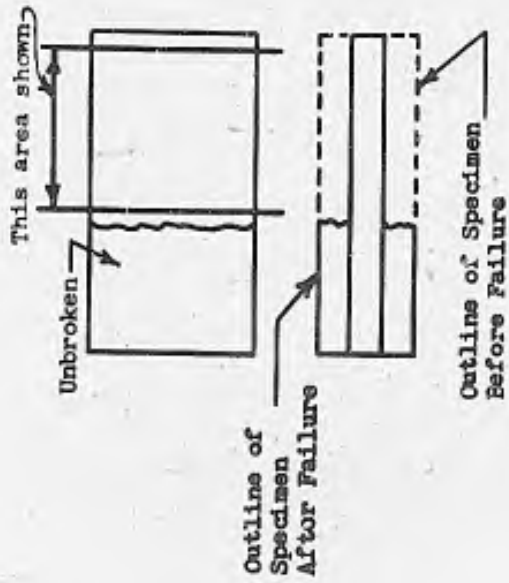
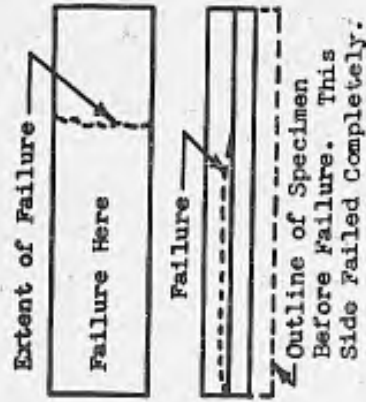
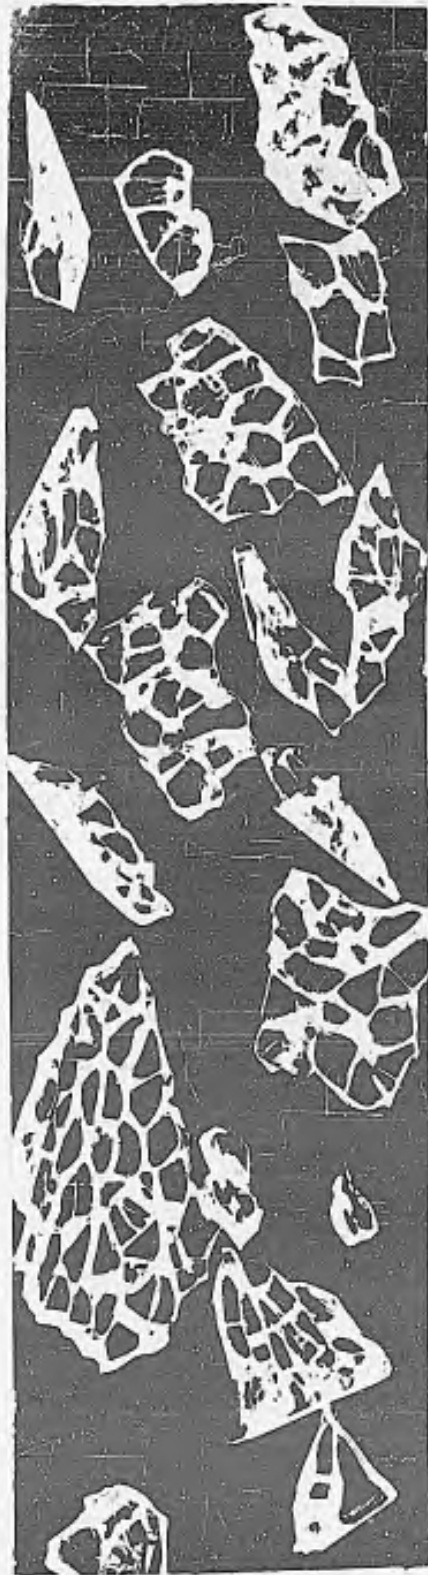
Chipping Failure. Fracture Path Longitudinal.

FIG. D-14 GLASS FRAGMENTS — SHATTERING OF TEMPERED GLASS — TYPE 7 FAILURE

(SPECIMEN NO. 17, TEST NO. 3)
