Report No. AAEE/Tech/122/Nav. Part II

# AEROPLANE AND ARMAMENT EXPERIMENTAL ESTABLISHMENT

EVALUATION OF BLUE SILK/G.P.I. MARK 4A - PART II

PERFORMANCE OVER VARIOUS TERRAINS AND UNDER  
SIMULATED OPERATIONAL CONDITIONS

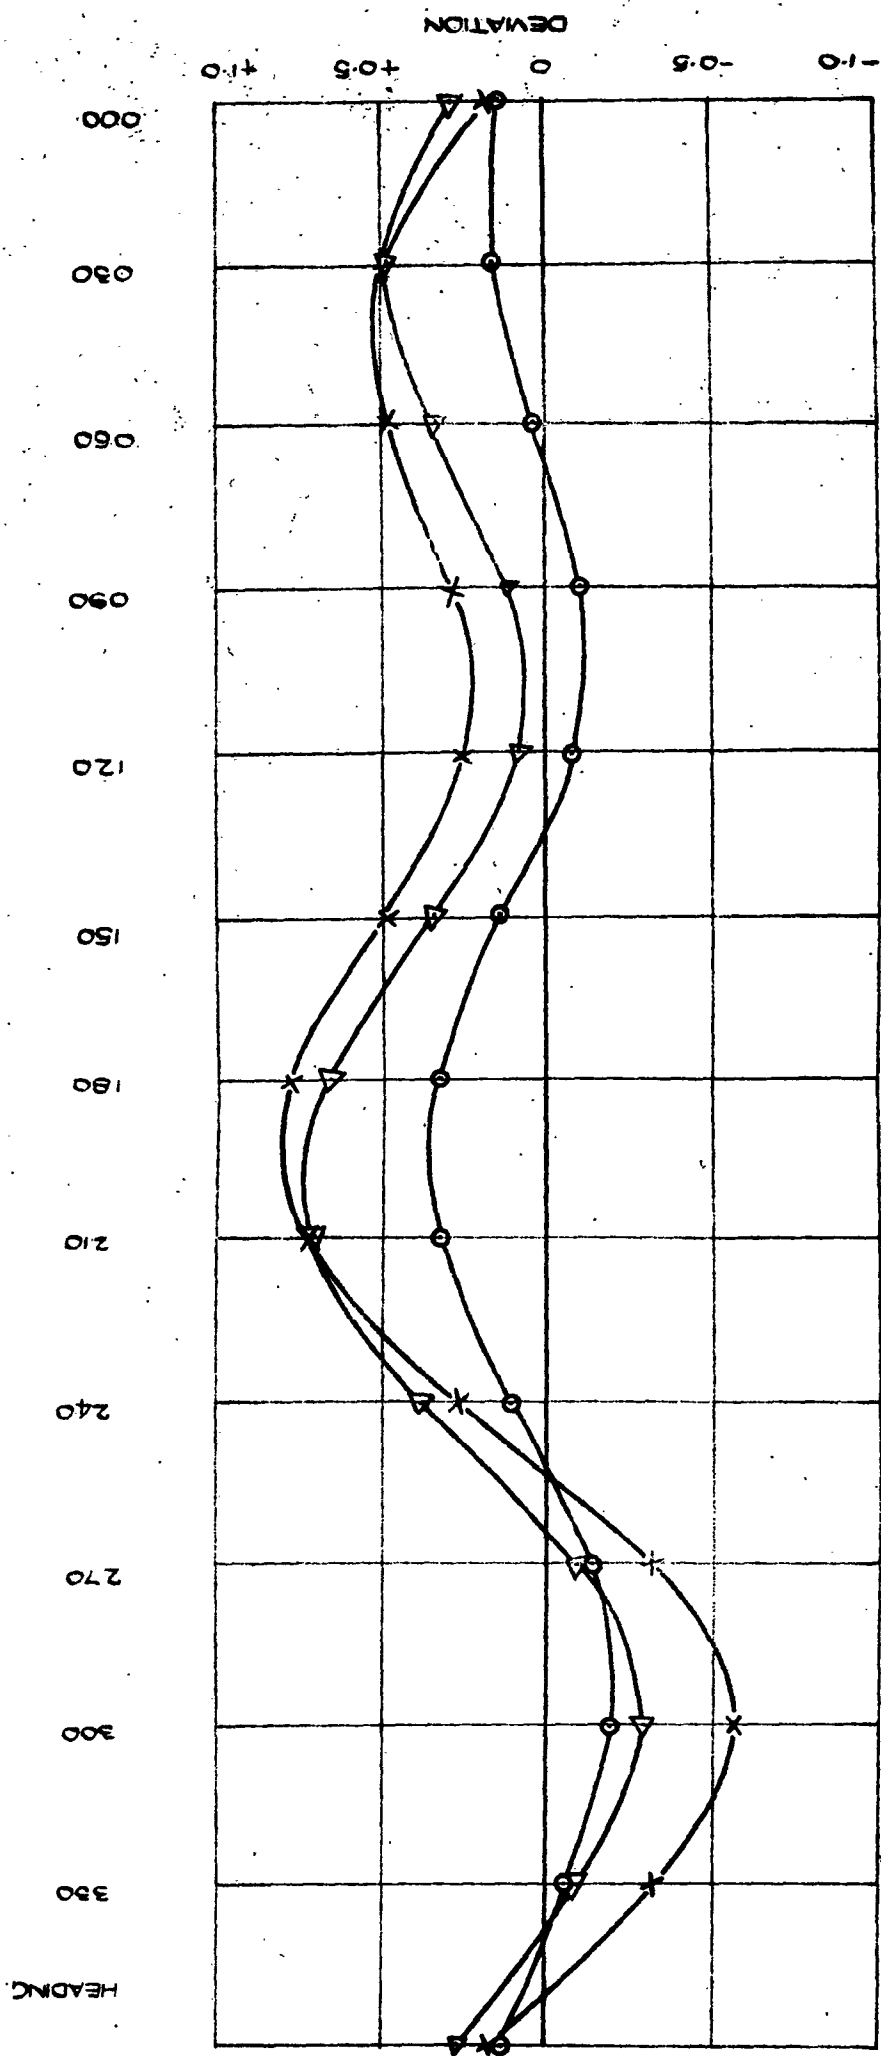
FIG. 3

3.2.2 All ground compass calibrations were carried out using the Watts Datum Compass. The maximum 50% error of determination of deviation on any single heading was  $\pm 0.10^\circ$ . The graphed deviations for the calibrations listed in sub-Paras 3.2 (a), (b) and (c) are given in Fig. 3 and those for sub-Paras 3.2 (d), (e) & (f) are given in Fig. 4. The results of the calibrations are very consistent, and the reduction in the residual deviations found at El Adem can be attributed to the lower magnetic latitude.

GROUND CALIBRATIONS-GIVE COMPASS.
