NAVORD REPORT

4422

EVALUATION OF COATING TREATMENTS FOR MAGNESIUM ALLOY TUBING

26 OCTOBER 1956

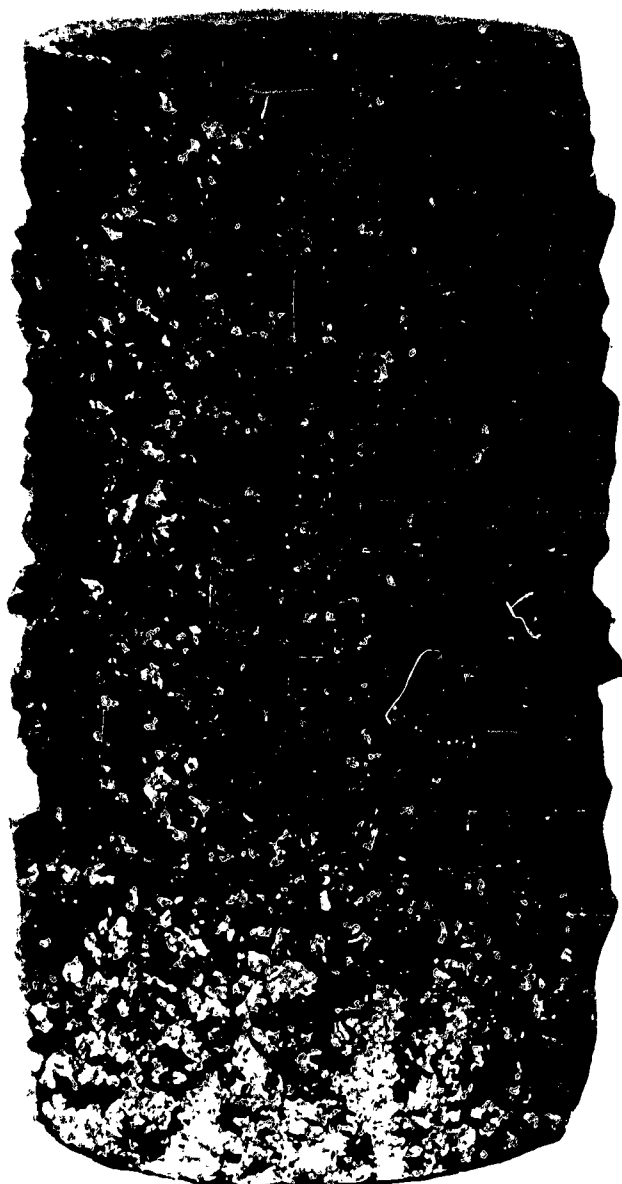
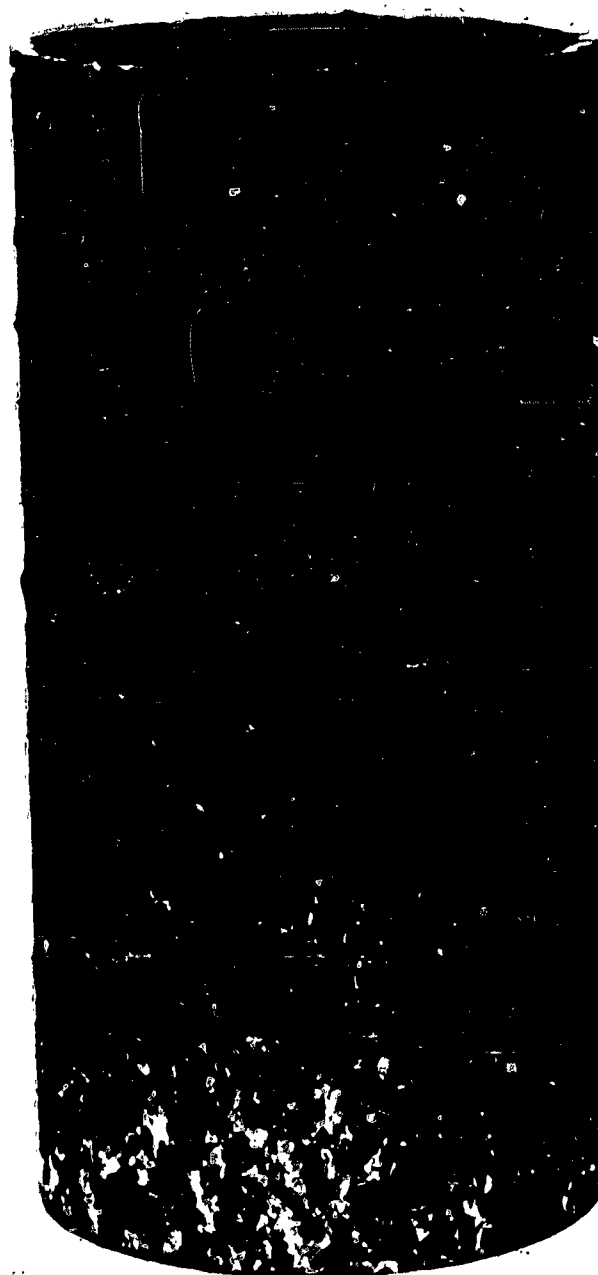
8. Tube No. 15 had a high voltage H.A.E. coating, .0002 inch thick, and had been aged. This system showed the greatest coating penetration by salt spray (fog) testing. Heavy lengthwise markings were noted within 23 hours of salt fog exposure. Figure 1 shows the condition of the tube when removed from the test after 96 hours of exposure. After photographing the unwashed tube, warm water and a soft brush were used to remove the magnesium hydroxide and salt prior to

rephotographing. The washed tube indicates the large amount of surface pitting. Two coats of zinc chromate primer in addition to the above H.A.E. aged coating (tube No. 16) provided protection for less than 48 hours. Figure 3 indicates the extent of coating penetration on tube No. 16 by 192 hours of exposure.

15  
UNWASHED

15  
WASHED

FIG. 1 SALT SPRAY (FOG) TEST - 96 HOURS  
H.A.E. COATING ON MAGNESIUM TUBE (SEE TABLE I)

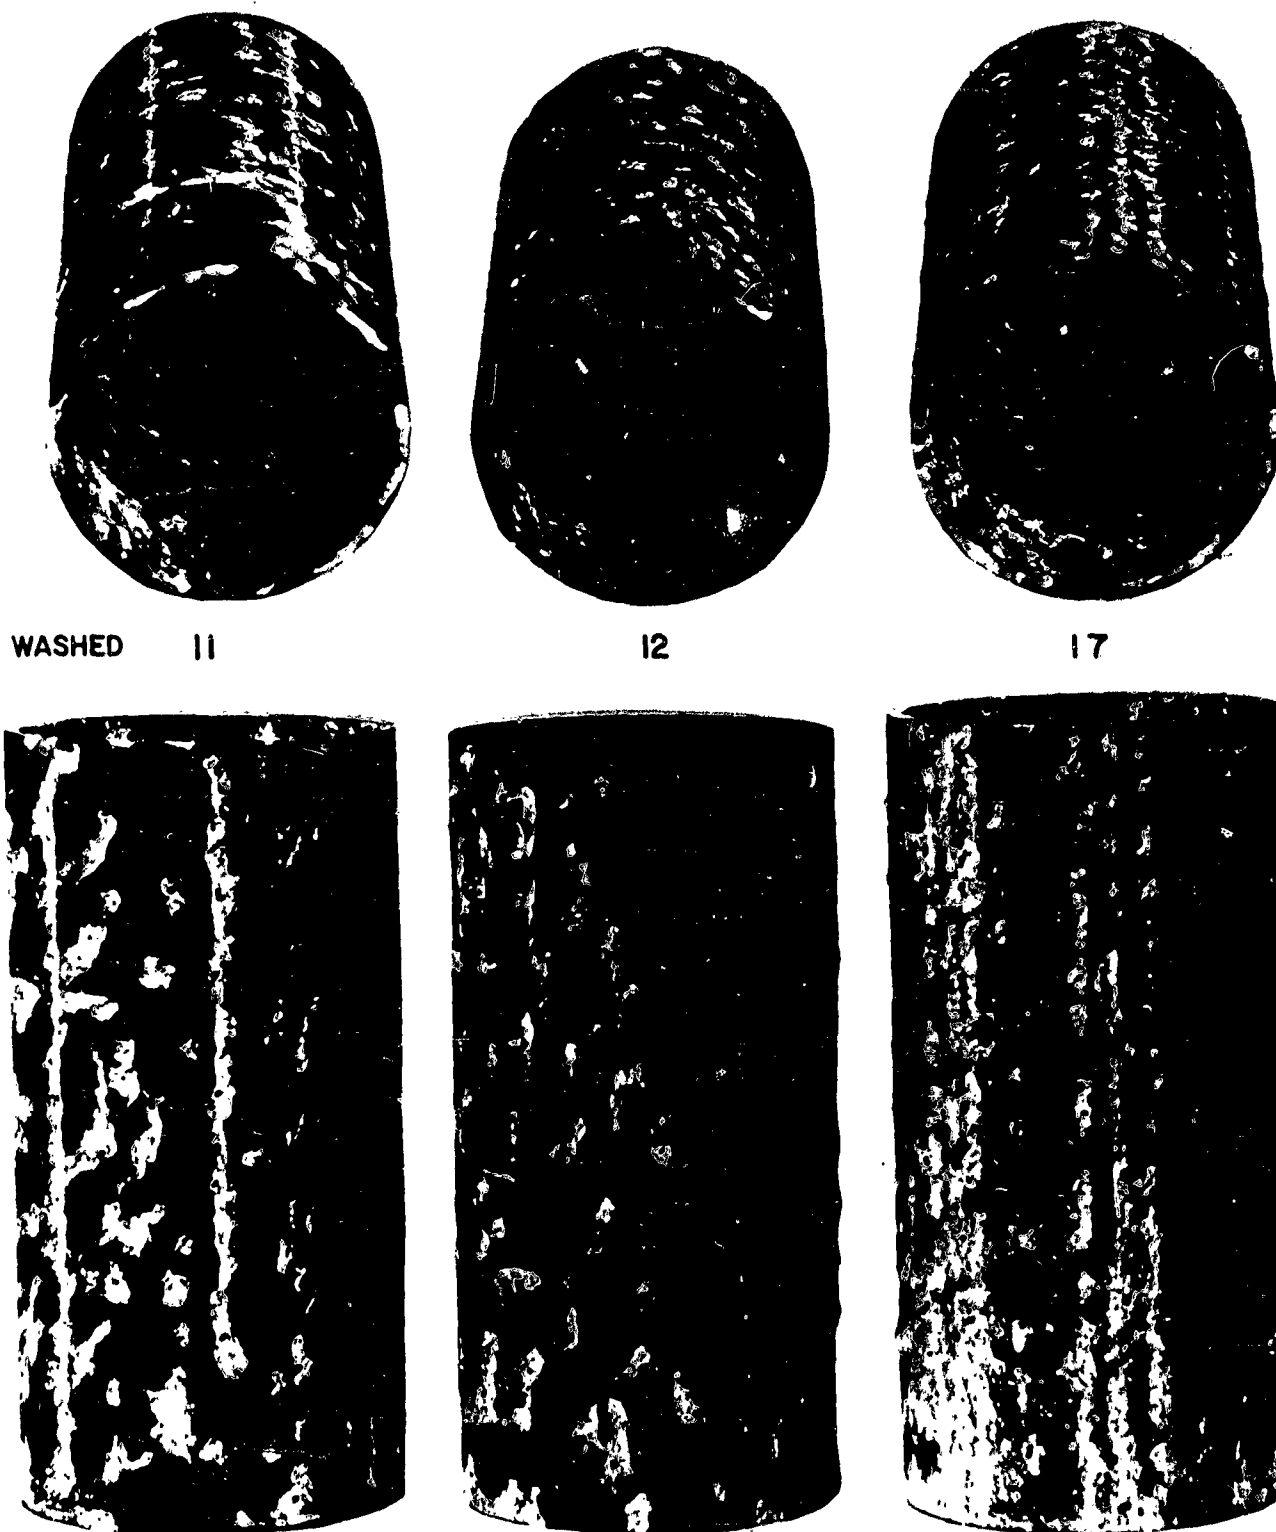
9. Low voltage H.A.E. was applied .0003 inch thick on four tubes. Tubes No. 12 and 14 were aged, tubes No. 11 and 13 were not. Two coats of zinc chromate primer were applied to tubes No. 13 and 14. Some breakdown was noted on tubes No. 11 and 12 by 23 hours of exposure. Figure 2 shows the condition of these tubes after removal from 96 hours of salt spray (fog) testing. Aging of tube No. 12 did not provide much more protection than the unaged coating on tube No. 11. Comparison of tubes No. 13 and 14, which had a primer coating, shows a greater difference between the aged and unaged tubes. Blisters were noted on the unaged tube No. 13 by 165 hours of exposure, and peeling had occurred as noted in Figure 4 by 240 hours. The aged sample, No. 14 showed breakdown in a few dots on the inside of the tube by 192 hours, and by 240 hours the lower edge had failed (Figure 4) but no blistering of the coating had occurred.

10. High voltage H.A.E. coating was increased to a thickness of .001 inch on tubes No. 17 and 18, and two coats of zinc chromate primer were applied over the aged coating on tube No. 18. Breakdown was noted on tube No. 17 by 23 hours. The tube was removed after 96 hours of exposure. Figure 2 illustrates the extent of breakdown on the inside as well as the outside of the tube. The two coats of primer provided some protection for the outside of the tube, but did not protect the inside of the tube as shown in Figure 4.

FIG. 2 SALT SPRAY (FOG) TEST - 96 HOURS  
VARIOUS H.A.E. COATINGS ON MAGNESIUM TUBES(SEE TABLE I)

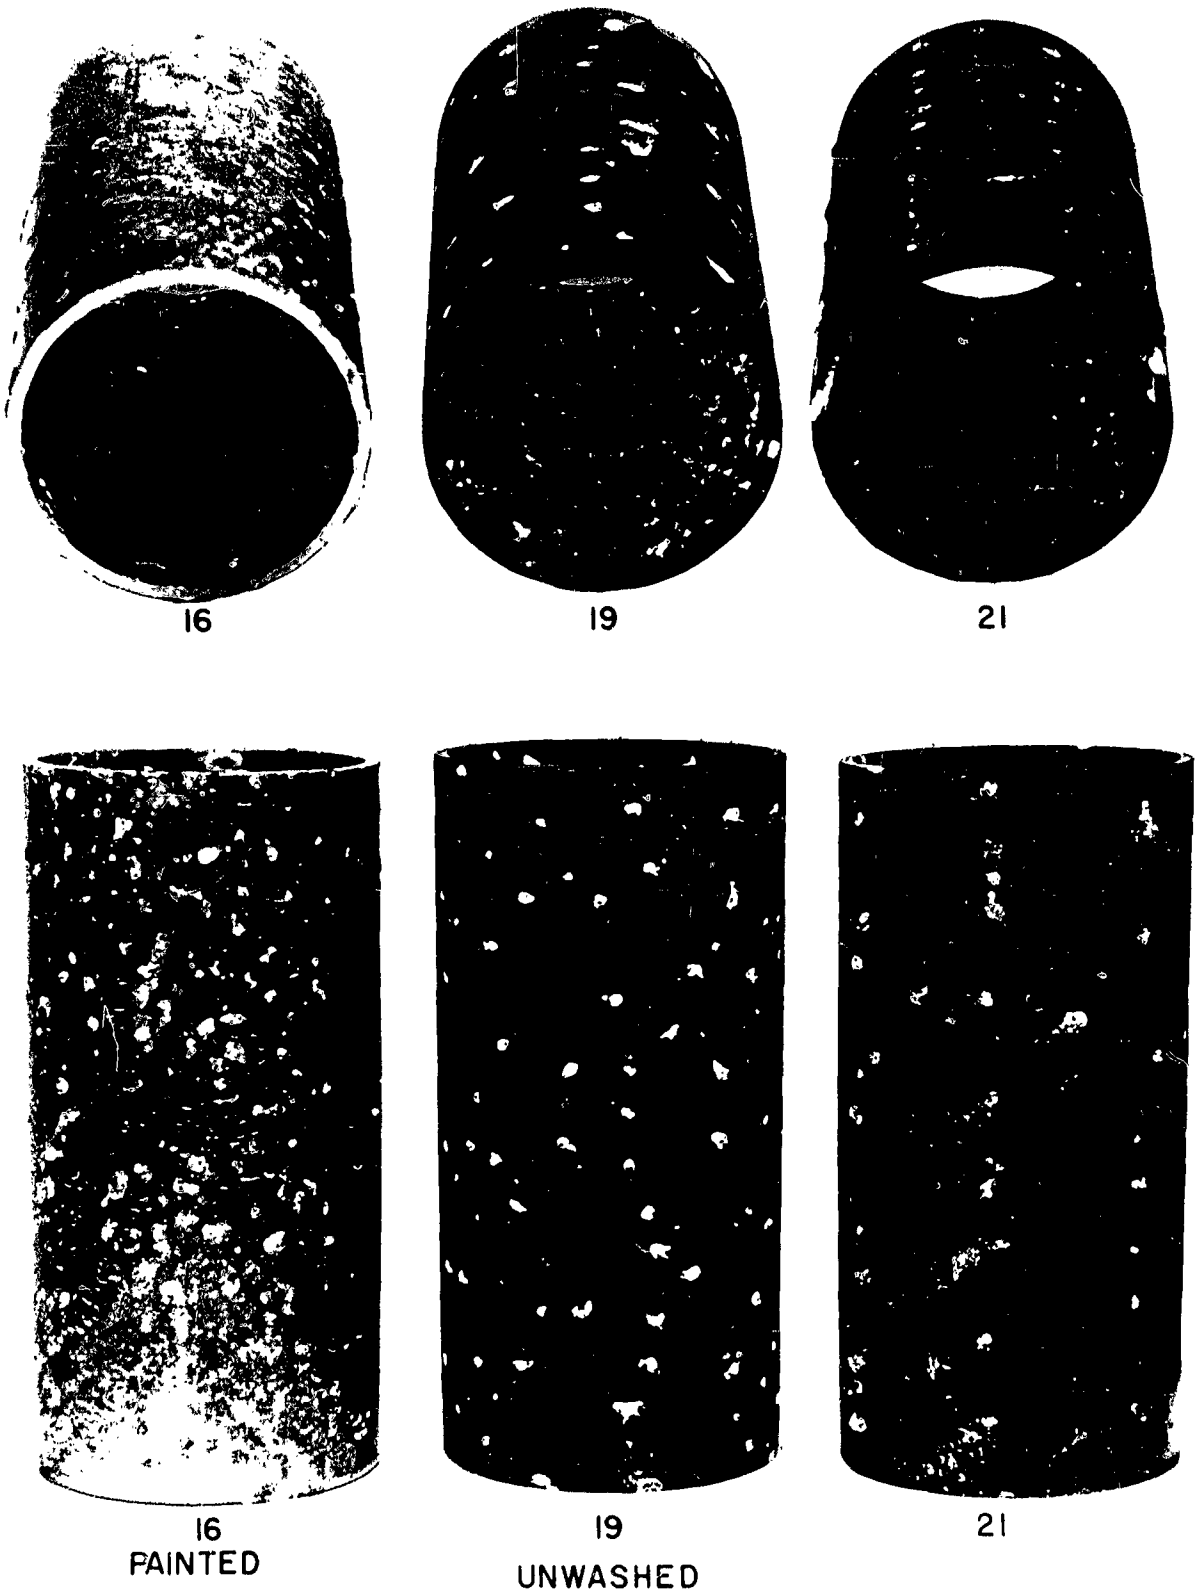
11. When high voltage H.A.E. coatings were applied .0015 inch thick and aged on tubes No. 19 and 20, an increase in protection was noted over the thinner applications. Some slight breakdown was noted on No. 19 after 48 hours. After removal at 192 hours of exposure, examination indicated greater breakdown on the inside of the tube than on the outside (Figure 3). Tube No. 20, which had been given two coats of zinc chromate primer, also showed greater breakdown on the inside of the tube. Figure 4 indicates very little breakdown on the outside other than that noted on the lower edge of the tube.

12. High voltage H.A.E. coating, .002 inch thick, and aged provided the greatest protection of the H.A.E. coatings which were tested. Tube No. 21 showed slight breakdown after 192 hours of exposure (Figure 3). When two coats of zinc chromate primer were applied on tube No. 22, very slight breakdown was noted on the inside of the tube and none on the outside (Figure 4).

FIG. 3 SALT SPRAY (FOG) TEST - 192 HOURS  
VARIOUS H.A.E. COATINGS ON MAGNESIUM TUBES (SEE TABLE I)

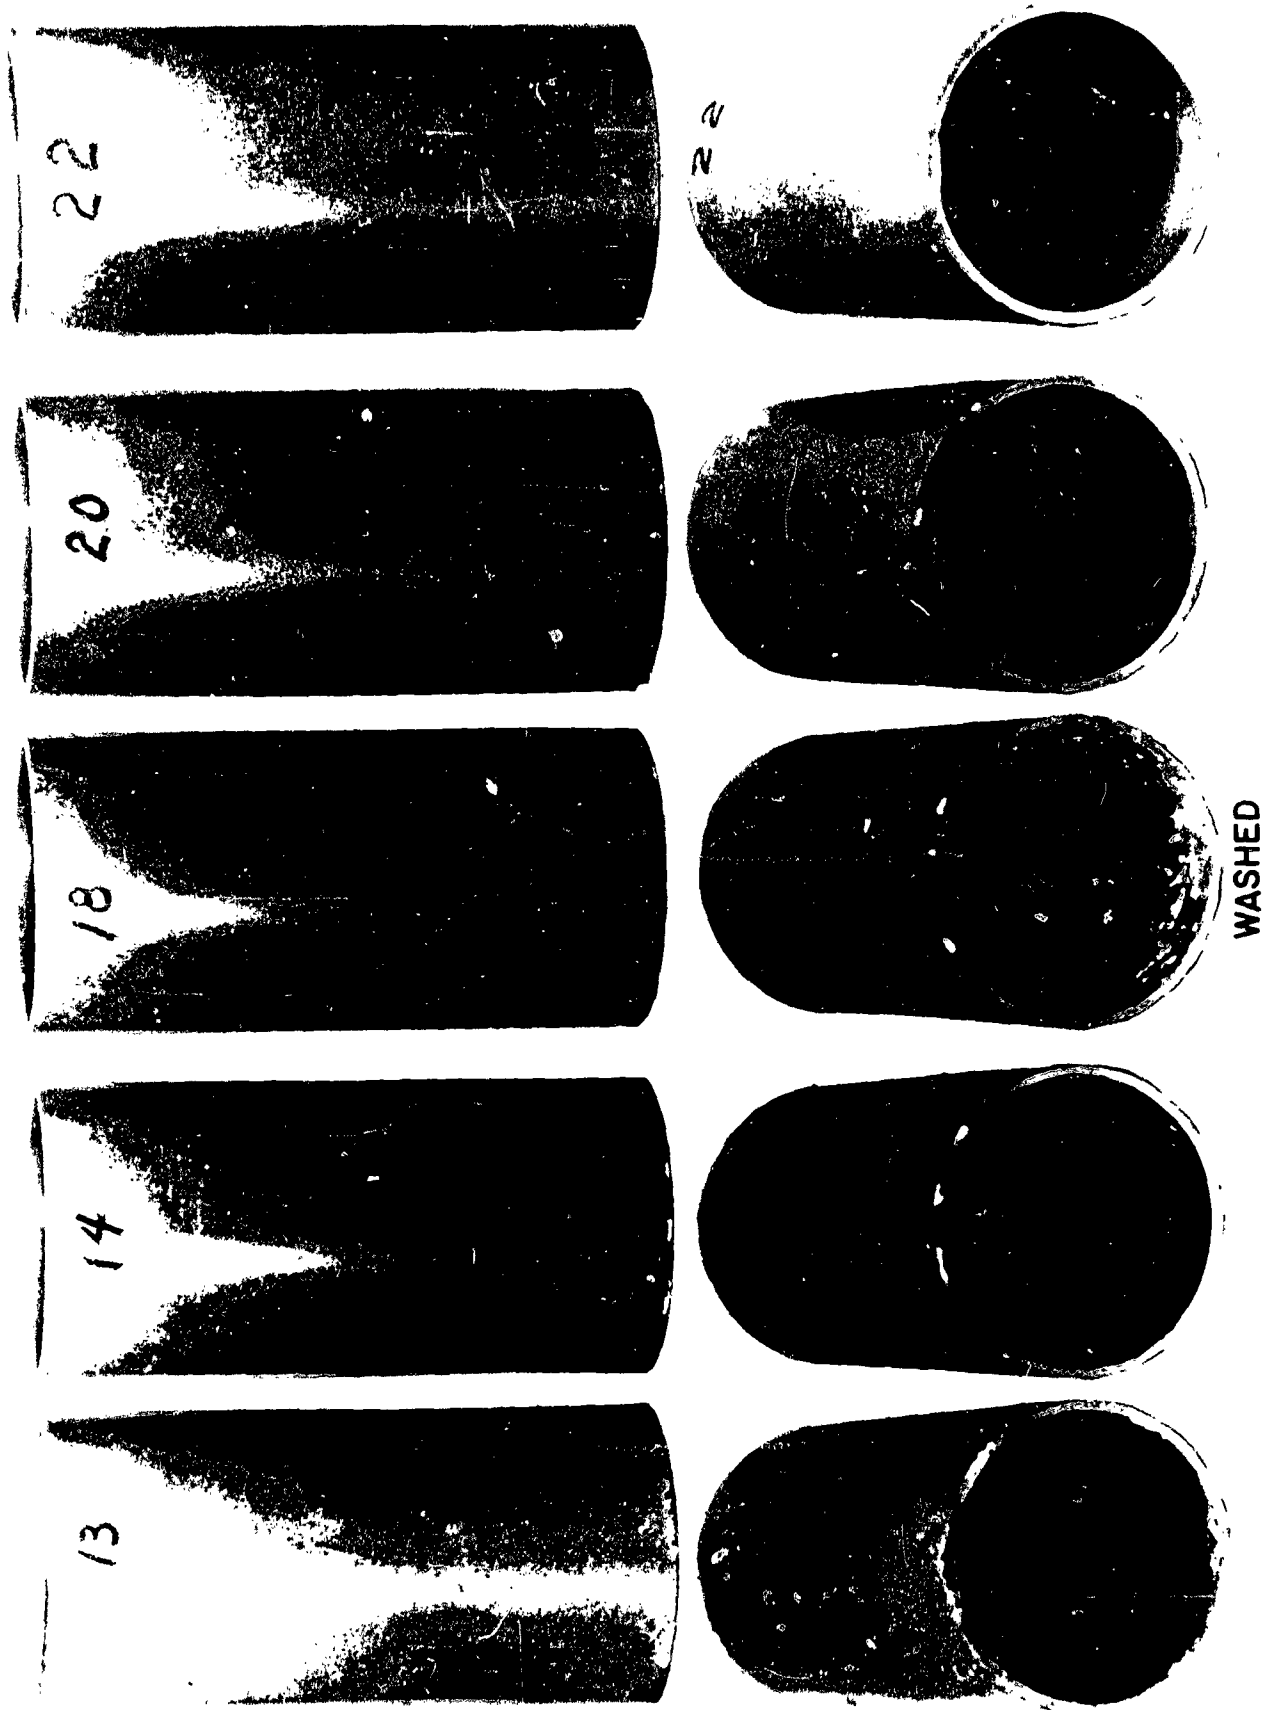
FIG. 4 SALT SPRAY (FOG) TEST - 240 HOURS  
PAINTED VARIOUS H.A.E. COATINGS ON MAGNESIUM TUBES (SEE TABLE I)

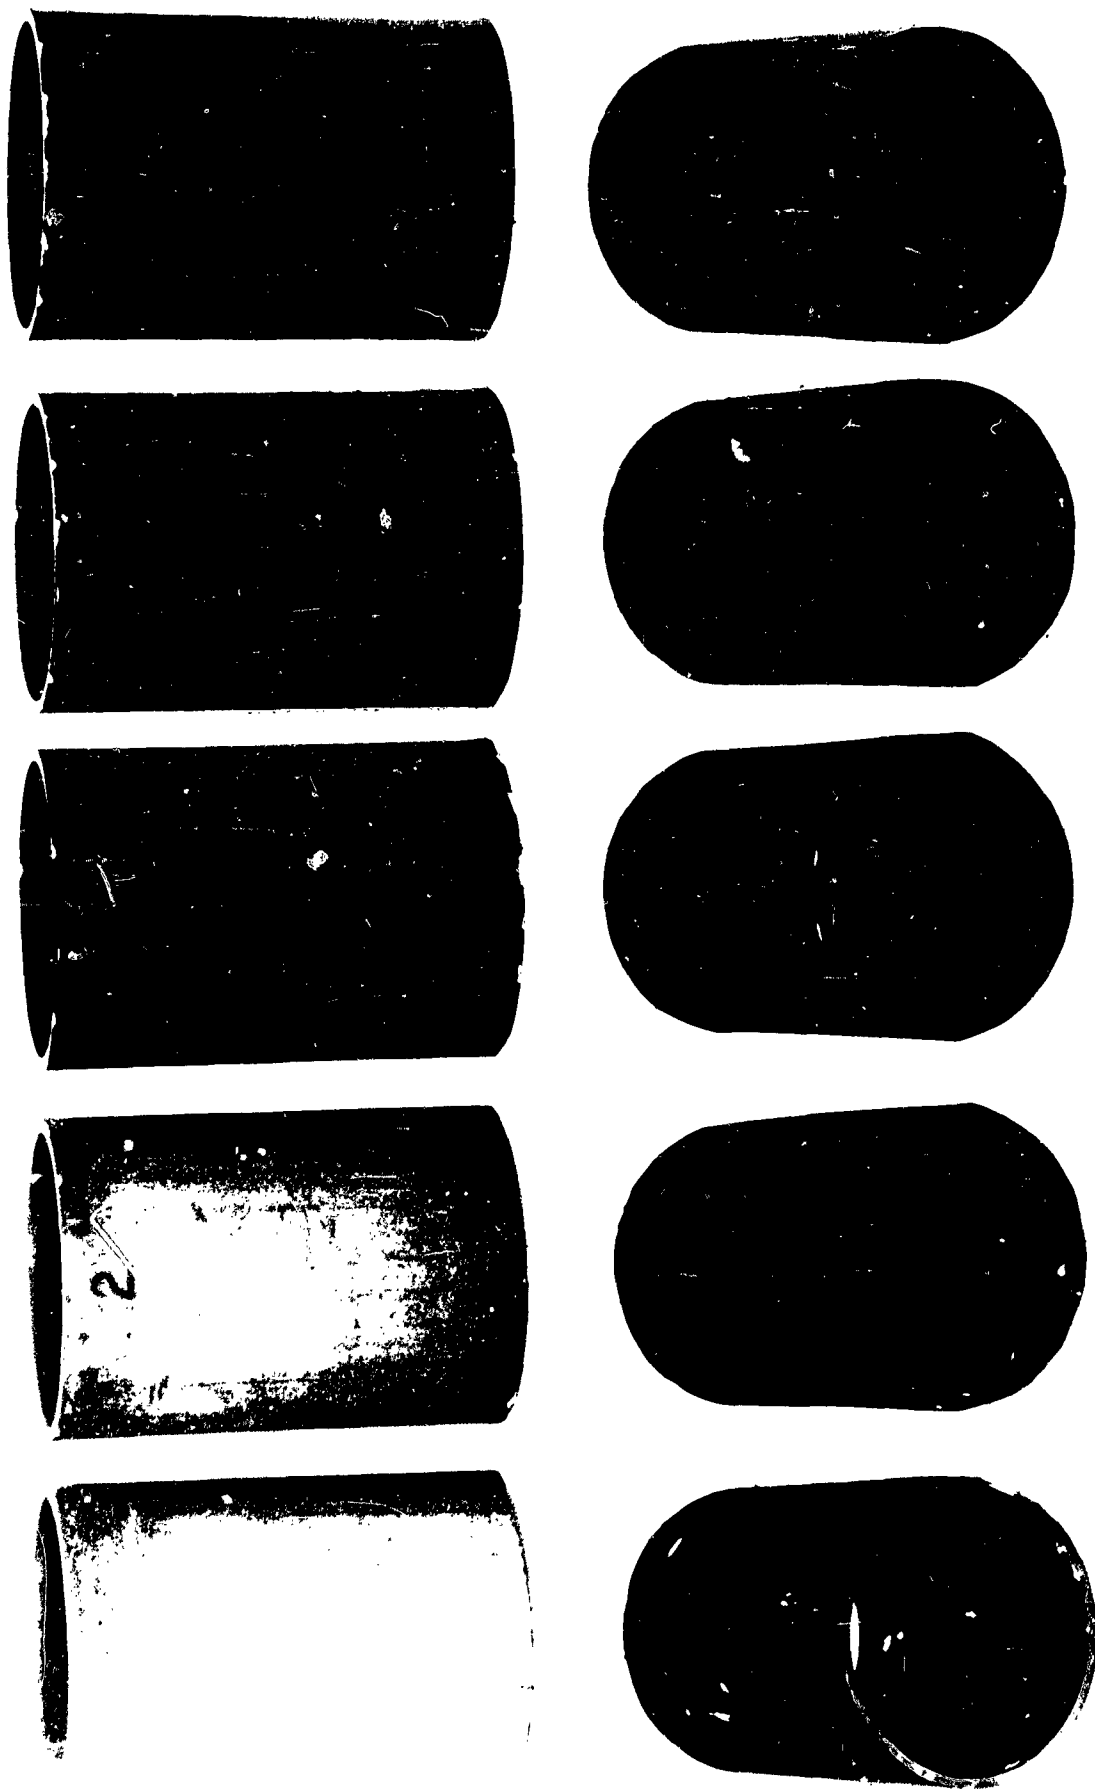
13. Duplicate samples were available of those systems which included Dow surface treatments. Tubes No. 1 and 2, which had two coats of AP 10 primer over Dow No. 1, showed slight breakdown after 165 hours of exposure. Figure 5 shows their condition when removed after 240 hours. Some breakdown was noted on the edges of tubes No. 3, 4, and 5 (Figure 5) which had one coat of black enamel in addition to the treatment given tubes No. 1 and 2.

FIG. 5 SALT SPRAY (FOG) TEST - 240 HOURS  
PAINTED DOW No. 1 COATINGS ON MAGNESIUM TUBES (SEE TABLE I)

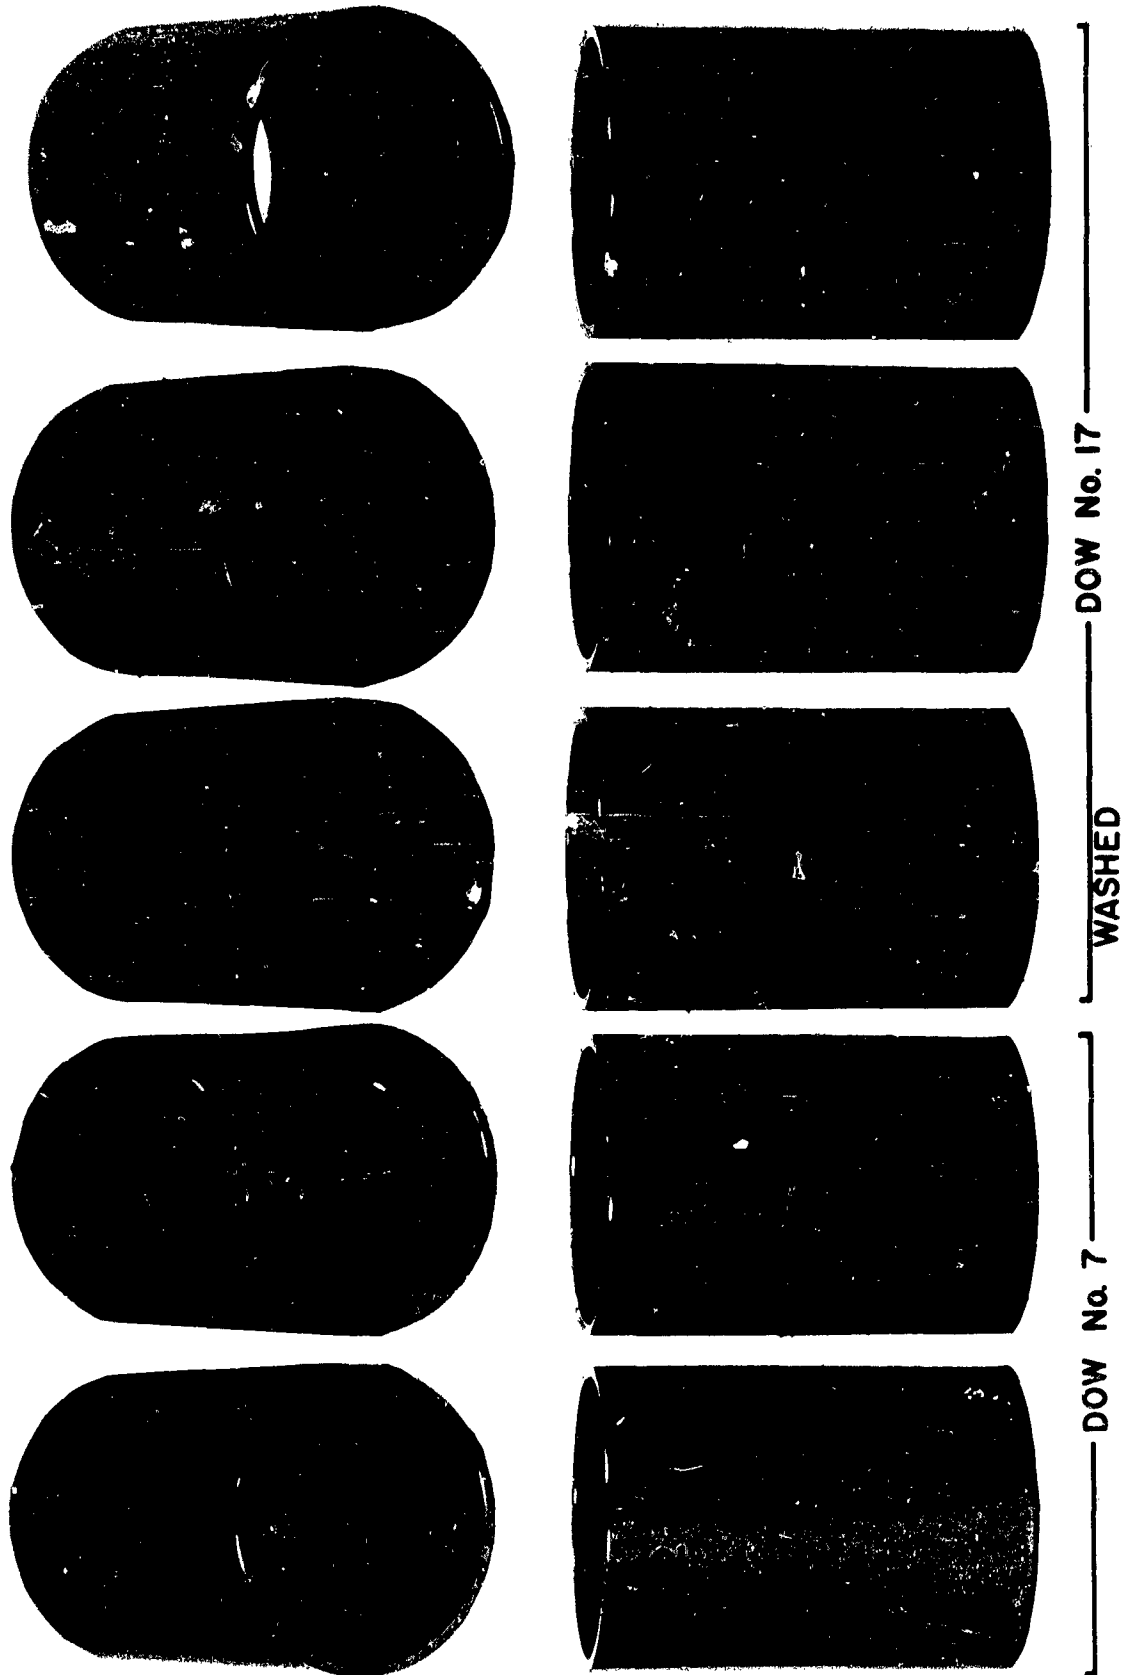
14. Coating systems which included Dow No. 7 and Dow No. 17 were tested for 240 hours. As indicated by Figure 6, no breakdown was noted on Dow No. 7 tubes. (Tube No. 6 shows an uneven painted surface at the clamp mark obtained during processing.) Most of the breakdown and blisters noted on Dow No. 17 tubes may be attributed to inadequate paint coating at clamp marks obtained during processing. In addition, some breakdown was noted on the edges of tube No. 10.

FIG. 6 SALT SPRAY (FOG) TEST-240 HOURS  
PAINTED DOW COATINGS ON MAGNESIUM TUBES (SEE TABLE I)

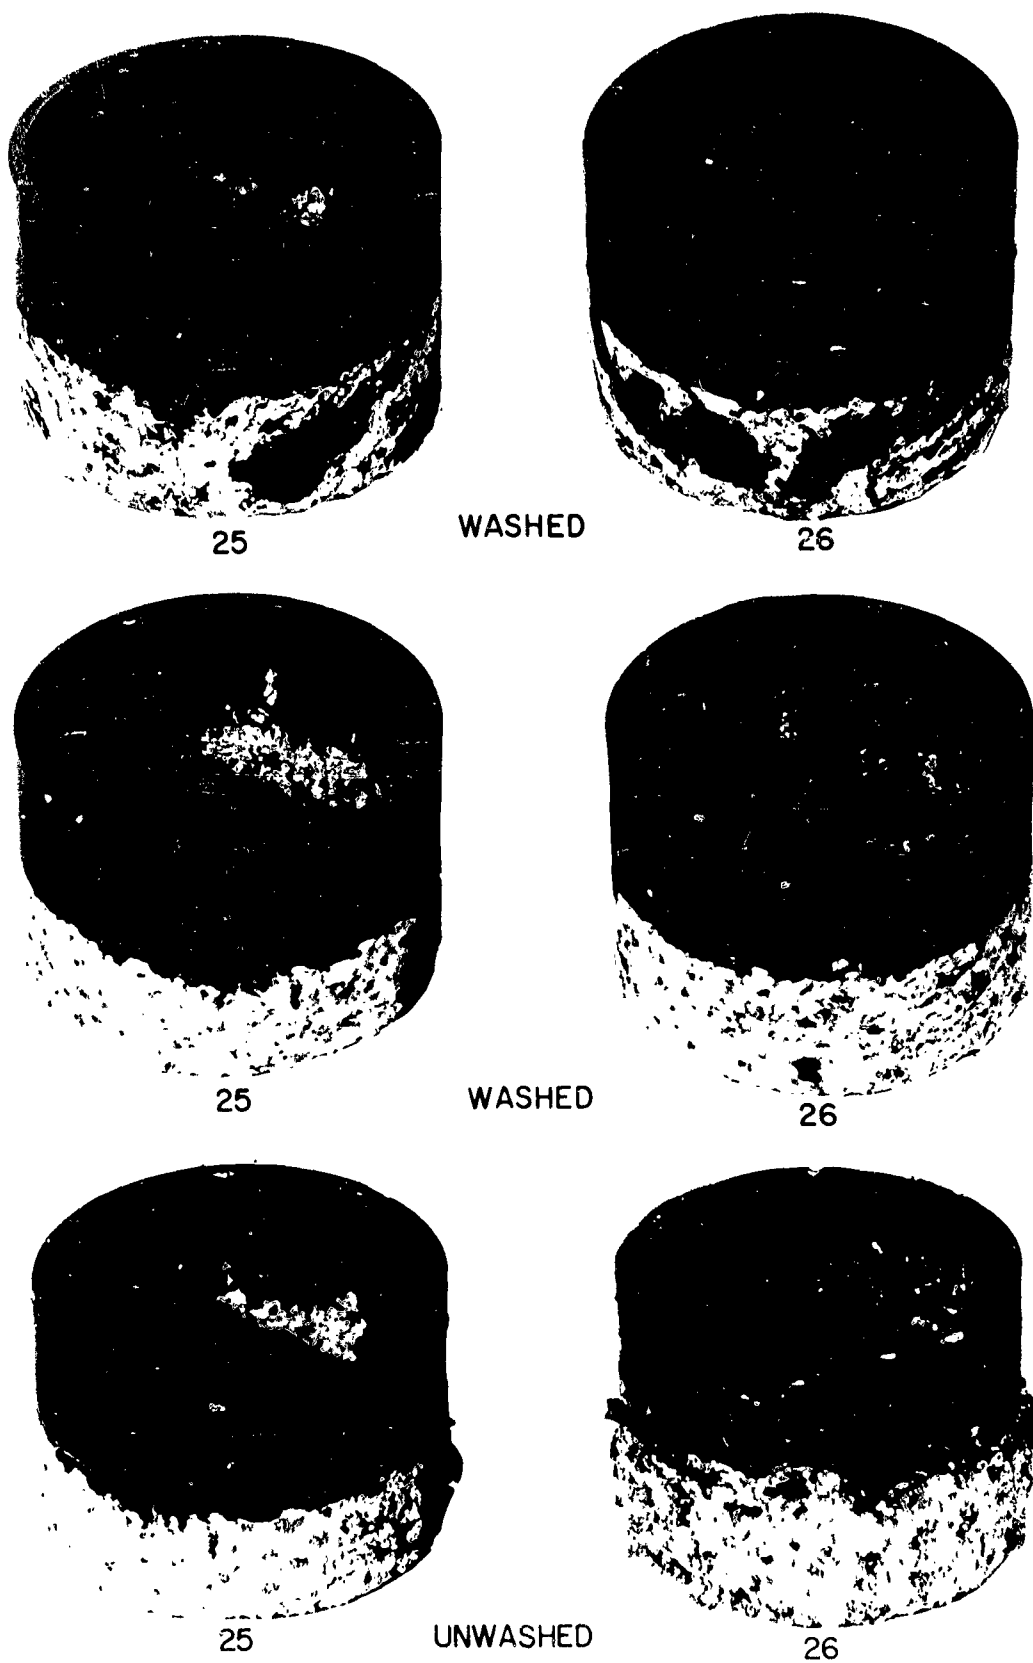
15. Duplicate samples were available of those systems which included Iridite 15. Two tubes, No. 25 and 26, were painted over the Iridite coating only on the upper half of the tube. The unpainted Iridite 15 coating was heavily marked within 24 hours of exposure, but breakdown was not noted on the painted half of the tubes until 165 hours. The large amount of blistering and chipping of the painted surface by 240 hours (as noted in Figure 7) may be the effect of lifting of the paint film from the underside, or by the corroding magnesium on the unpainted half of the tubes. For this reason, additional Iridite 15 tubes were tested either completely painted or unpainted.

FIG. 7 SALT SPRAY (FOG) TEST- 240 HOURS  
IRIDITE 15 COATING (PARTLY PAINTED) ON MAGNESIUM TUBES  
(SEE TABLE I)

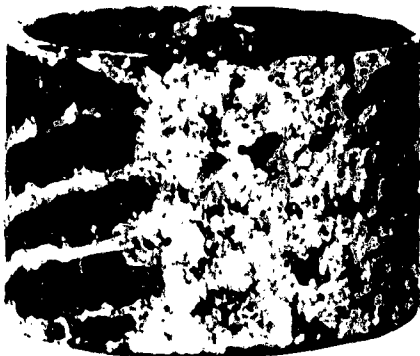
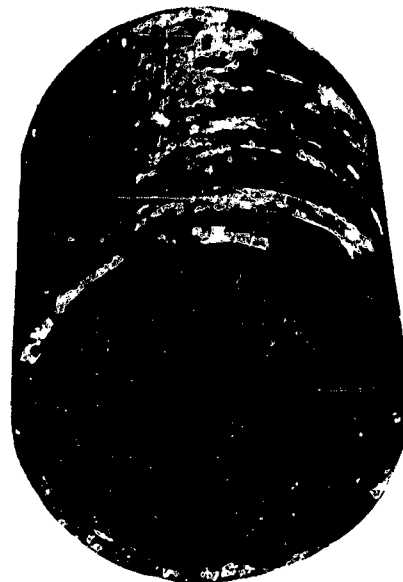
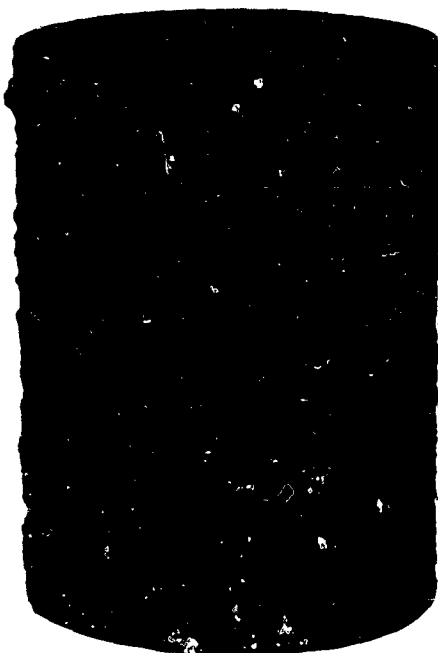
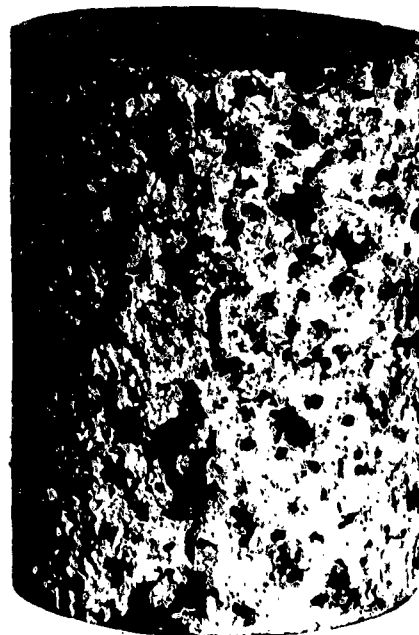
16. Three unpainted tubes with Iridite 15 were heavily marked within 24 hours of exposure. Tubes No. 23 and 24 were removed from testing after 96 hours. Tube No. 27 was photographed after 96 hours and returned to the salt spray test for additional exposure. The additional breakdown noted on tube No. 27 by 240 hours may be compared with 96 hours exposure on tubes No. 23 and 27 in Figure 8.

23  
WASHED

27  
WET, UNWASHED  
96 HOURS

27  
WASHED  
240 HOURS

FIG. 8 SALT SPRAY (FOG) TEST  
IRIDITE 15 COATING ON MAGNESIUM TUBES

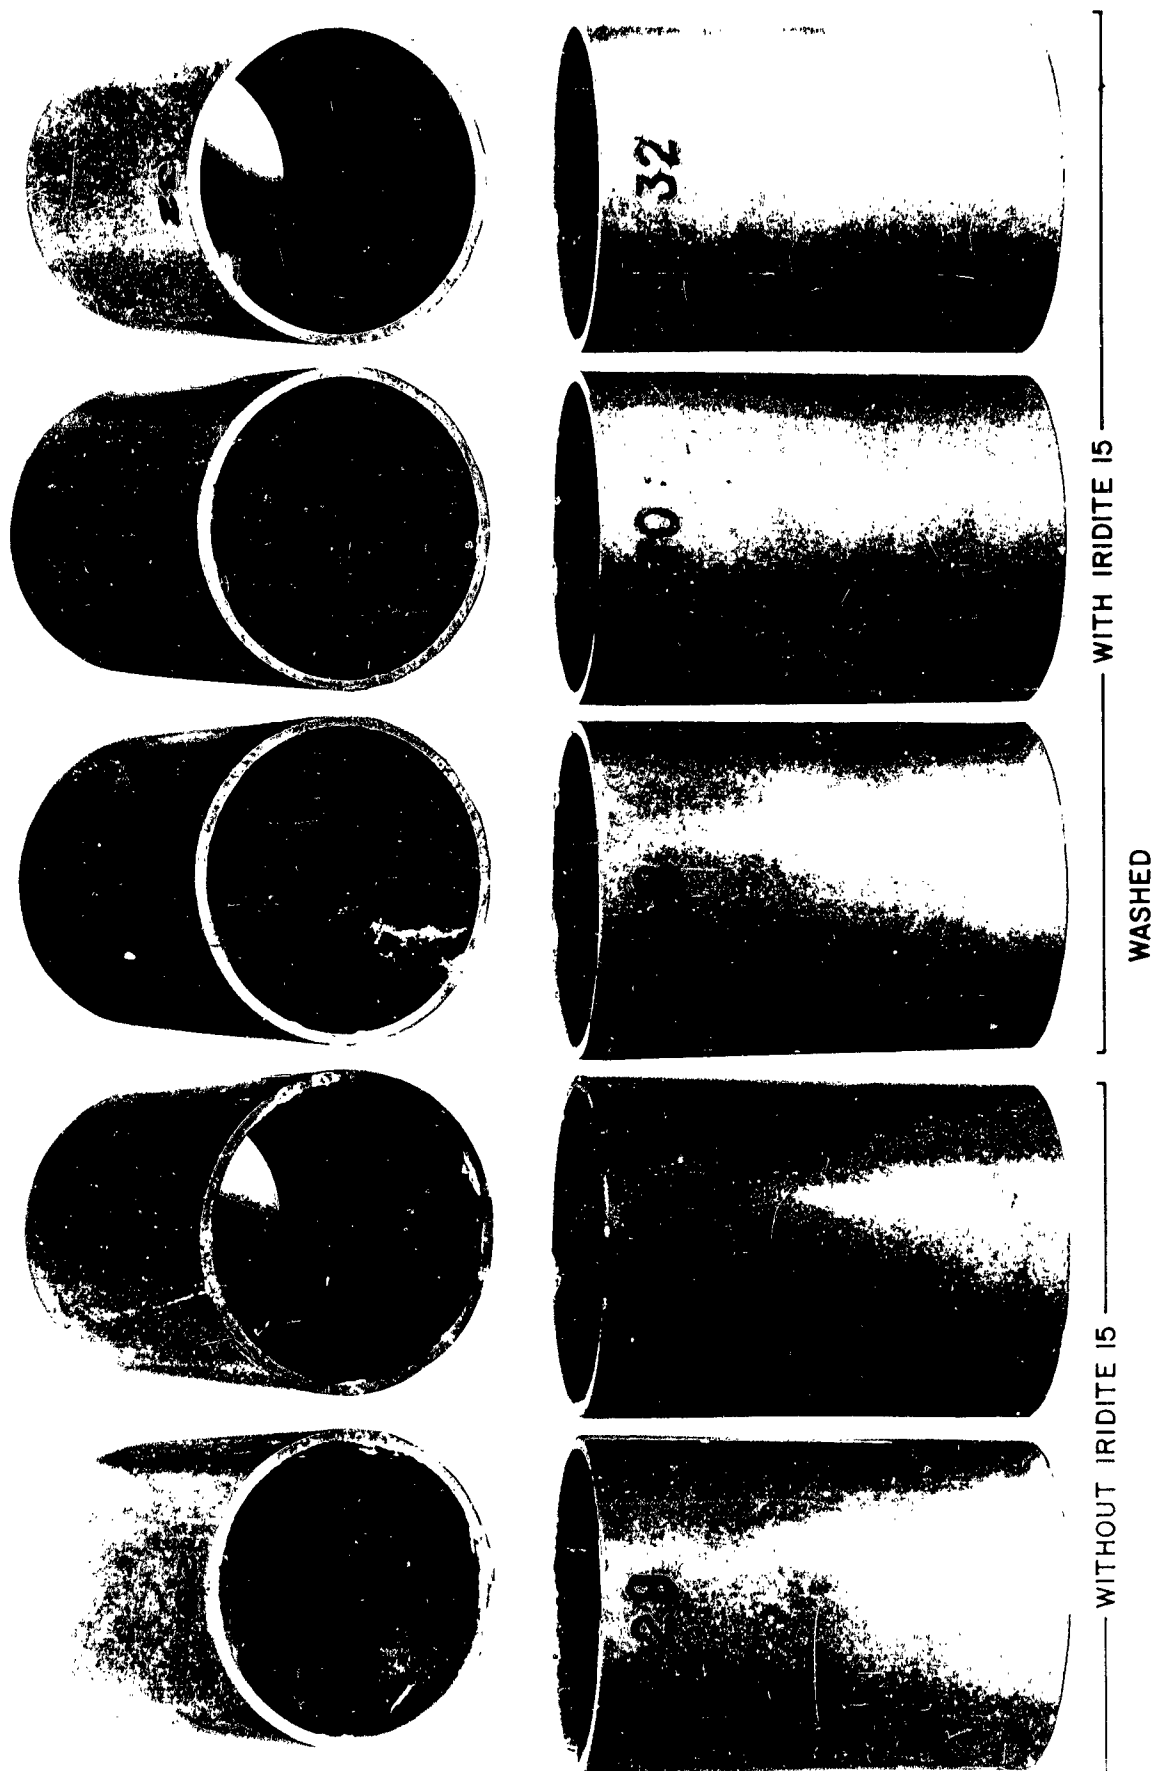
17. Three tubes with Iridite 15 were given a standard Navy paint system and salt spray tested for 240 hours. Tube No. 28 blistered only on the top edge as noted in Figure 9, and tubes No. 30 and 32 did not show any breakdown.

18. A standard Navy paint system was tested on tubes which had not been given the Iridite 15 surface treatment. These tubes, No. 29 and 31, were exposed for 240 hours. As shown by Figure 9, the paint coating blistered on the top edges and lifted from the tubing surface at the edge. Otherwise, the surface of the tubes appeared to be unchanged. Comparison of these results with those of painted tubes with a chemical film surface treatment would suggest no benefit from the surface treatment. However, according to reference (b), paint coatings may be attacked by the basic corrosion products of magnesium, causing underfilm attack which would result in peeling and blistering of the paint coating and loss of paint adhesion over an extended period of time.

FIG. 9 SALT SPRAY (FOG) TEST - 240 HOURS  
PAINT COATINGS ON MAGNESIUM TUBES (SEE TABLE I)

23. The standard Navy paint system, tested without a surface treatment of the magnesium alloy tubing, blistered only on the edges of the tubes. Although these tubes appeared to be protected on the surface, further study should be made on the paint adhesion before this system is recommended for use without a surface treatment.
