REPORT NO. 176

PROJECT CGTD J16/2-3-4

PHOTOELECTRIC ALARM DEVICE  
FOR ROTATING OPTICAL SYSTEMS

15 OCT 1958

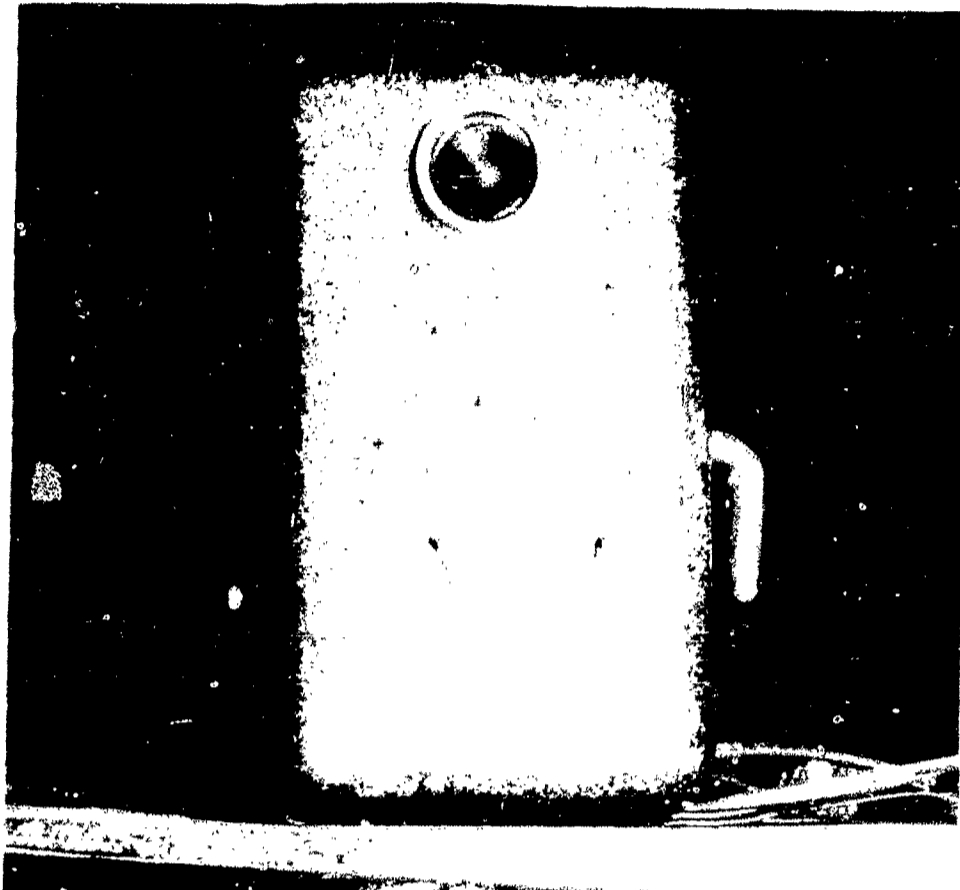
Figure 1  
Photoswitch Type 20DA2, Model  
1001 Photoelectric Control Device

It consists essentially of a light sensitive, gas-filled phototube (Type 1P40, S-1 response, non-hygroscopic base) and an electronic relay assembled as a package unit whose overall dimensions are 7-7/16" X 4-15/16" X 9-5/8" high. It operates from a 115 or 230 volt, 50/60 cps, power source. The manufacturer's ratings for the unit are as follows.

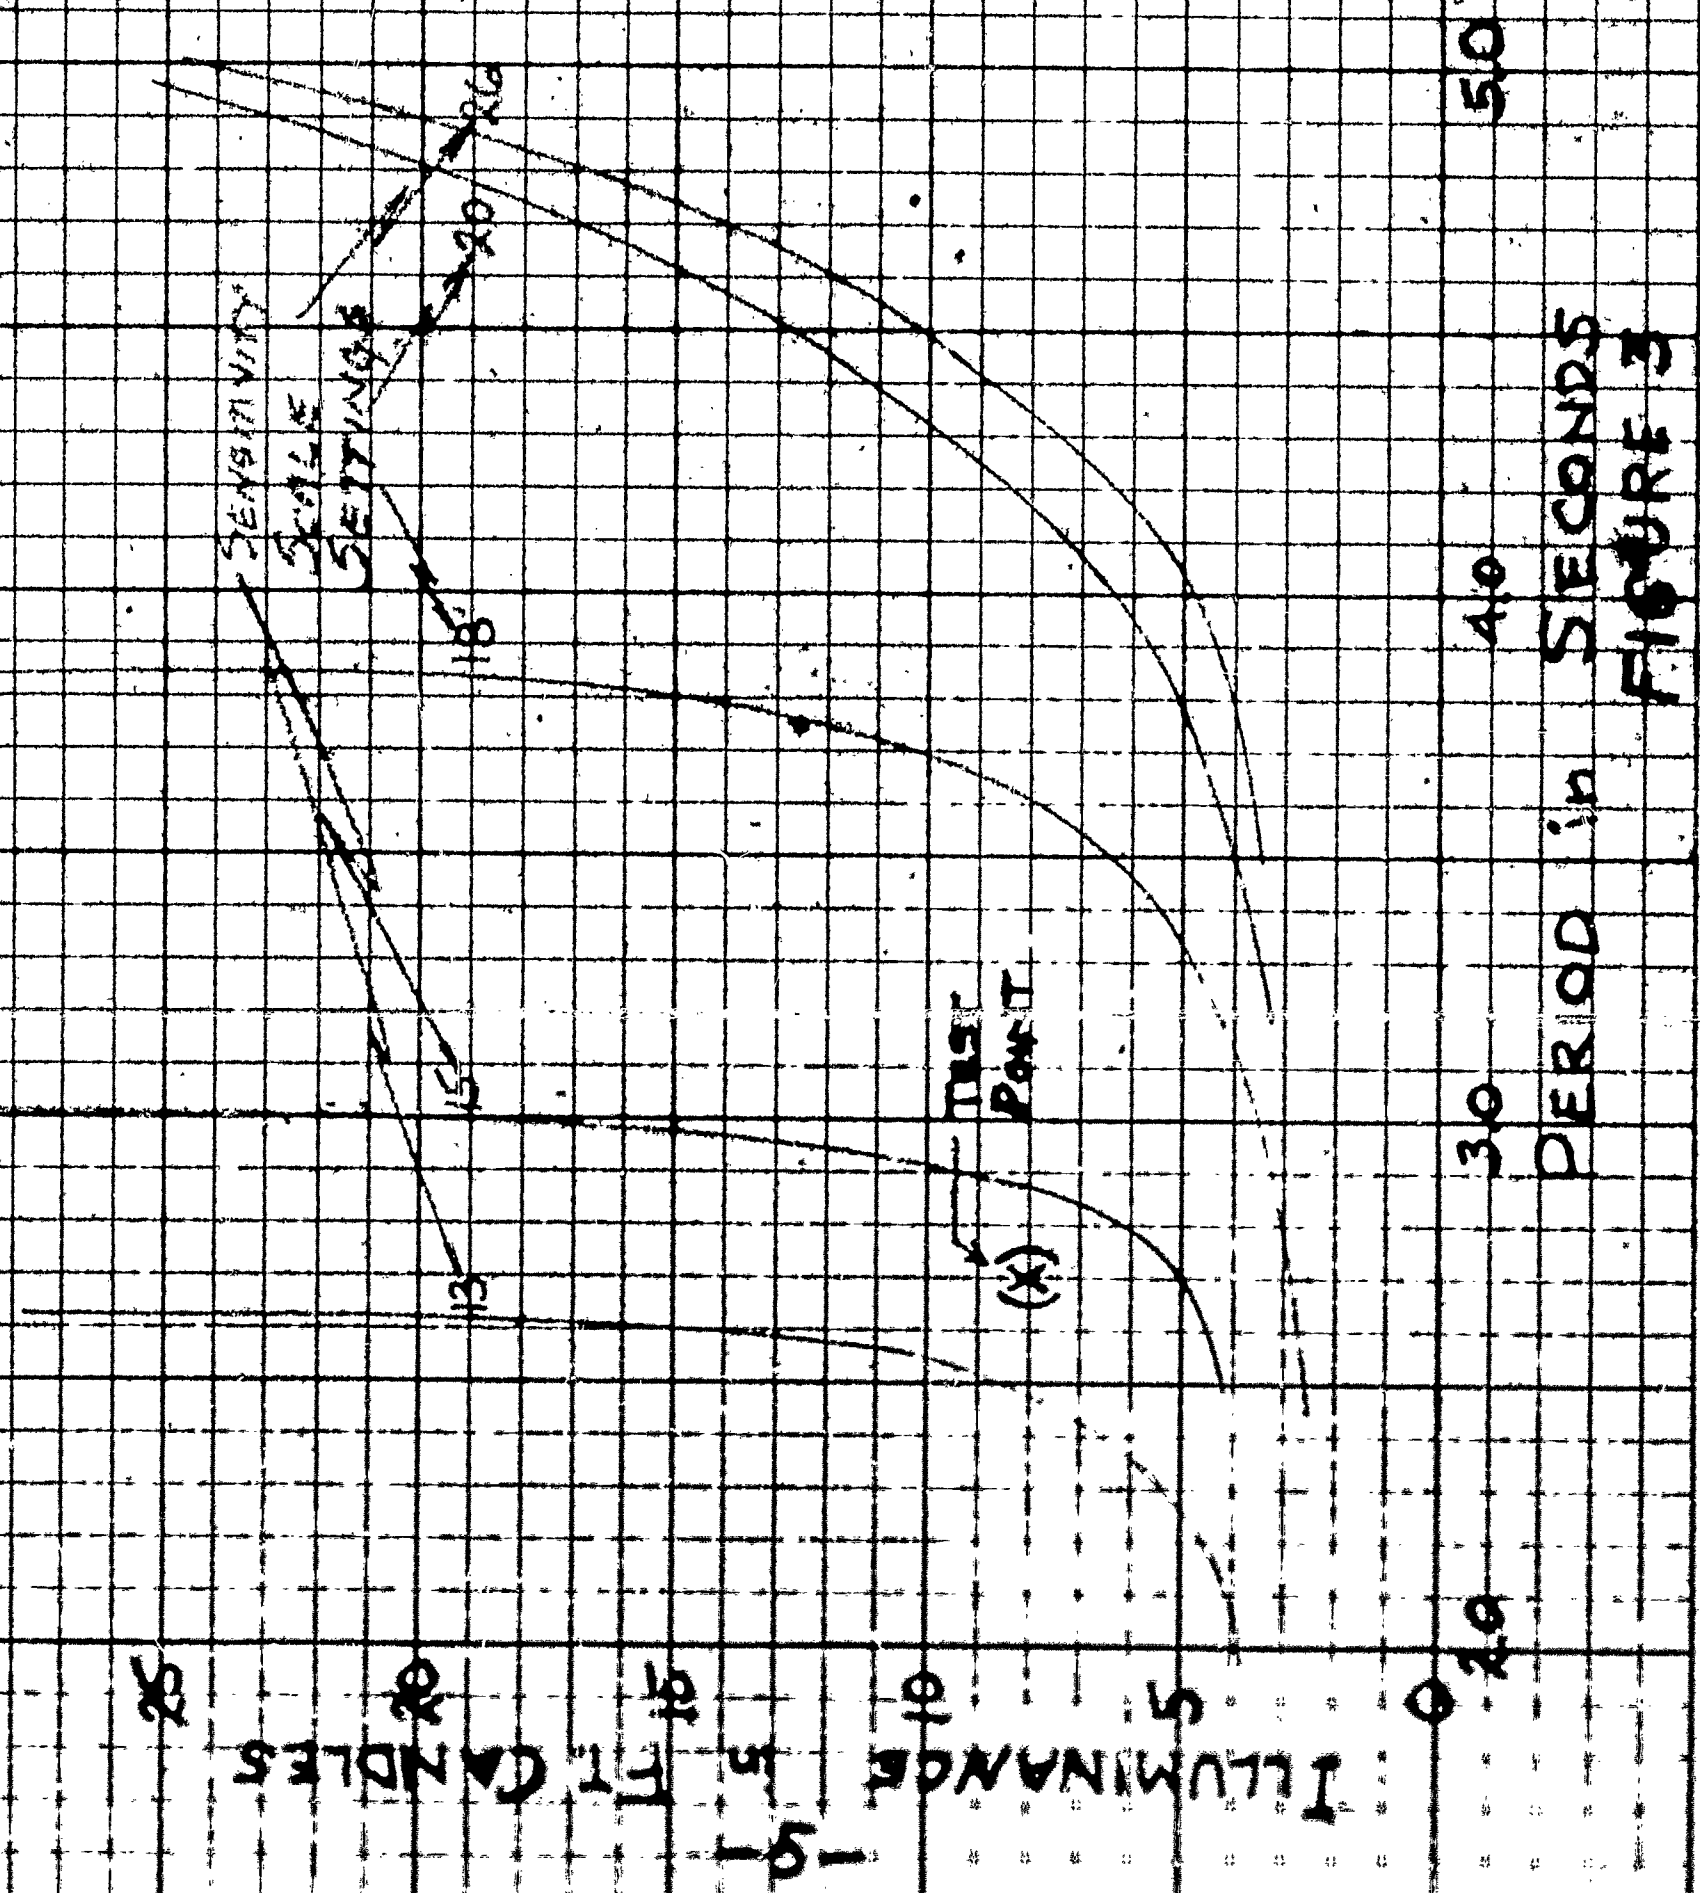
## FIGURE 3: CALIBRATION OF SENSITIVITY CONTROL MODEL ZODAR

7.1 Calibration Curves. The calibration curves for the alarm device are shown in Figure 3 (Page 5). The parameters on the curves are the arbitrary reference numbers on the scale which FTDU added to the sensitivity adjustment screw.

8.1 The calibration curves of Figure 3 indicate, in general, the range of illuminance and flash periods over which the tested alarm device operates satisfactorily in a new condition. It should be noted, however, that these curves apply to a specific light to dark ratio, which was not recorded when the data were taken.

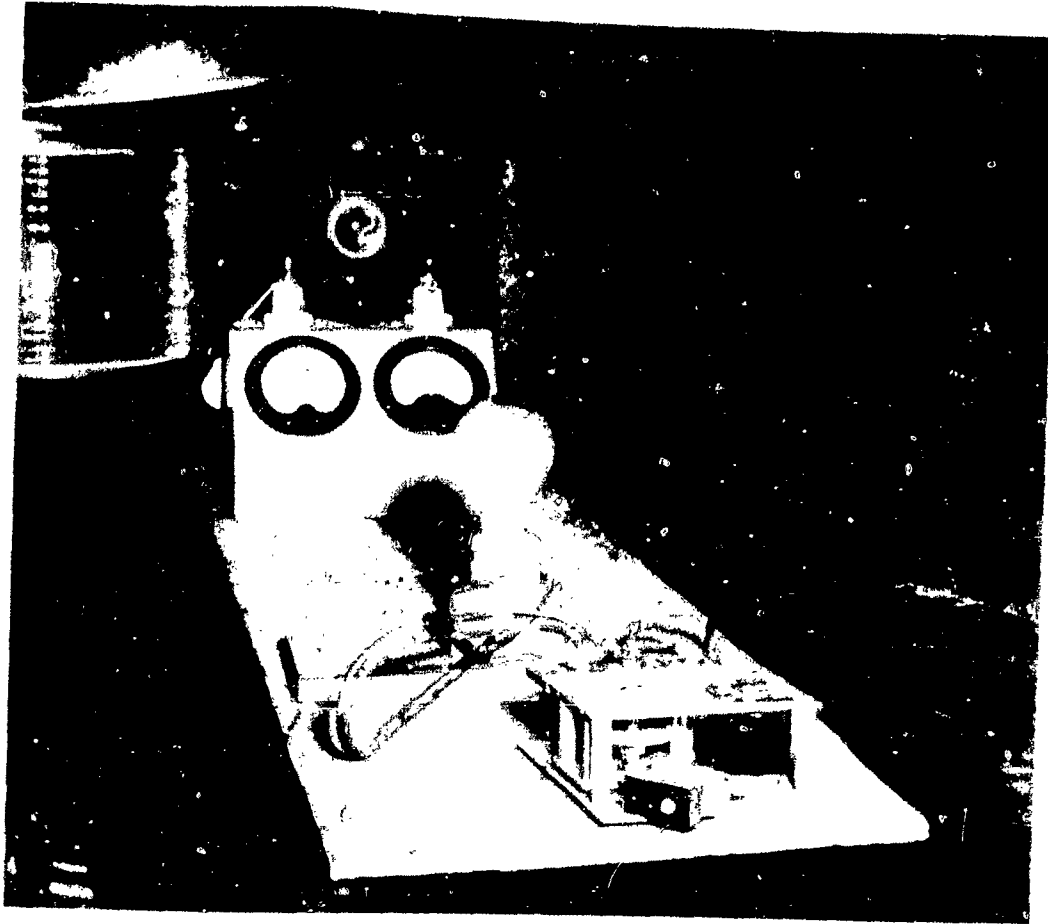
7.3 Second Endurance Test. For the second endurance test, the steady-burning lamp and rotating disc were replaced by a 115 volt, 15 watt lamp actuated by a Time-O-Matic timer equipped with a cam cut for a light to dark ratio of 1:5, the timer was set for a flash period of 4 seconds. The illuminance at the window of the alarm device was set at five foot-candles. The test set-up is illustrated in Figure 4 (Page 6).

Figure 4  
Test Set-up for Second Endurance  
Test of the Photoelectric Alarm Device

8.2 The results of the second endurance test are such that it can not be accurately determined how much of the apparent fatigue of the photocell in the device was actual fatigue, and how much was due to the slowdown of the flasher. The fact that the device operated properly, when, at the end of the test, the illuminance and flash period were restored to original values leads to the conclusion that much of the apparent fatigue was caused by flasher slowdown. In considering this conclusion, however, it should be noted that:
