PROGRESS REPORT 32

Project Vulcan.. **RESEARCH and DEVELOPMENT**

R61APB769-32

PROGRESS REPORT NUMBER 32

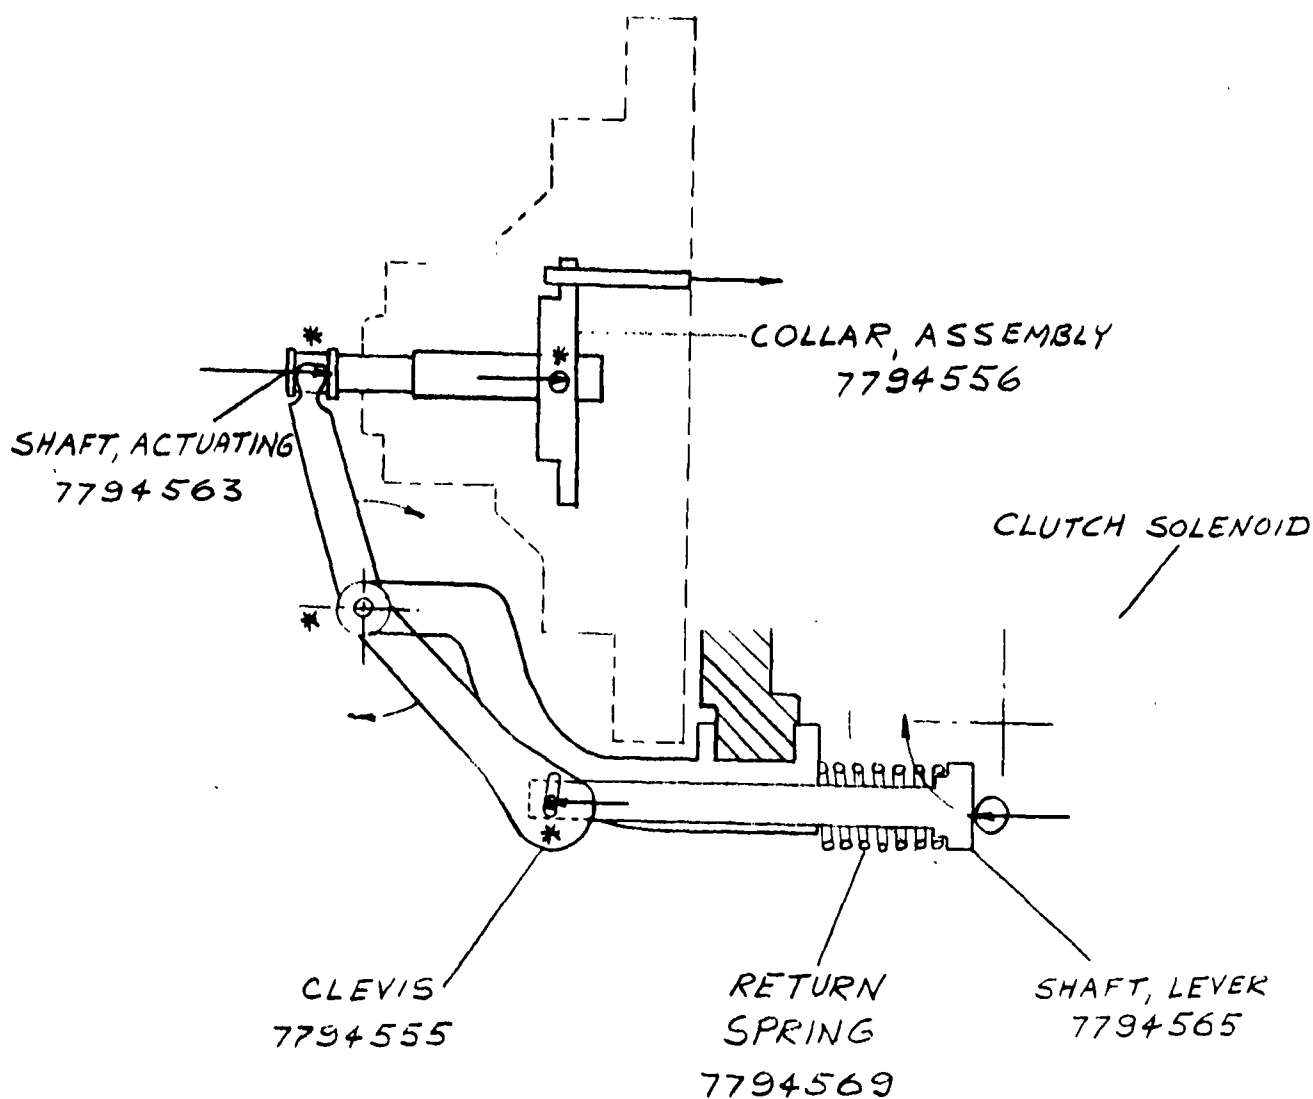
Figure 3-1. Clutch Actuation Linkage

The difficulty lies in the fact that the spring return force in the linkage is being applied at the wrong location, i. e., on the shaft lever 7794565. In addition, to impart a turning moment on the clevis 7794555 there is required a slot on the clevis to transform the axial force from the lever shaft to a turning force. Finally the tolerances are additive between the various components in the clutch linkage, especially between the clevis and the actuating shaft 7794563. These three conditions all add up to a situation in which there is a glaring lack of control of the pin and collar in the present design. This is illustrated in Figure 3-1. Those linkage connections designated with an asterisk (*) are points where tolerance conditions are unavoidable and detrimental to the linkage function. To move the collar assembly from its re clutch to its declutch position it is desirable to have these linkage junction fits closed tightly. Note, however, that when the clutch solenoid imparts a force to the lever shaft, the return spring merely serves to keep the lever shaft tight against the solenoid pin. Although the linkage system is responding to a force signal, the only forces which are available to close up the various junction fits are the minute inertia forces on the parts. These are believed easily overcome by gun vibration forces. The worst junction point is the clevis connection to the lever shaft. The clevis has a slot in which rides a spring dowel pin fastened to the lever shaft. Rotational motion of the clevis results from a camming action of the pin in the slot. The change of angle of the slot, occurring when the clevis rotates, results in practically no resistance to forces (such as gun vibration forces) in the opposite direction. All of these situations combine to create a lack of control on the pin and collar (the key part in the declutching operation) during its travel from the re clutch to the declutch position. This lack of control is shown in Figures 3-2 and 3-3.

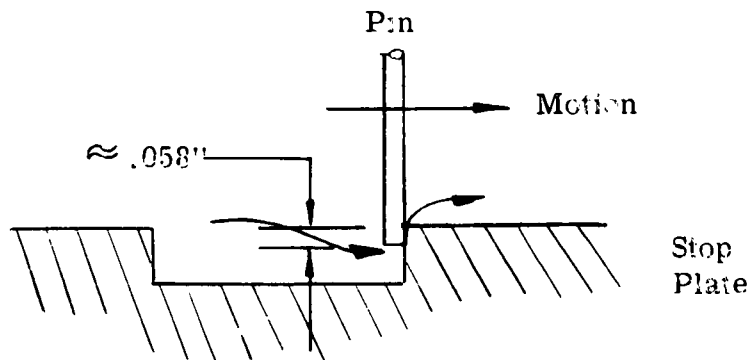
Figure 3-4. Sketch Showing Approximate Depth Pin Could Engage Slot End and Slip Out After Starting Clutch Action

Figure 3-4 shows what this means. On some occasions the pin could enter a stop plate slot and while at a depth of 0 to .058" strike the slot end. After clutch actuation has commenced vibration could shake the pin out of the slot thus interrupting the clutch actuation allowing the traveling lock ring lugs to be jammed between the gear drive lugs and the stationary housing lugs. This .058" looseness must be eliminated.

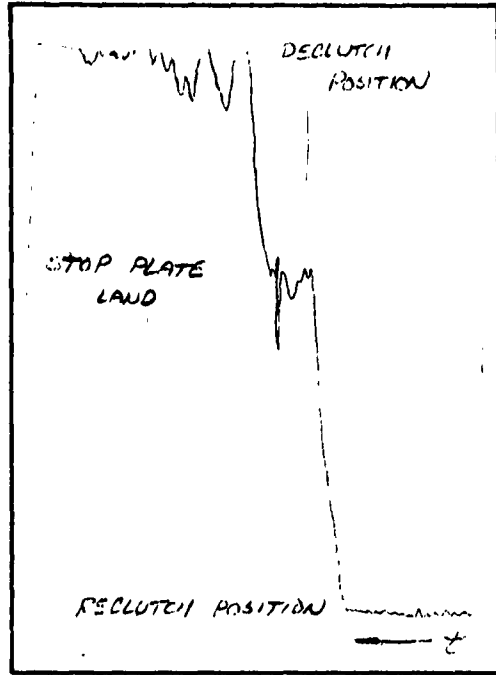
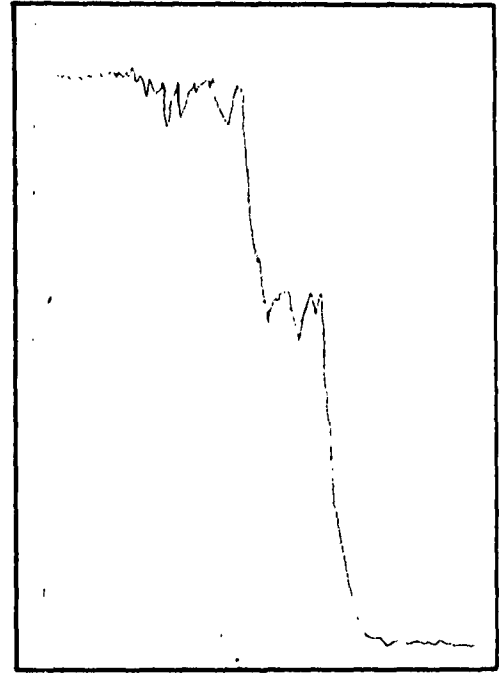
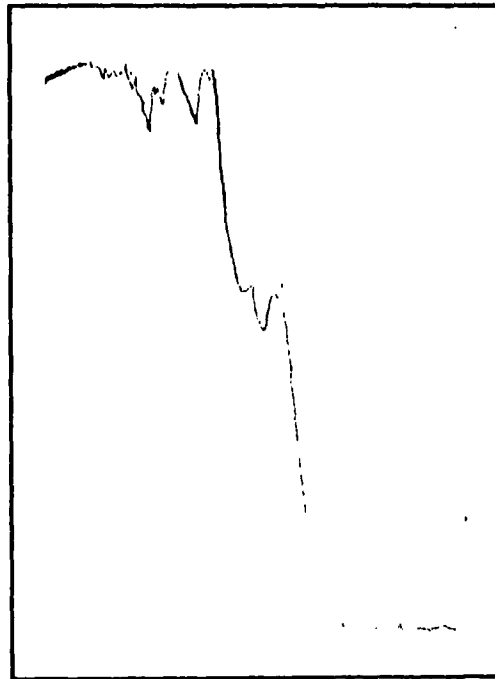
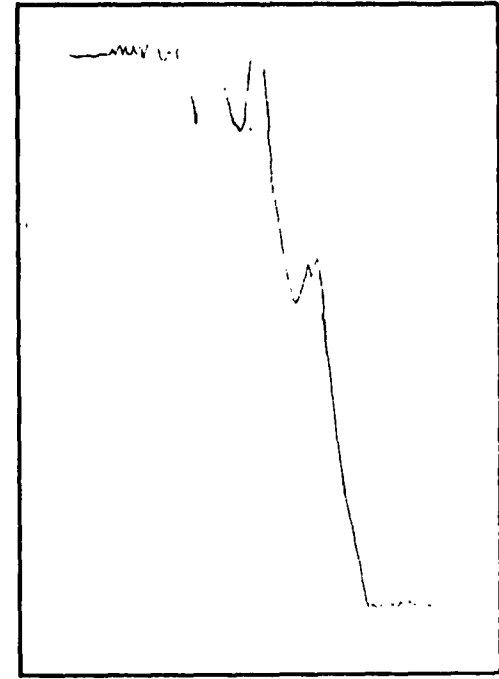
Figure 3-9 Typical Pin And Collar Motion On Proposed Clutch Design

Figure 3-9 shows four typical oscillograph traces of displacement vs. time for the actuating shaft in the present clutch. They are to be compared with four typical oscillograph traces (Figure 3-10) of the actuating shaft in the proposed clutch linkage. Note the reduction in bounce obtained where the pin on the pin and collar has struck a land between the slots in the stop plate.

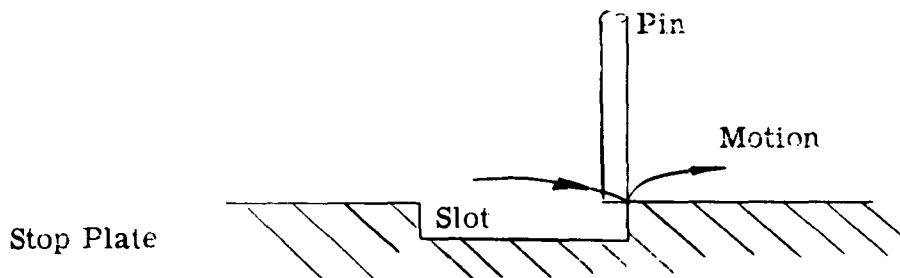
Figure 3-11. Statistically Remote Corner to Corner Condition of Pin on Slot End

The proposed design was compared with the existing design by cycling the same feeder clutches, with both methods of clutch actuation, on the bench tester. At the beginning of each test a new pin and collar and a new stop plate were placed on the test feeders to eliminate the possibility of wear on these parts causing declutching malfunctions. Feeders with the new proposed design consistently averaged about one malfunction in 600 declutching operations as opposed to about 2 out of 300 for the existing design. It is believed that it is still remotely possible to get a malfunction if the clutch is actuated under exactly the right circumstances such that the pin on the pin and collar strikes the stop plate slot end corner to corner as shown in Figure 3-11. This condition may be enough to start clutch actuation before the pin slips free to set up a declutching malfunction. Very little wear is caused during malfunctions of this nature and its occurrence is so statistically remote that a solution to this situation is not warranted.

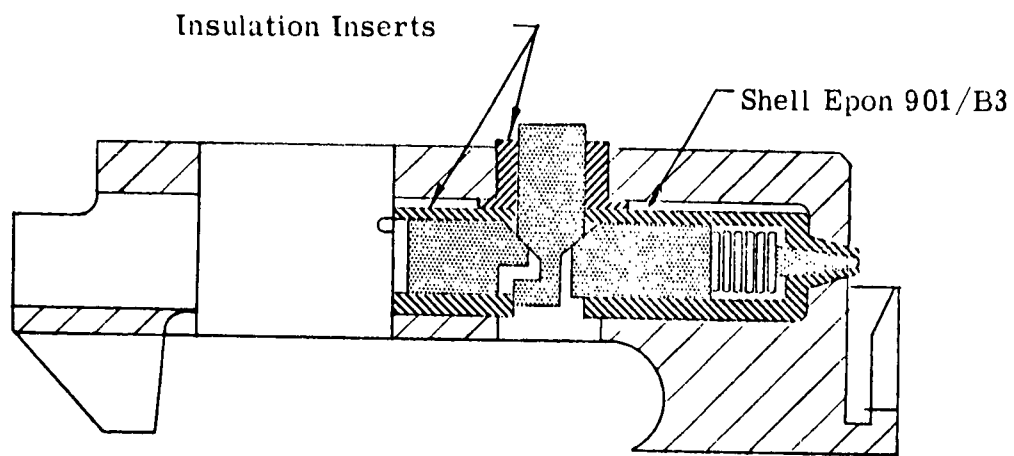
Production of the bolt body has been hampered by the high rejection rate of parts received from the plastic molding vendor. From April through November 1961 (40%) of the 7790675 bolt sub assemblies were defective and required MRB action (1809 of 4547 parts). This action resulted in 60% of these units being returned to the vendor for remolding (1090 of 1809). These parts were returned because of poor plastic quality.

To use the inserts it is necessary to make several minor changes to the 7790674 bolt body. These changes are shown in Figure 5-6. The tighter tolerance on the firing pin and cam pin holes is necessary to obtain a

fit of .001 tight to .003 loose with the insulator (with the insulation molded in place, the size of the holes was of little consequence). An included angle taper of $3^{\circ}40'$ was added to the cam pin hole to assure that the insulation will not be forced out of the bolt during normal operation. Failures of the retaining tabs occurred before the taper was employed. There have been no failures with tapered inserts (see test summary below).

As shown in Figure 5-6 the firing pin insulator is held in place by Shell Epon 901/B3 adhesive. The purpose of the adhesive is to retain the insert when the bolt body is disassembled. Because this was a last minute change requested by OWC, most of the range testing was conducted without the adhesive. However, early in the test program three sets of inserts were locked in place by Epon 901/B3 and were fire tested for 19,000 rounds without coming loose.

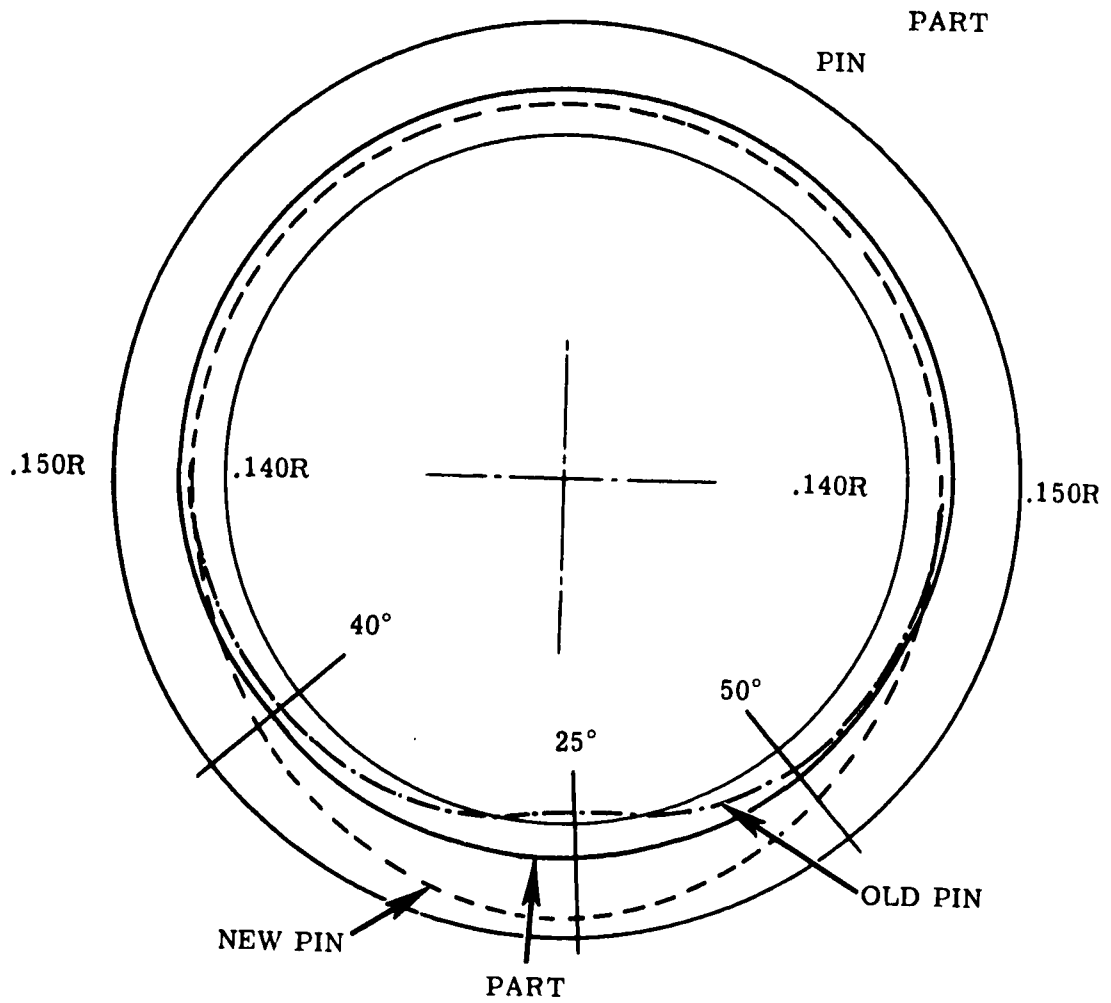
Figure 5-9. Old and New Pin/Part Relationship

One of the major problems which was encountered in molding the inserts was an out of round condition of the firing pin insulator I. D. The I. D. varied from a minimum of .283 to a maximum of .288 inches (drawing dimension .282 + .003). To make the core pin, shrinkage of the plastic was estimated as .002 inch therefore the core pin was machined to .2863 inch. By sectioning the resulting parts and examining them on a shadow graph comparitor it was discovered that the plastic was .008 inch larger on a side than the core pin except for the area under the insulator flat (see Figure 5-9). This area showed a shrinkage up to .004 inch. To compensate for this shrinkage a pin with a bump on it was manufactured as shown in Figure 5-10. With this pin the parts were produced to the drawing tolerances.

A second problem which has been encountered is the poor concentricity of the .282 + .003 diameter with the .100 + .002 diameter. Figure 5-9 shows that this condition is the result of the part being distorted. It is felt that this distortion is caused by the placement of the molding gate. To eliminate this problem the gate will be moved to the thin (flat) section of the insert. It must be pointed out that the concentricity is within drawing tolerances when the insulator is inserted in the bolt body.
