Report HTC-62-39

THE HIPEG SYSTEM

(20mm Aircraft Gun Mk 11 and Gun Pod EX 1)

Progress Report for May 1962

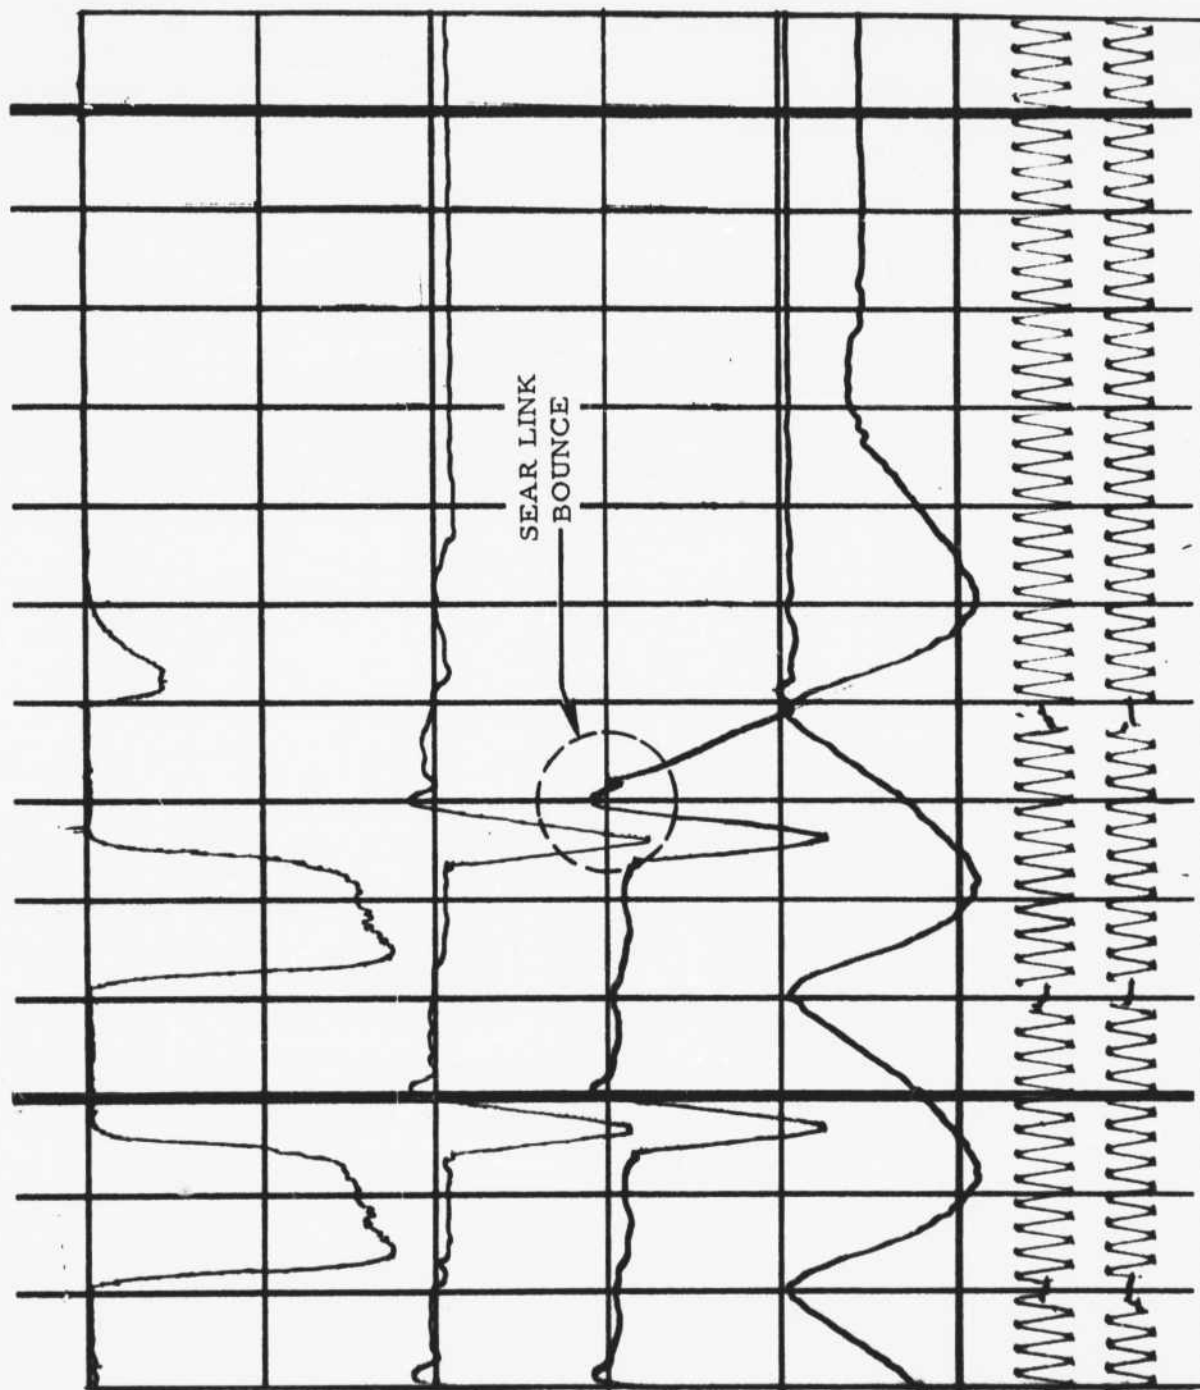
Figure 3. Oscilloscope Showing Sear-Link Bounce

One recording was made (Figure 3) that shows that the sear link bounced out of engagement. The sear did have a mouse-trap spring which shows that the spring was inadequate and was not preventing sear link bounce. A sear latch is being tested on the R & D gun that will prevent sear bounce by latch action. The latch operates in the following manner: As the sear link cams over the sear, the sear link rotates the latch out of the way. When the sear link moves into the sear position, the latch rotates and positions itself under the link. An over-center lock is established by this latch and the sear link cannot bounce out of engagement.

Of the 16 loader stoppages recorded, 12 had to do with ramming. Ten of these were failures to resear and two were failures to ram deep enough. As stated earlier, the resear problem is being attacked with more instrumentation. Part of the problem has now been definitely proved as being caused by sear link bounce. Some of the failures to resear may also be caused by rammer contamination, which in turn would result in energy loss. It appears that the sear link bounce can be corrected by the rammer latch now under test.

The latch principle is the same as that used to eliminate pawl bounce in the 30mm Mk 1 feeder. High-speed movies have been taken of the rammer latch during gun firing and performance is as designed. There is no latch bounce and good locking action is provided.

Present plans call for continued testing to verify these initial results

and to establish if causes other than sear link bounce may be contributing. In the interim, latch hardware will be made for the Reliability Test guns.

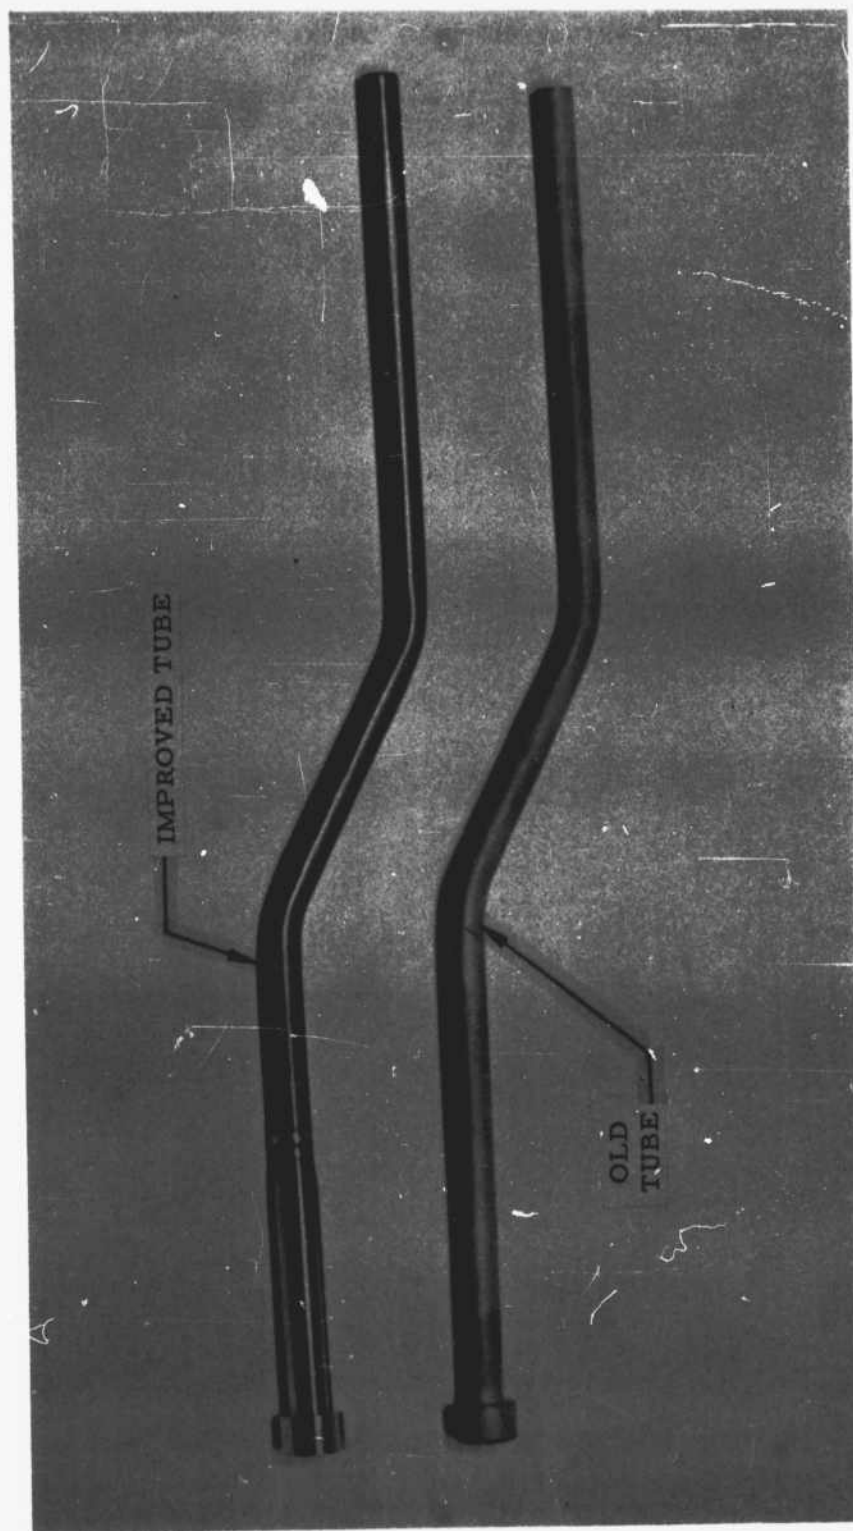
Figure 4. Ejection Gas Tube Redesign

One stoppage was the result of a broken gas ejection tube. The flange at the upstream end of the tube parted from the basic tube. The part was redesigned and the new and old parts are compared in Figure 4. The flange was made stronger and the welded joint moved downstream.

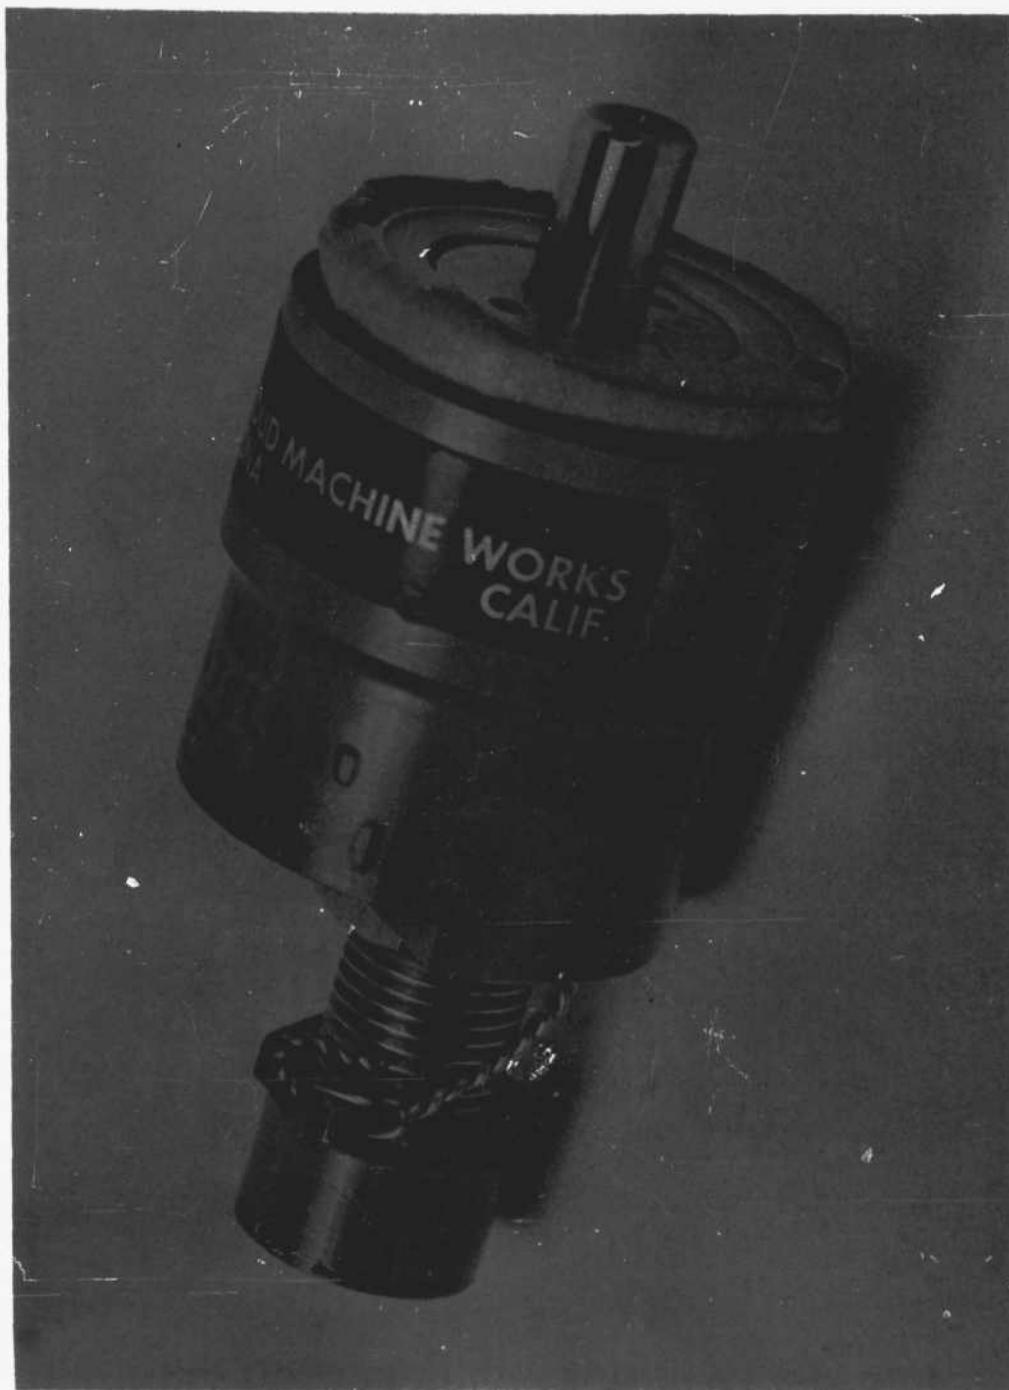
Figure 5. Liquid Spring Buffer for Loader Rammer

The liquid spring buffer (Figure 5) for the loader rammer was mounted in the test fixture as shown in Figure 6. Approximately 1000 cycles were applied, and land photographs of oscilloscope traces were recorded as shown in Figure 7. The data collected indicates that the liquid spring buffer as installed has a 60% efficiency. This is 10% lower than that recorded with the pneumatic buffer. The additional loss is partially due to the heavier piston in the liquid spring. Assuming that satisfactory function can be achieved with this spring, the advantages of it outweigh the 10% loss in efficiency.

One of the springs was placed in a low temperature chamber for 24 hours. The low temperature of  $-65^{\circ}$  did not induce a seal leak. No dynamic tests at this temperature have been performed as yet.

The next step in the liquid spring tests is to mount the springs on loaders of firing guns. One spring will be mounted on a reliability gun and the other on the R&D weapon.
