HEADQUARTERS  
62ND ENGINEER BATTALION (CONSTRUCTION)  
APO 96321

31 October 1966

SUBJECT: Operational Report - Lessons Learned (RCS CSFOR-65), for Quarterly Period Ending 31 October 1966.

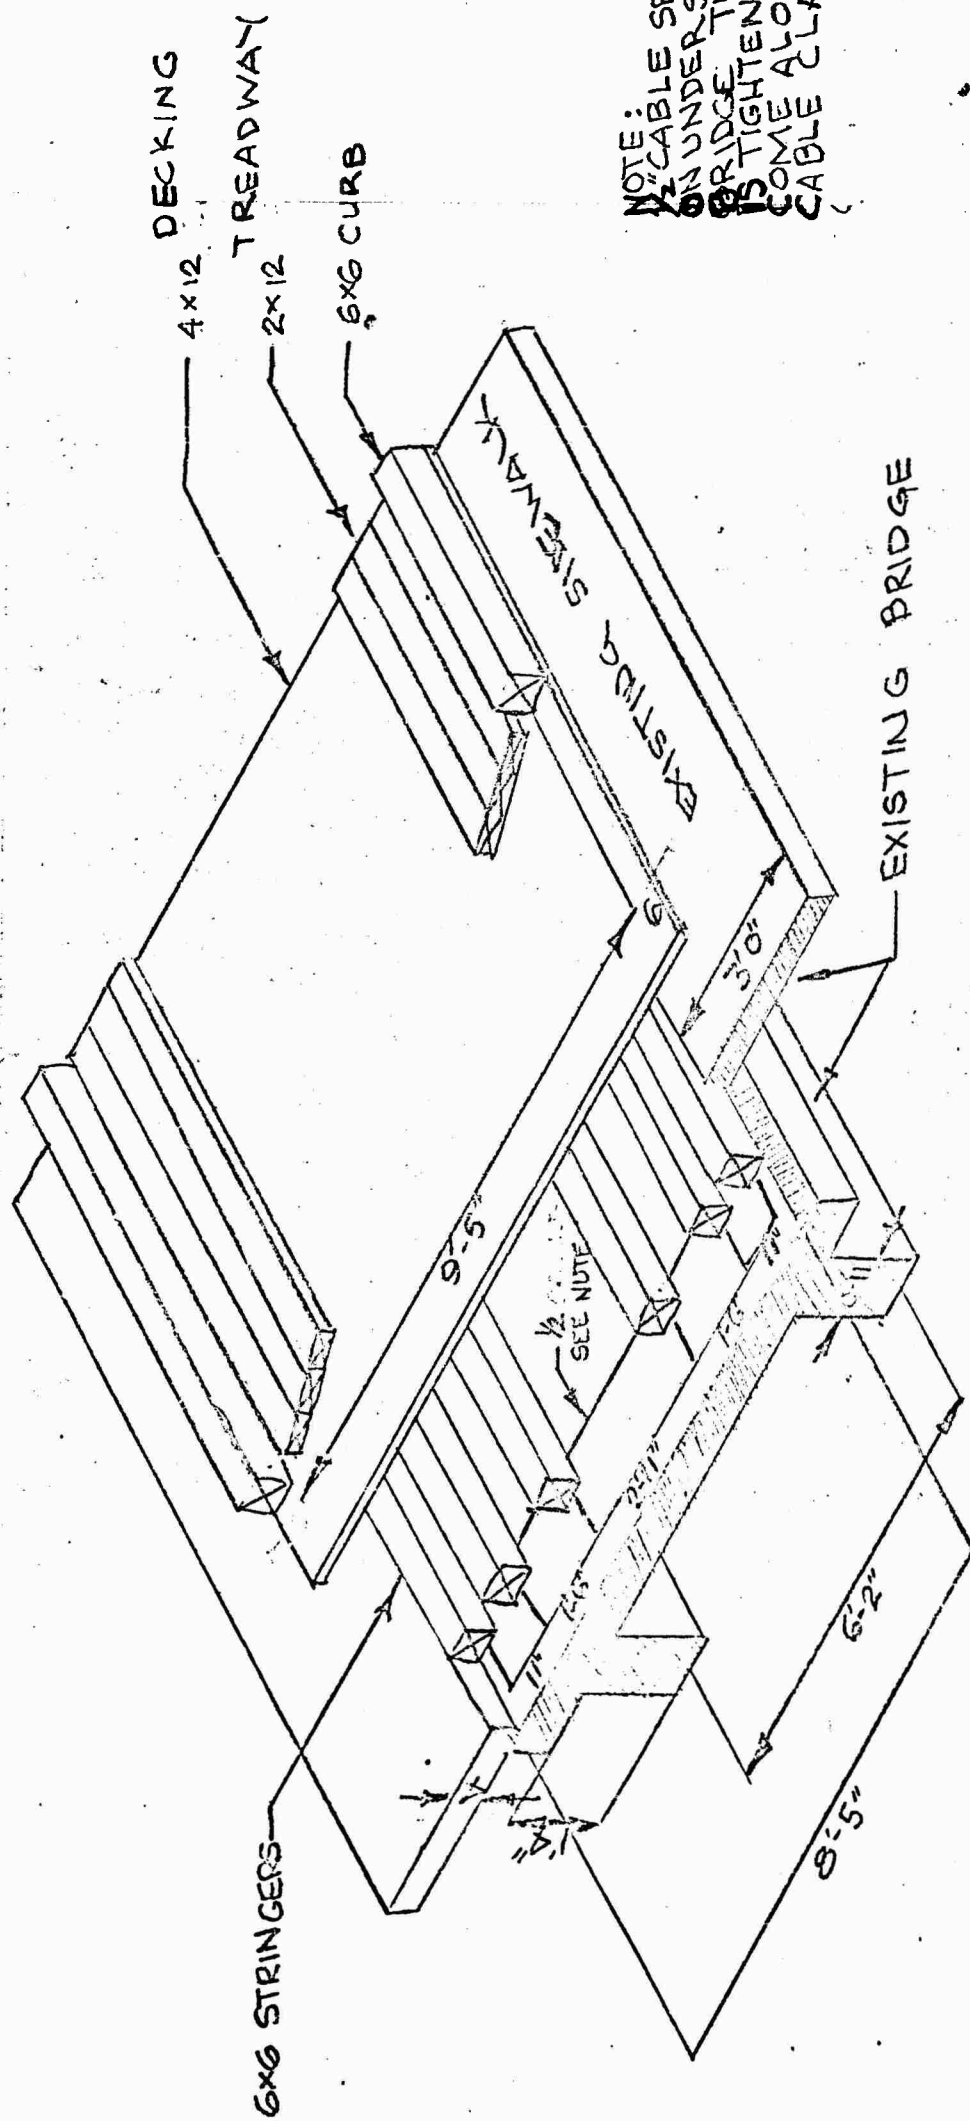
# BRIDGE REPAIR DETAIL

DISCUSSION: Throughout Ninh Thuan Province, RVN, along Routes QL#1 and #11, there are numerous masonry bridges. The bridges vary in length but have the same cross section which consists of a roadway which is 8.25 feet wide and .58 inches thick. There are two concrete beams supporting the roadway and are 1.33 feet by .87 feet. Sidewalks are cantilevered from the roadway and are 4 inches thick. Due to the restricted roadway width, standard US Military Vehicles consistently utilize one side walk for the roadway. This practice has caused failure of the sidewalk which is manifested by complete shearing of the sidewalk section from the bridge structure. The resulting structure is a hazard to military and civilian traffic.

NOTE:  
1" CABLE SECURED  
ON UNDER SIDE OF  
BRIDGE. THE CABLE  
IS TIGHTENED BY  
COMING ALONG AND  
CABLE CLAMP

OBSERVATION: Sidewalk failures as described above have occurred on several occasions on bridge along Rt QL # 1. A method of repair which consists of decking the damaged span as shown in inclosure 1 has been used with satisfactory results. Average manhours required per linear foot of decking is 2.1 .
